ATWORTH ARBORICULTURE LTD

PICUS TOMOGRAPH TEST ON NINE OAK TREES AT LYONS OAK.

Prepared for: Calibra Tree Surgeons.

The Inspection was carried out on the 6th July 2020. The conditions were dry and clear. The Inspector was Kim Dear.

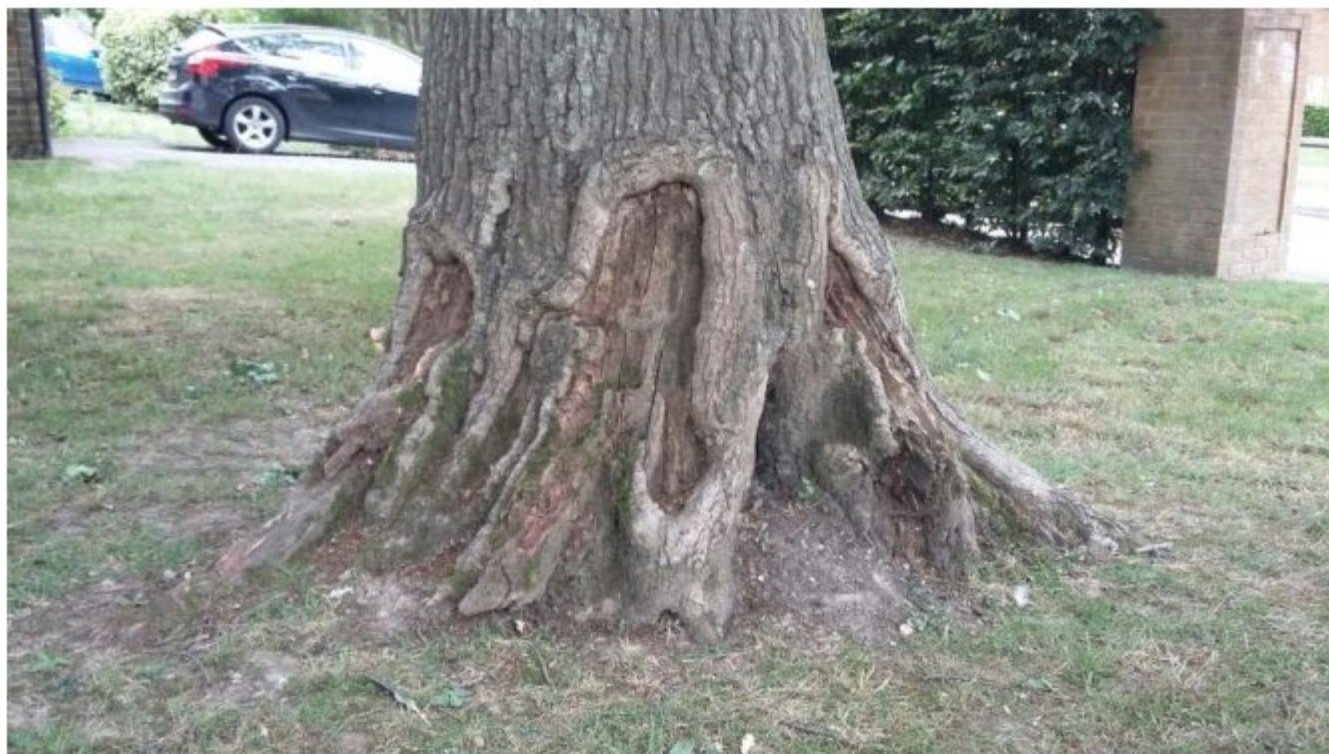
Photo 1. Tree 1.

There are bark wounds from the north west to the east from ground level to 1m (Photo 1), with some decay into the buttresses. The crown is in fair condition with minor deadwood.

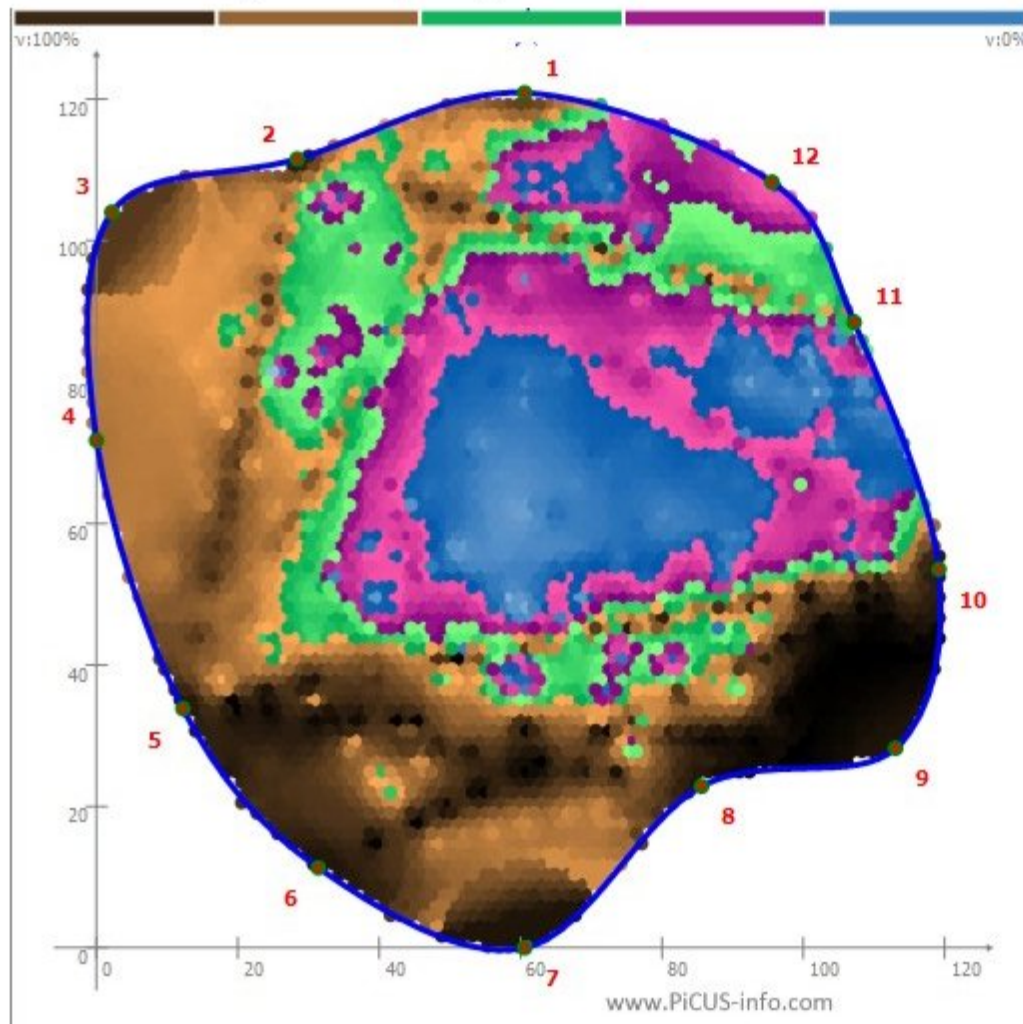
Picus Tomograph result t1 at 35cm agl.

The tomograph shows an area of decay to the East and North of the stem with a cavity shown in blue, advanced decay coloured pink/purple and the incipient or early decay coloured green.

The area of decay is fairly extensive at this height, and the visible deterioration of the buttress roots also raises concerns as to the tree's stability.

As a TPO is in place on this tree the local authority is reluctant to allow removal. Regular monitoring is therefore recommended as part of the tree management schedule.

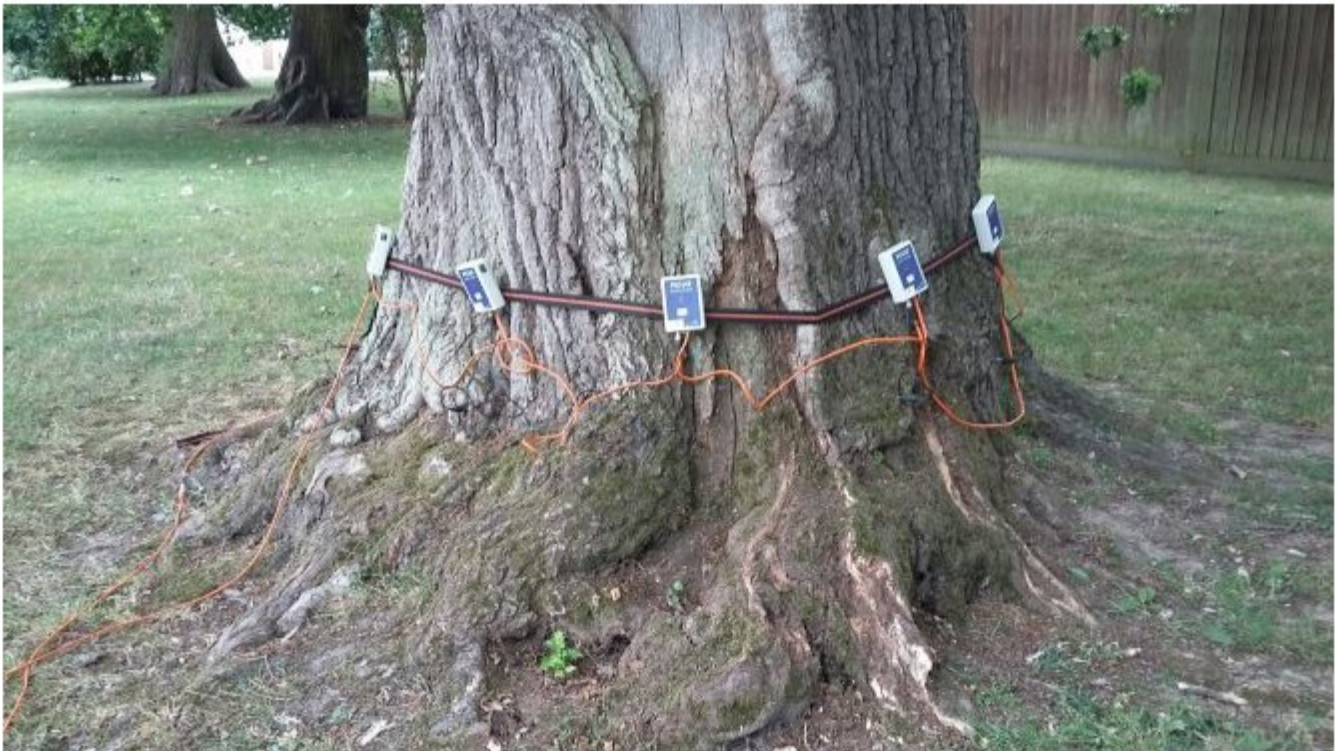
Photo 2. Tree 2.

This tree is situated 4m east of T1. There are bark wounds at 1.5m to the North, from ground level(gl) to 1m to the East, and from gl to 1.6m above ground level (agl) to the south. The crown appears sparse with minor deadwood. There is also damage and decay in the buttress roots. (Photo 2).

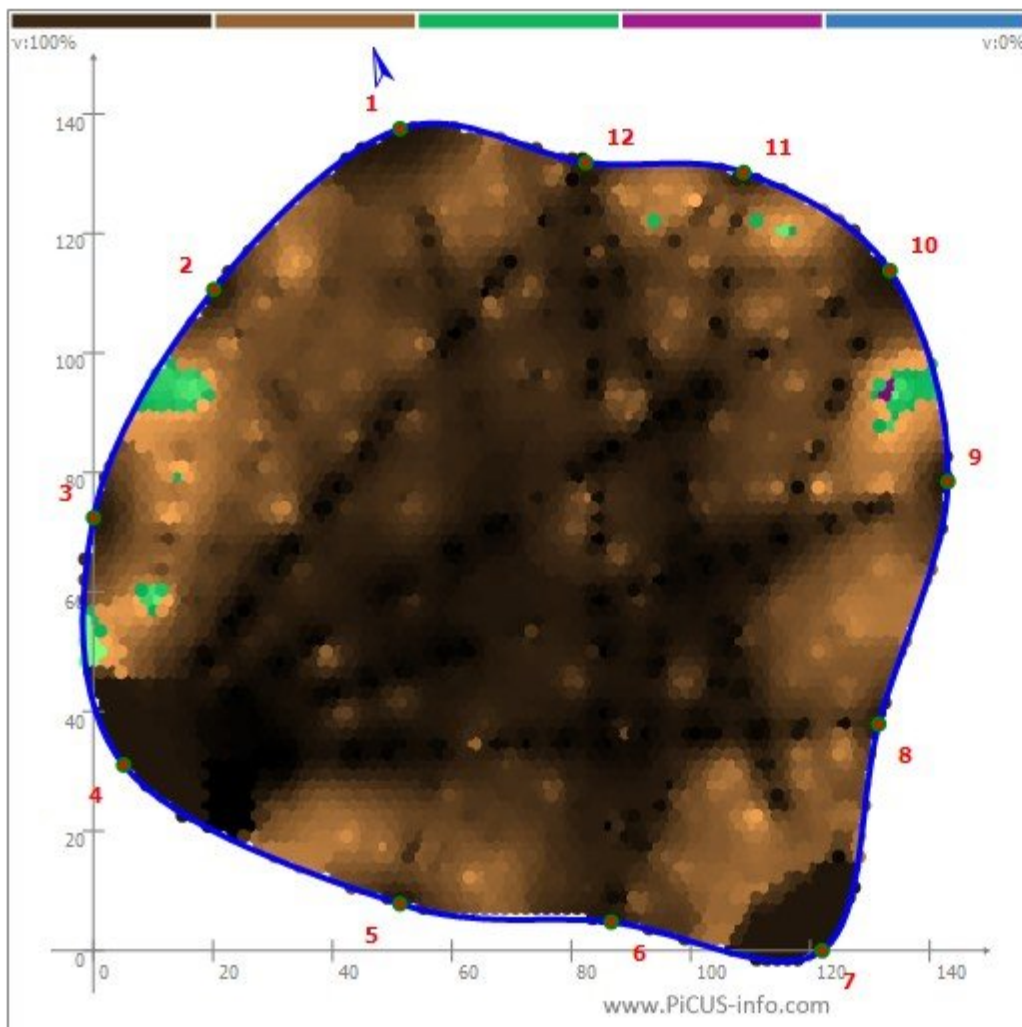
Picus tomography image T2 at 30cm agl.

The Picus image indicates sound wood coloured brown, with some minor patches of early decay to the East and West coloured green.

Re-test in 5 years, or sooner if the tree shows signs of decline.

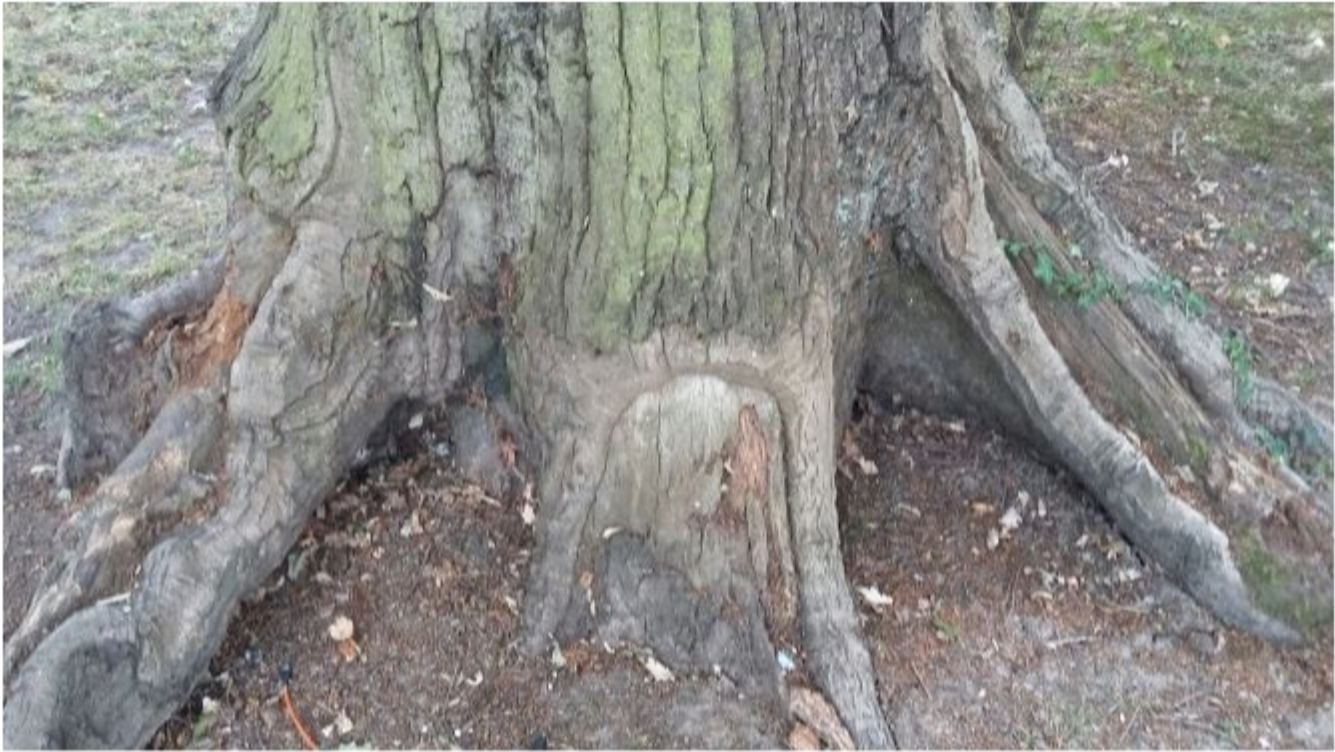
Photo 3. Tree 3.

This tree is situated 14m East of T2. It has three distinct buttresses (Photo 3), to the North, North West and North East, all are damaged and decayed. There is a further bark wound at 1m agl to the South which is occluding. There is minor deadwood in the crown and epicormic growth on the main stem.

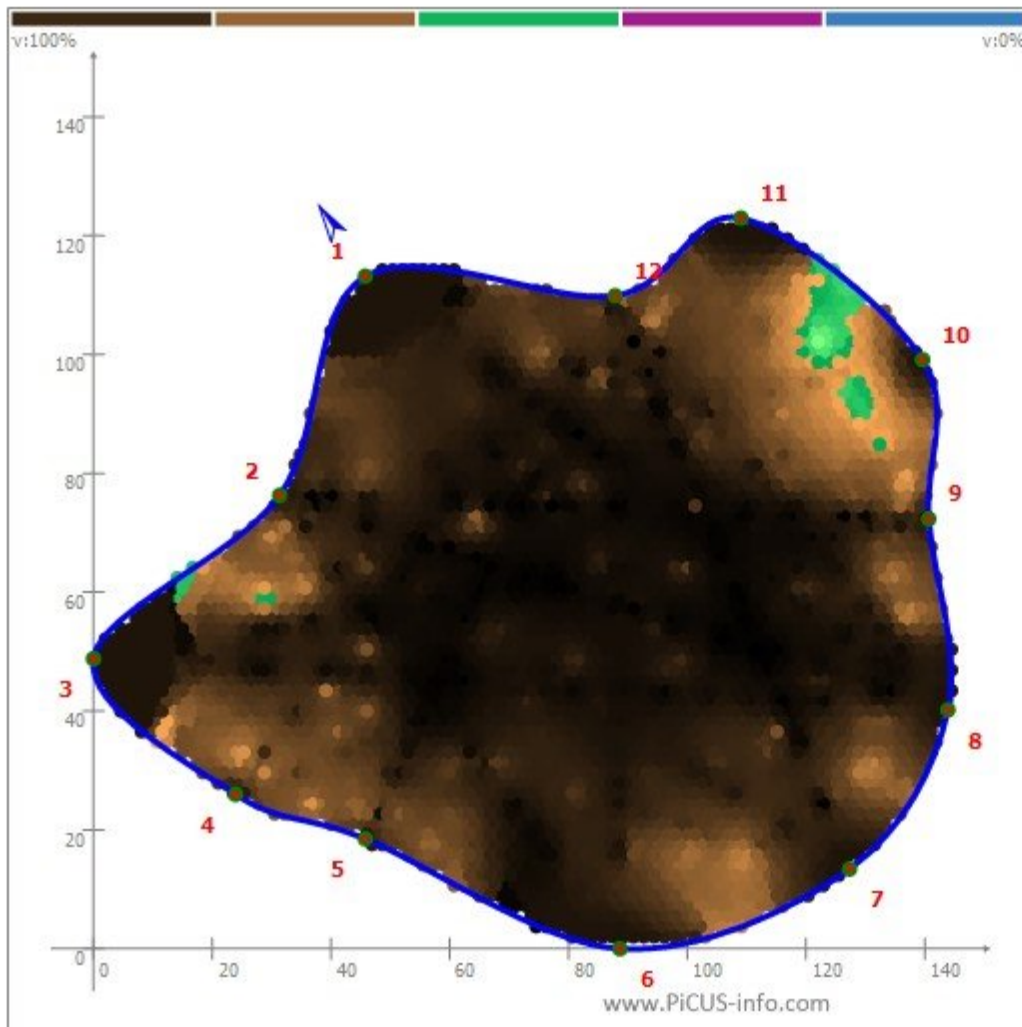
Picus tomography image T3 at 40cm agl.

There is sound wood at this level indicated by the brown colouring, with a small patch of early decay indicated by the green colour to the East.

Re-test in 5 years or sooner if the tree shows signs of decline.

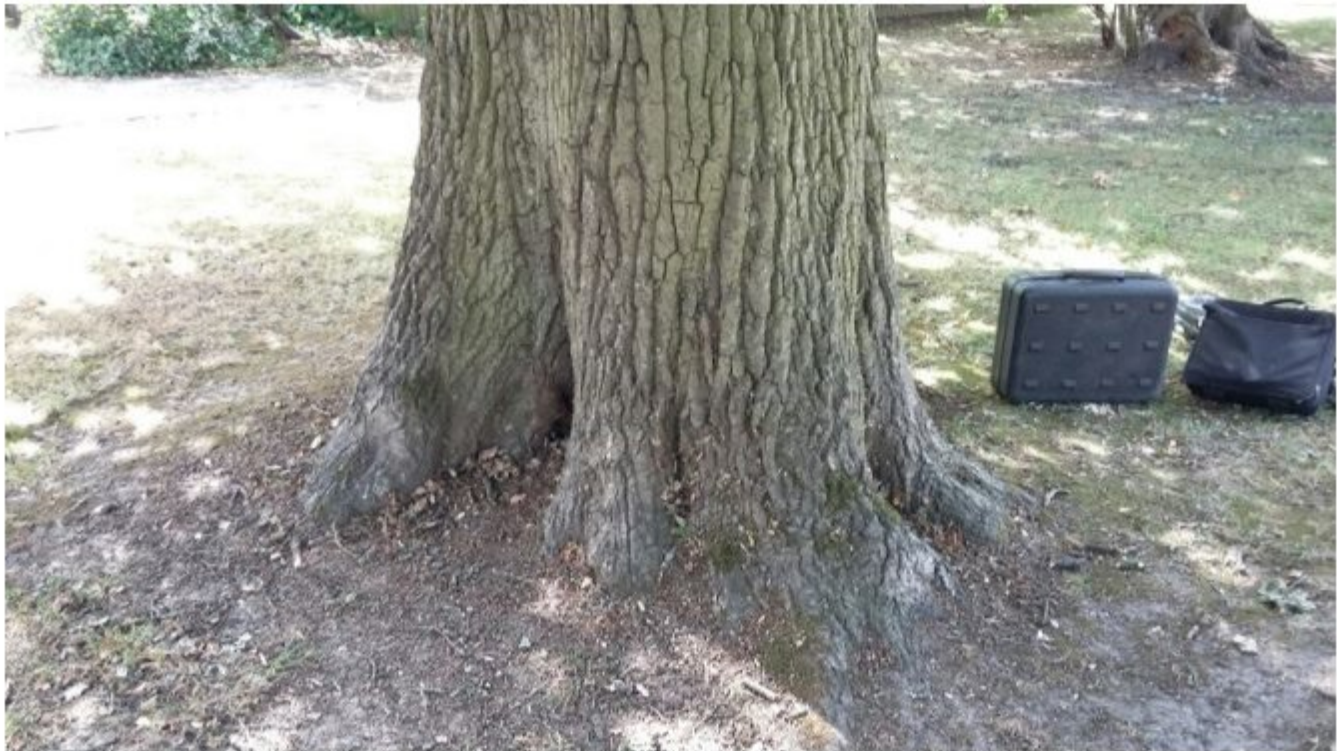
Photo 4. Tree 4.

This tree is situated 8 m East of T3. It appears in fair condition, with old pruning wounds on the main stem.

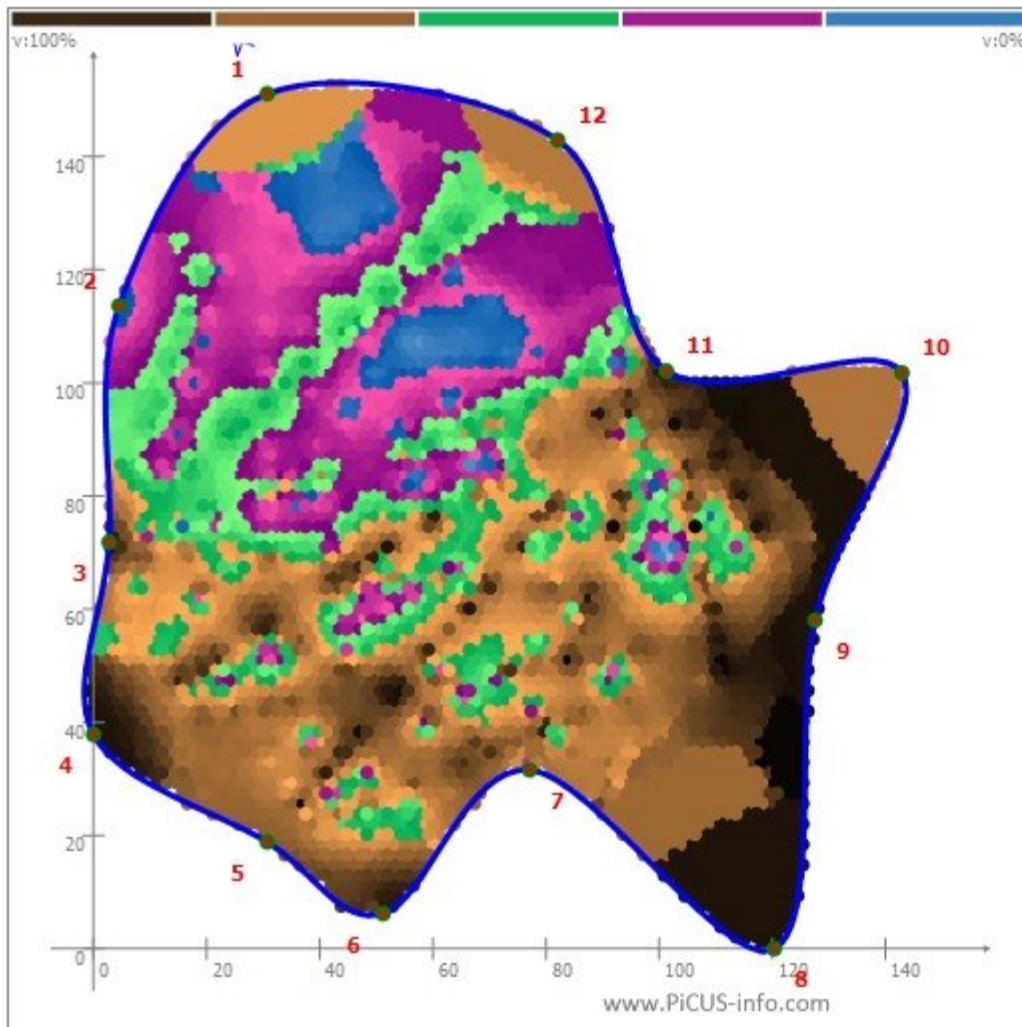
Picus tomography image Tree 4 at 20cm agl

There is an area of early decay to the North indicated by the green and purple colouring.

As with tree 1, careful monitoring is recommended with a further test in 5 years, or sooner if there is a decline in the trees condition.

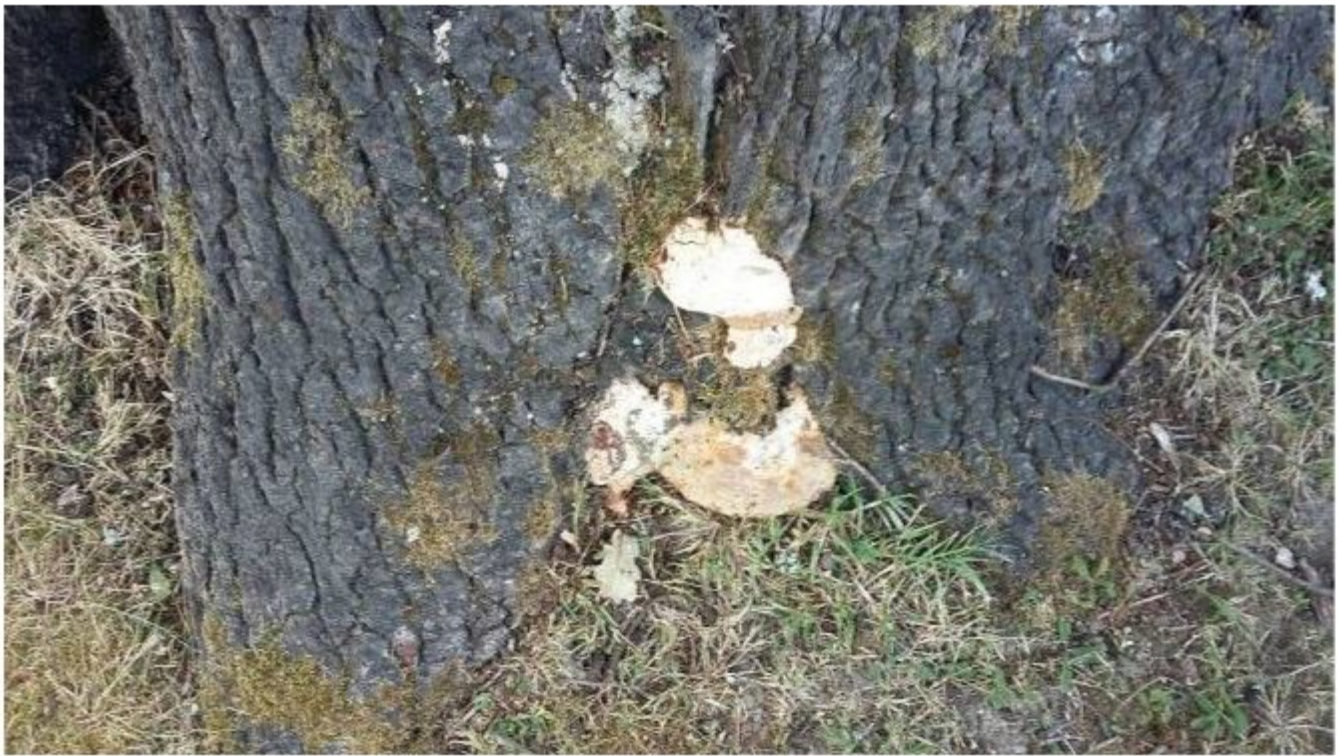
Photo 2.

This mature tree is situated on an area of common land to the west of the entrance to Lyons Oak. (Photo 1). It has a slight lean to the north and a sparse crown. There are fungal brackets (Photo 2) to the south, west and north east at ground level, most likely *Inonotus hispidus*. The tree has been reduced in the past.

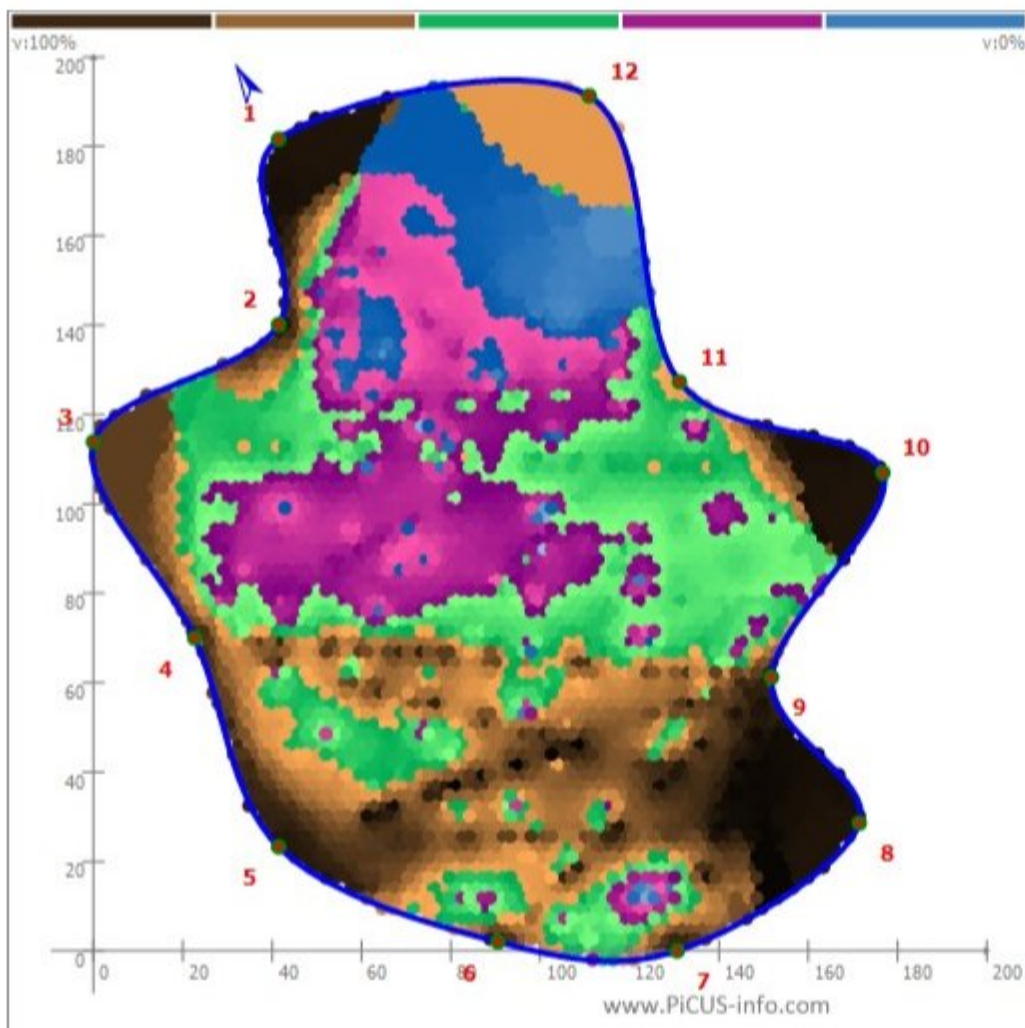
Picus Tomograph result T5 at 10cm agl.

The Tomograph shows an area of decay to the North East of the stem with a cavity shown in blue , advanced decay coloured pink/purple and the incipient or early decay coloured green.

There is a significant area of decay which is likely to degenerate further with the active growth of the fungal pathogens.

Discussion on site with Mark concluded that the tree should be reduced, particularly to the north over the neighbouring garden.

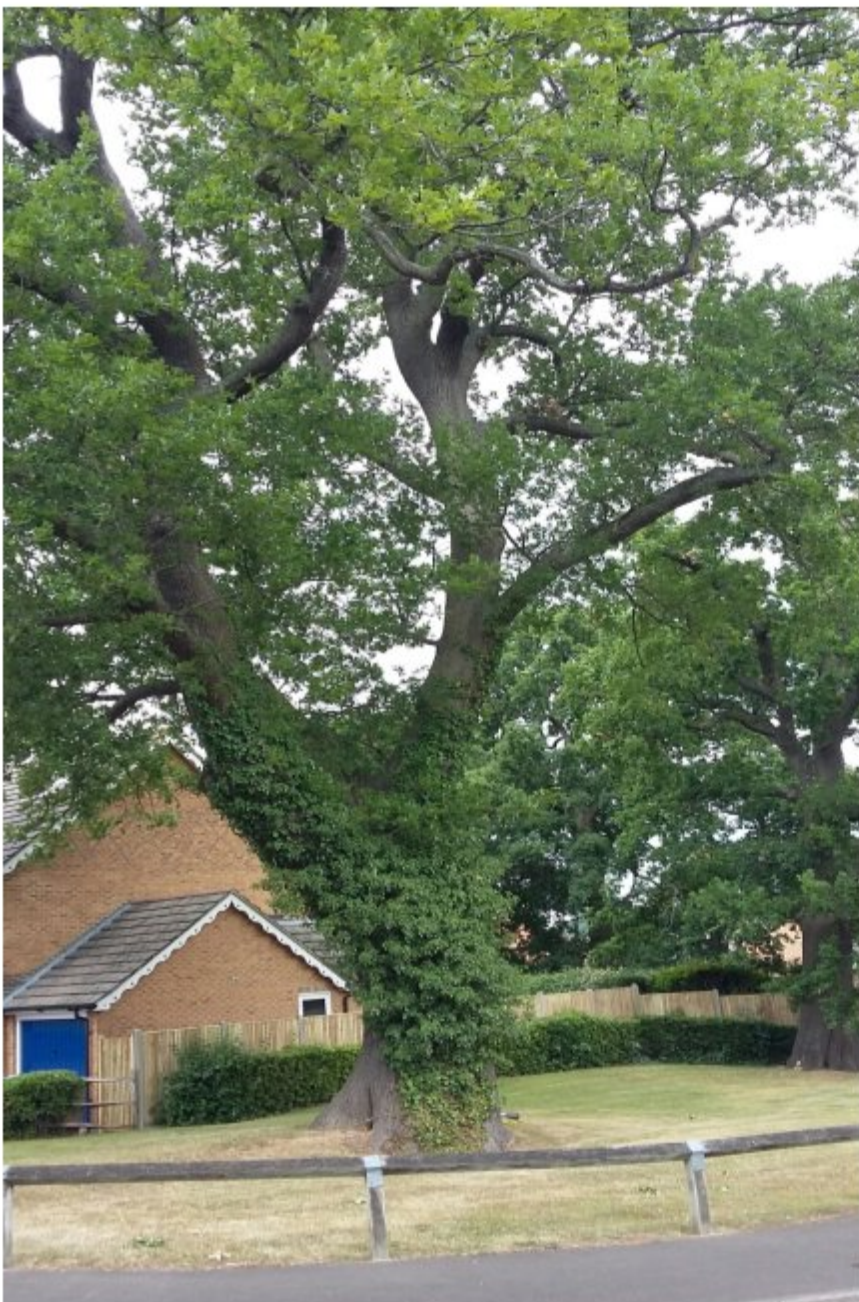
Photo 3. Tree 6.

This tree is situated 18m south of T5. It is bifurcated at 4 m with the crown on the southerly stem noticeably sparser. There is Ivy growing to the east reaching a height of 6m.

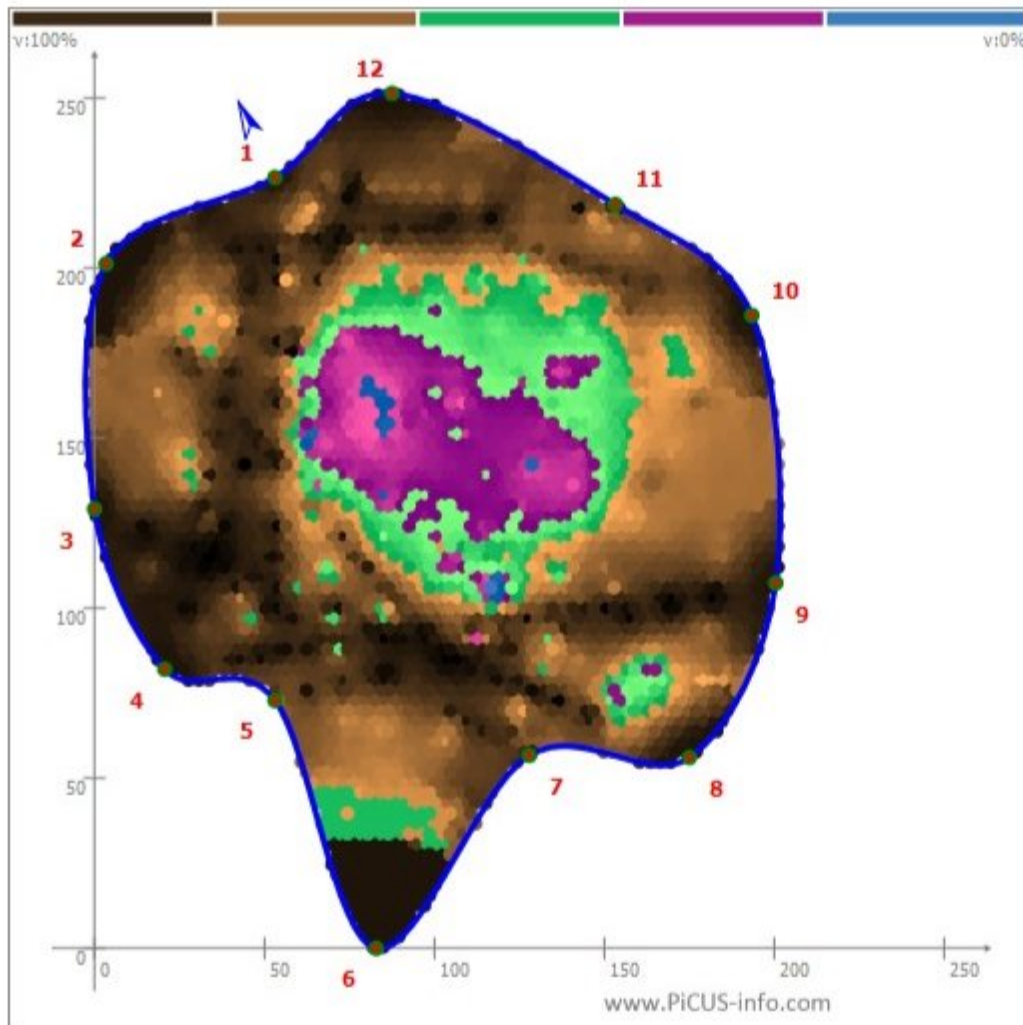
Picus Tomograph image T6 at 15cm agl.

There is a central area of decay indicated by the purple and green colouring. This currently does not significantly affect the structural integrity of the tree.

Retest in 5 years or sooner if the tree shows signs of decline.

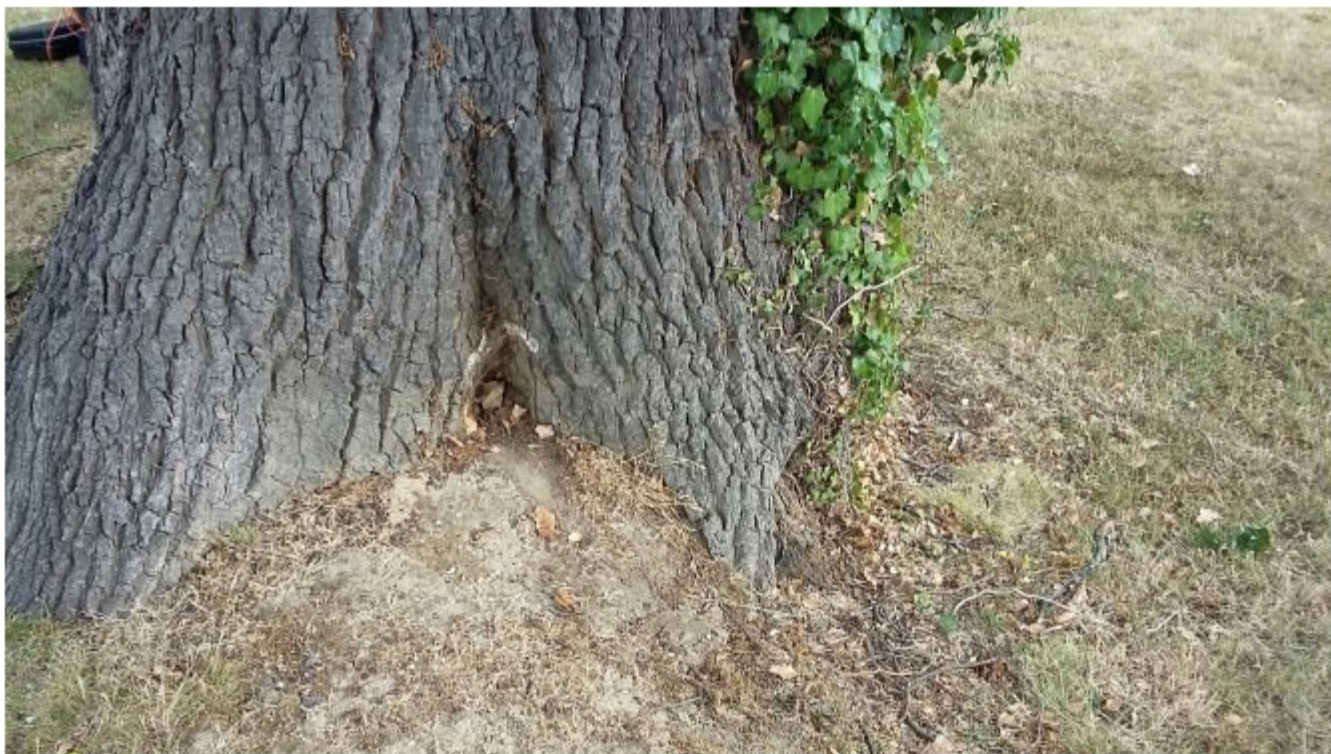
There is some staining to the south (Photo 4), possibly caused by a fungal bracket that has been removed.

Photo 4. Tree 6 staining.

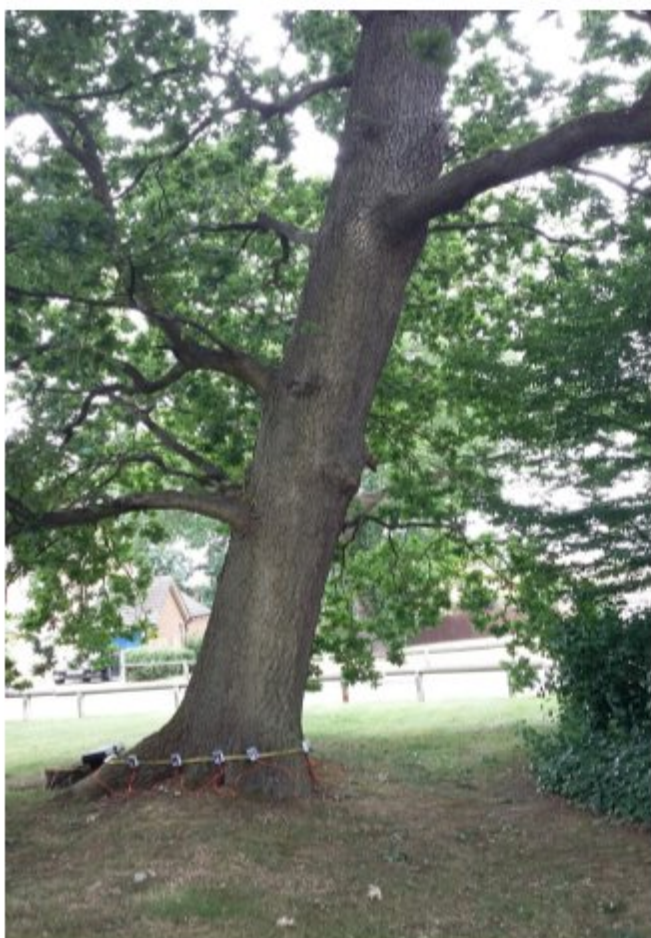
Photo 5. Tree 7.

This tree is situated 20 m south of T6. It has a severe lean to the east, with the crown over the road and adjacent property. There is a large exposed buttress root to the west. The crown has normal vitality. There is a wound at 4m to the east from a lost limb.

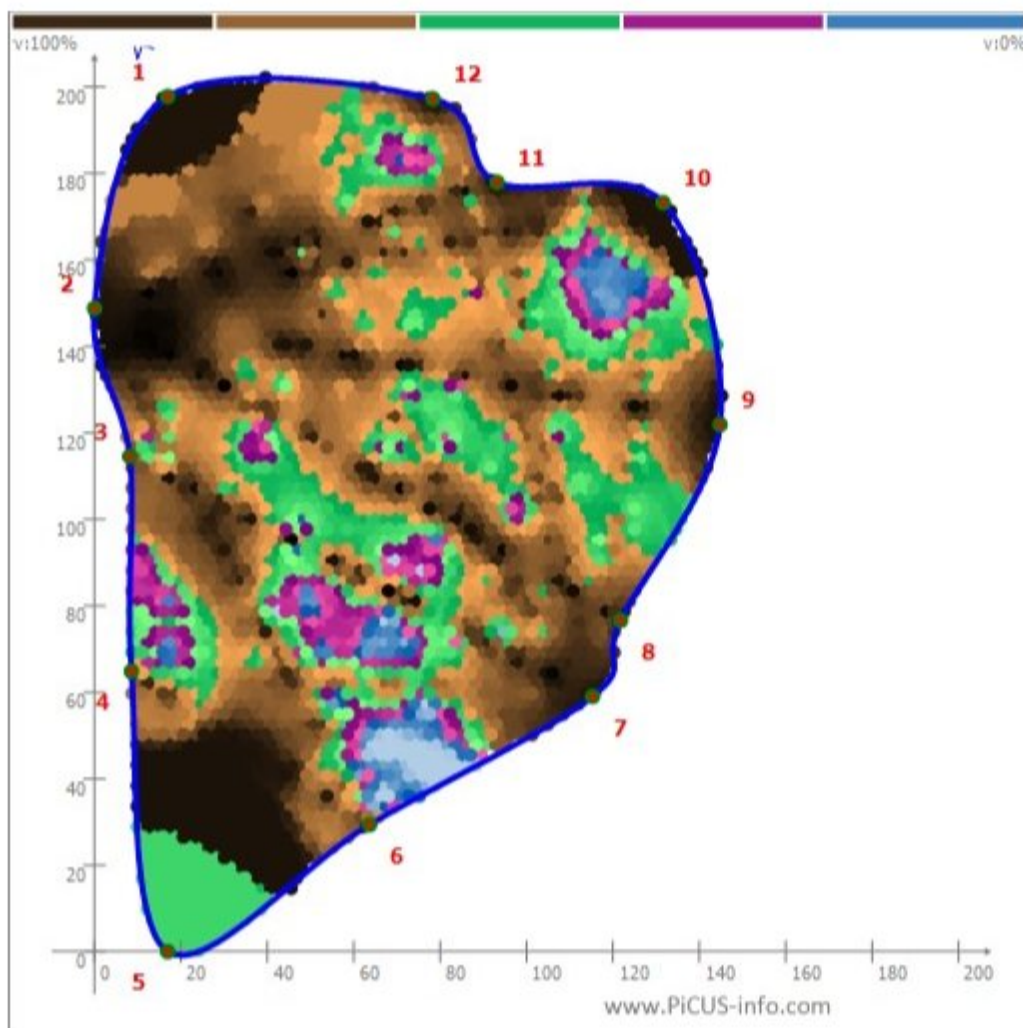
Picus tomography image T7 at 15 cm agl.

The Picus image shows some early incipient decay. This currently does not significantly affect the structural integrity of the tree at this level. Failure is likely to be caused by uprooting, so the root plate security needs to be monitored as part of the tree management schedule.

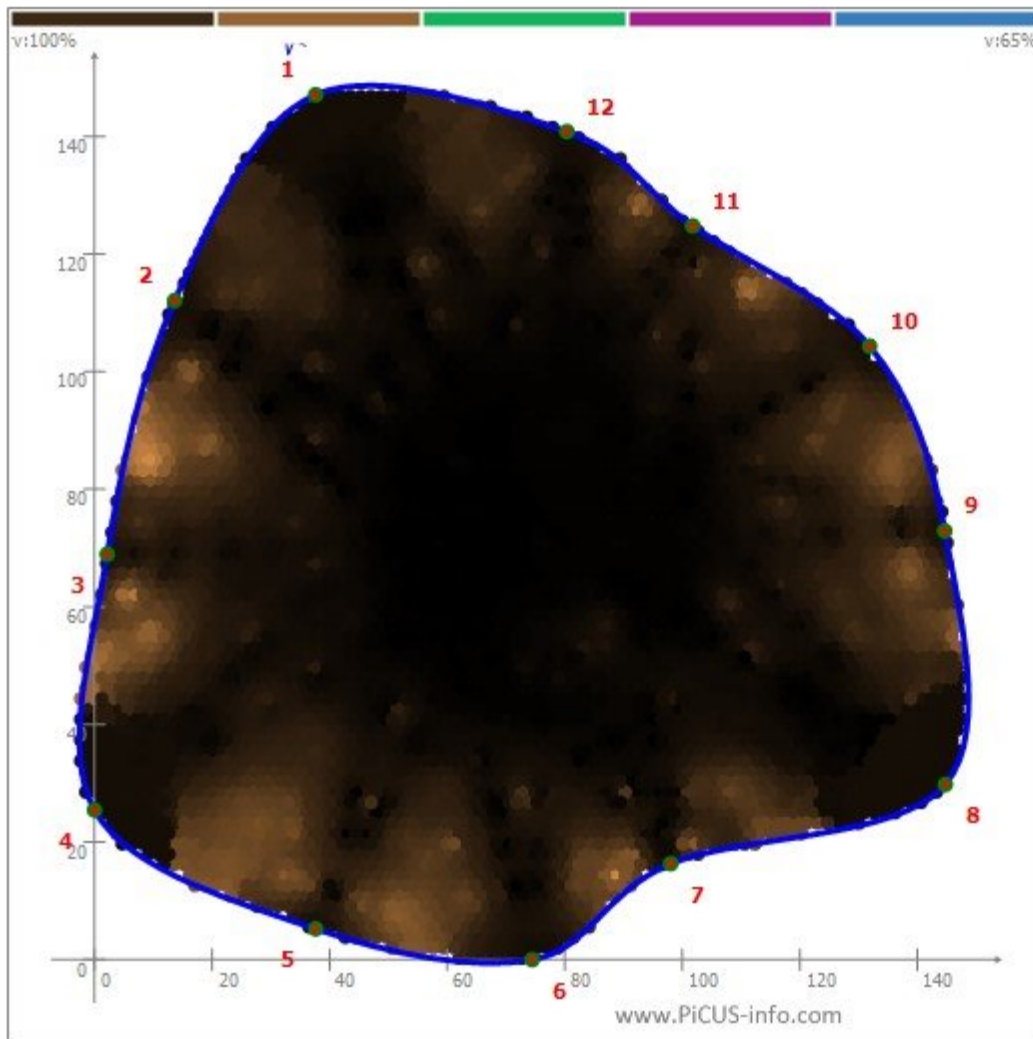
Picus Tomography image T8 at 20cm agl.

There is no decay at the height tested.

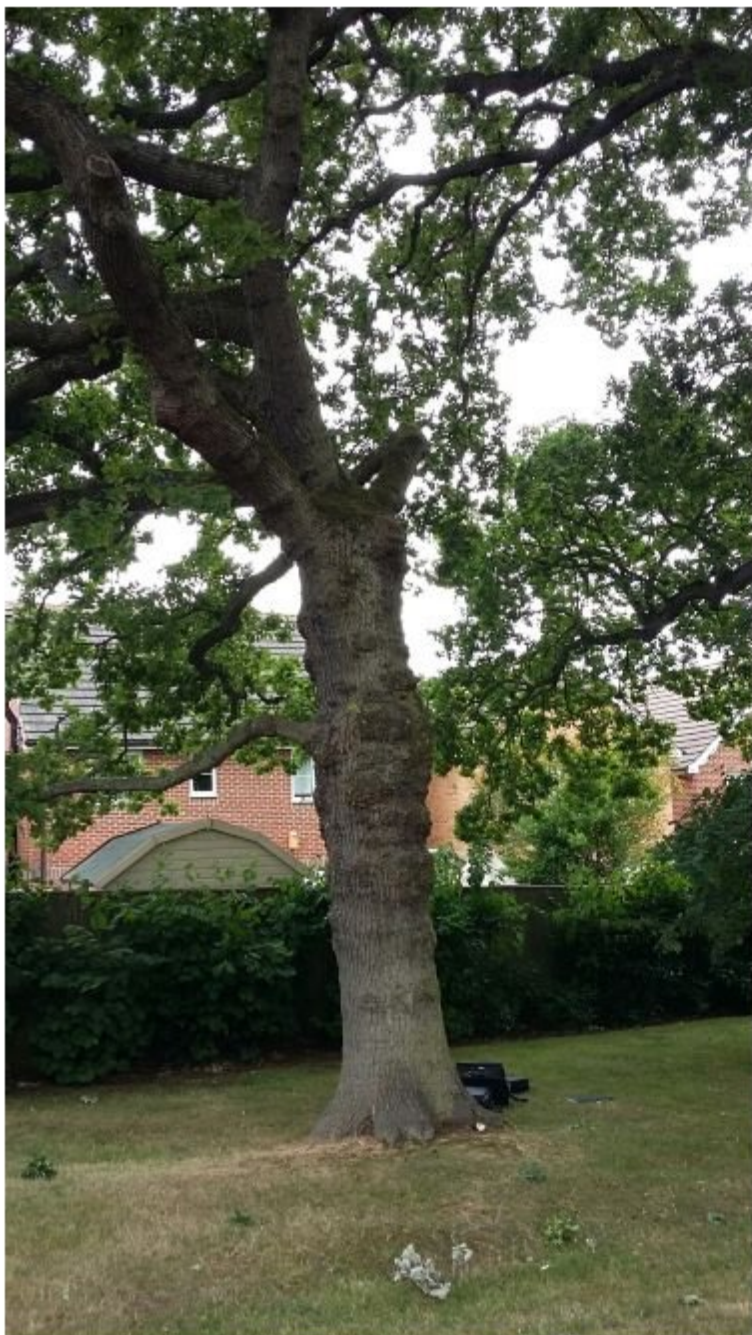
Photo 7. Tree 9.

This tree is situated 5 m south of T8. It is suppressed by T8 and all of the crown is to the south of the main stem. There is minor deadwood throughout the crown and damage to the buttress roots to the north, north east.

Remove minor deadwood. Retest if the tree shows signs of decline.

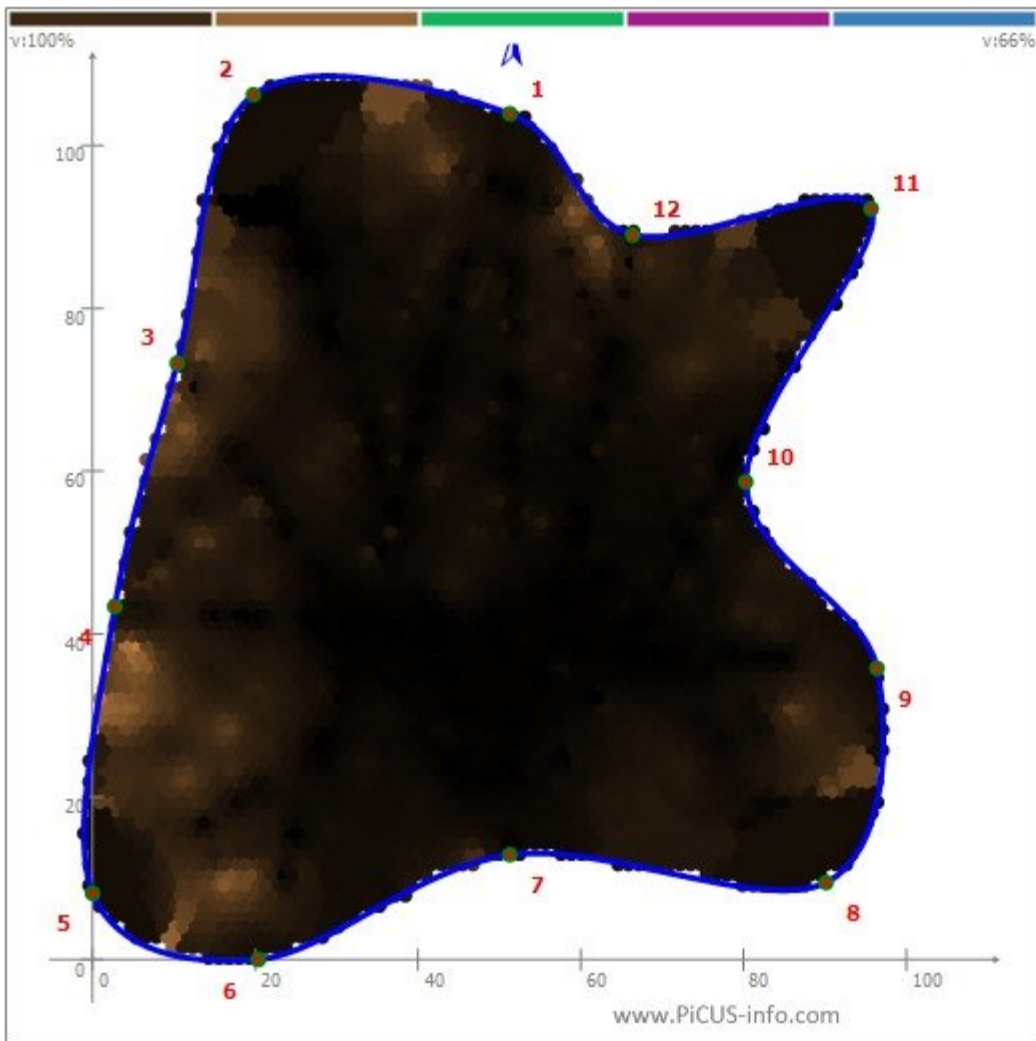
Picus tomography image T9 15cm agl.

There is no decay at the height tested.
