Arboricultural Report

**Land at Penventon Nursery, Lanner,
Cornwall**

Date: September 2020

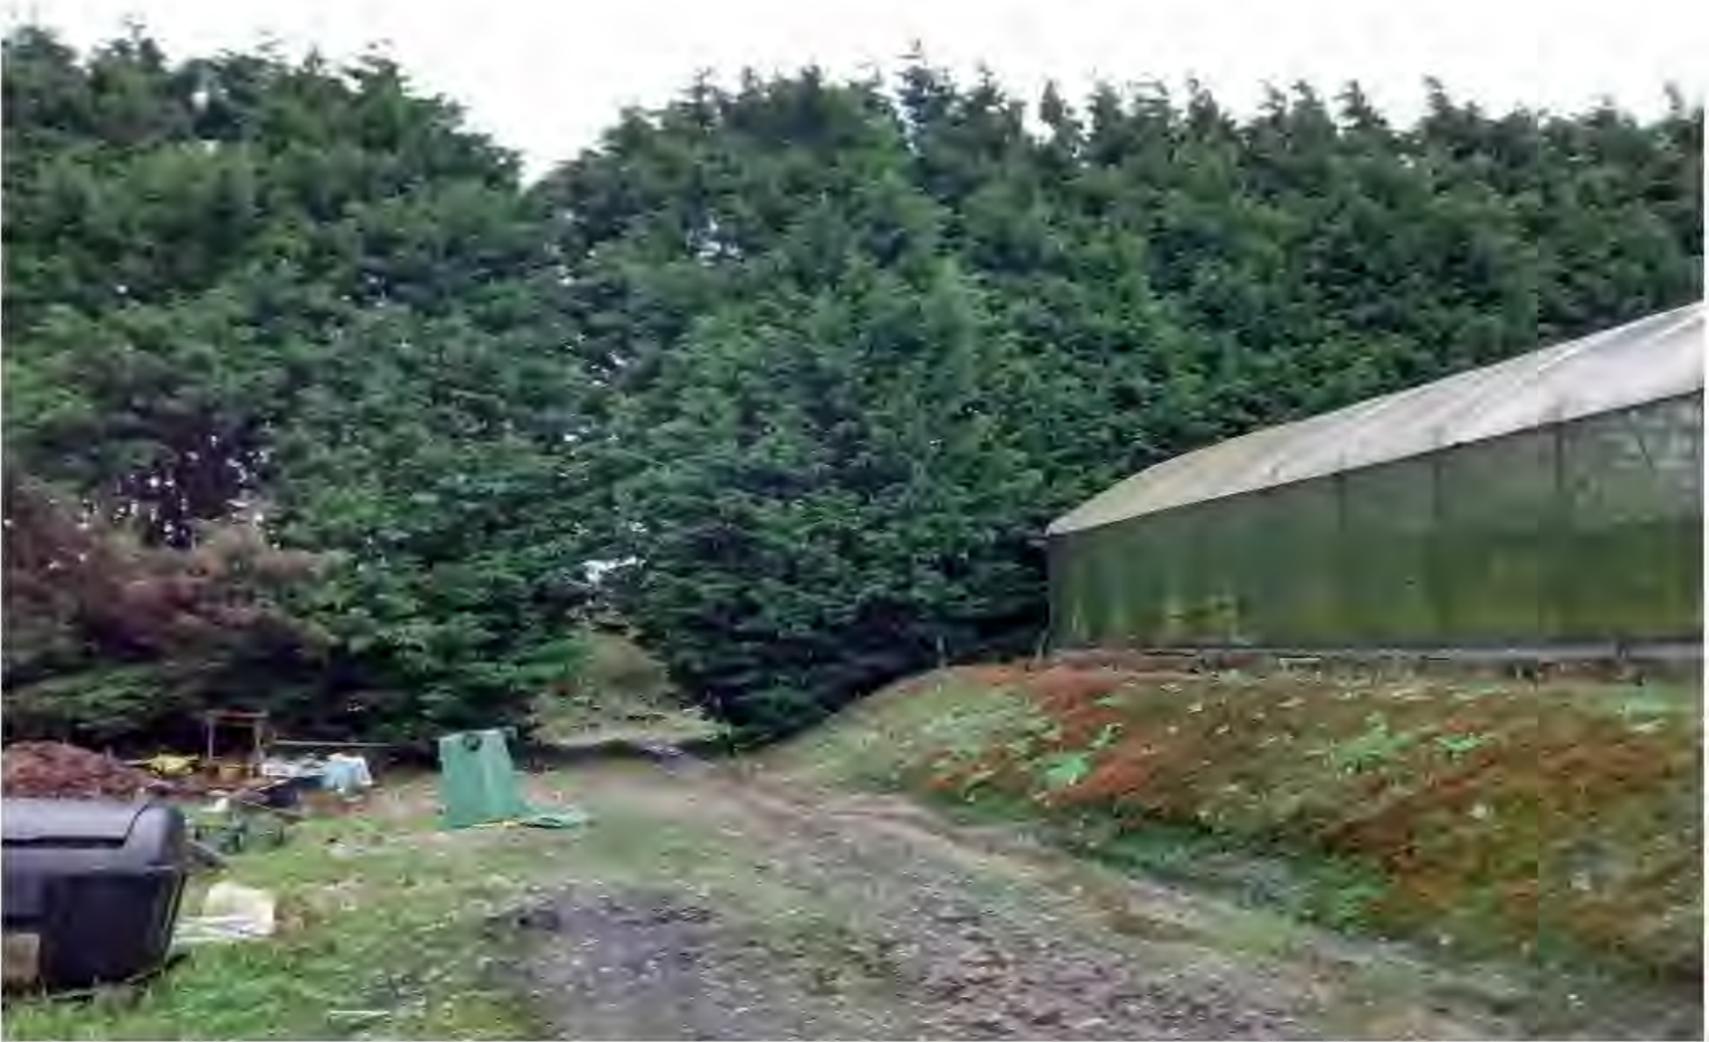
Fig 1: Leyland cypress of group (G4)

- 6.2 The future management of retained Leyland cypress shelter belts could be addressed. Group (G1) is recommended for trimming up of the south side, (only to green wood), to form a better hedge and also to remove the dead trees and replant, either with new Leyland cypress or evergreen shrubs (to retain the year round cover) or a new native hedge. Group (G4) is recommended for topping to a similar height and to trim up the western front to control the outward spread onto site.

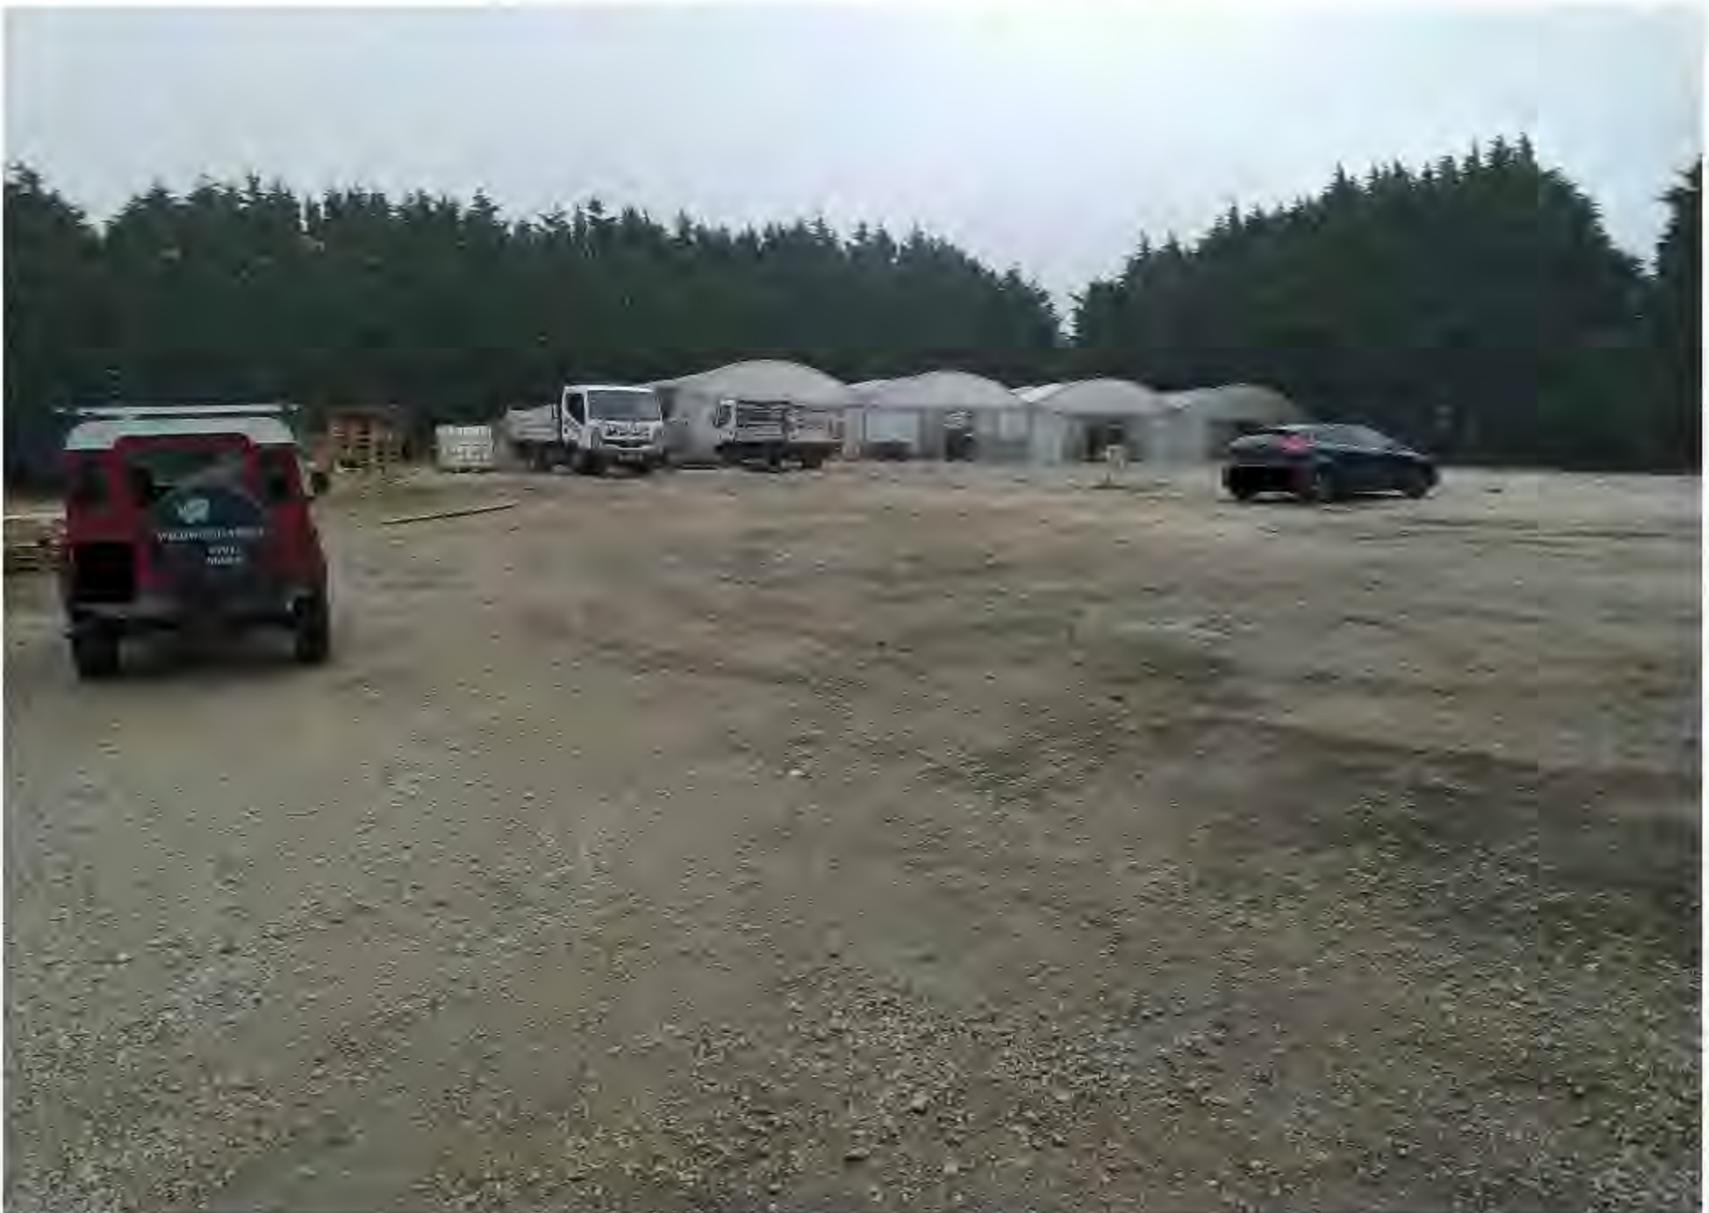
Fig 2; General site area, with polytunnels and Leyland cypresses (G4) behind and (G3) to the right

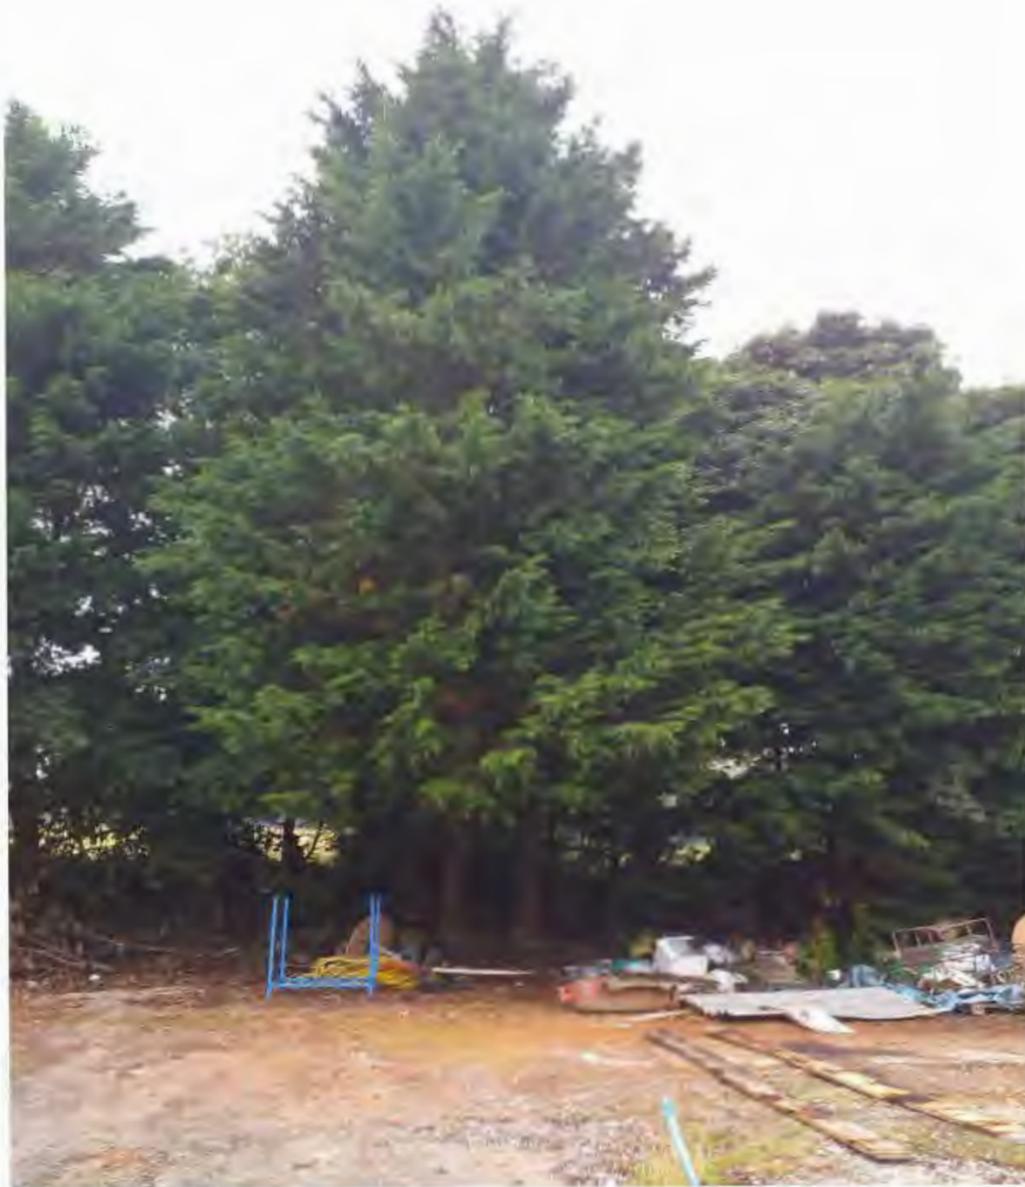
Fig 3; Leyland cypress (T1) – recommended for removal

Tree ID	Common name (Latin name)	Height of (m)	Number		Crown		Ht. Crown Clear (m)	Physiological Condition	Condition comments	Cat. grade	Est. Rem Yrs
			of Stems	Stem dia (mm)	spread NESW	Maturity					
T1	Leylandii (X Cupressocyparis leylandii)	16	1	350	4:7:4:4	SM	3	Good	Asymmetric crown to east	C	40+
T2	Sessile Oak (Quercus petraea)	13	1	500	6:5:1:6	SM	5	Good	Minor unbalanced crown due to suppression from T3. On hedge bank. Integrated crown with T3	B	40+
T3	Sessile Oak (Quercus petraea)	13	1	625	5:5:5:5	SM	6	Good	Exposed roots on hedge. Heavy ivy growth. On hedge bank. Integrated crown with T2	B	40+
T4	Monterey cypress (Cupressus macrocarpa)	19	5	1220	9:9:9:9	M	8	Good	Significant, historical pruning wounds around base. Collapsed branch to South <300mm	B	40+
T5	Sycamore (Acer pseudoplatanus)	13	1	500	5:5:6:5	SM	6	Good	On boundary	C	40+
T6	Sycamore (Acer pseudoplatanus)	12.5	4	700	7:7:7:7	SM	1	Good	Heavy ivy growth. On boundary.	B	40+

- 6.3 The Leyland cypresses in Group (G2), e.g. (T1) are recommended for removal, due to poor form (shape), growing into the site, plus the fact that they are shading/suppressing growth of more 'valuable' native, broadleaves and that they will become a maintenance burden in the future.

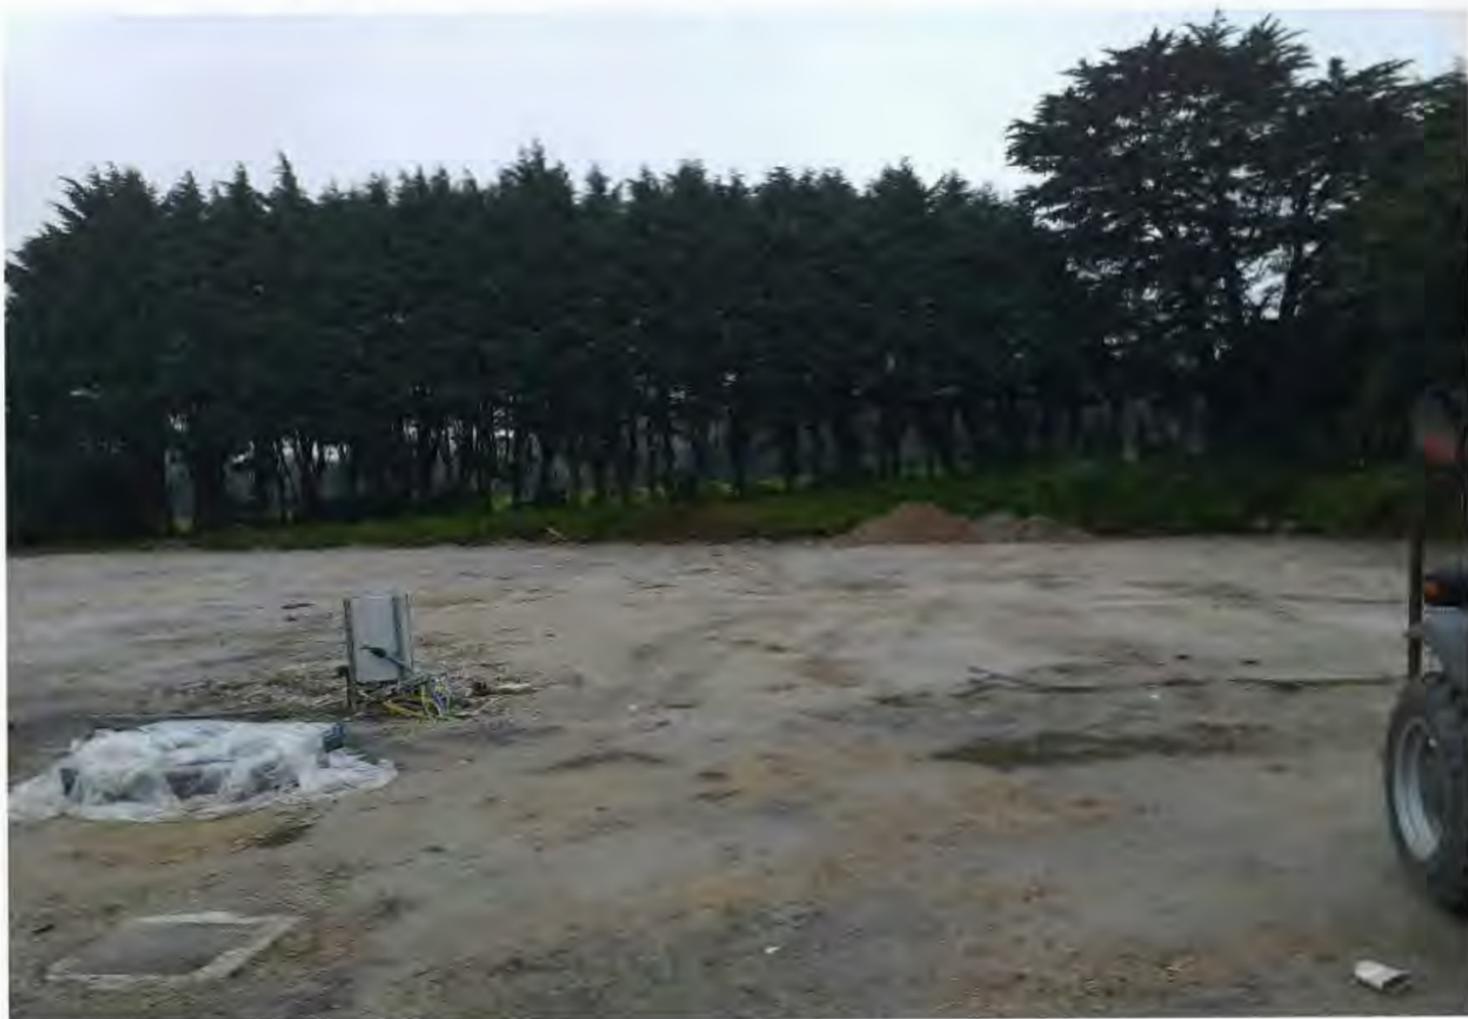
- 5.4 In the southern corner of the site is a large, mature Monterey cypress (T4). This is located up on the boundary bank, (the levels difference being approximately 4m), and away from the construction area. It is in overall good condition and should be retained. Again the bank has been dug away quite extensively in the past, with little historical root severance observed. As above the majority of the root growth area is probably to the west and south into the open fields beyond.
- 5.5 Attached is a Tree Constraints Plan, showing the location of the principle trees on the site, with retention category colour coding and Root Protection Areas (RPA) plotted as radiuses given in the schedule in the Appendix. Also attached is a Tree Protection Plan, showing the location of the protective fences to be erected, around the retained trees.

Fig 4; Level site with Monterey cypress (T4) to the right and leyland cypress group (G3) on the left

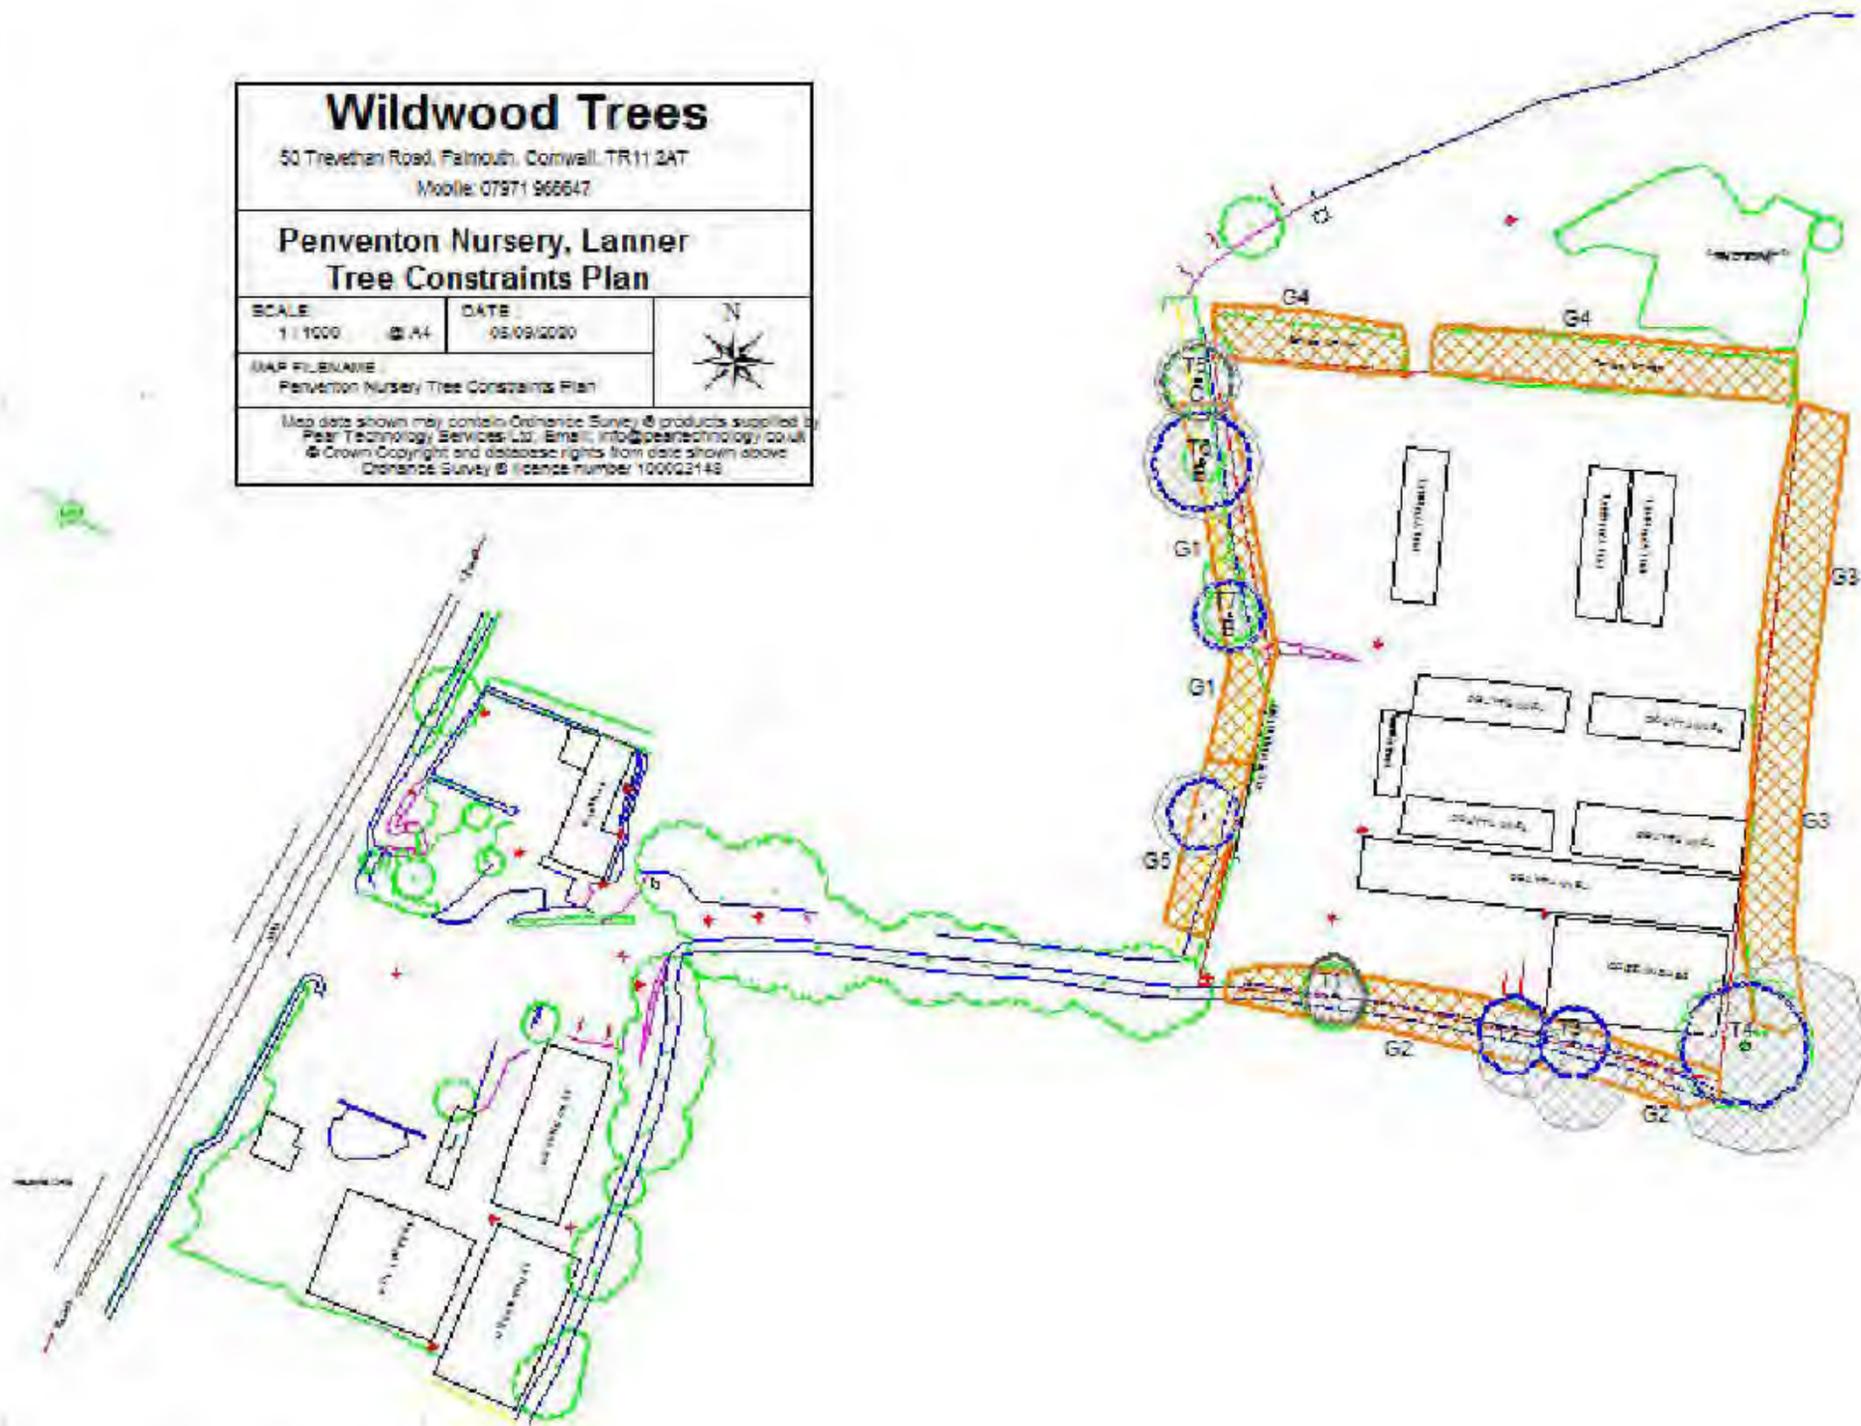
Fig 5: Tree Constraints Plan

along the axis of the hedge bank and probably with a greater area spreading into the open, undisturbed fields to the west of the bank (this has been indicated on the Tree Constraints Plan – see appendix)
