Visual Inspection and Health Appraisal

Semi-Mature and Mature Trees

24 Herrison Cottages, Charlton Down, DT2 9RJ

23<sup>rd</sup> October 2020

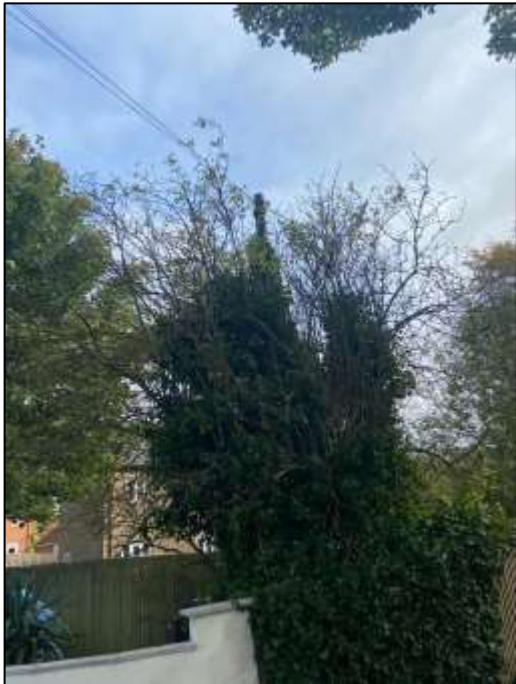
A mature elder tree (T1) was noted in the southern corner of the property (Plate 1). This tree is covered in ivy and is touching the overhead telephone cables.

Plate 1 – The elder tree (T1) on the southern corner boundary

It is recommended that trees T1 and T2 are pruned to give a minimum of 0.5m clearance around the telephone cable. The maintenance of trees around telephone cables lies solely with the land owner and when branches rub on the cables, it often causes disruption to the telephone and/or internet service. This work is recommended as good practice for avoidance of any such damage.

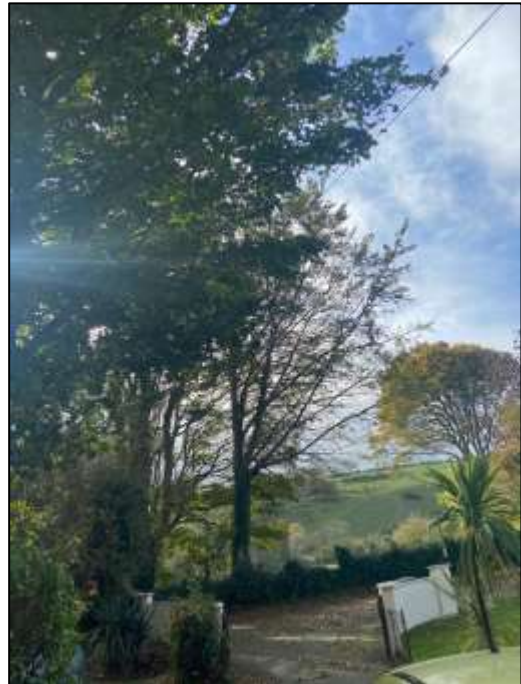
There is a mature sycamore tree (T2) on the south-eastern boundary (between the surveyed property and number 18). This also has branches touching the overhead telephone cable (Plate 2).

Plate 2 – The sycamore tree (T2) on the south-eastern boundary

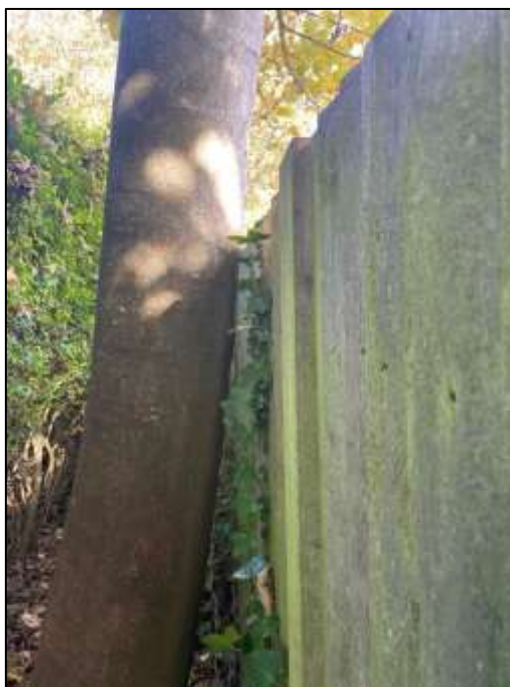
There are two further mature sycamores along this south-eastern boundary but are in the rear garden of the property, between the hedge and boundary fence. The first one (T3) has been pollarded at approximately 4.5m and is very close to the boundary fence (Plate 3). The second one (T4) appears in good condition and requires no remedial work.

Plate 3 – The stem of the sycamore tree (T3) in close proximity to the boundary fence

Sycamore tree T3 and the north-eastern most stem on T5 are too close to the boundary fence to allow incremental stem growth for many more years before they will push the boundary fence. It is recommended that these are removed before this becomes an issue.

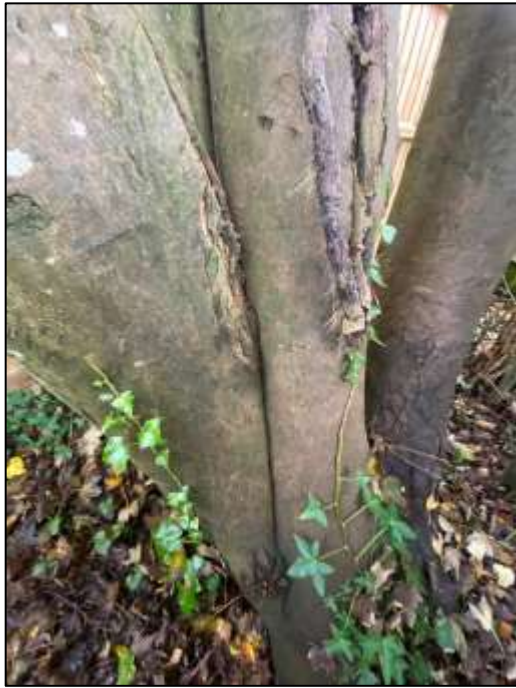
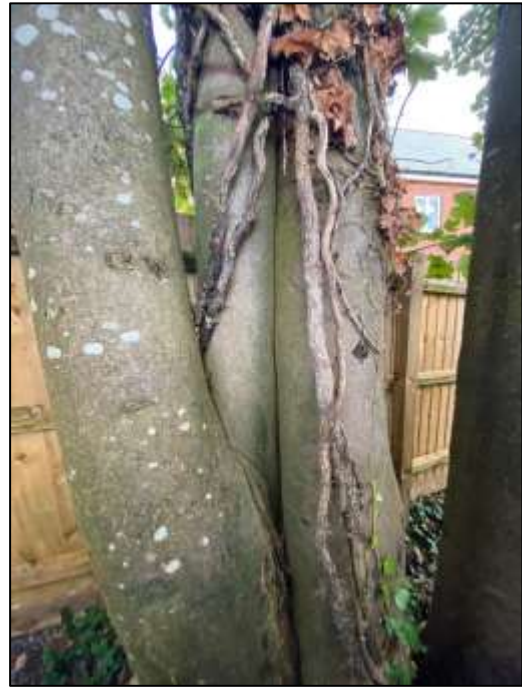
Near the rear boundary there are two mature multi-stemmed sycamore trees between the hedge and the boundary fence. The one near the eastern corner (T5) has compression forks in the stem unions where the stems bifurcate and there is insufficient room for one of the stems to put on incremental growth (Plates 4&5). The north-eastern most stem from this tree is also very close to the boundary fence (Plate 6).

Plate 4 – Compression fork on lowest union of T5

Plate 5 – 2<sup>nd</sup> compression fork on T4 and the two stems touching

Compression forks, as seen on T5 and T6, usually originate as a consequence of phototropic growth but the result is often that the stems run out of room for incremental growth and mutually crush themselves, enclosing bark which acts as a crack before encompassing annual rings are put on to help weld the stems together. The 'ears' are a reference to adaptive growth. Mattheck (2007) states that the safest compression fork is one with 'small ears' whereas 'large ears' or 'no ears' are the likeliest to fail. No 'ears' were noted on any of the compression forks that were observed on T5 or T6. Management of compression forks is either to remove one of the stems, reduce the tree so that the leverage and subsequent loading is reduced or remove the tree in its entirety. My suggestion would be to remove all but one stem on T5 and remove T6 in its entirety.

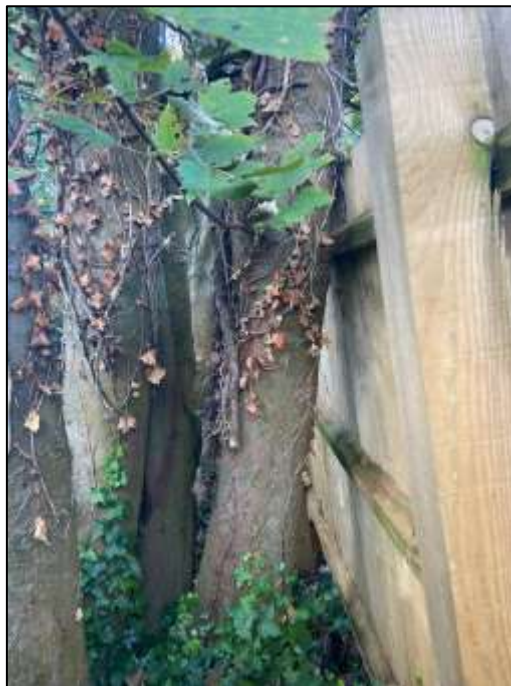
Plate 6 – North-eastern stem almost touching the boundary fence

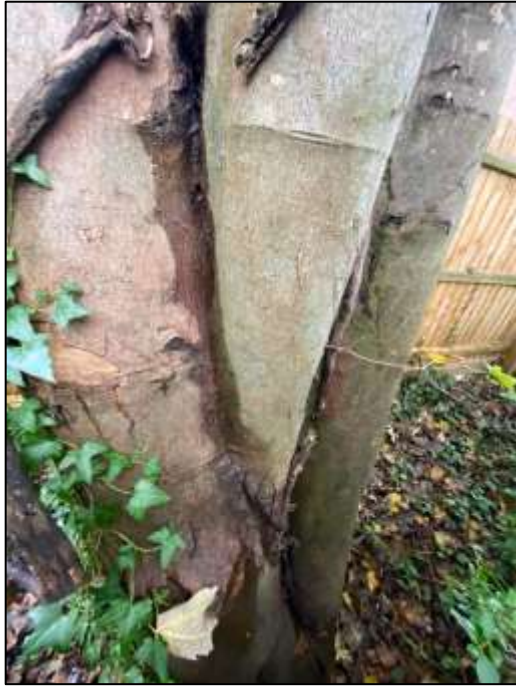
Multi-stemmed sycamore (T6) also has two compression forks at the unions where the stems bifurcate (Plate 7) and also a crossing branch resulting in the concave growth of a stem at a height of approximately 2.25m (Plate 8).

Plate 7 – The compression forks on T6

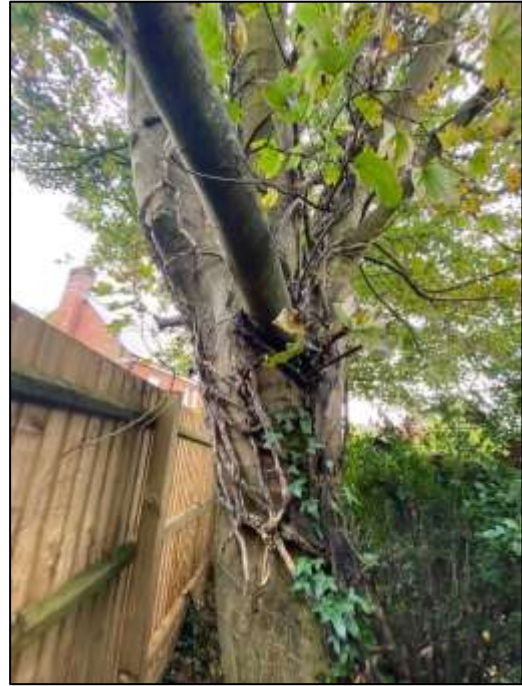
Plate 8 – The crossing branch on T6

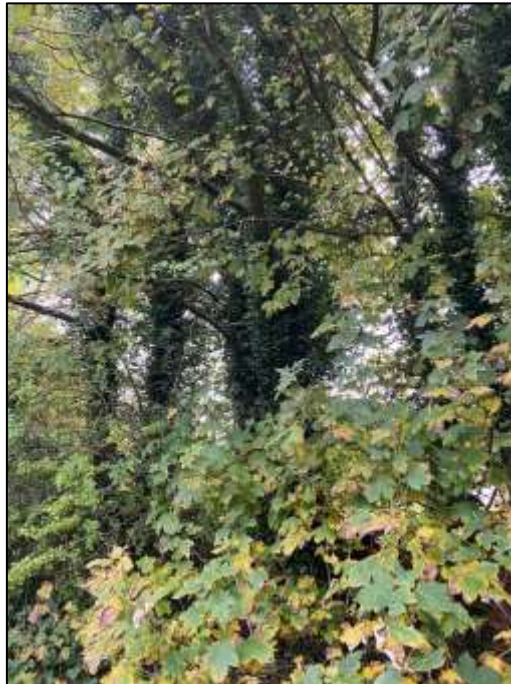
T7 is a semi-mature and T8 is a mature sycamore tree. Both are twin stemmed and are covered in ivy. T9 is three semi-mature sycamore stems that are likely all growing from the same root stock. This is also covered in ivy.

Plate 9 – The ivy seen covering the stems of T7, T8 and T9

Whilst ivy affords nesting and good late food sources for birds, it also increases the sail area of tree crowns and subsequently the loading stresses on the tree increases. This can increase the risk of failure of defective parts of the tree and subsequently, ivy covered trees in areas with high target area values is not recommended. Ivy also hides defects from surveys and inspections which is undesirable. Ideally, the ivy on trees T1, T7, T8, T9, T10 and T11 should be addressed by severing a ring of the ivy on the stem to kill the growth

above. This is not deemed a priority but is recommended as a method of abating potential hazards.

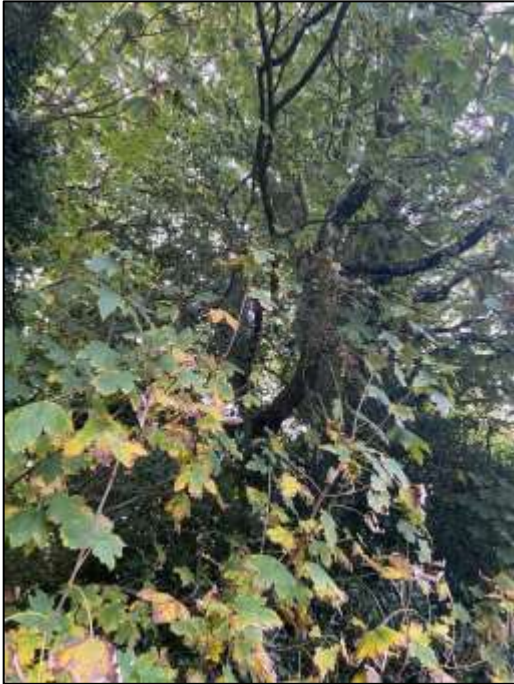
T10 is a mature sycamore tree (Plate 10) which is heavily suppressed by the large beech adjacent. The main leader is growing out over the garden rather than the typical apical dominance which happens in sycamores of a similar age. There is also a large lateral branch which grows out towards a neighbouring property to the north-west and is forming a lever arm.

Plate 10 – Suppressed sycamore tree T10

Sycamore tree T10 is heavily suppressed by the large beech adjacent and will always grow out in search of light. This can result in lever arm type growth as it is currently displaying. This can lead to branch failure in the same way as a lever acts with the end weight not spreading load evenly over the length of the branch. The remedial work to reduce such risk to acceptable levels is to reduce the length of the branches or to remove the tree in its entirety. The removal of the whole tree should be seriously considered as branch reductions would only be a temporary reprieve.

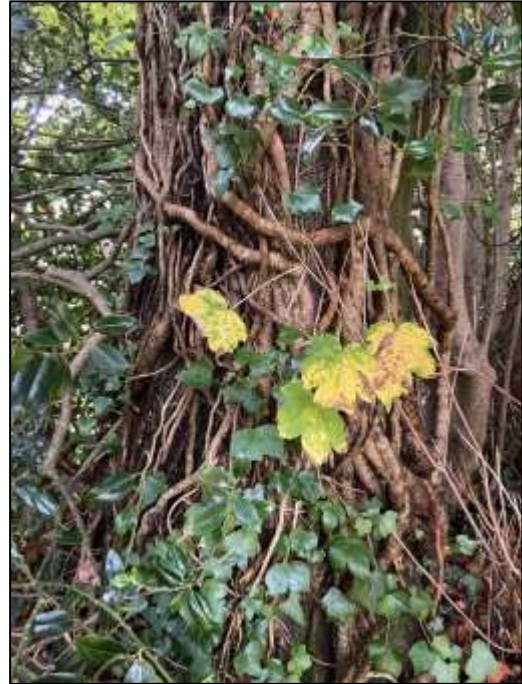
The largest tree on the property, which can be seen on the approach to 24 Herrison Cottages, is a large mature beech tree (T11). This tree appears to be the end of an avenue of beech trees flanking a path to the north-east of the property. This tree is covered in ivy (Plate 11)

Plate 11 – Ivy around the lower stem of the beech tree (T1)

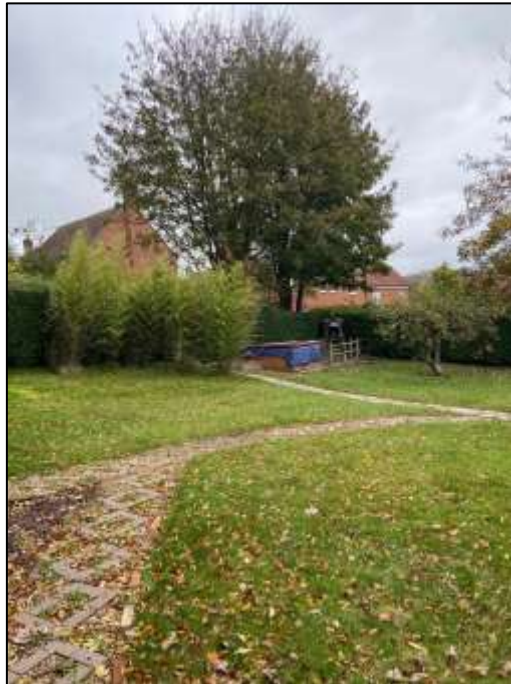
There are several clusters of bamboo currently providing a linear feature in the rear garden (Plate 12).

Plate 12 – The apple tree and bamboo shown with sycamores T5 and T6 in the background

Bamboo can often become invasive, spreading along rhizomes underground which can pass easily under boundaries. It is recommended that the bamboo is managed to retain it at an acceptable size (which will require the regular digging out of clumps and/or installation of a physical barrier underground to control the size) or its removal (which usually requires a chemical application to kill all rhizomes).
