COCKEY HOOP BARN, LITTLE MASSINGHAM

Following instructions received from yourself on 11th November 2020, a visual inspection was carried out of Cockey Hoop Barn, Little Massingham on 2nd December 2020. The following report is based upon the findings of this inspection to consider the condition of the barns as they presently exist.

This report has been prepared specifically to accompany a Planning Application for change of use of the existing barns.

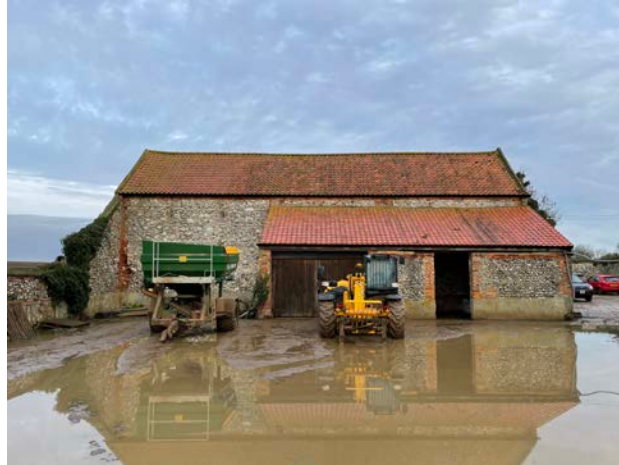
Photo 1 - Front elevation

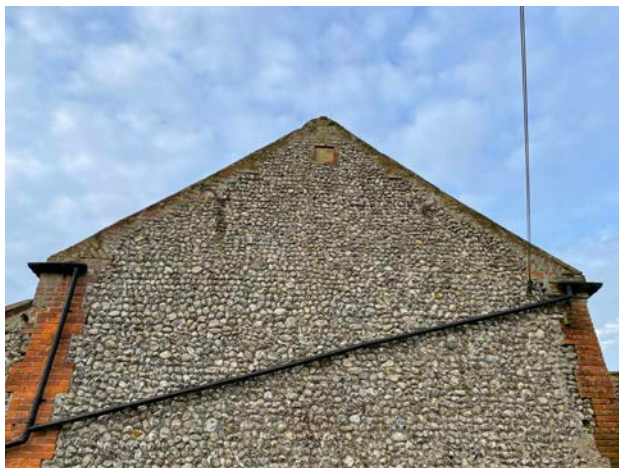
Photo 2 - Right / east gable

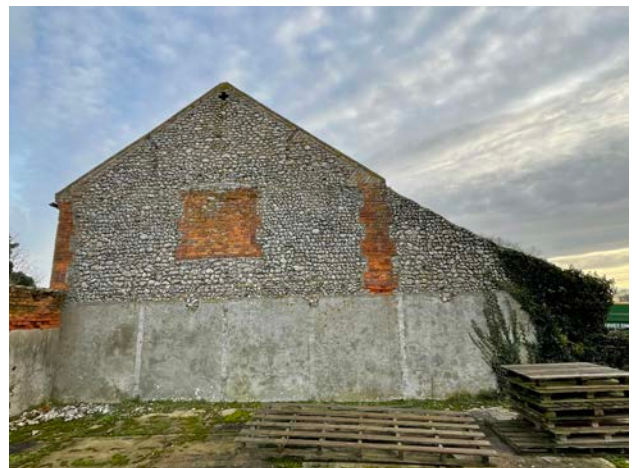
Photo 3 - Left / west gable

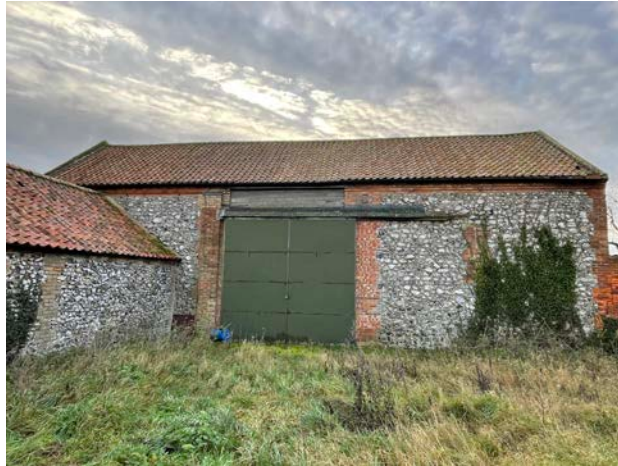
Photo 4 - Rear / north elevation

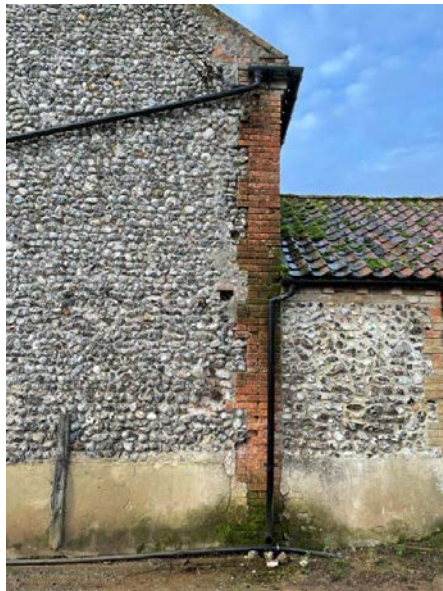
Photo 5

On the eastern gable there is some separation of the quoins from the flint infill and some cracking has been repointed in the past, see photo 5. The high level verge on this gable is showing signs of weathering and in the centre of the wall there is a reasonably large bulge at high level indicating some separation of the external flint from the internal backing masonry. The northern verge also has some signs of horizontal displacement, see photo 6.

- General masonry repairs will be required to repair all cracking in the existing masonry walls. Note Helifix masonry reinforcement is unlikely to be able to be used in this barn structure due to the high flint content.

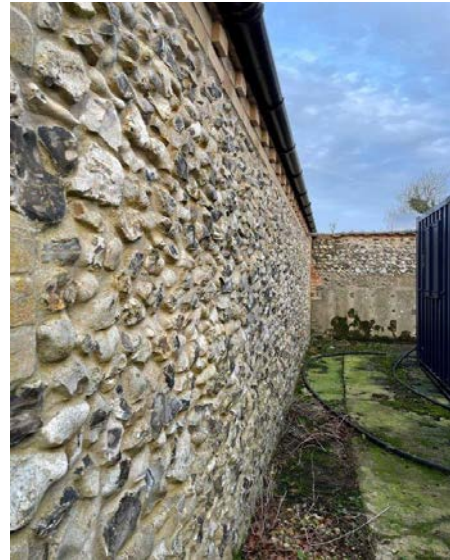
Photo 7

The eastern flank wall of the northern section also has some bulges in it, although this wall is much lower and therefore the movement is not as significant as in the main eastern gable, see photo 7.

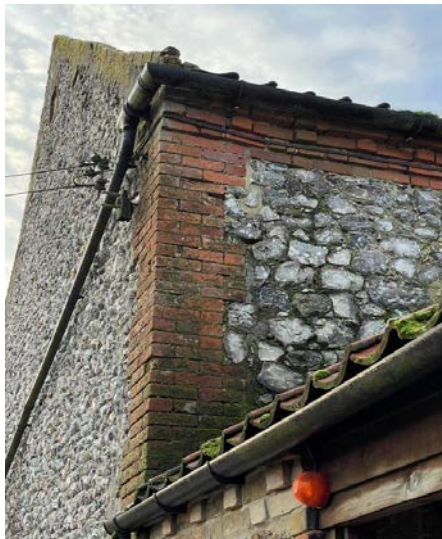
Photo 8

There is also evidence of some separation of the brick quoins on the north eastern corner of the main barn with the rear northern elevation, see photo 8. Cracking internally within the barn indicates potentially some settlement of the north eastern corner of the barn, see photo 9.

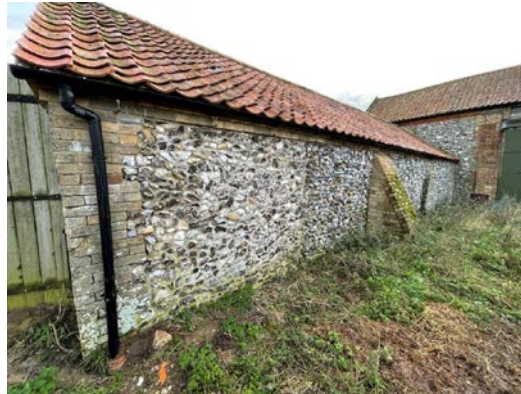
Photo 10

The northern single storey section has external walls of partly whole flints and partly knapped flints with intermediate brick quoins and brick quoins at corners and door openings. A buttress exists on the western flank wall due to the lean on this wall. Internally some of the walls have been rebuilt with modern blockwork for an unknown reason. There is also evidence of an infilled window.

The western flank wall of the northern section of the barn has a reasonably significant external lean and as already mentioned a buttress has been provided externally against this wall to assist with stability, see photo 10.

- That an internal steel frame will be necessary to provide support to the first floor structure but mainly to provide restraint to the external walls at all of the corners of the main structure and also at intermediate positions along all of the four walls. Tie bars with external patrix plates will need to be provided between the walls and the steel frame and the steel frame will need to be braced sufficiently to provide adequate tying to the external walls.

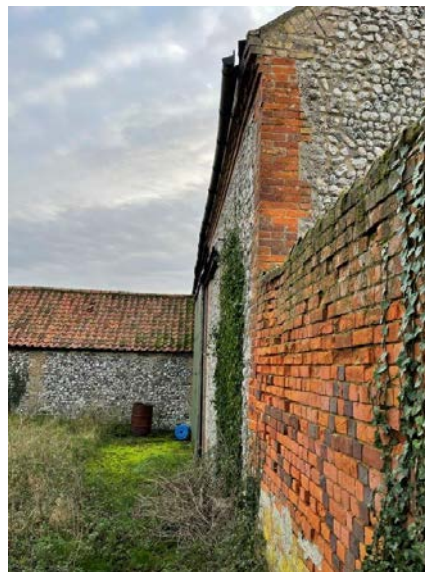
Photo 11

Some horizontal roof thrust is evident at eaves level on the rear northern wall of the main barn, primarily above the large door opening in this elevation, potentially caused by the original roof structure which has now been replaced, see photo 11.

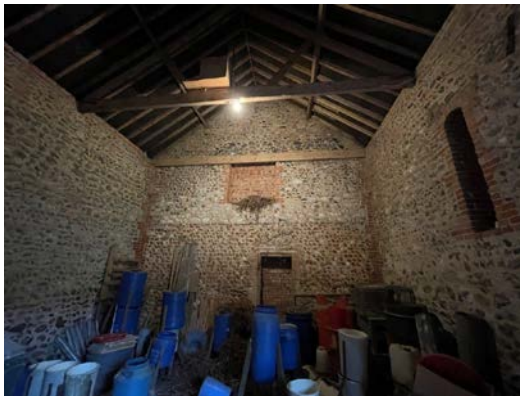
Photo 12

Internally there is also evidence of separation between the brick quoins at corners and the internal surfaces of the wall in the main barn and also some of the walls of the lean-to at the front, see photo 12 and 13.

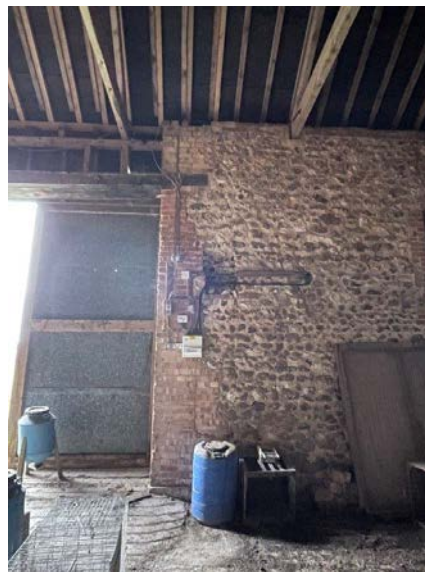
Photo 14

The eastern side of the main door opening in the rear elevation has been rebuilt at low level at some time in the past, possibly due to vehicle impact, see photo 14.

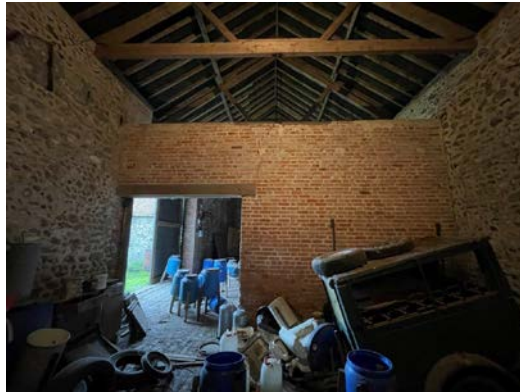
Photo 15

All floors are of rough concrete. There is a brick arch in the southern wall of the main barn providing access into the front lean-to and also an internal partition at the western end of the main barn which is built up to approximately 750mm from the top of the external walls. The internal partition is of solid brickwork and contains some cracks indicating either settlement of the floor slab that the wall is built upon or some movement of the external walls relative to the internal partition.

Cracking to the internal partition is shown in photo 15 below.
