12 Cobb Road, Lyme Regis

Photographic Condition Survey

Nov 2020
Rev *

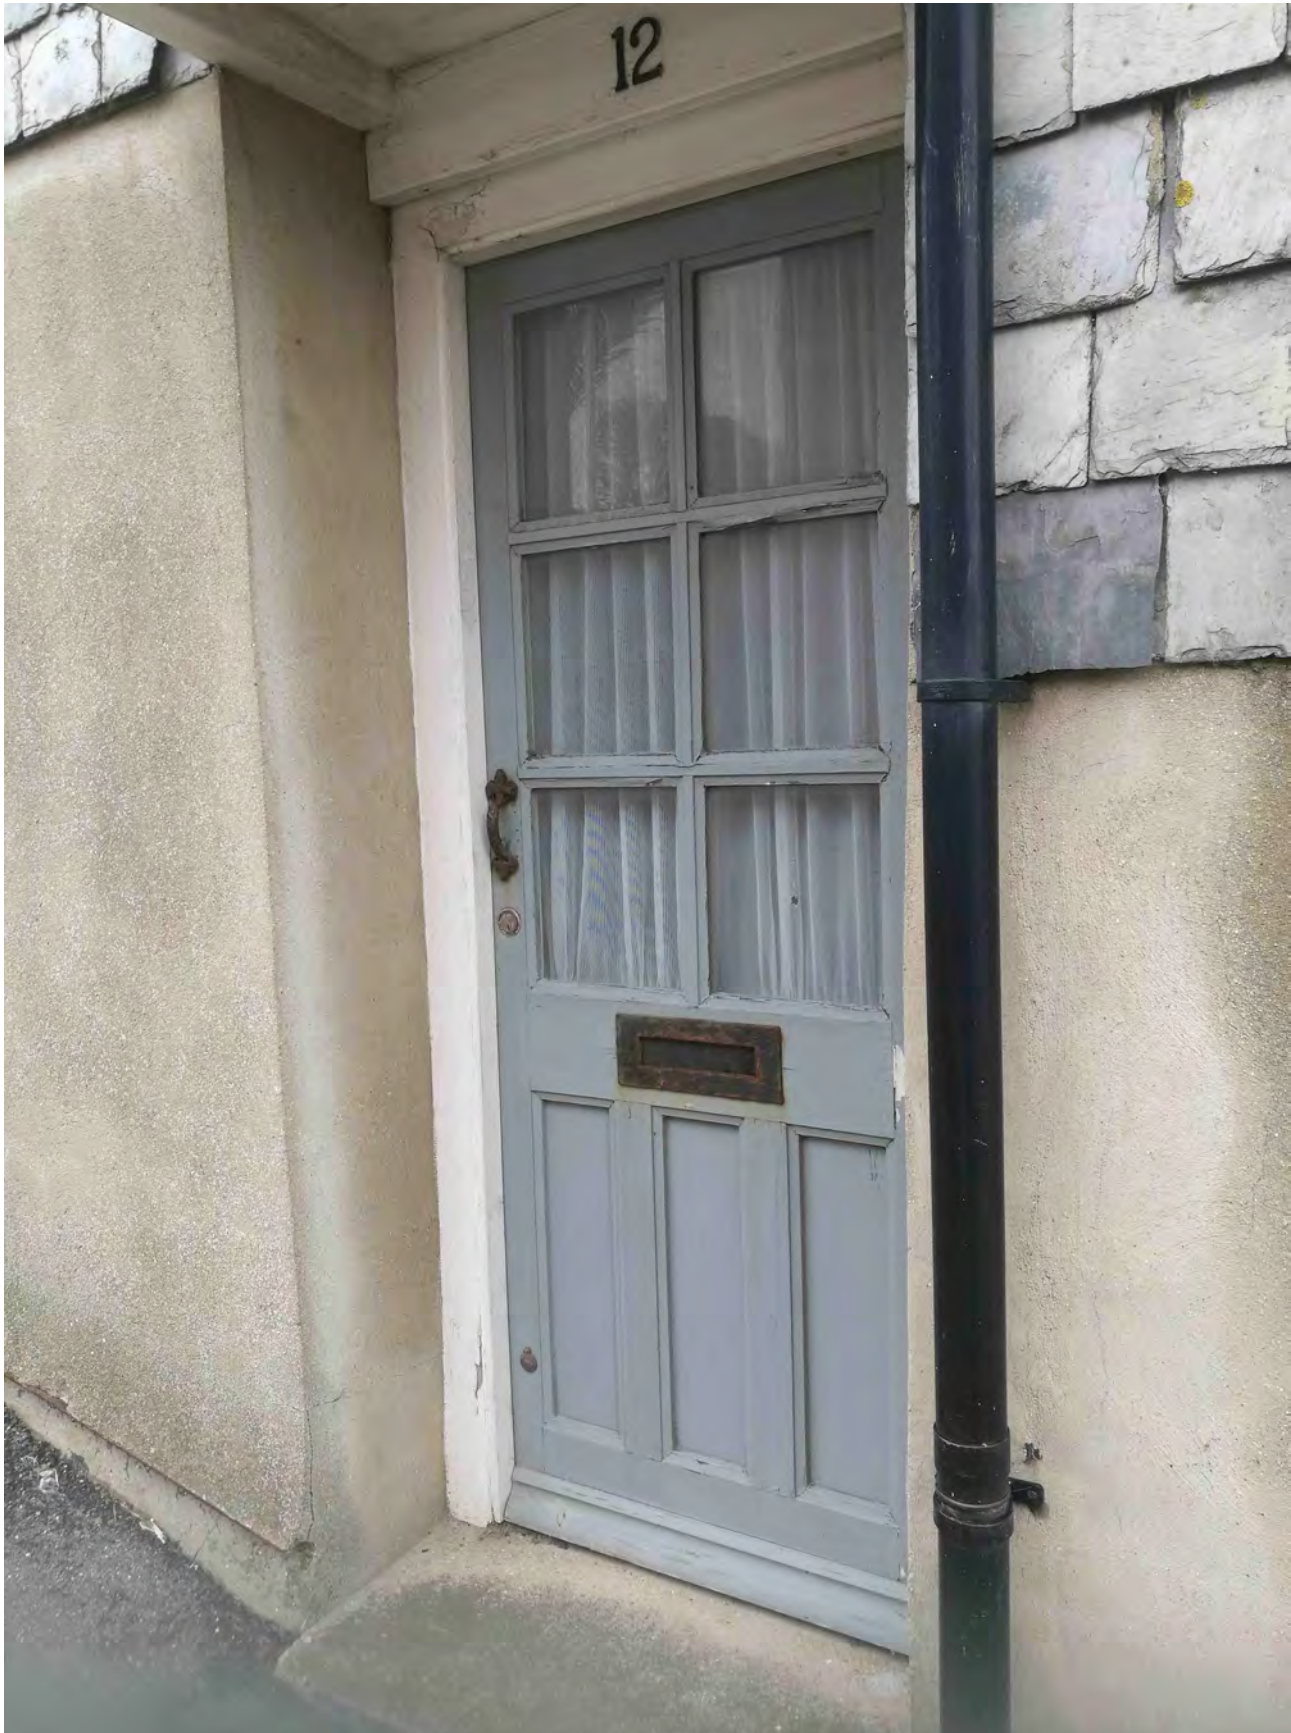
Photo of northern external door; deteriorating door and frame along with cracked adjacent render.

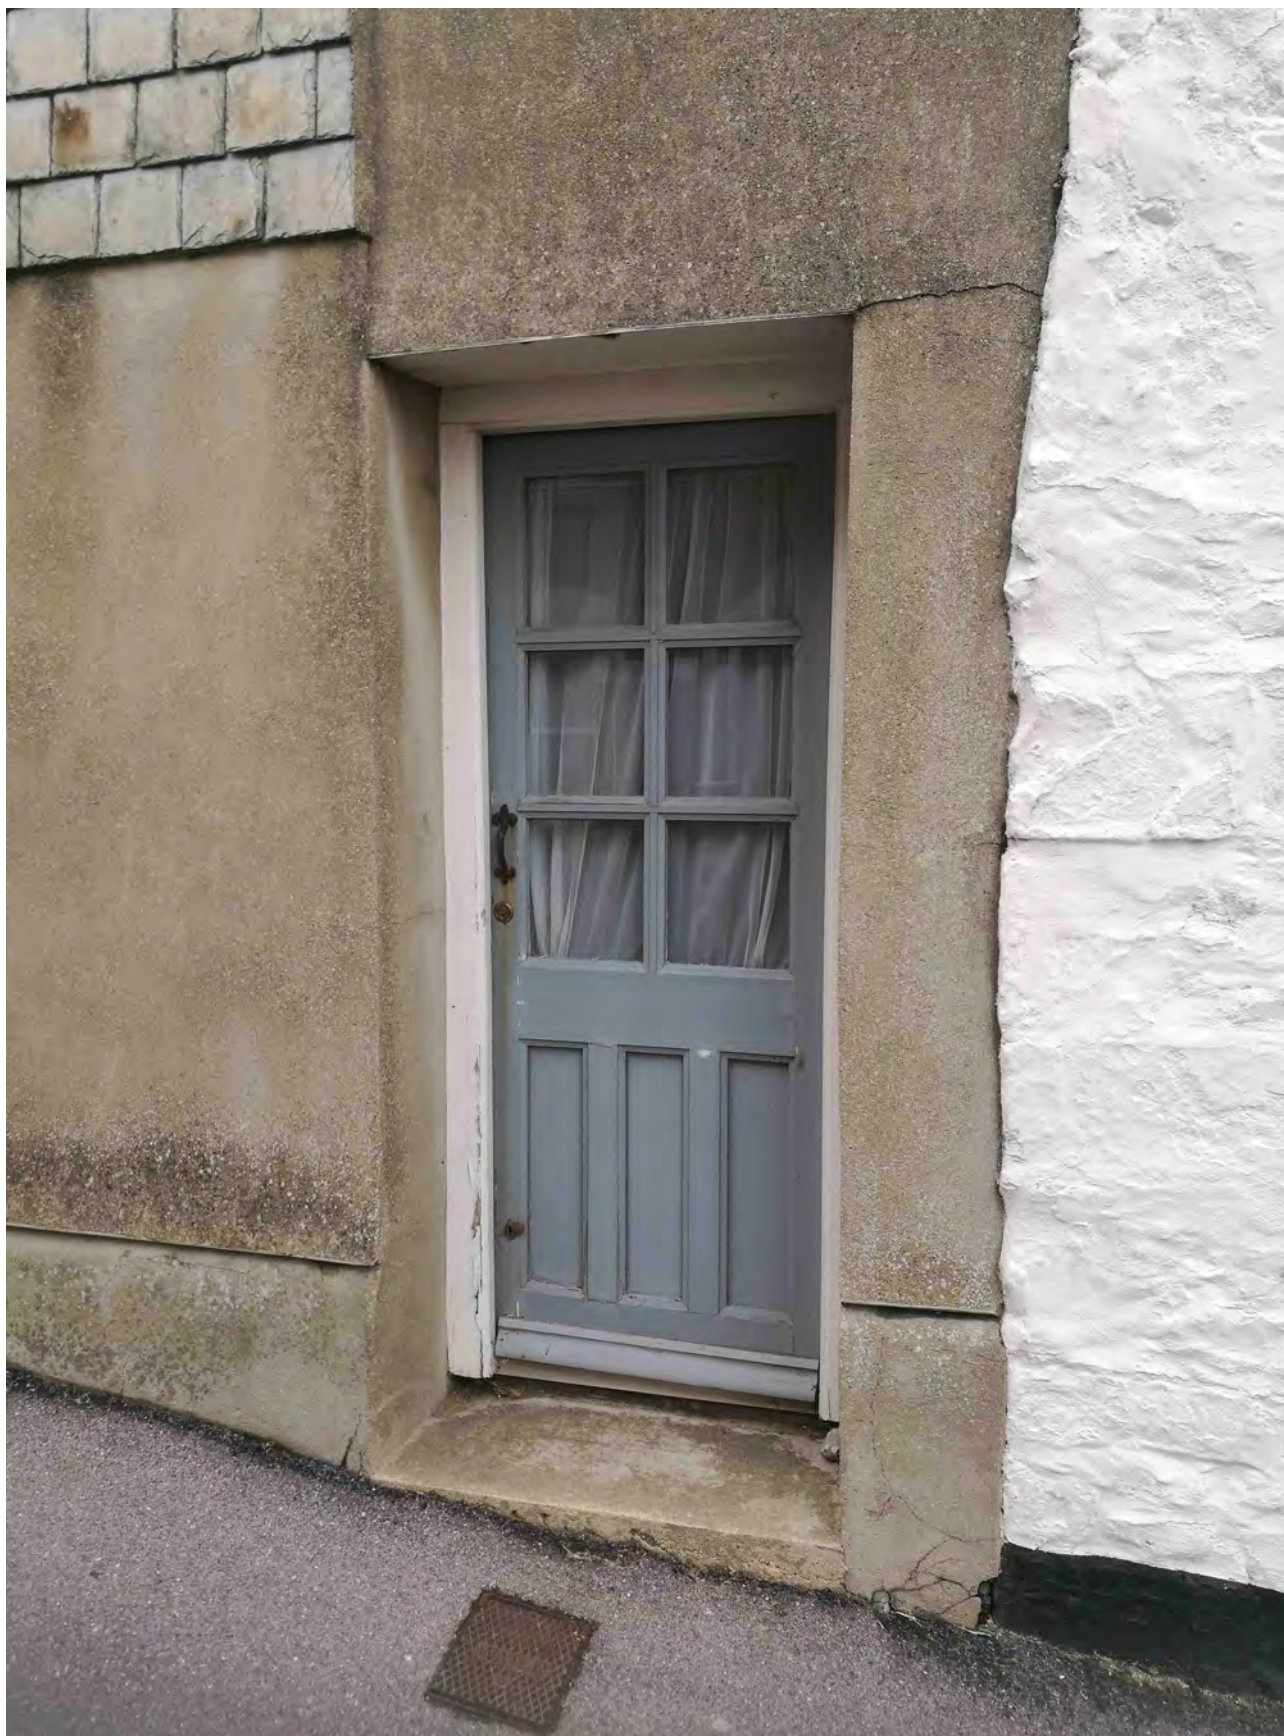
Photo of southern external door; deteriorating door and frame along with cracked adjacent render.

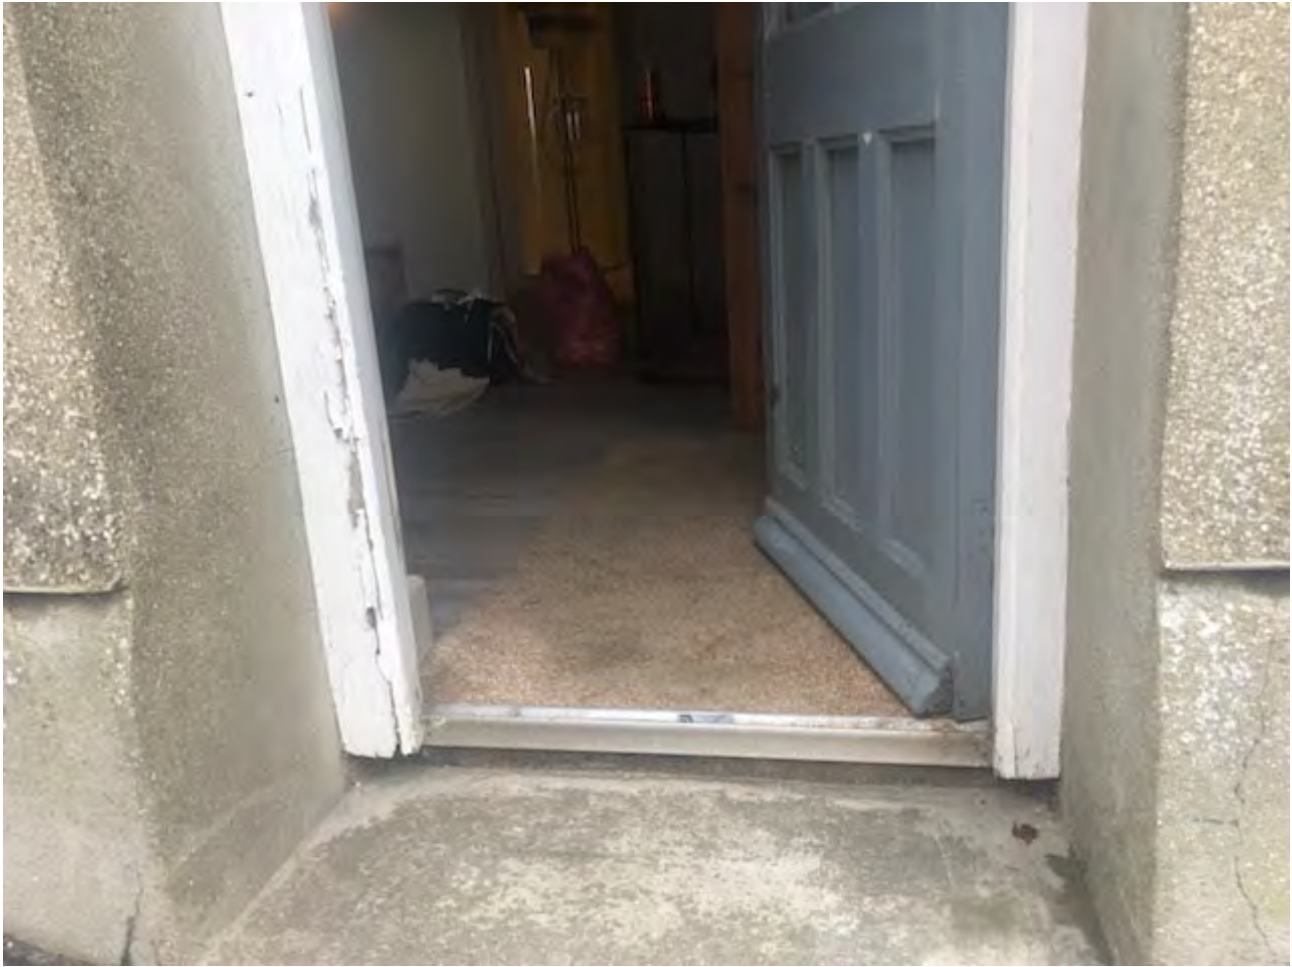
Photo of southern external door; deteriorating door and frame along with cracked adjacent render.

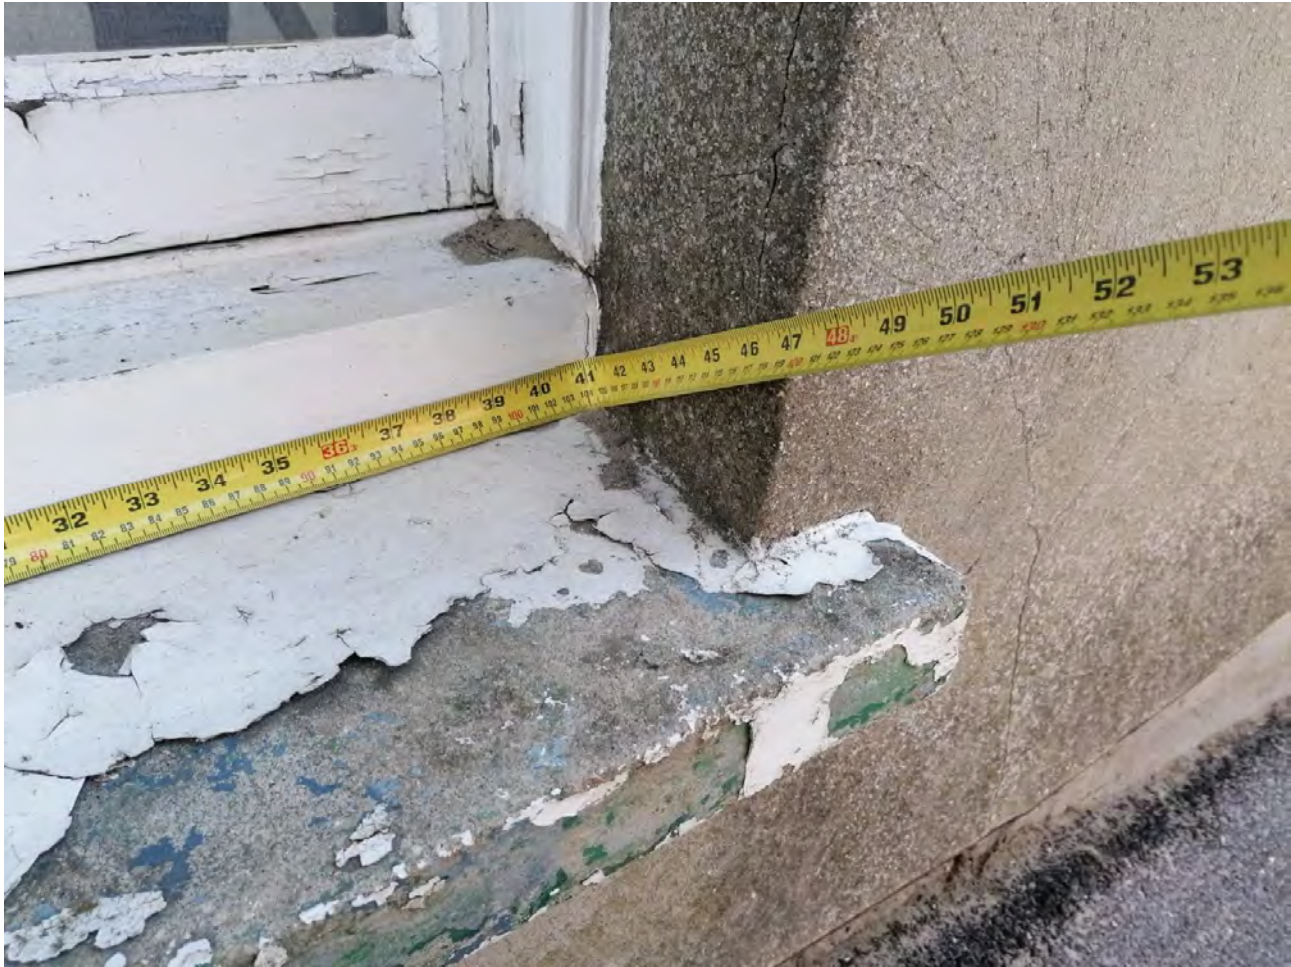
Photo of ground floor window cill; deteriorating window and frame along with cracked adjacent render.

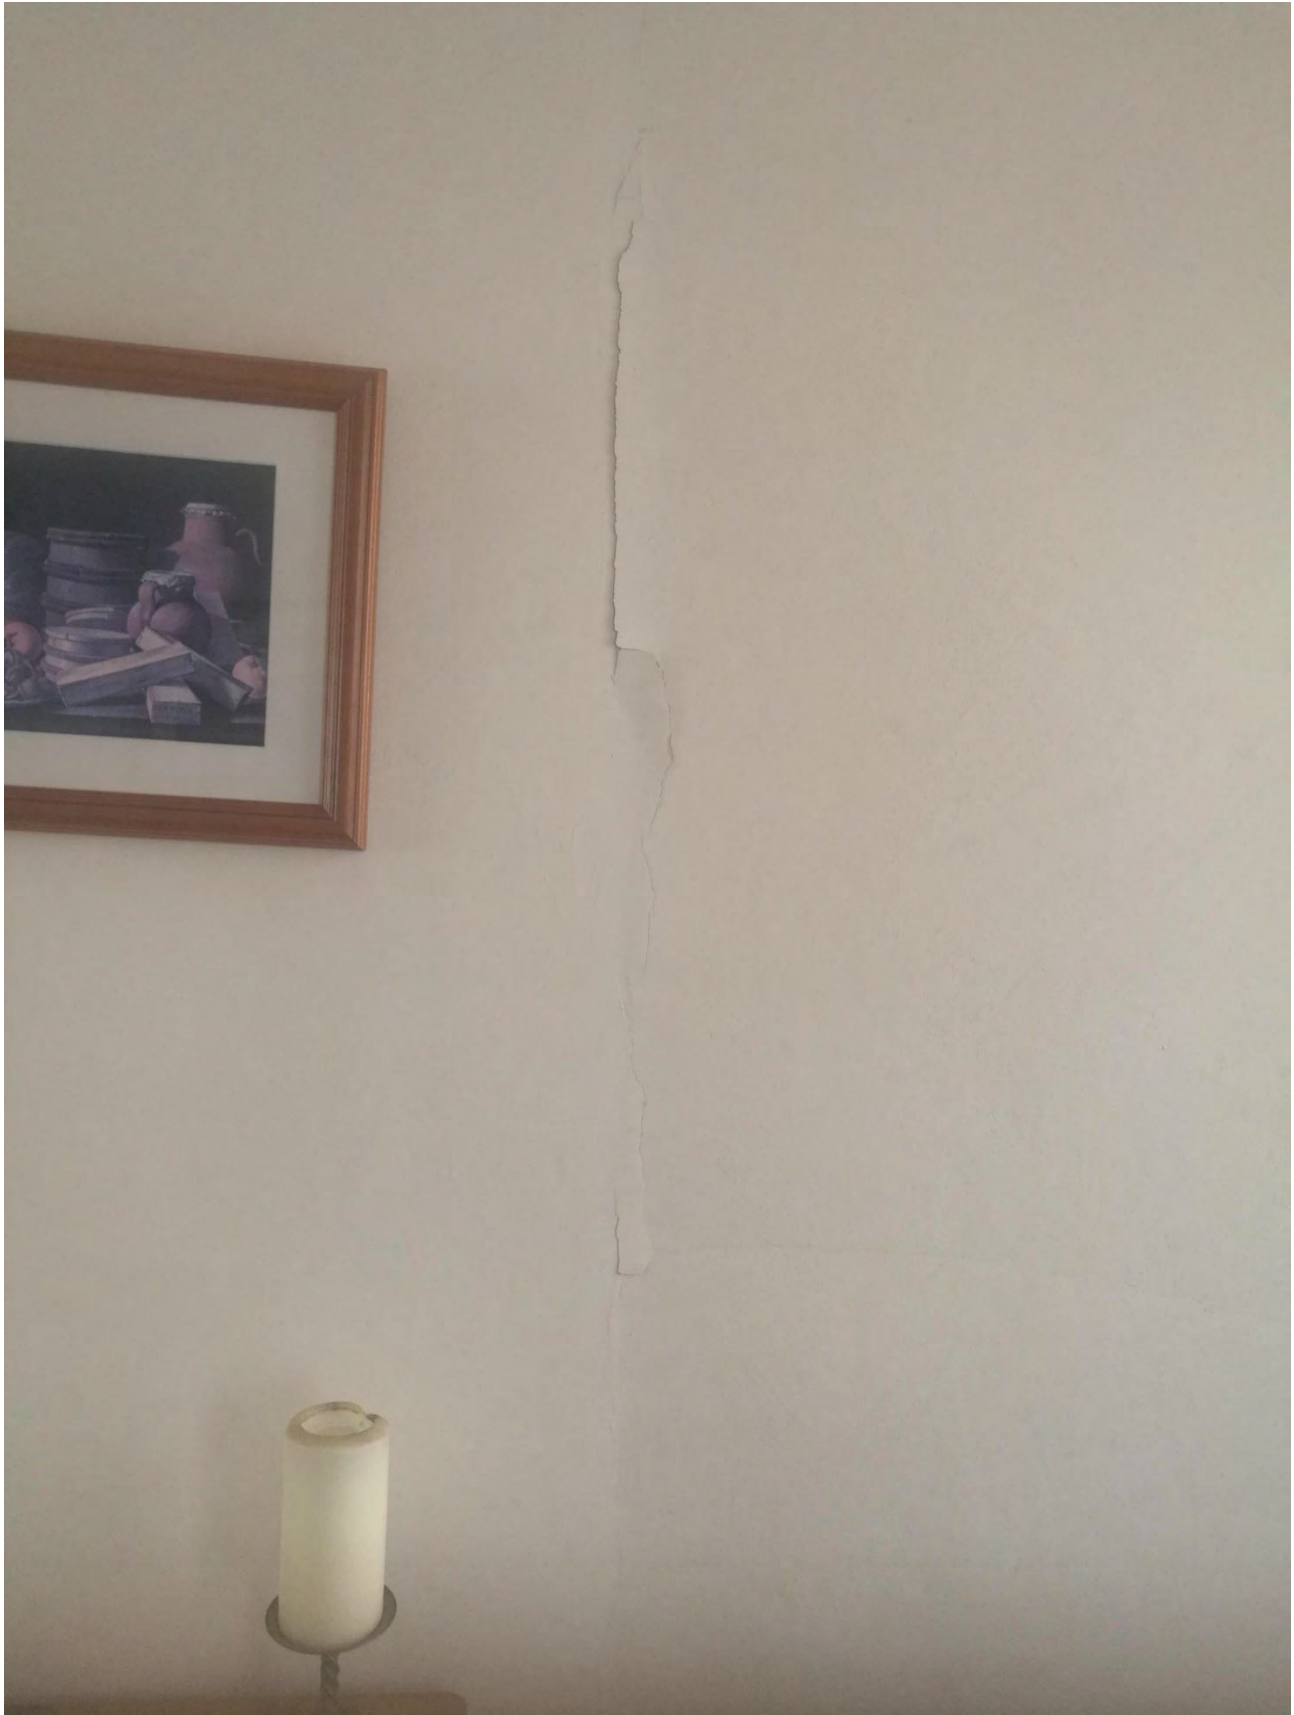
Photo of internal dining room wall with cracked plasterwork.

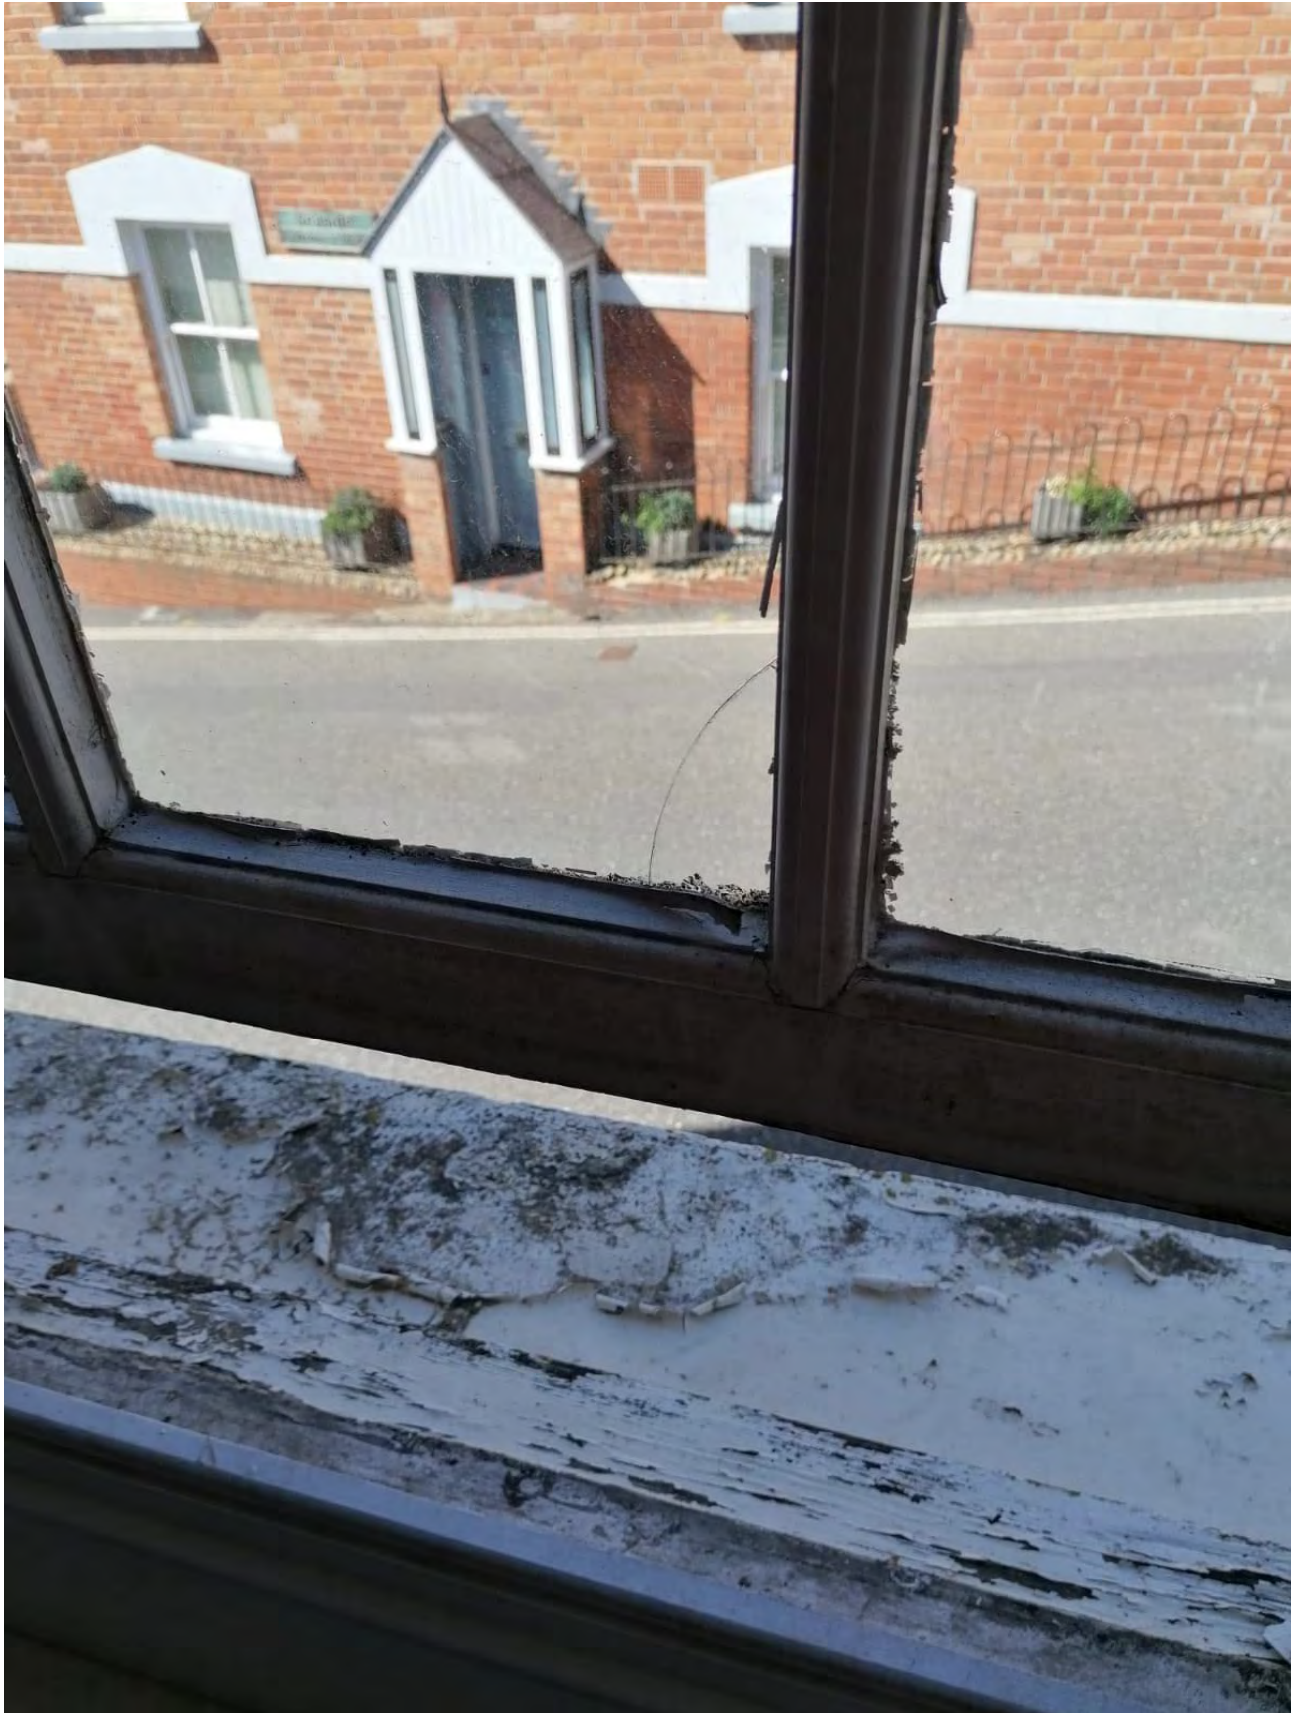
Photo of first floor bedroom window; deteriorating window, cill and frame, along with a cracked pane of glass.

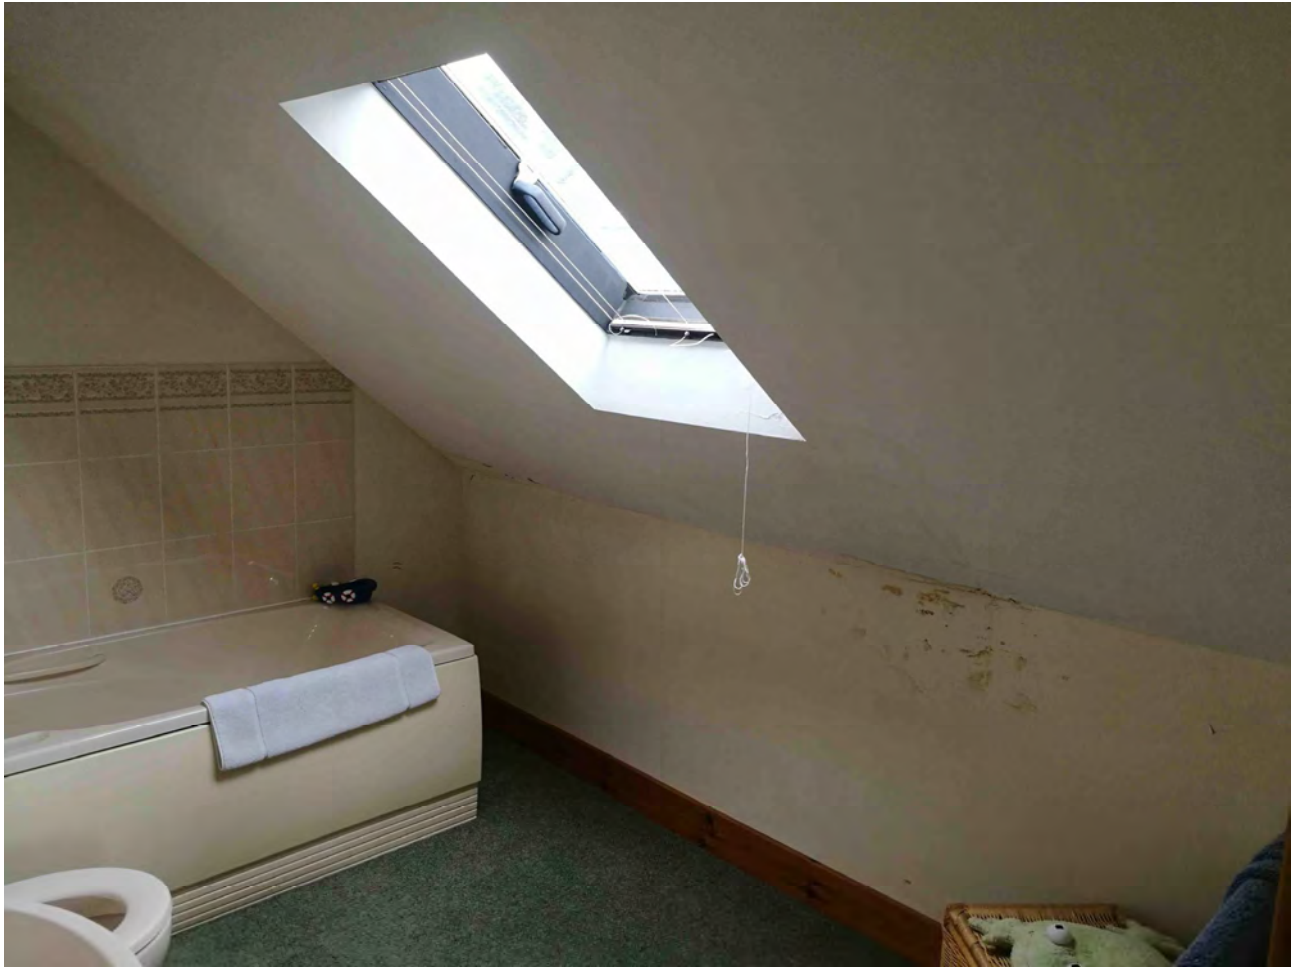
Photo of first floor bathroom rooflight; cracked plasterwork along with water damage to external wall.

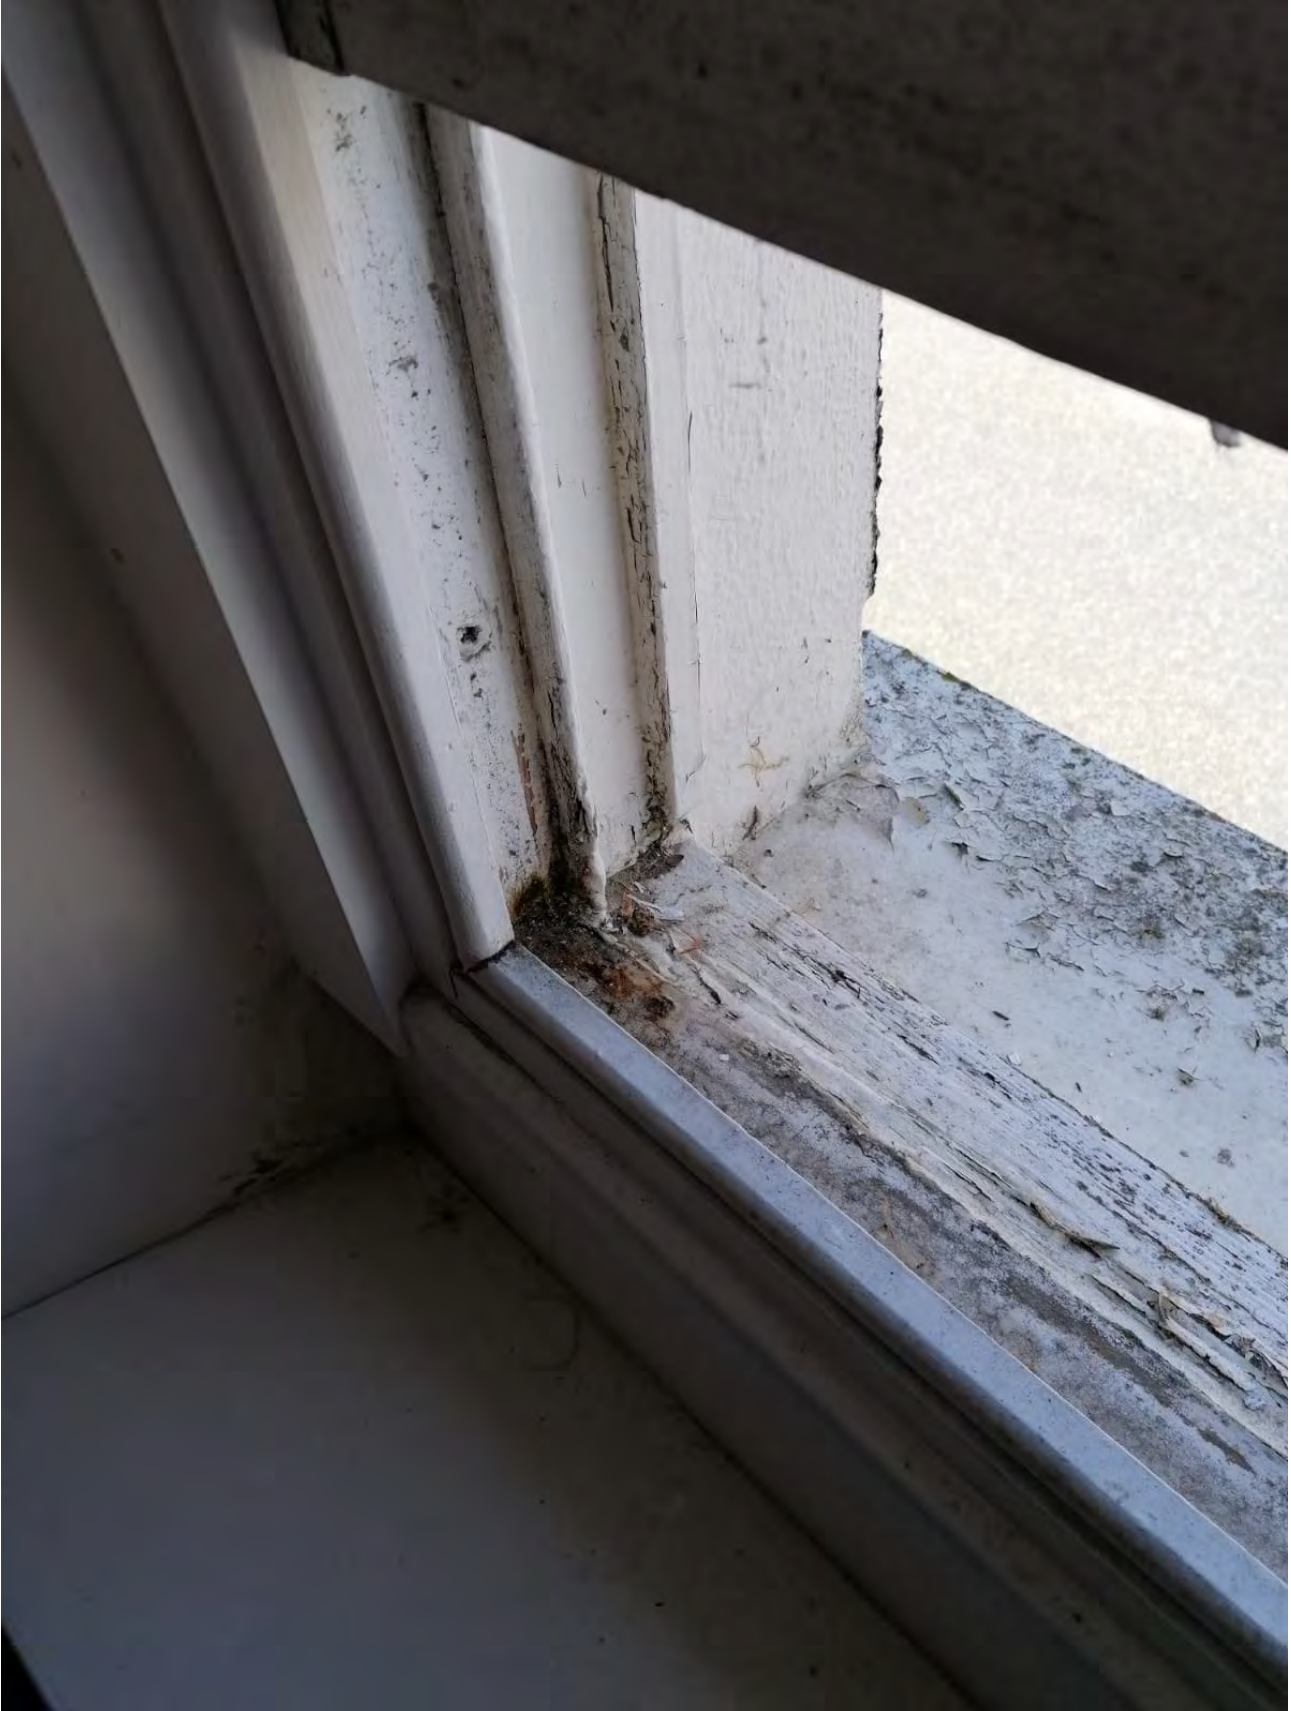
Photo of first floor bedroom window; deteriorating window, cill and frame.

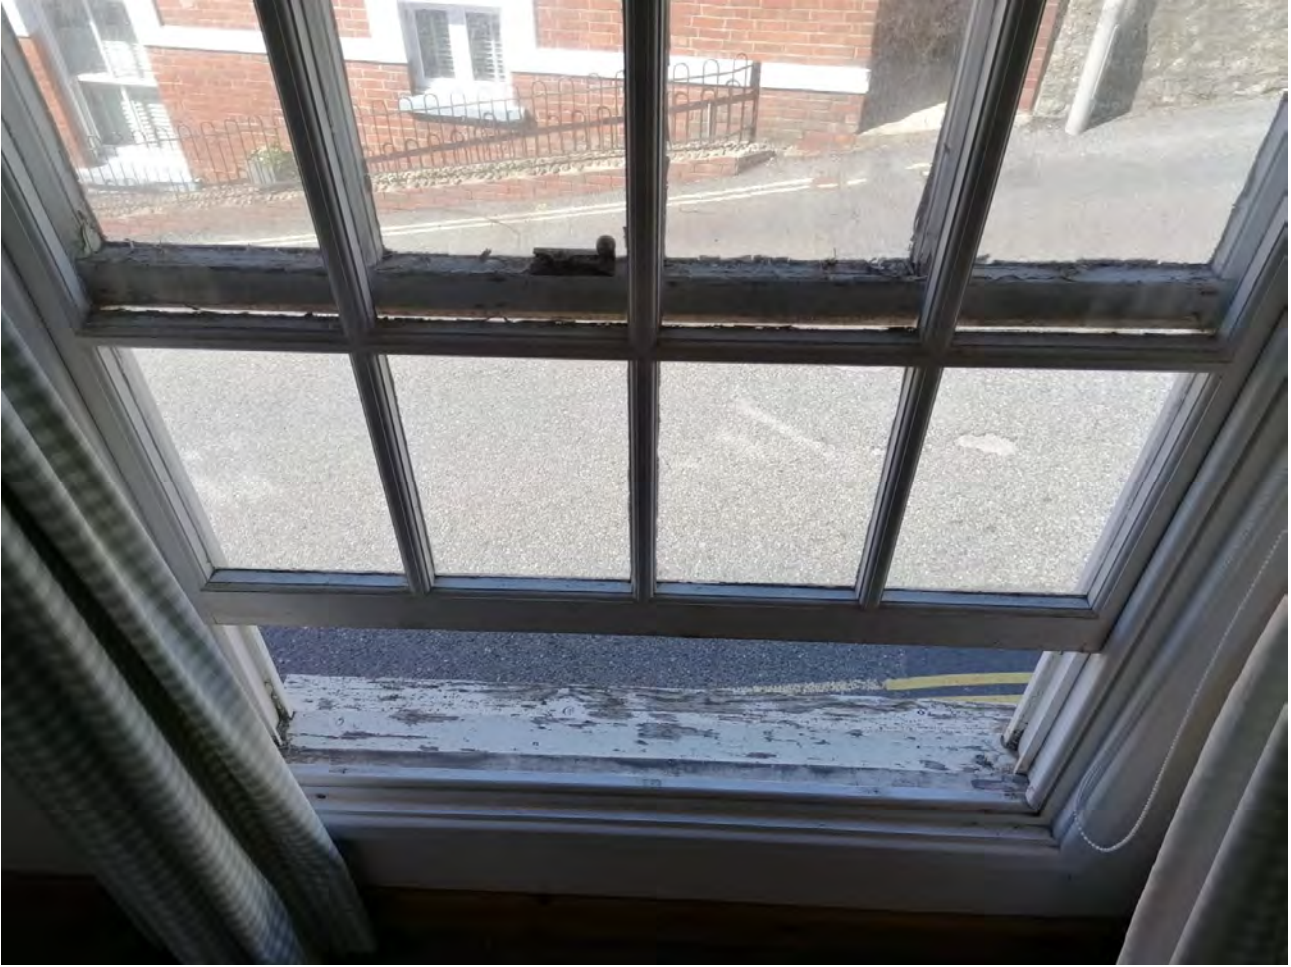
Photo of first floor bedroom window; deteriorating window, cill and frame.

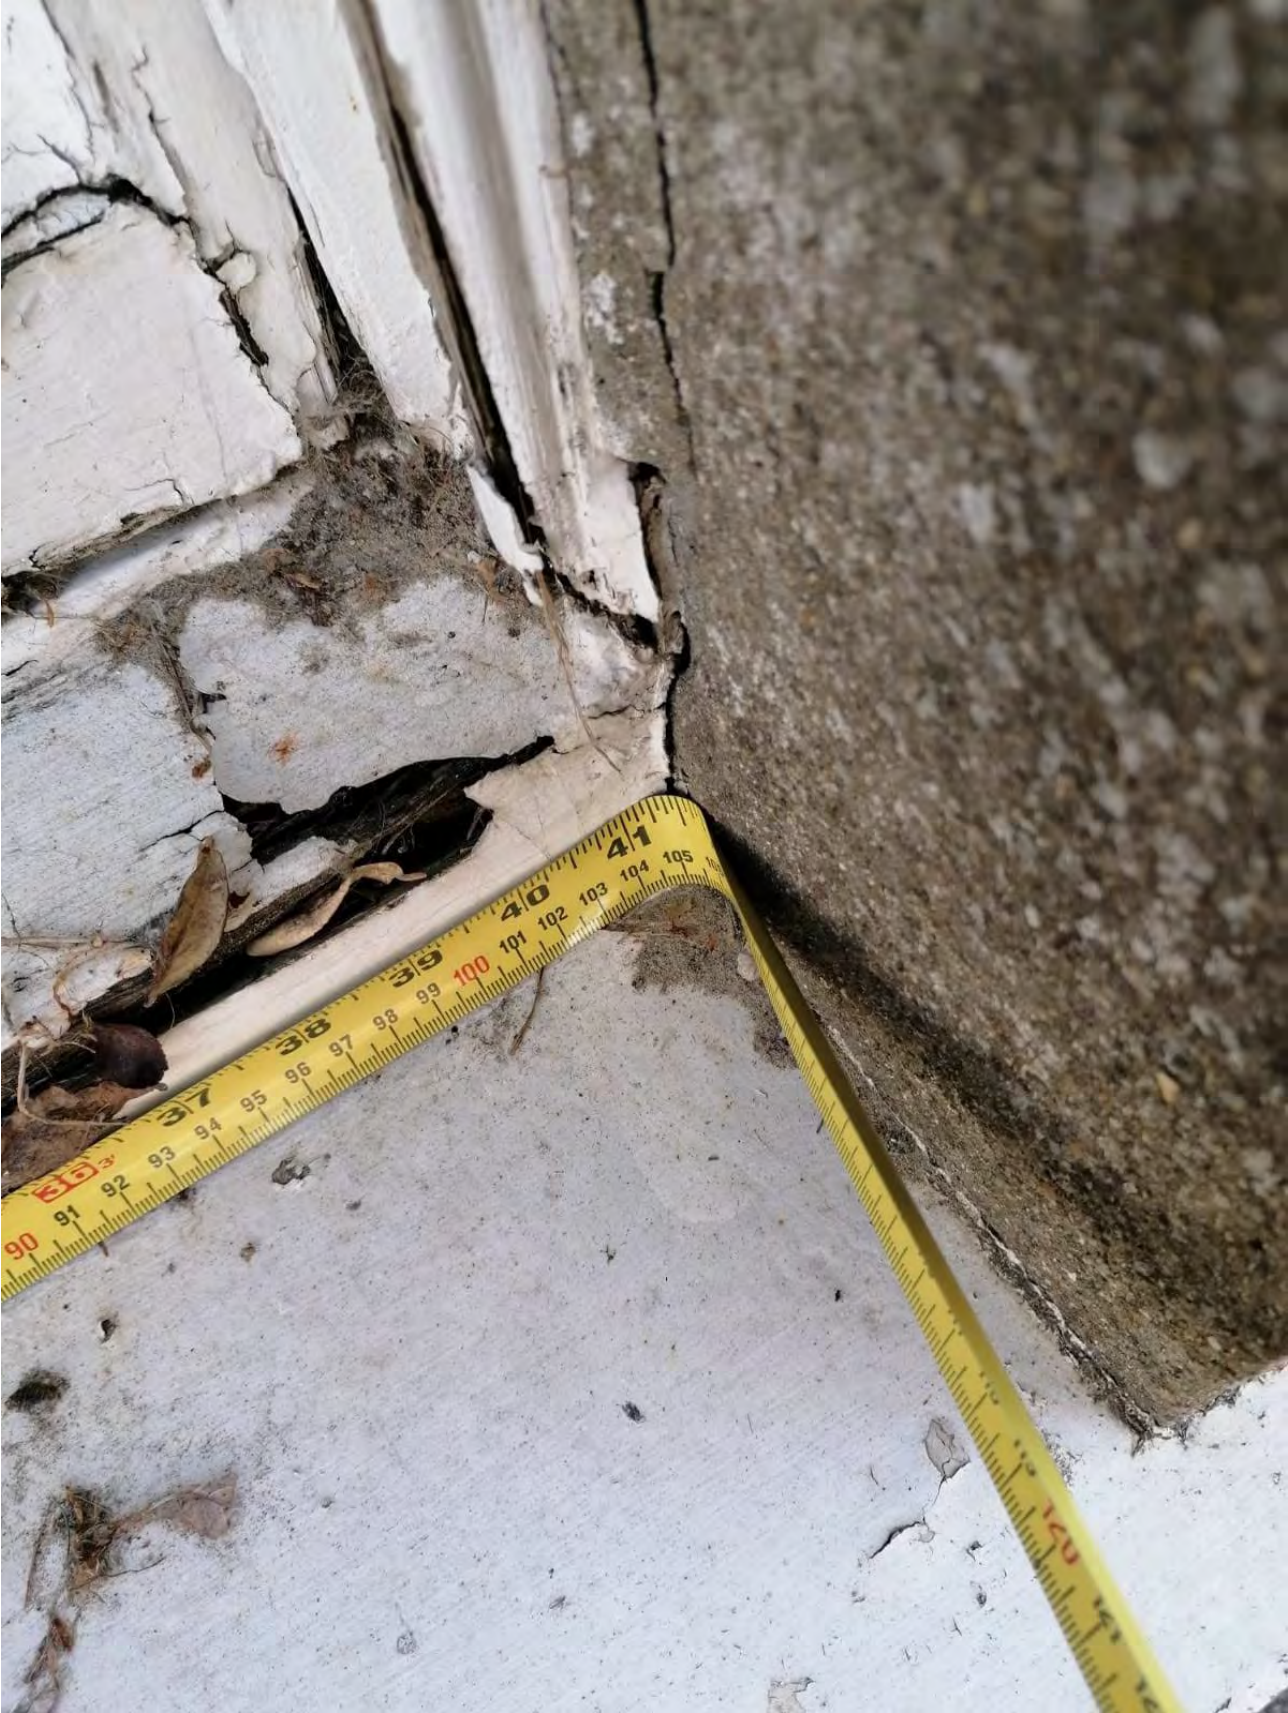
Photo of first floor bedroom window cill; deteriorating window and frame along with cracked adjacent render.

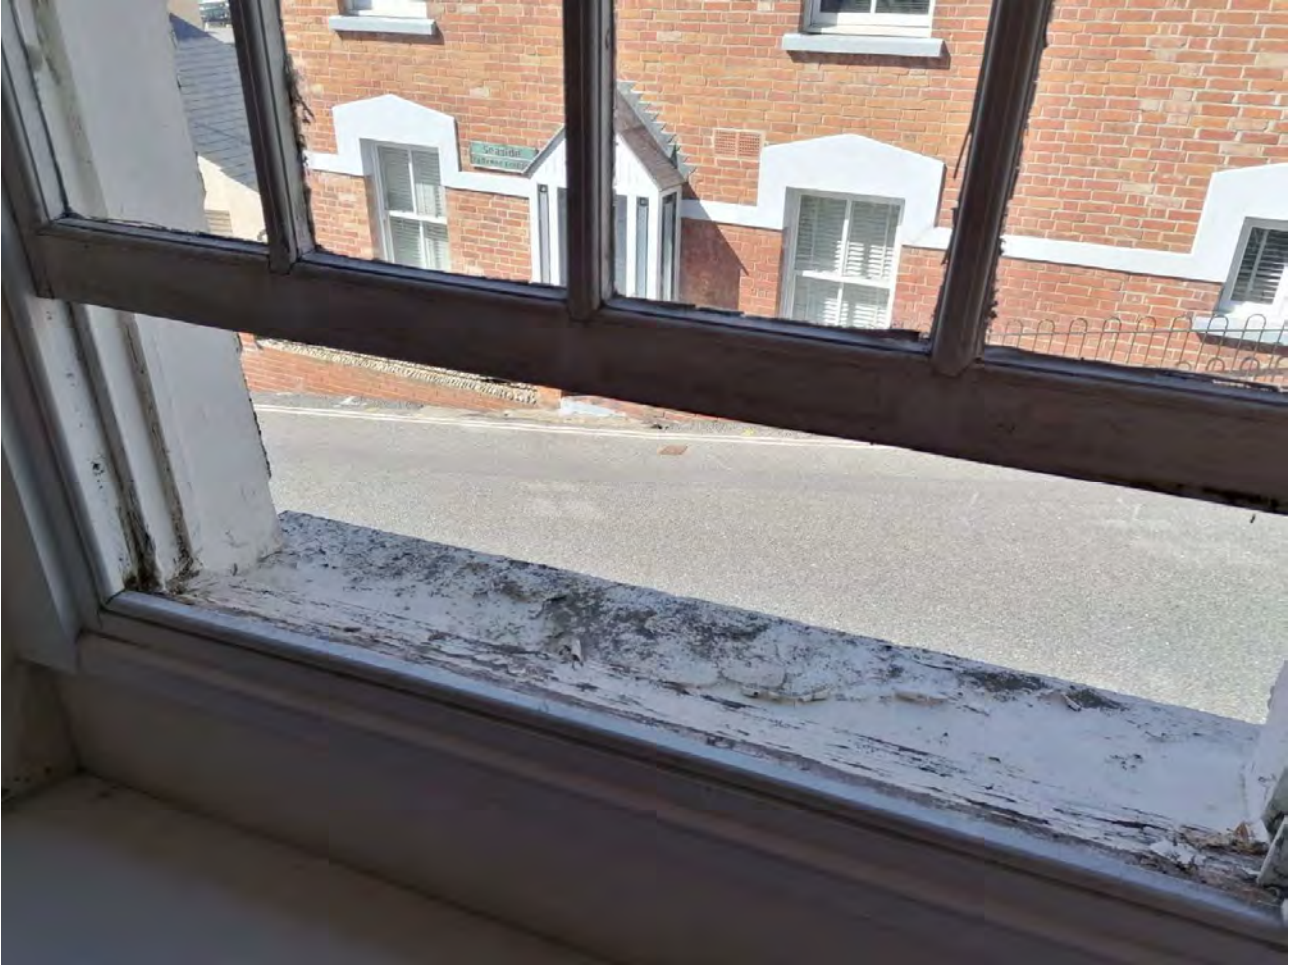
Photo of first floor bedroom window; deteriorating window, cill and frame.

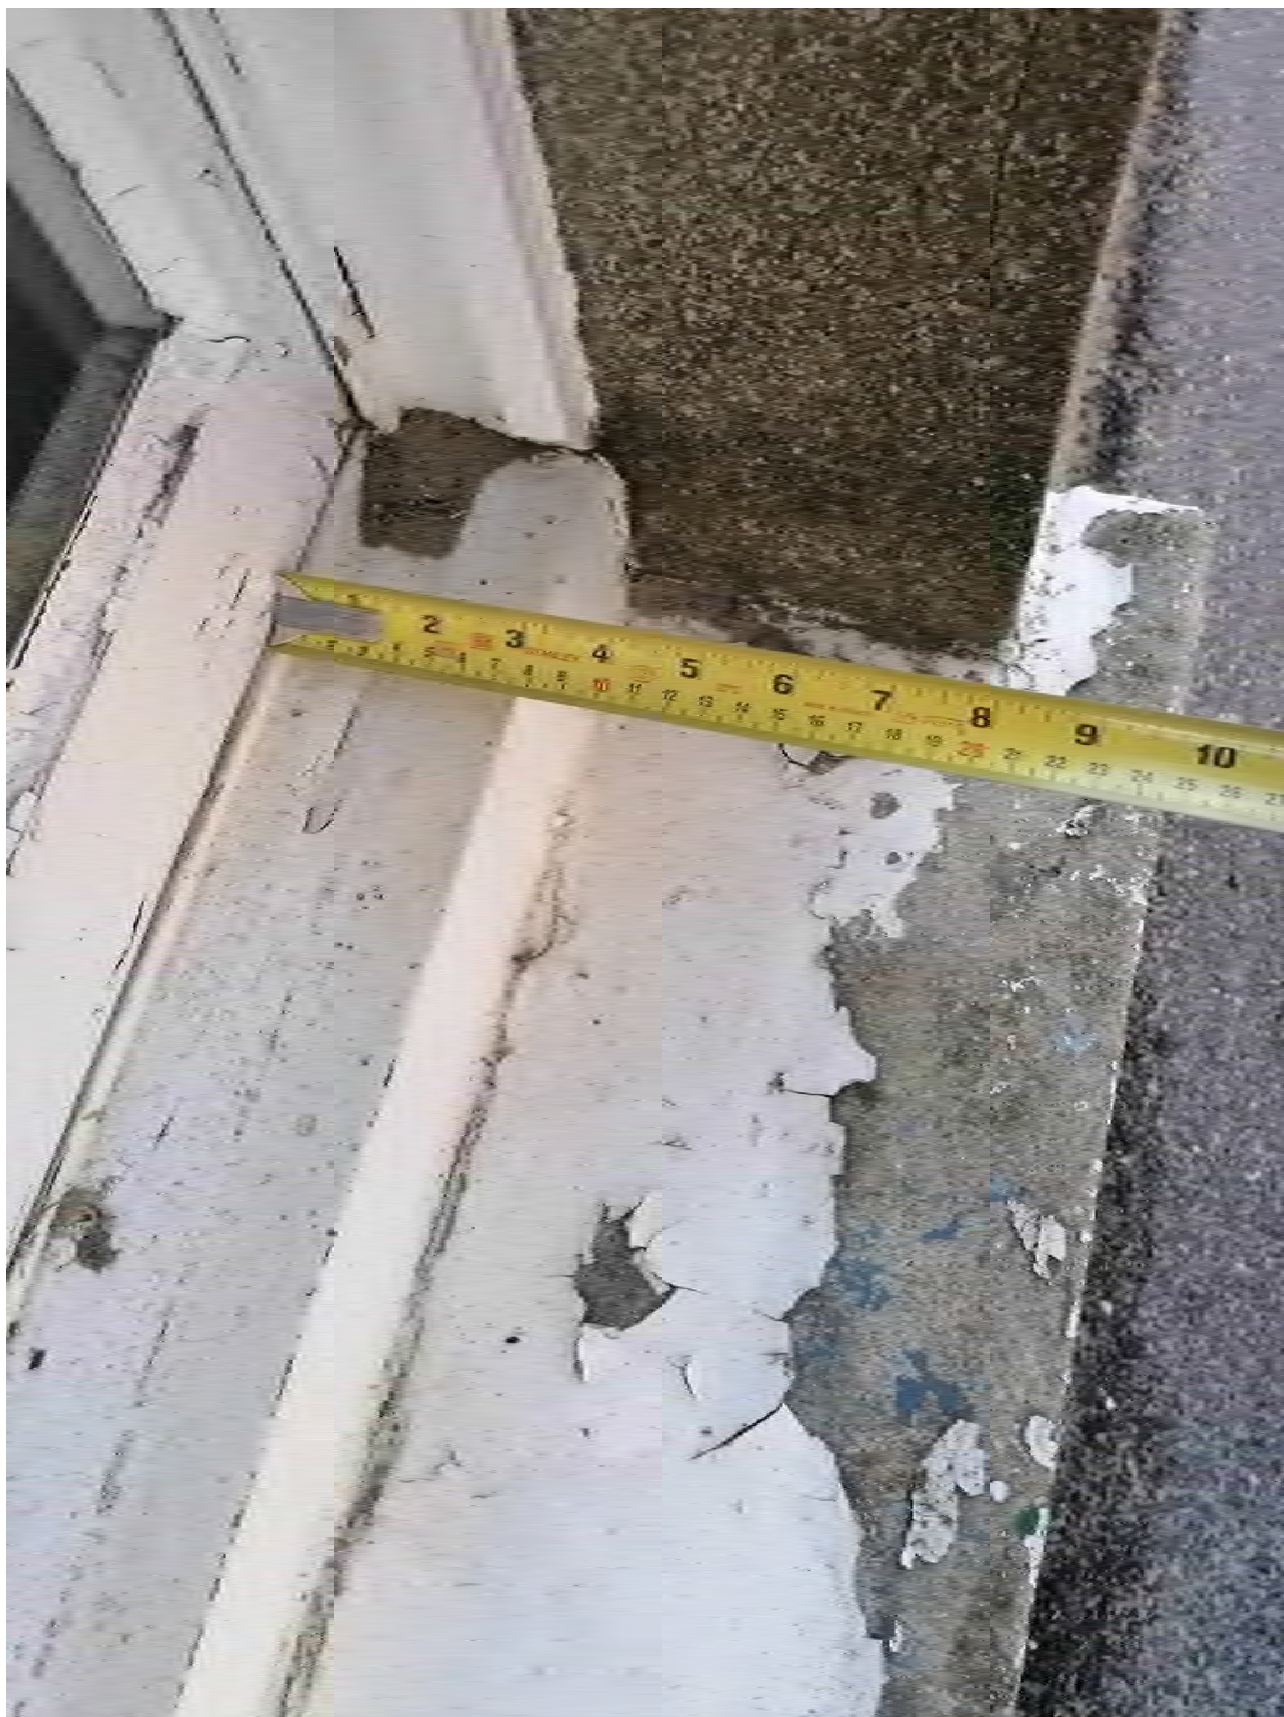
Photo of ground floor window cill; deteriorating window and frame along with cracked adjacent render.
