12 Cobb Road, Lyme Regis

Photographic Condition Survey

Nov 2020
Rev *

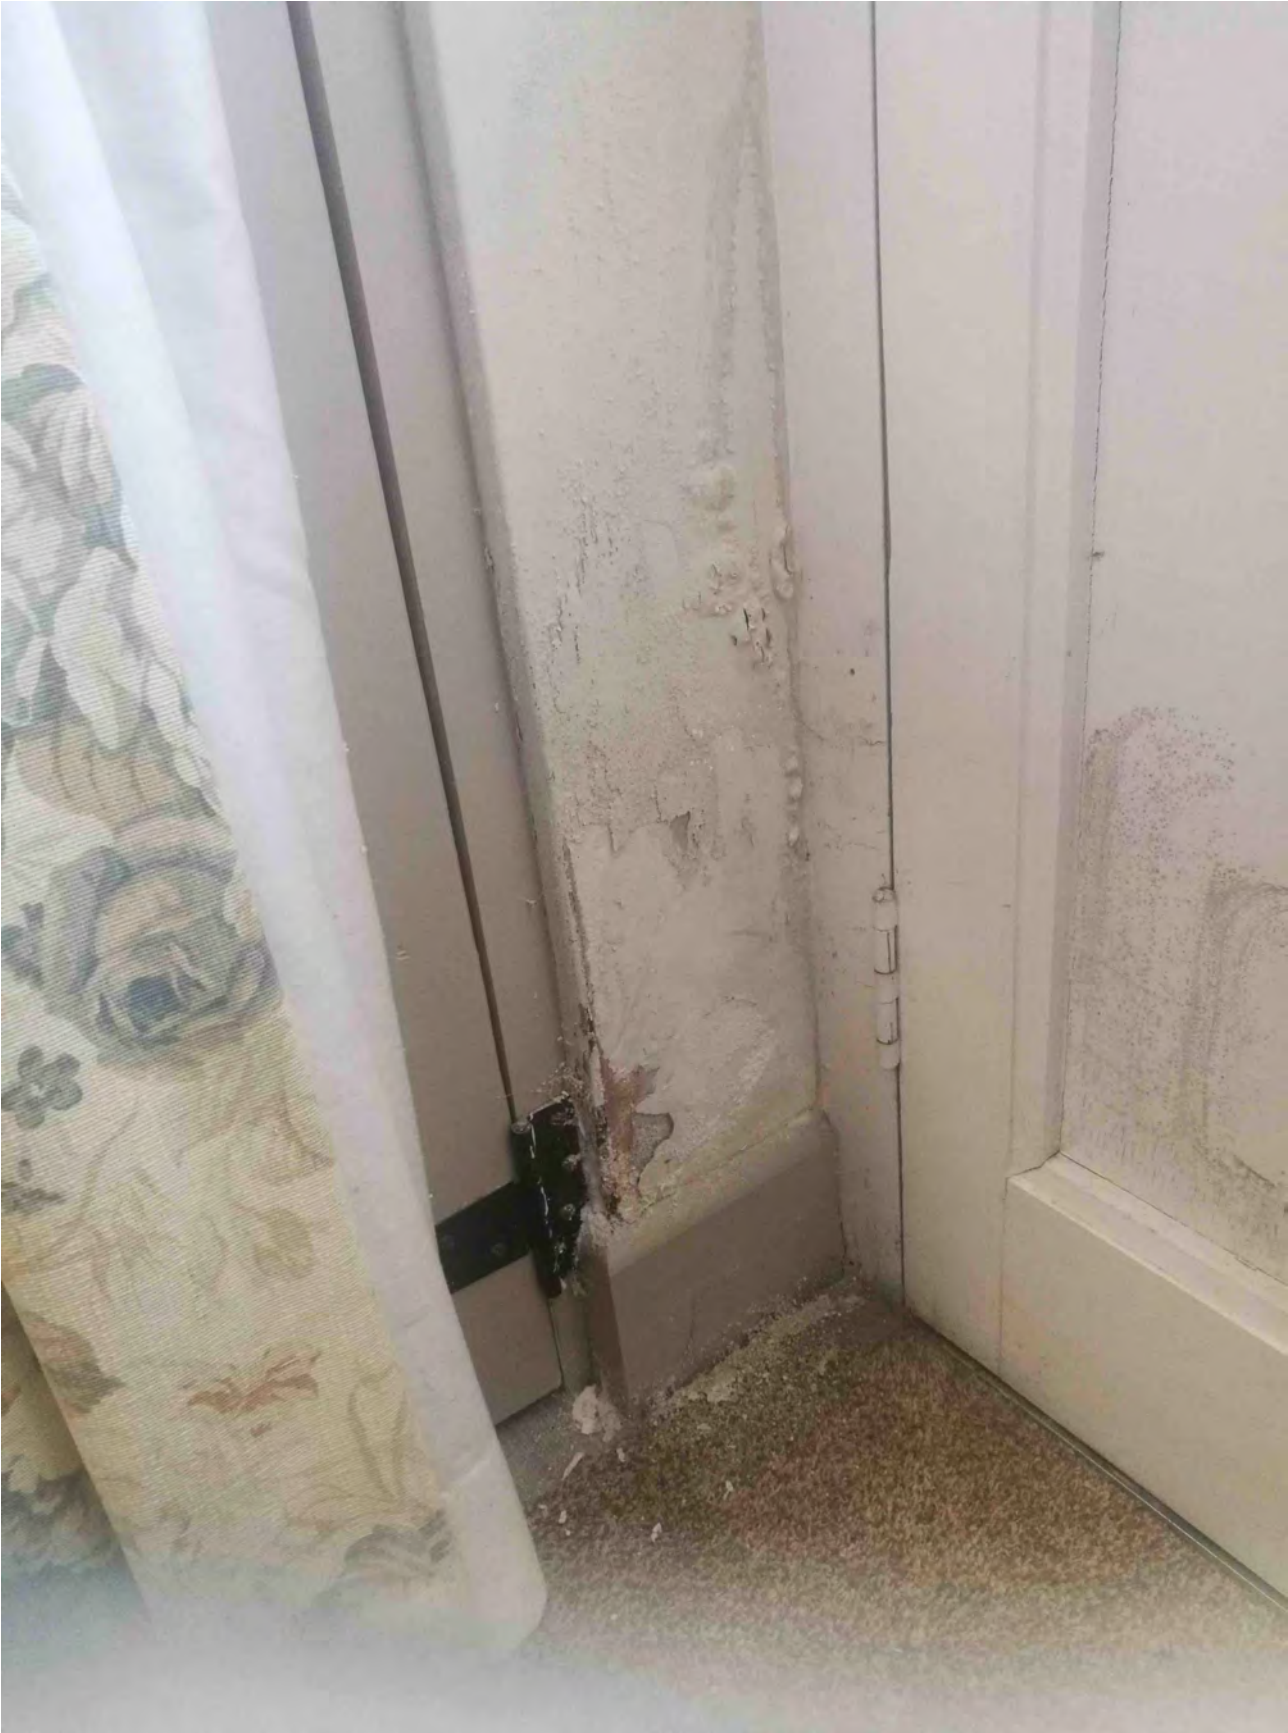
Photo of ground floor southern external door; water ingress damage to plasterwork.

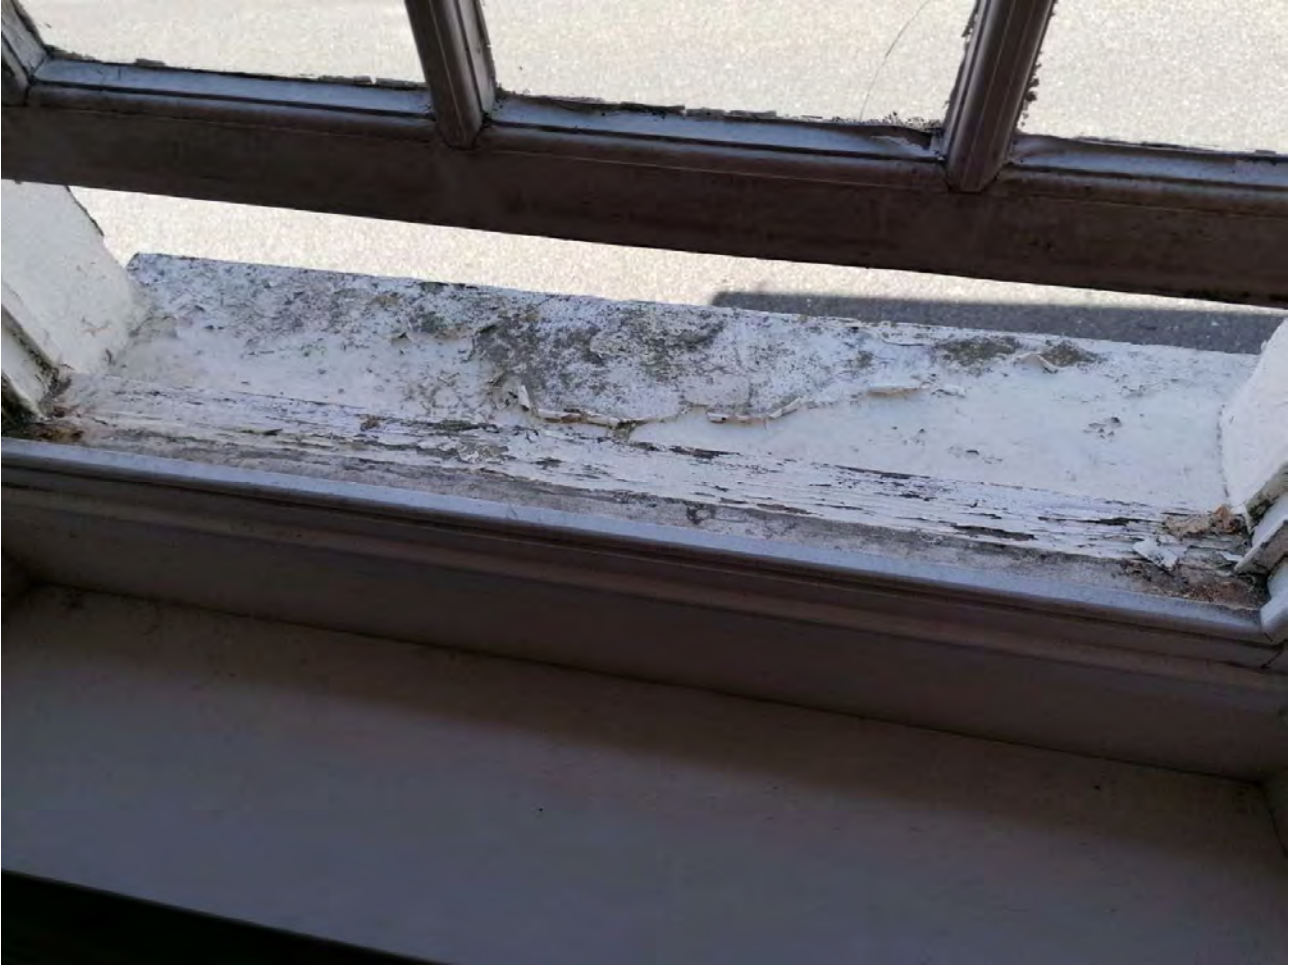
Photo of ground floor window cill; deteriorating window and frame, along with flaking paintwork.

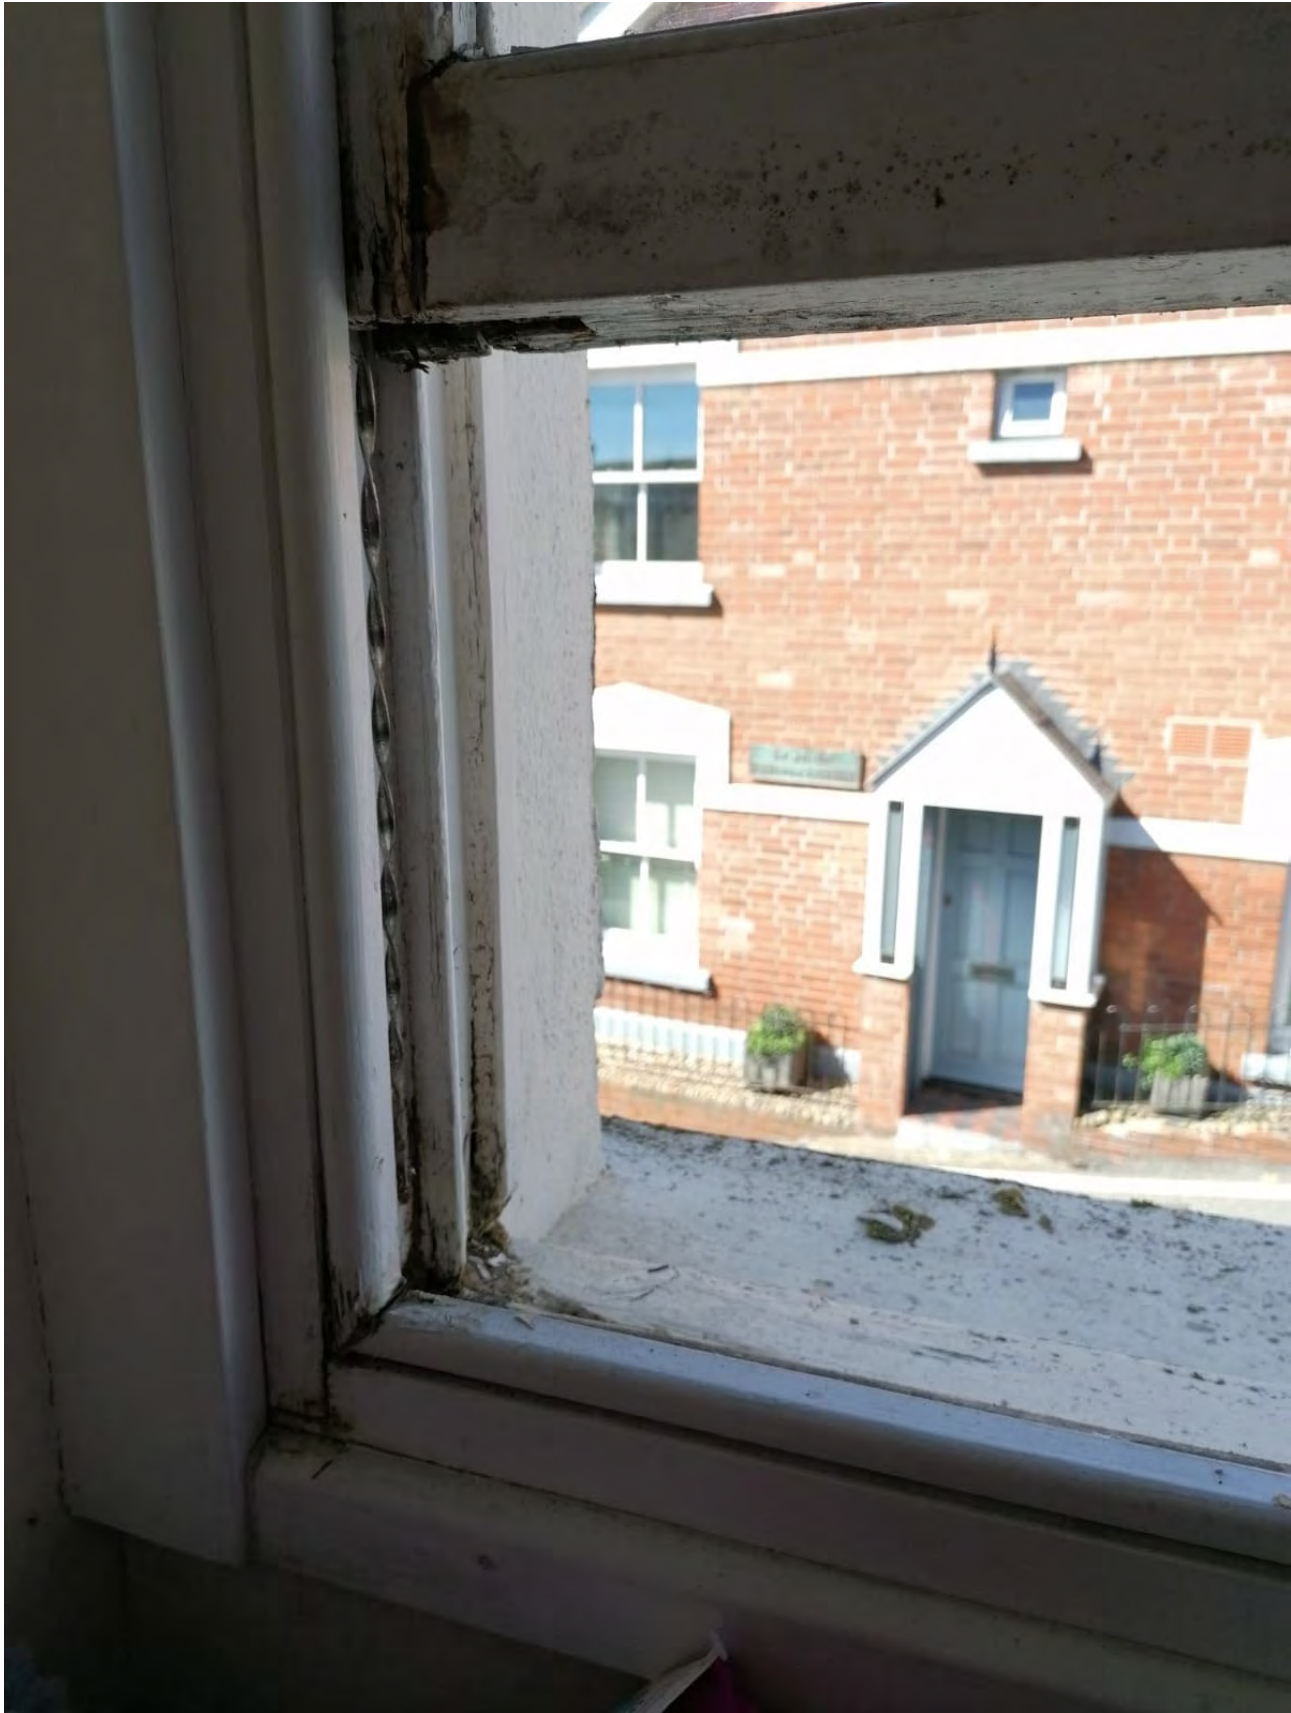
Photo of first floor bedroom window; deteriorating window, cill and frame.

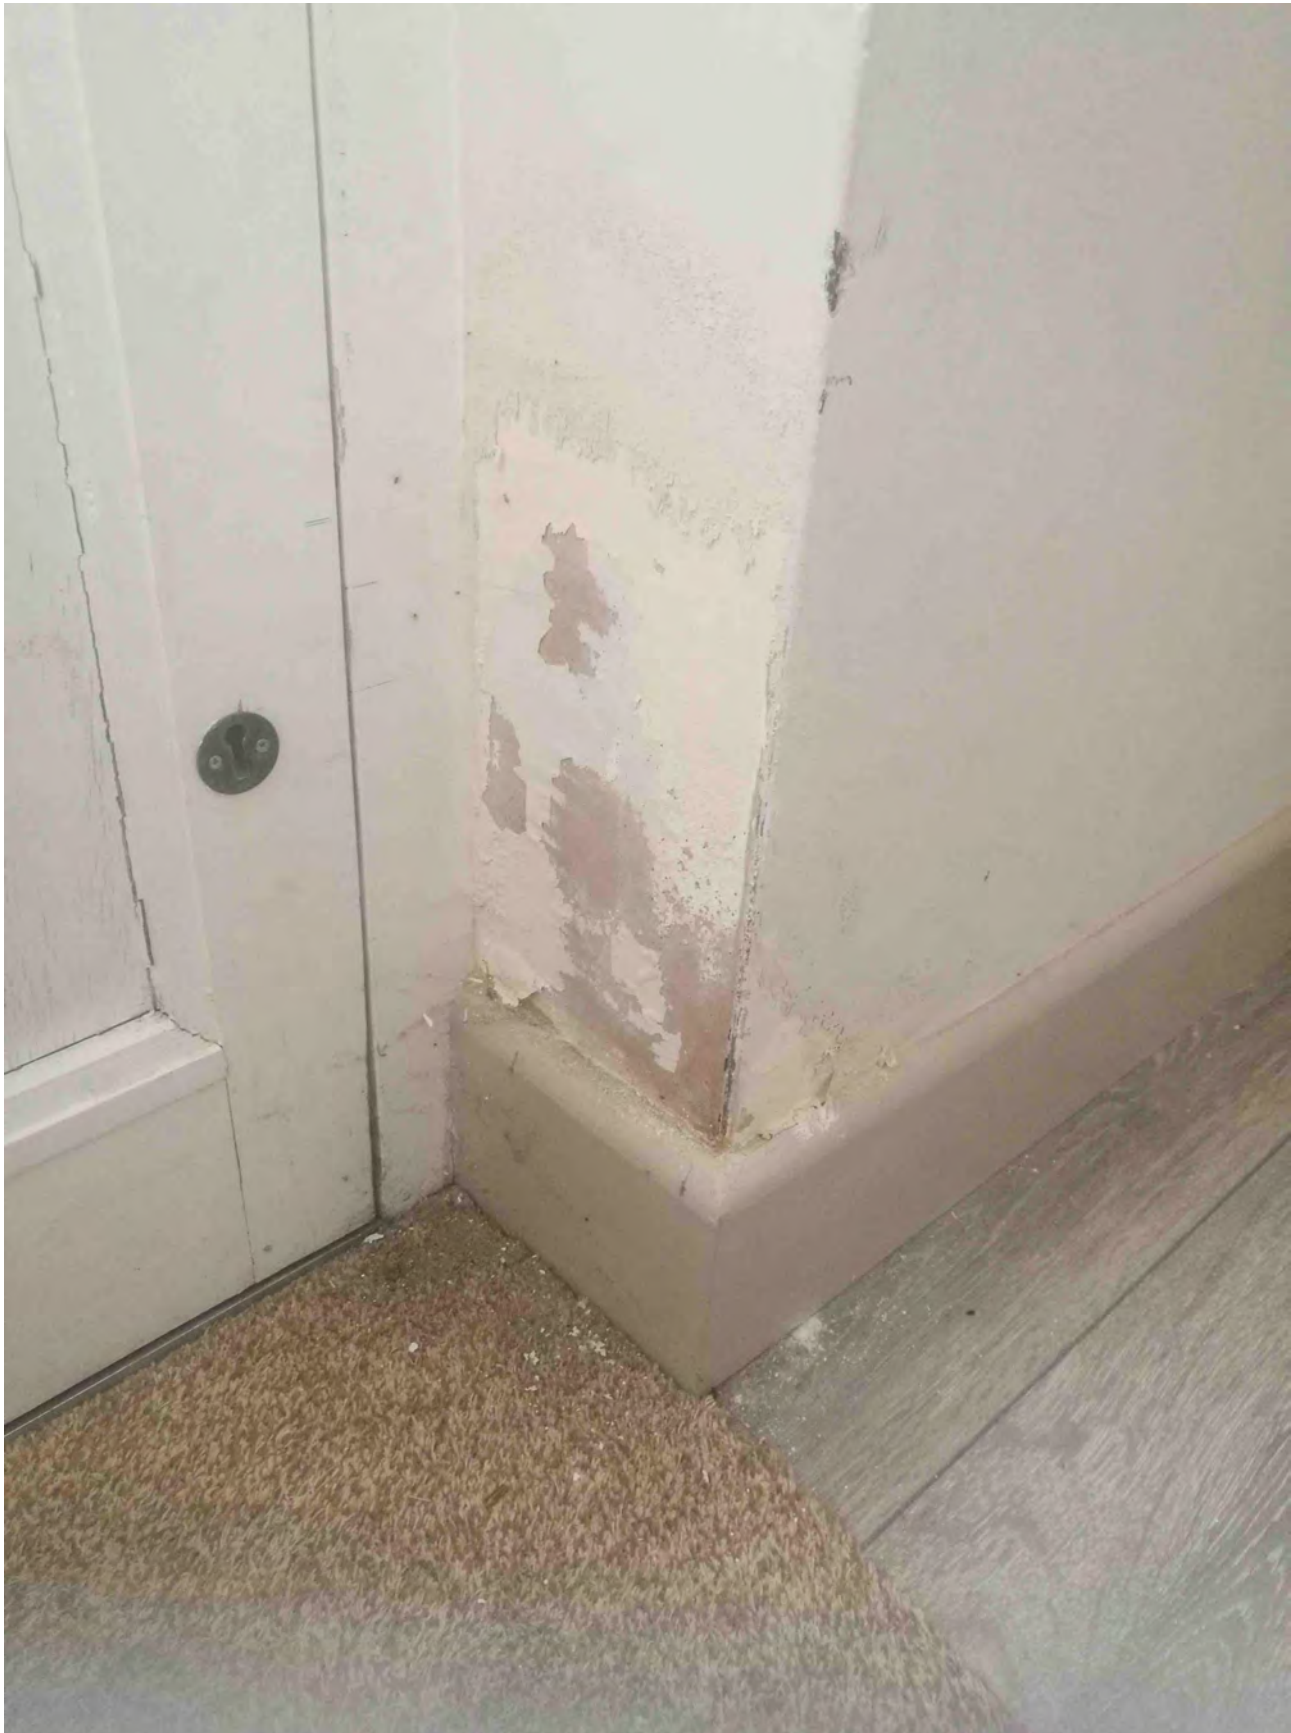
Photo of ground floor southern external door; water ingress damage to plasterwork.

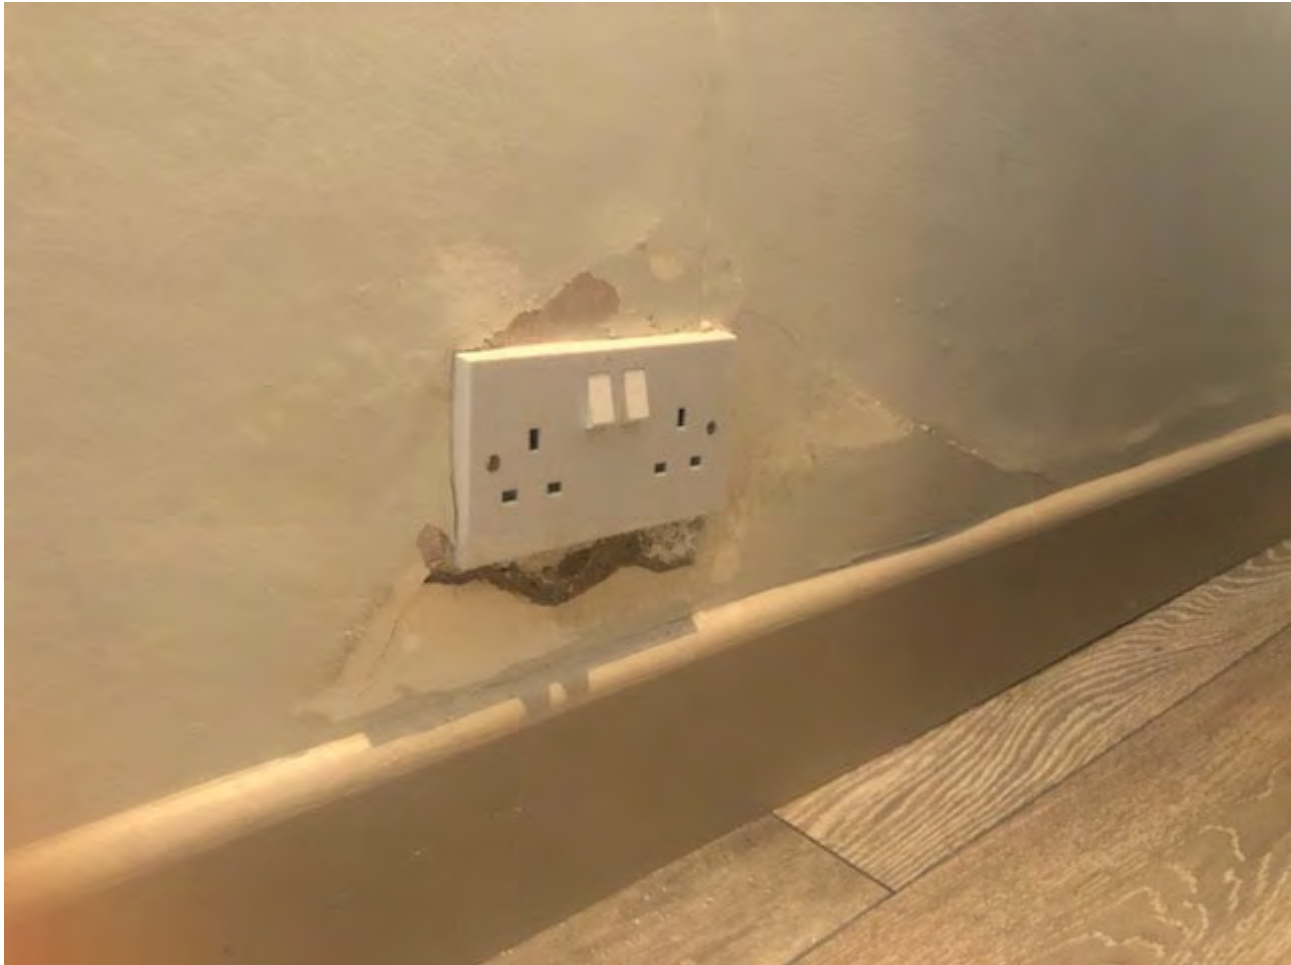
Photo of ground floor external wall; water ingress damage to plasterwork and electrics.

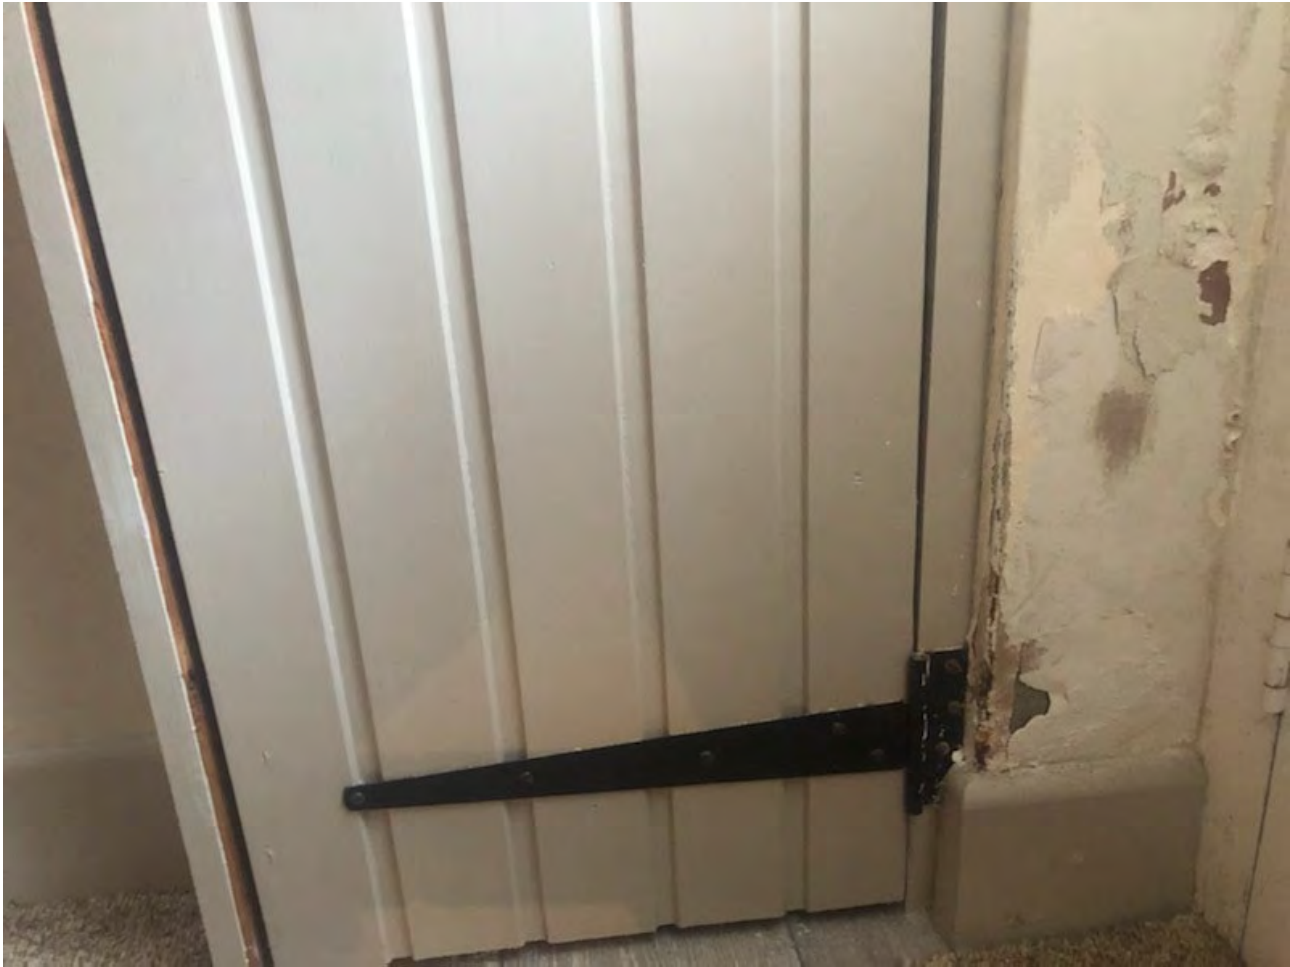
Photo of ground floor southern external door; water ingress damage to plasterwork.

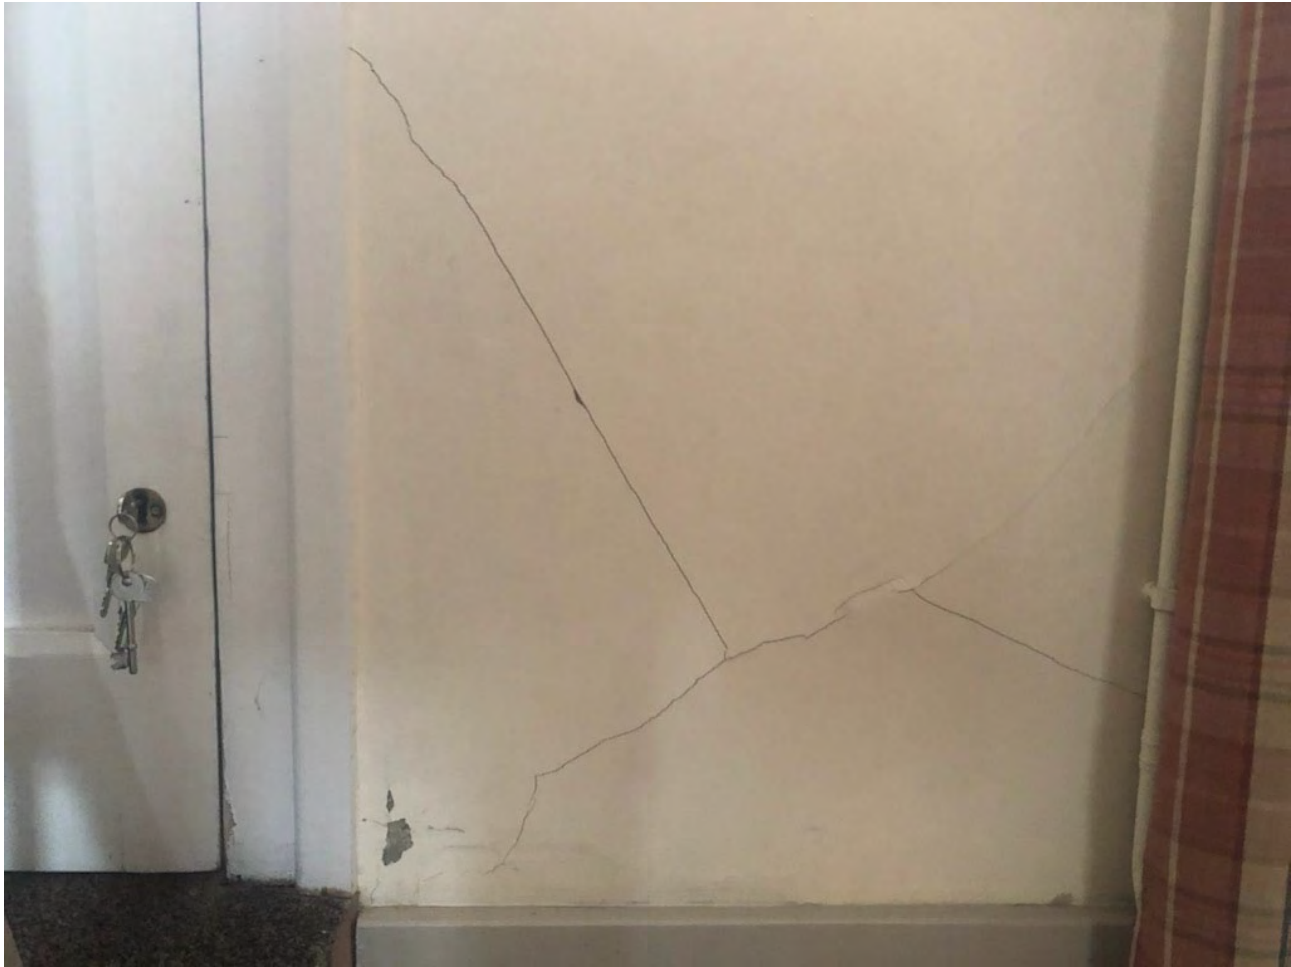
Photo of ground floor northern external door; water ingress damage to plasterwork, heavily cracked.

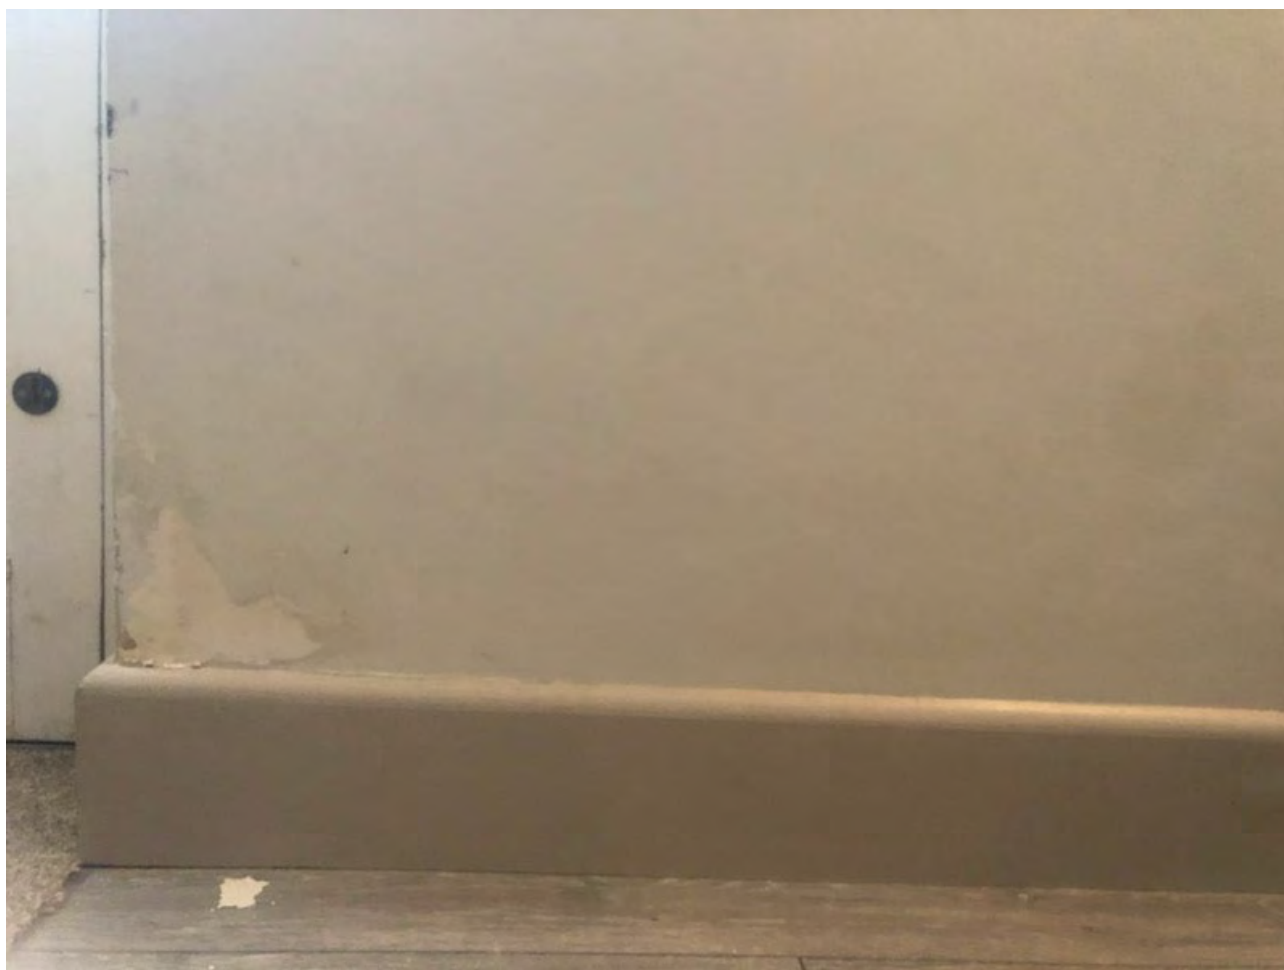
Photo of ground floor southern external door; water ingress damage to plasterwork.

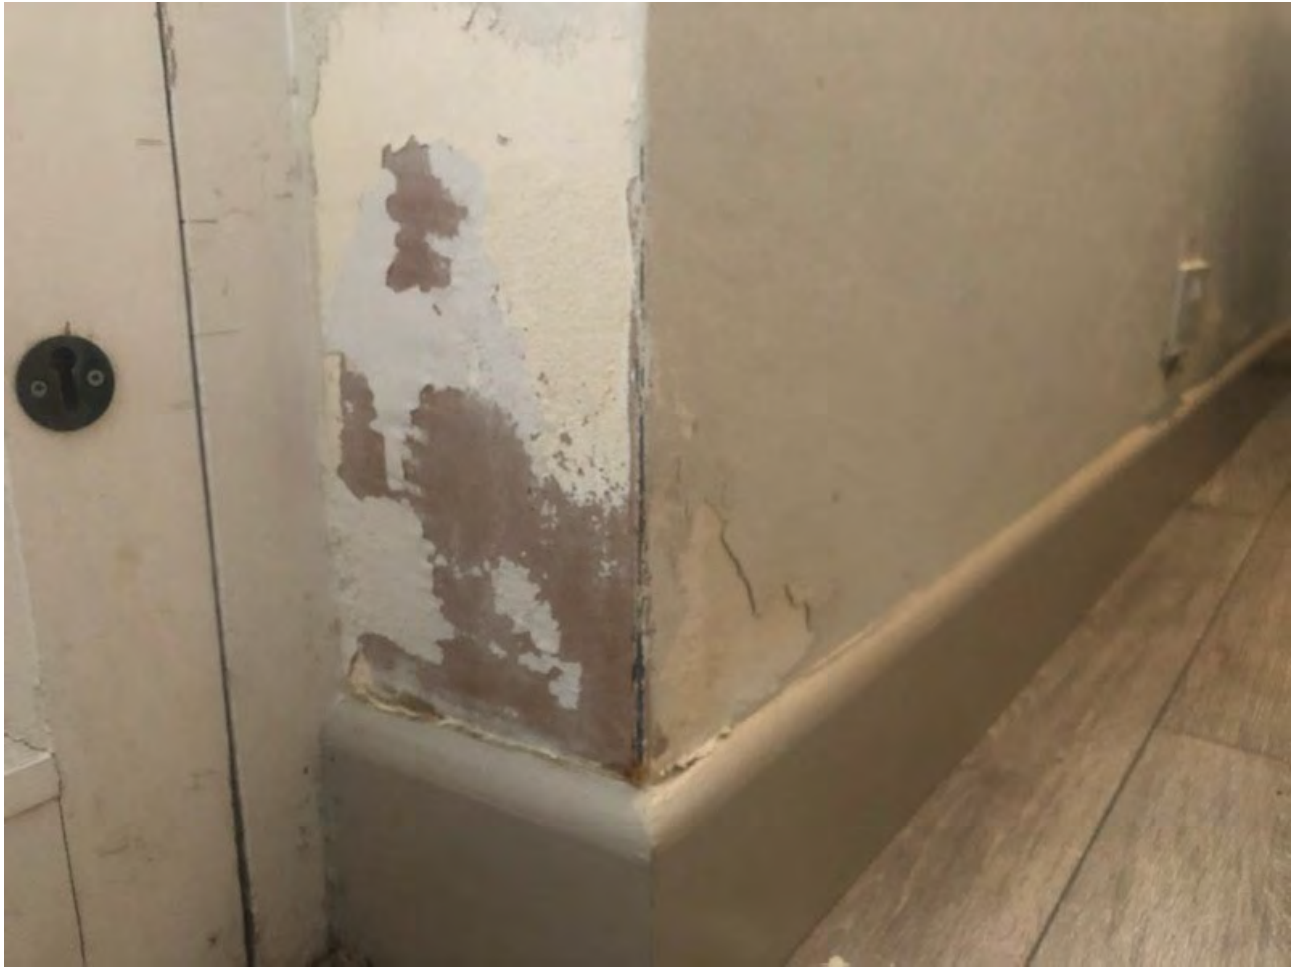
Photo of ground floor southern external door; water ingress damage to plasterwork.
