**Proposed works to
the barn at
Kemyel Crease
Paul
Condition report**

25 November 2020

Peggy Rickaby
BA Dip Arch RIBA Chartered Architect

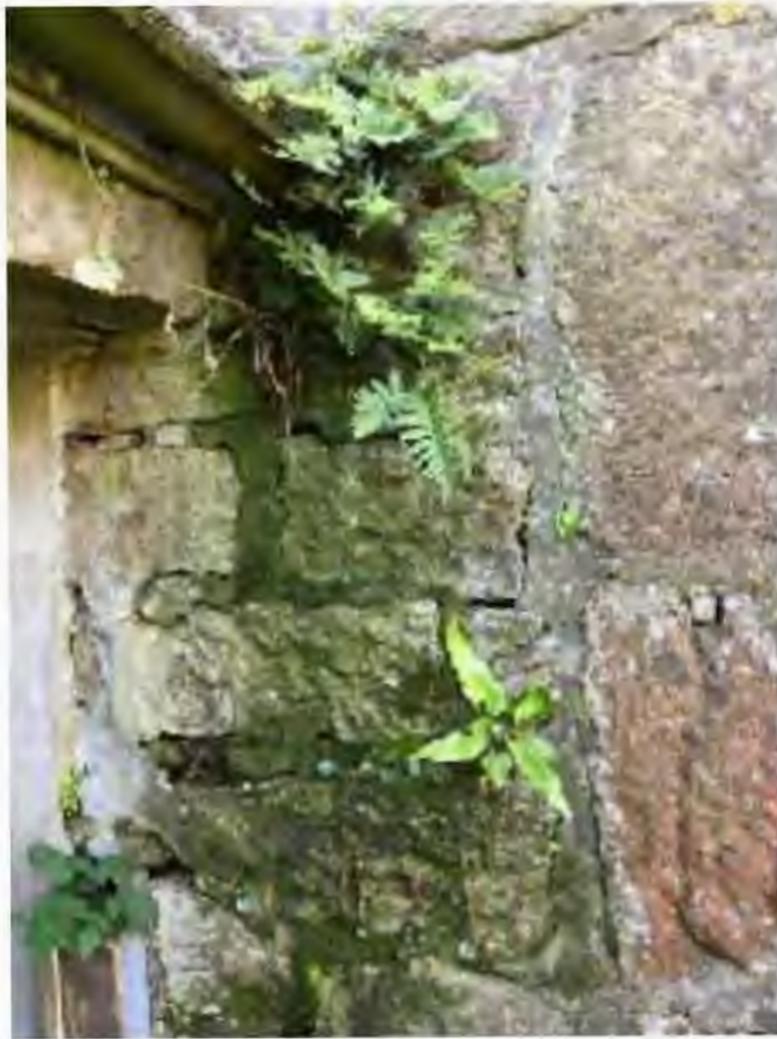
The external walls are solid granite with a rab / rubble core and are about 600mm thick. They are in good condition for their age and exposure but all need repointing. The gutter to the adjoining building against the north elevation has lost its stop end and rain water is washing down the wall causing further damage to the pointing and threatening the core of the wall.

Part of the north wall where the gutter to the adjoining building is leaking

The gutter to the adjoining building needs to be repaired to stop water damage to the wall to the left of the shower room window in the north elevation.

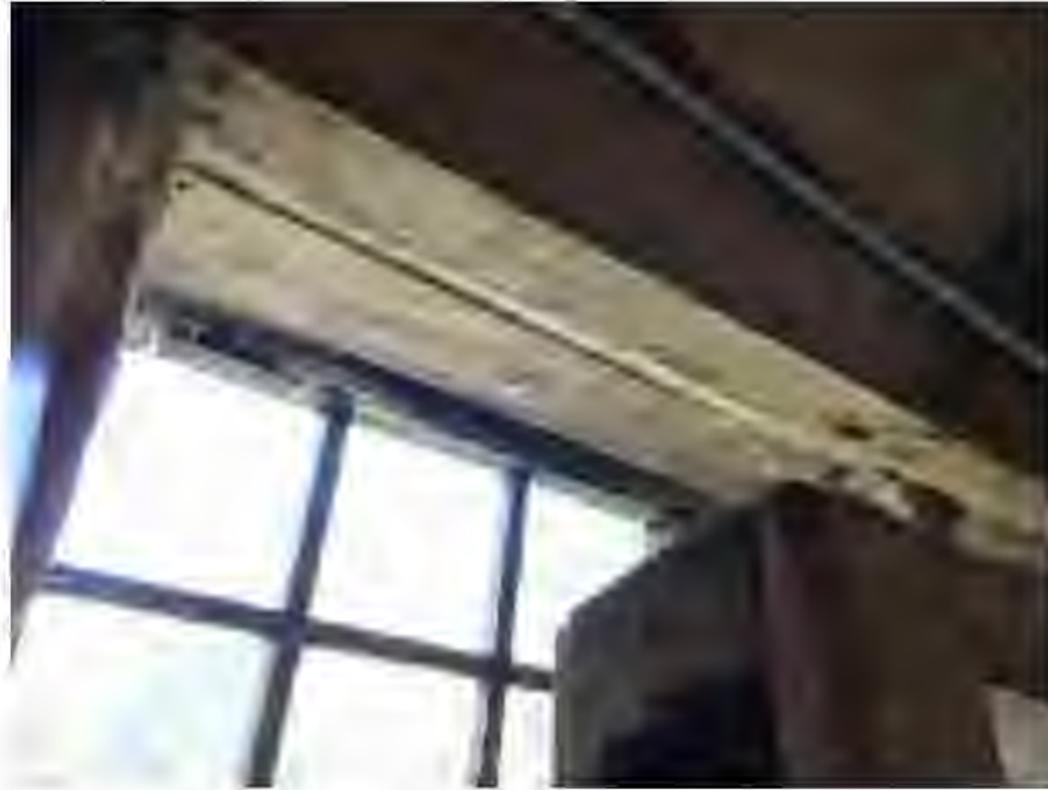
The barn has more windows and door openings than are often seen in buildings of this nature. The ground floor openings and the first floor window in the east gable have granite lintels externally which appear sound, as is normal the remaining first floor openings are tucked under the eaves and do not have external lintels. The internal lintels are timber and need to be checked.

Some internal lintels need to be replaced

The internal timber lintels need to be carefully removed and replaced with concrete lintels.
