Contaminated Land Phase One Desk Study Report for Clifton House Farm, Clifton Hill, Preston PR3 OAR

September 2016

This report consists of a phase one contaminated land desk study produced in support of planning application for residential properties at Clifton House Farm, Clifton Hill, Preston, PR3 0AR.

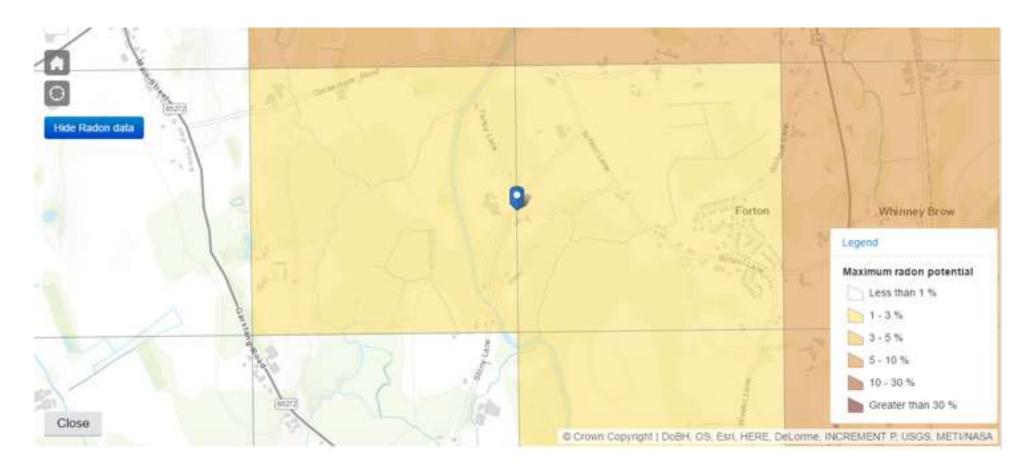
Appendix 3 - Radon Maps

The property is in an area identified as having between 1% and 3% of properties above the action level of 200 Becquerel's per cubic metre. However further detailed information for the specific site can be found on the UK radon website (www.ukradon.org). A copy of the Health Protection Agency Maps, (Appendix 3) is included. Radon protection measures may be required for new buildings or any future development.

However further information on the radon levels are required and radon protection measures may be required within the construction of new properties.

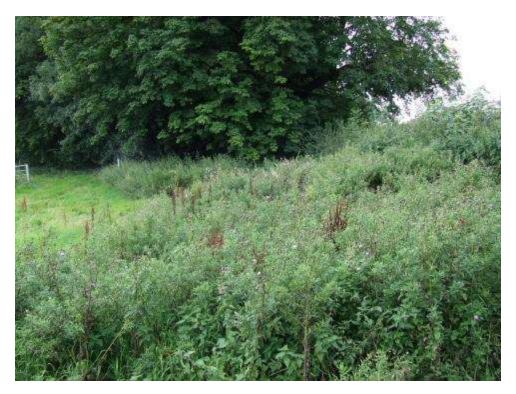
The site of the pond located in the northwest corner does not appear to have been infilled, but is a drained "Dew Pond" which would only contain water during winter months, some infilling may also have occurred during normal farming activities.

Close up of dried up pond northwest corner

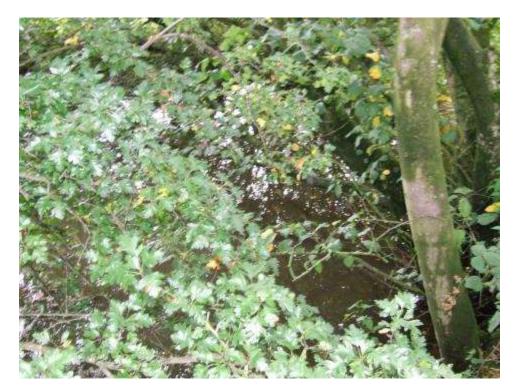
The remaining ponds were carefully inspected and are not considered to be significant. No evidence of any contamination was found, the ponds are surrounded by lush vegetation and have significant quantities of wildlife resident. They may however be a receptor for any future potential contamination.

Pond on western edge

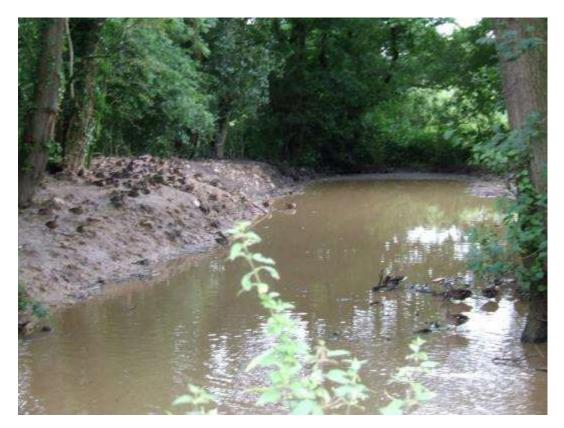
Pond on south-eastern edge

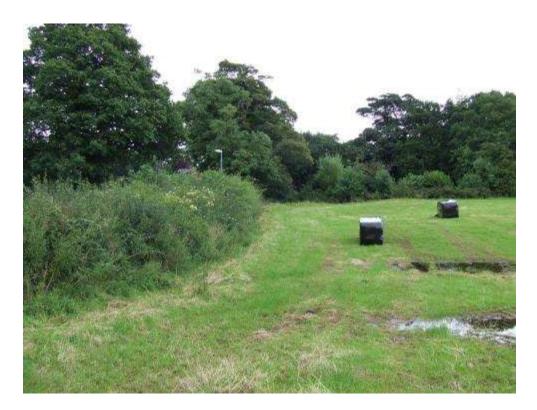
Eastern corner towards pond

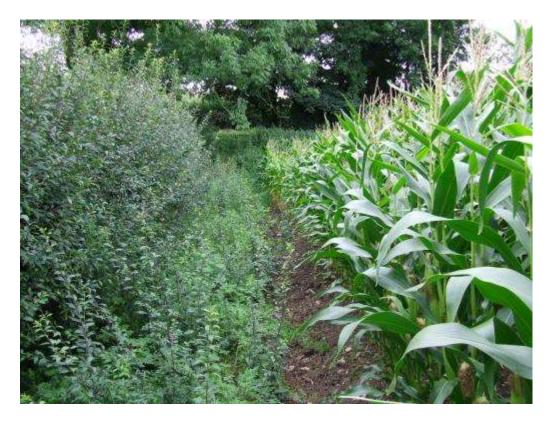
The site of the pit was confirmed as being infilled, due to its location, reference to historic maps and aerial photographs and actual inspection. We considered it most likely to have been infilled from spoil produced during the establishment of the cricket ground. No evidence of contamination was found and it is considered of low risk of

causing significant harm. However, a watching brief is recommended during development.

View back toward location of infilled pit

In addition, a watching brief is required during the development, particularly in the area of the infilled land (unspecified pit) located on-site and discussed previously.

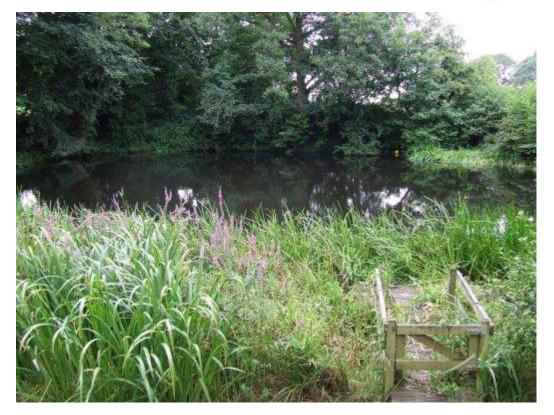
Pond at eastern edge
