Job No. 20578

'BEAUCHAMPS'

REPORT

STRUCTURAL INSPECTION

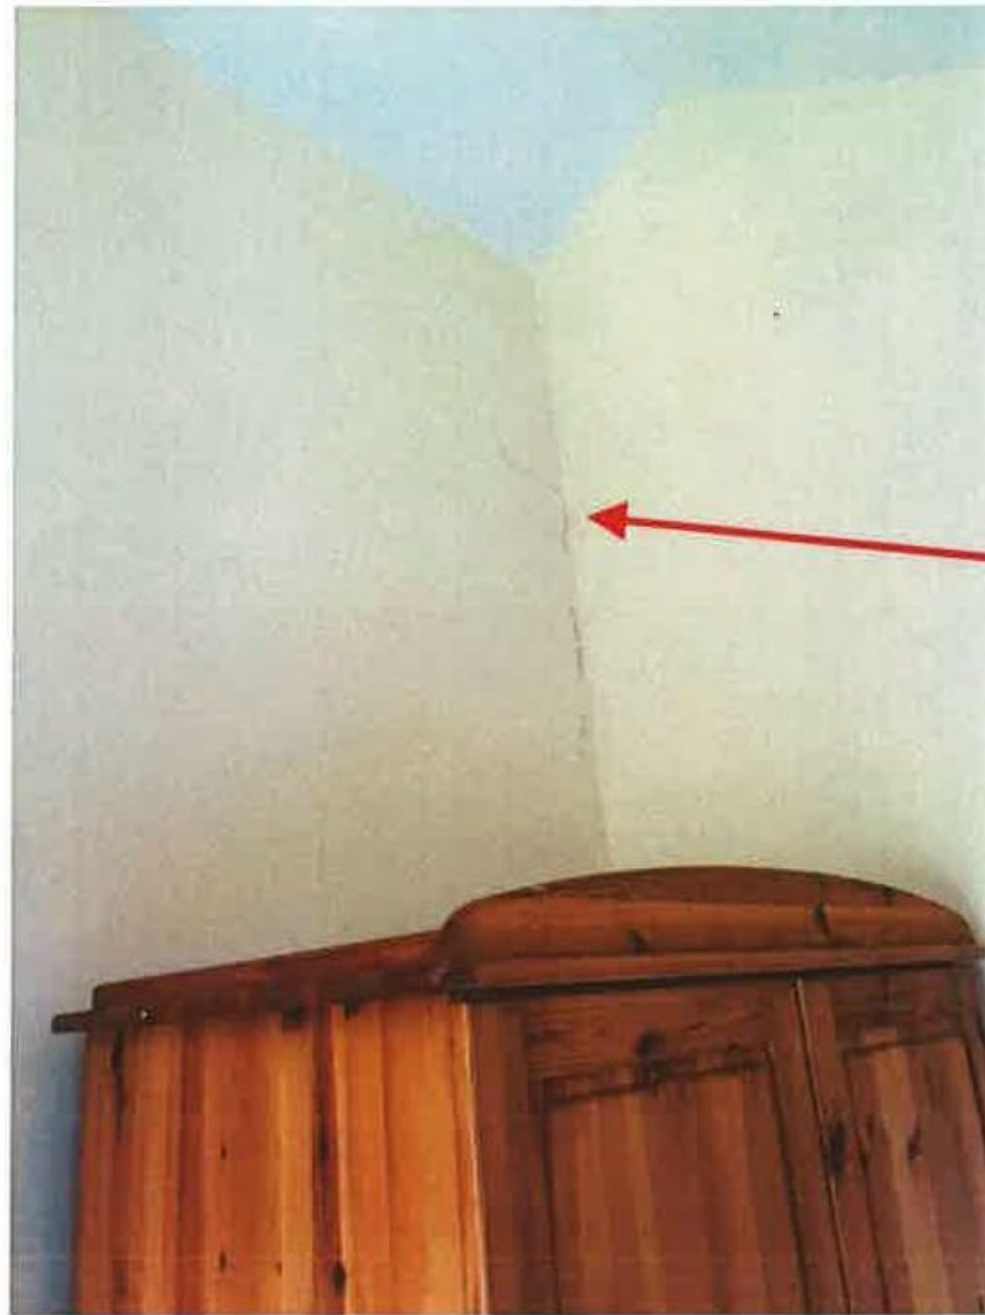
Cottage

- 3.07 There are fine cracks at high level and also above the skirting boards.
- 3.08 The Entrance Porch is coming away from the cottage walls, evidenced by fine cracking.

Cracking at high level.

4.02 We would recommend that the building (both the barn and the cottage) are re-built on the same footprint to modern standards with 1.00metre deep foundations and insulated to modern standards. The foundations near the well may need to be much deeper with ground beams to avoid loading the walls of the well. The heating could come from Thermal Slate roofing, Solar Panels and a Ground source heat pump, which could make this new domestic property extremely energy efficient. If required, some of the existing timbers could be re-used.

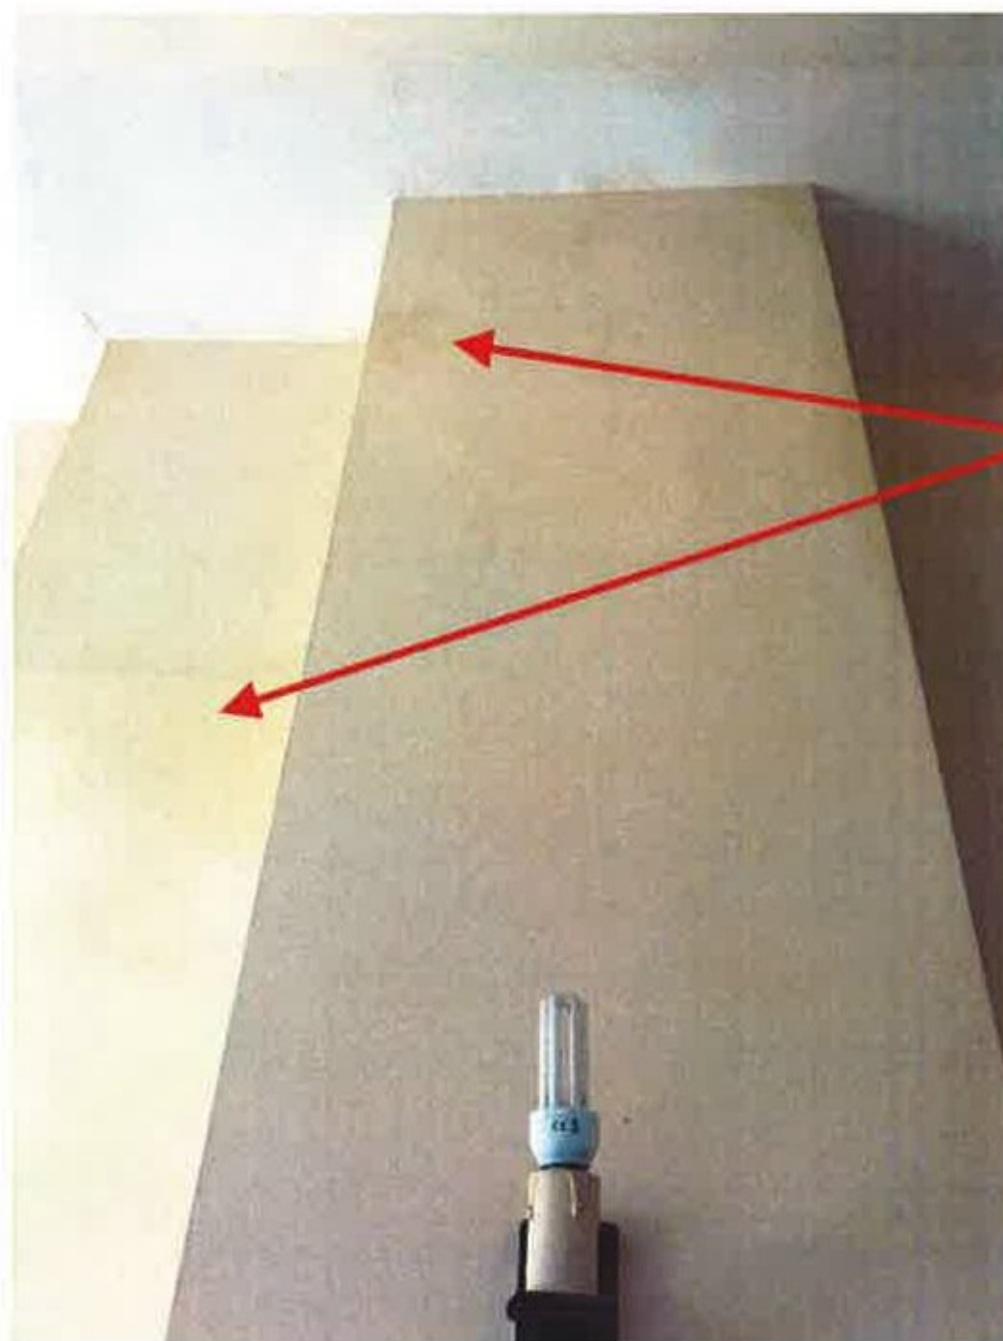
- 3.05 The cottage has several areas of damp on the internal plaster surfaces. There are several damp patches around the inner plaster surface of the chimney. We understand that Roofing Contractors have carried out lots of remedial works to the roof and the flashings around the chimney, but this work has not solved the damp problem. The kitchen also suffers from large amounts of condensation.

Damp on internal face of chimney.

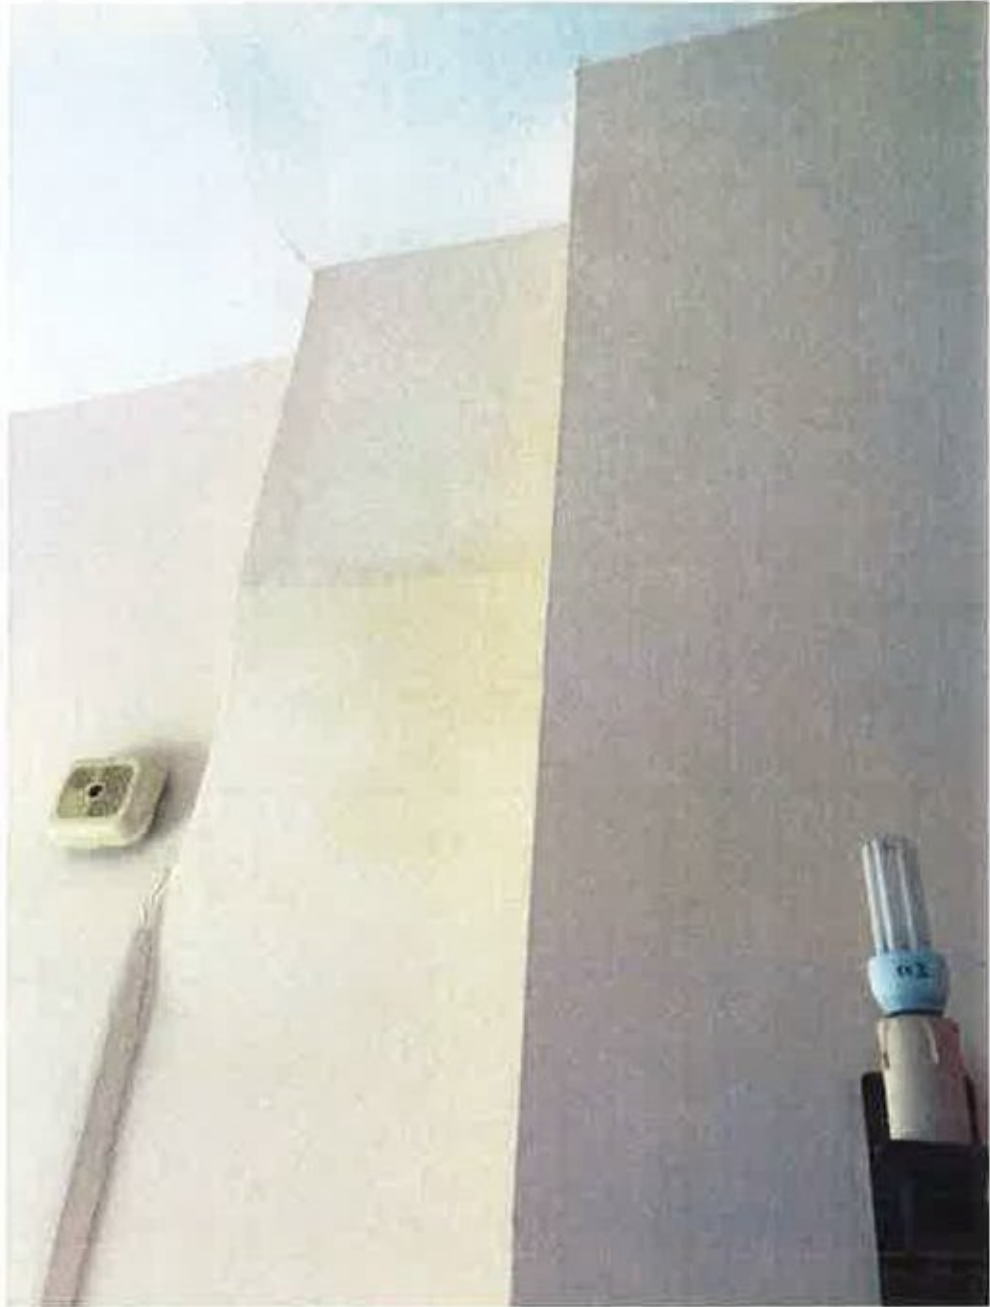
Damp on internal face of chimney.

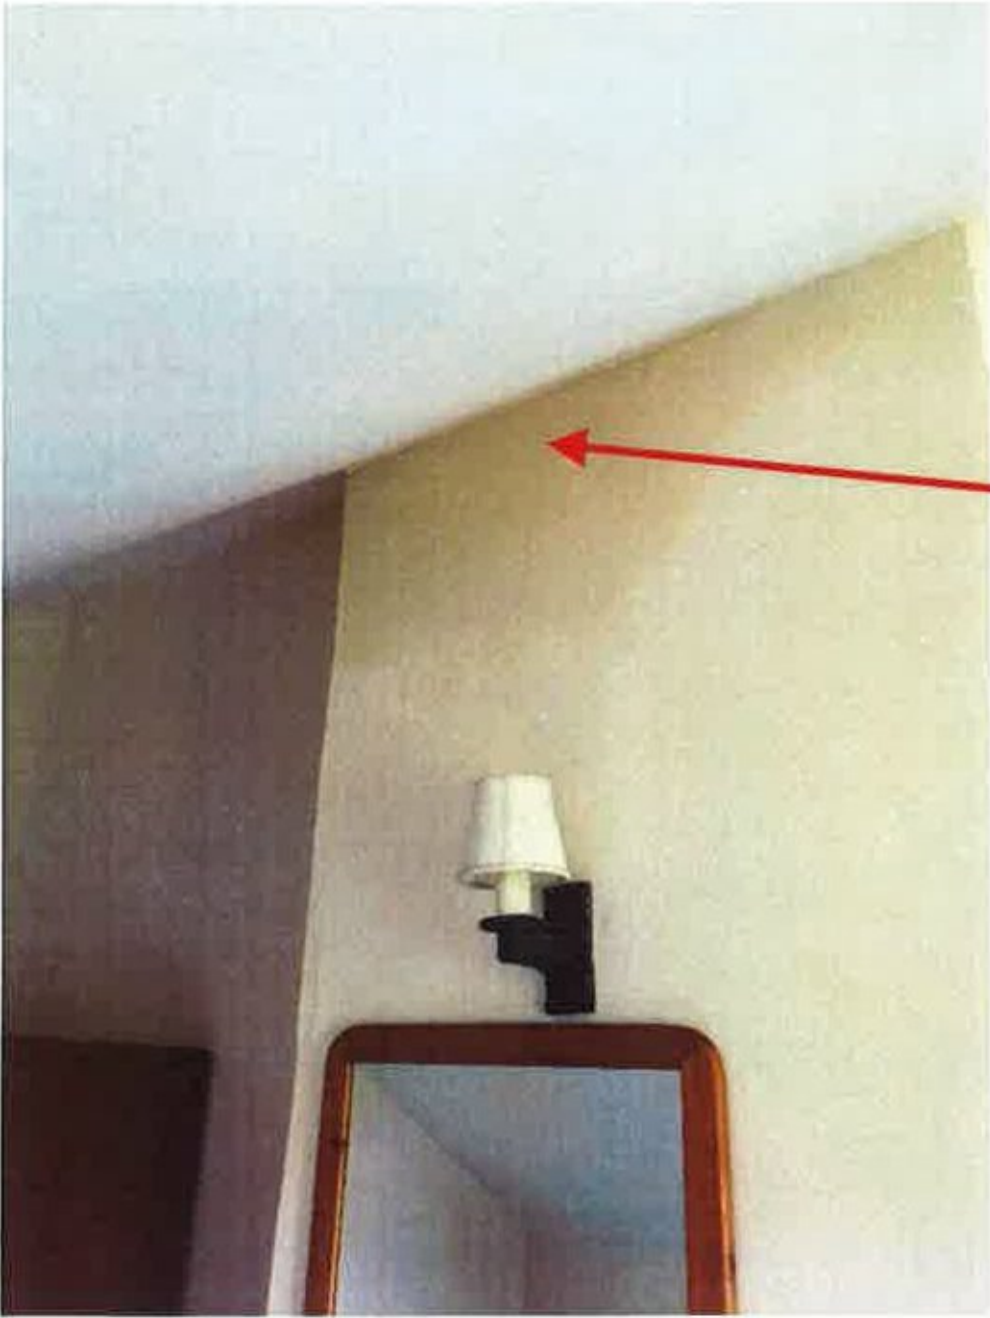
Damp on internal face of chimney.

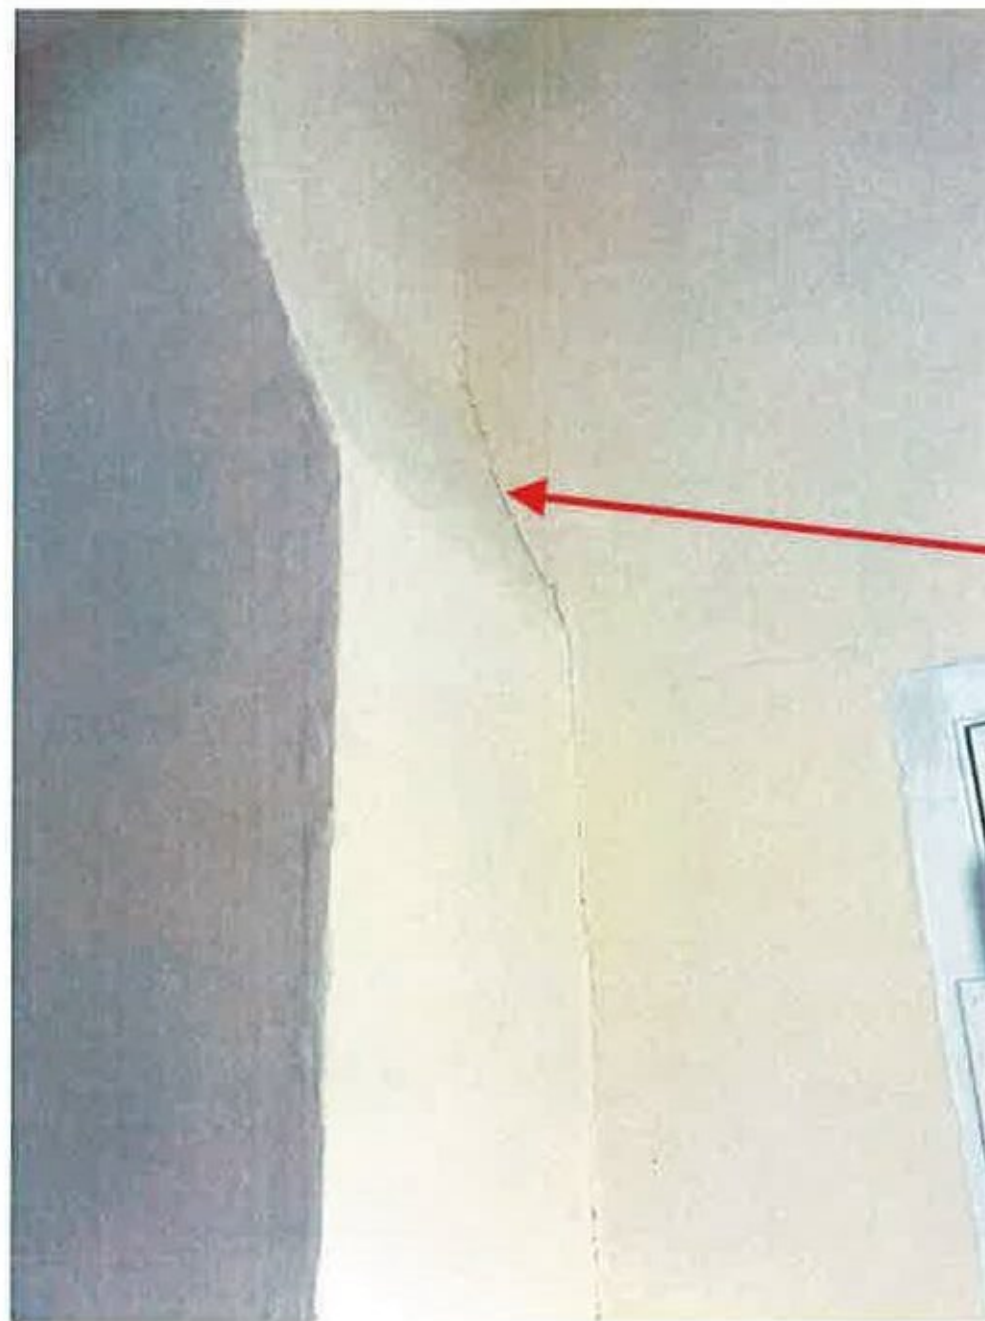
Cracks around chimney and signs of dampness on the internal plaster surfaces.

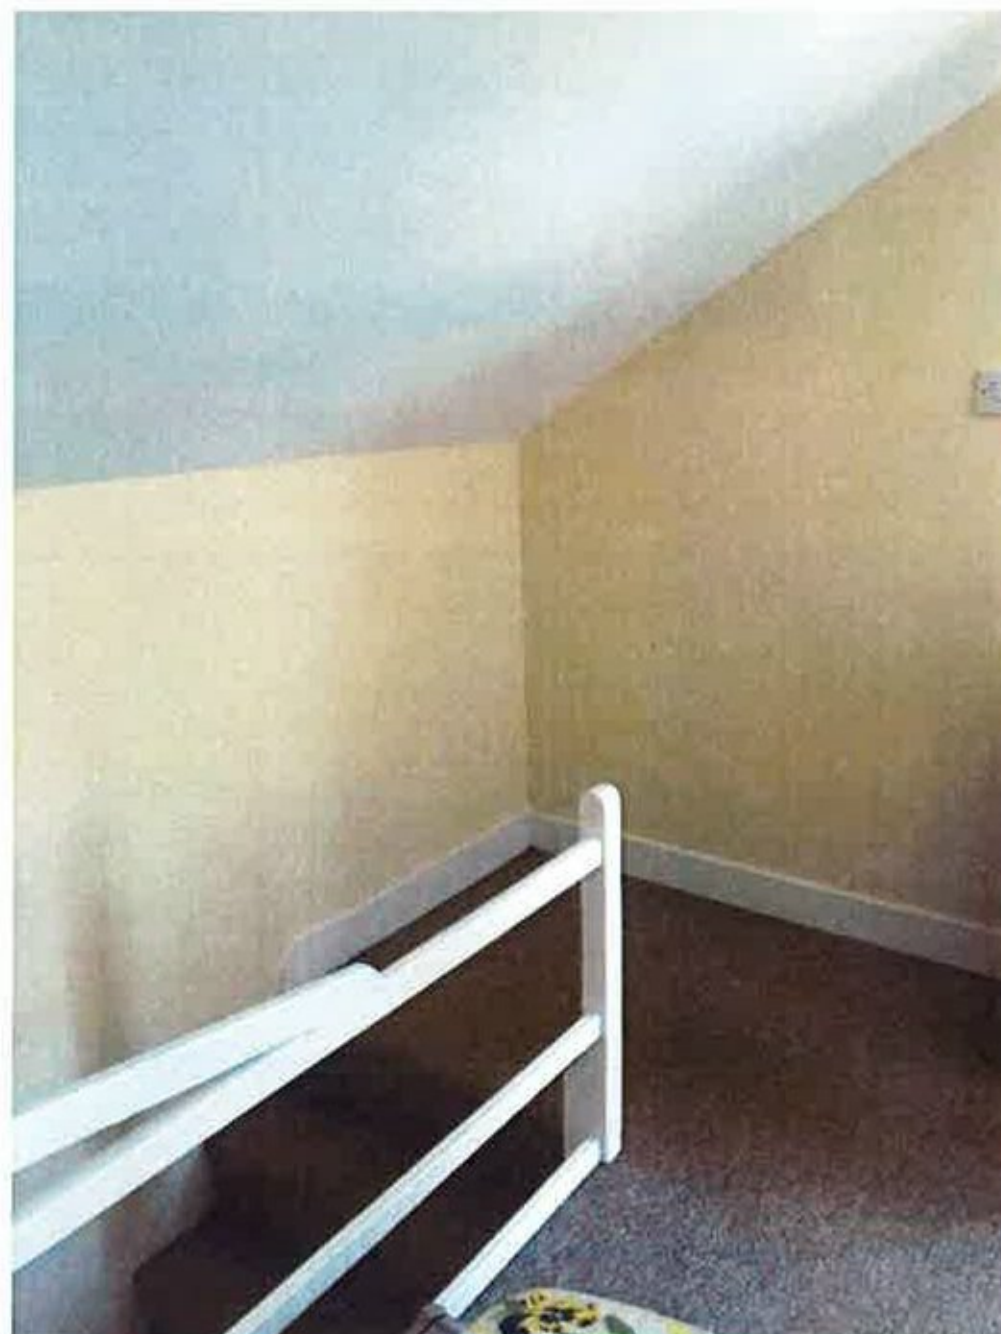
- 3.09 At the top of the staircase there is very low head height. If the stairs were moved this would compromise the bedroom size. The bedrooms on the first floor are fairly small rooms without the staircase being relocated.

Low head room above the staircase.

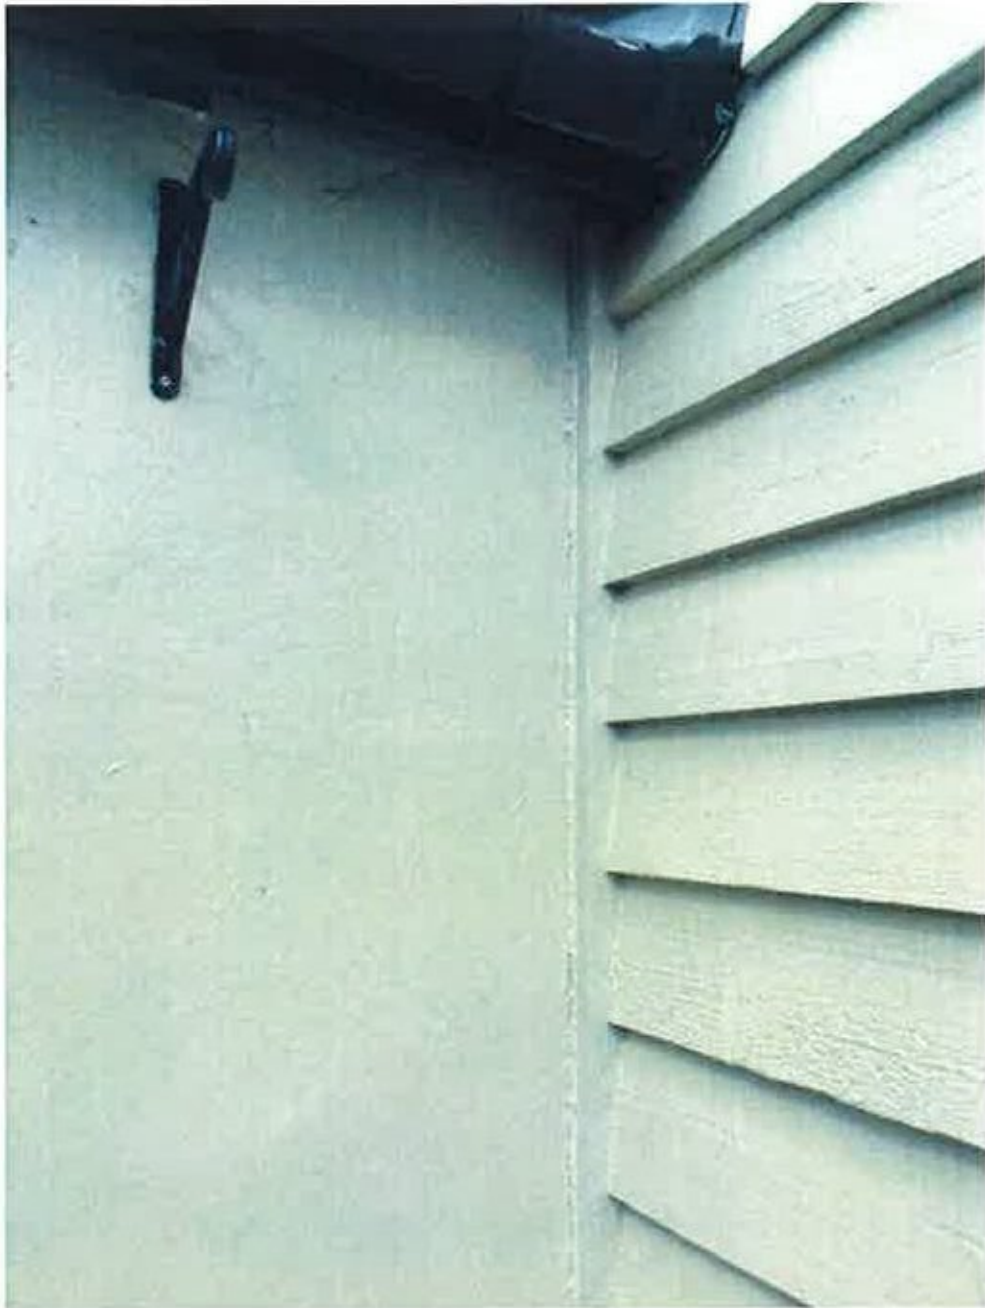
Entrance porch is pulling away from the Cottage.

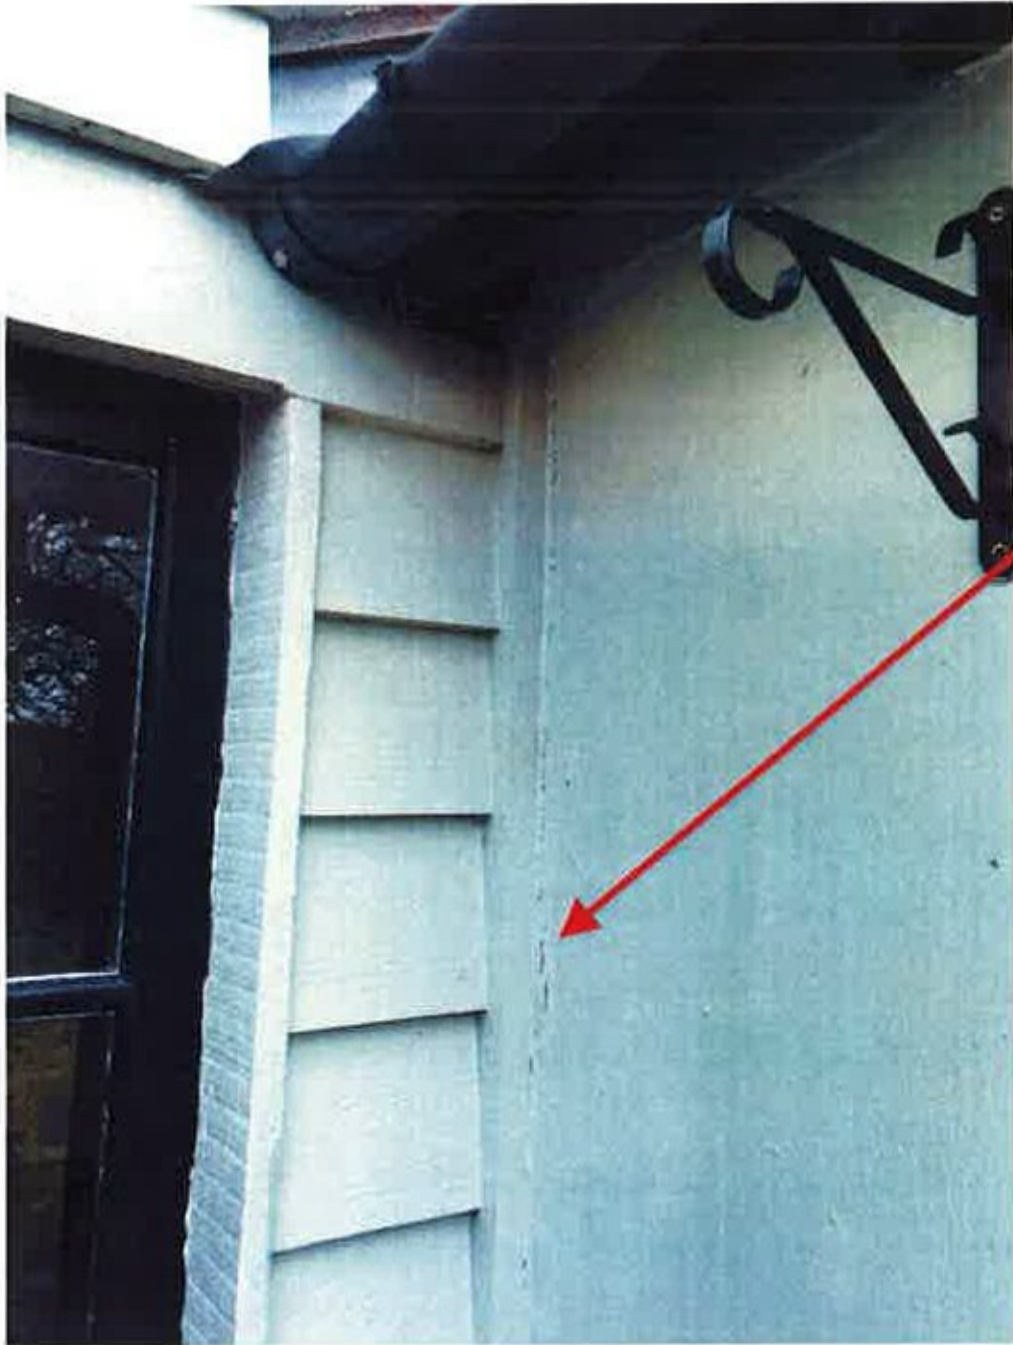
Crack between the Entrance porch and the Cottage.

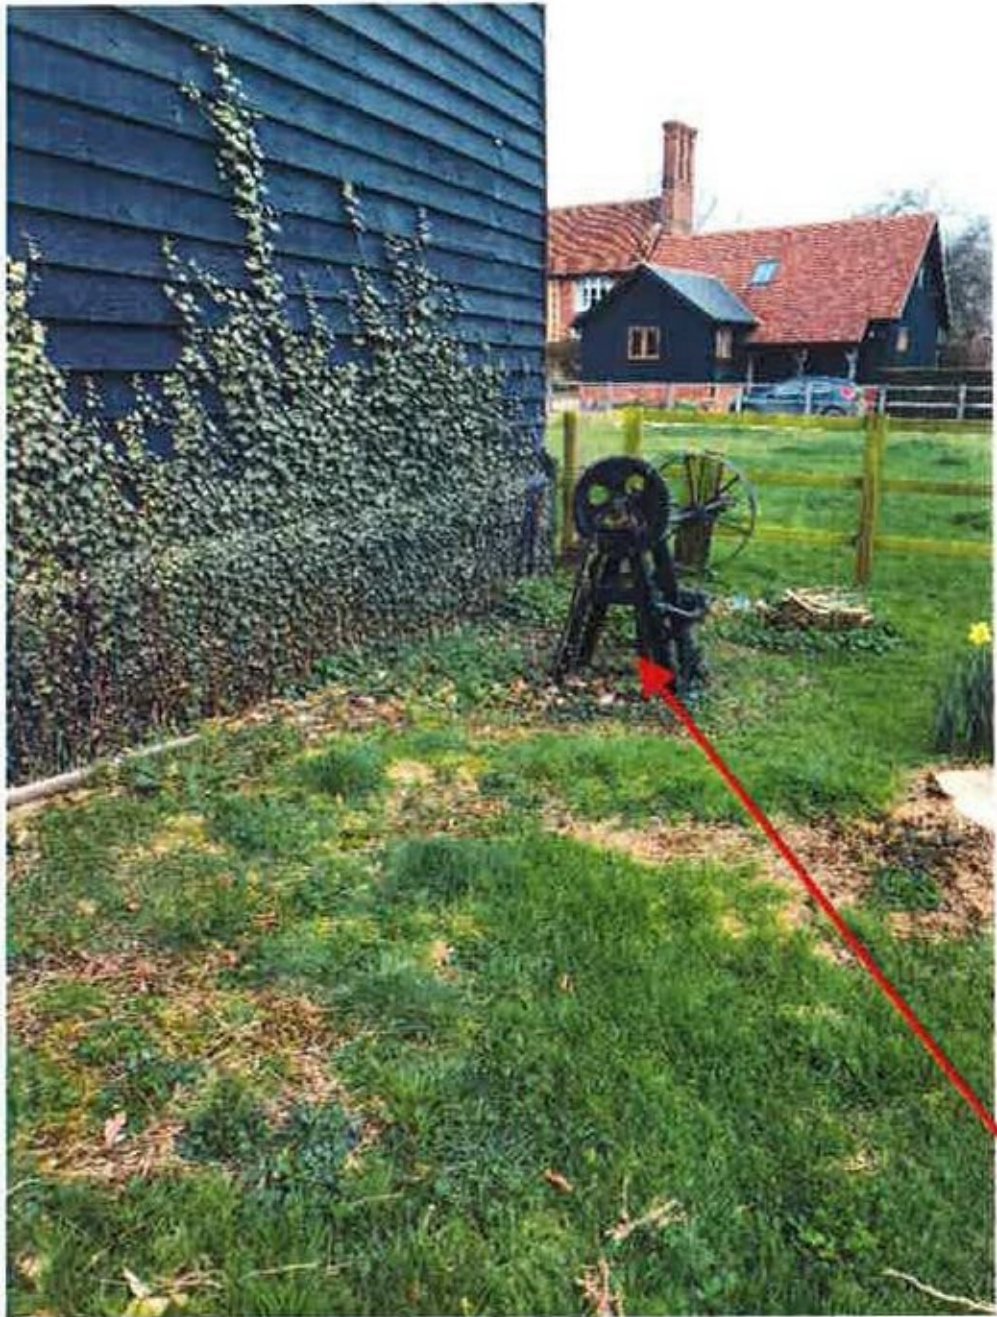
Barn

- 3.01 Upon inspection, we saw that the foundations to this building are brick spread footings and are very shallow (100mm. to 200mm. deep).
- 3.02 There is a 30 metre deep well very close to the North-East corner of the barn.

30.m deep well adjacent to the north - East corner of the barn.

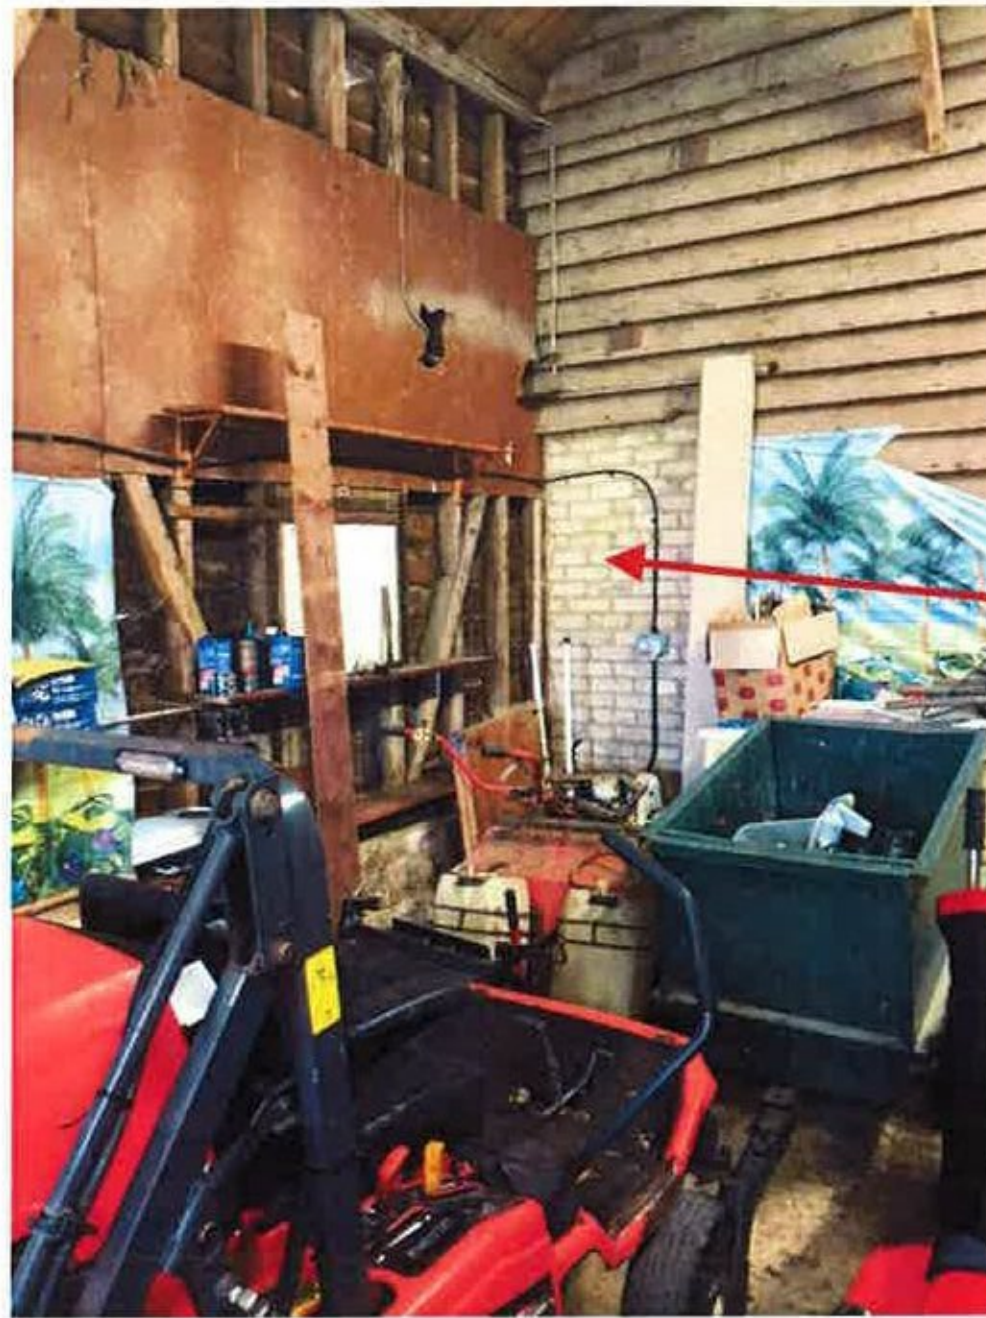
- 3.04 At the junction of the barn with the cottage there is a section of timber boarding on the inside of the roof and plain Clay tiles externally. There is also a section of modern brickwork between the end of the barn and the cottage. We are unsure as to the purpose of this brickwork, but it might be the dividing partition wall.

Modern brickwork wall at the junction of the barn and the cottage.

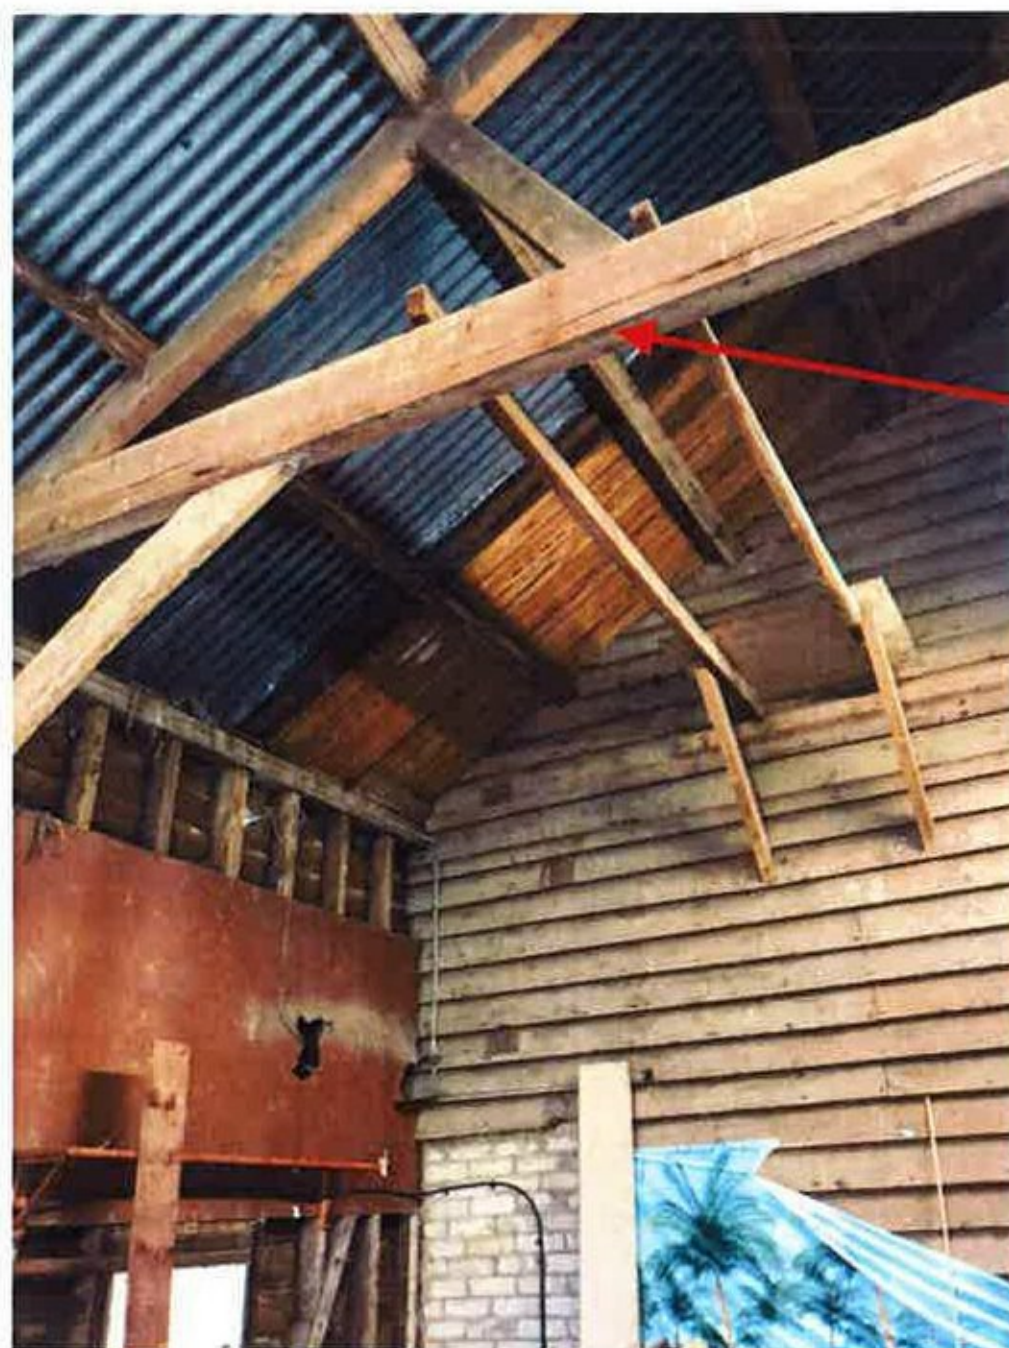
- 3.03 The timber trusses within the barn appear to be constructed with fairly new machine cut timbers, so we do not know whether these are more recent additions. They do not seem to be consistent with the age of the barn.

Modern timber to barn roof trusses.

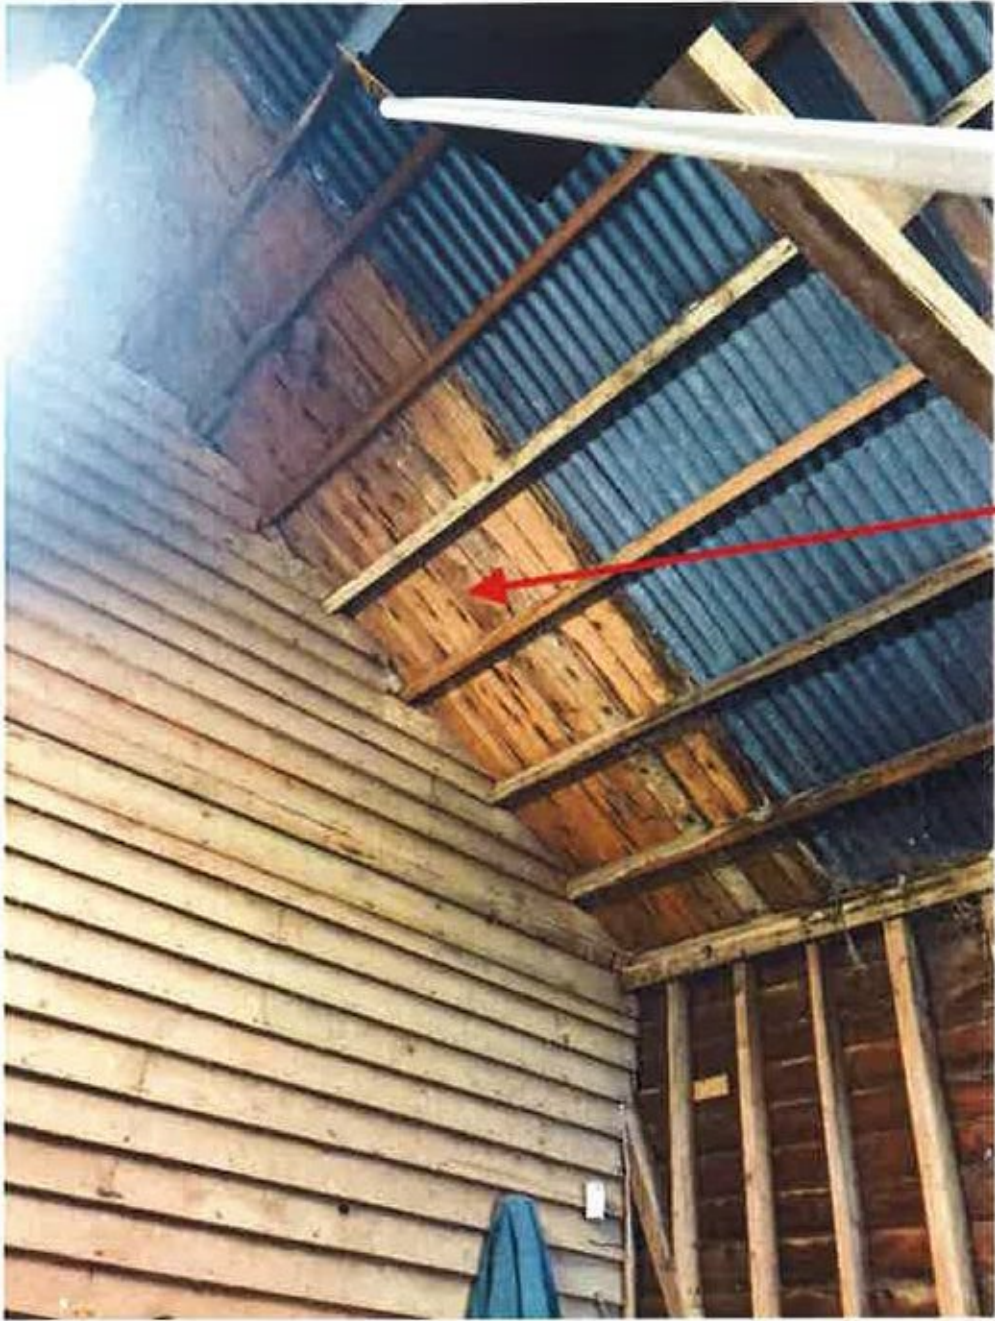
Timber boarding at the junction of the barn and the cottage.

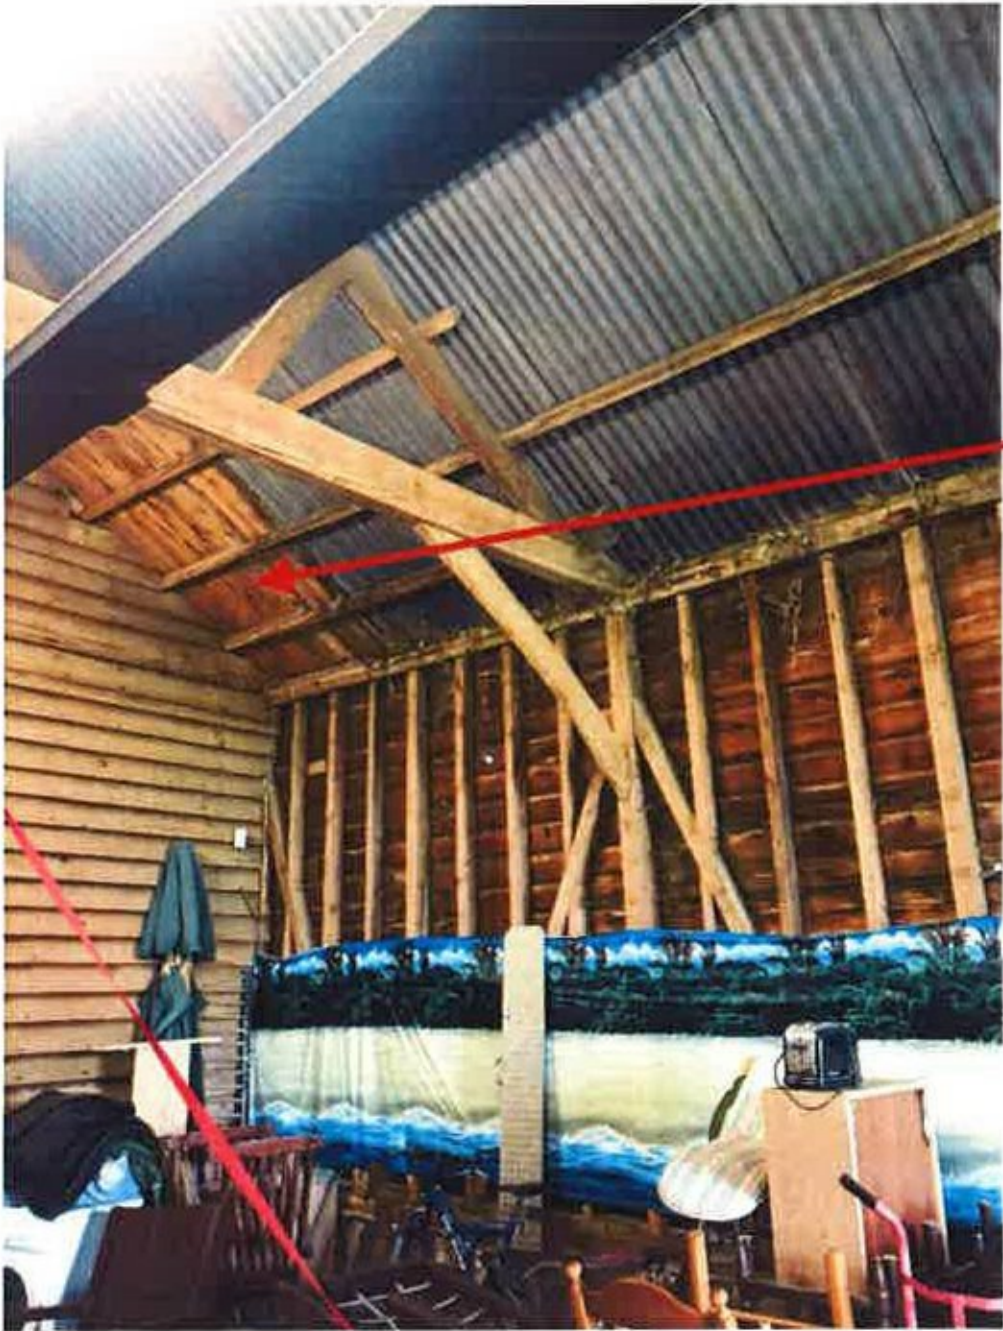
Timber boarding at the junction of the barn and the cottage.

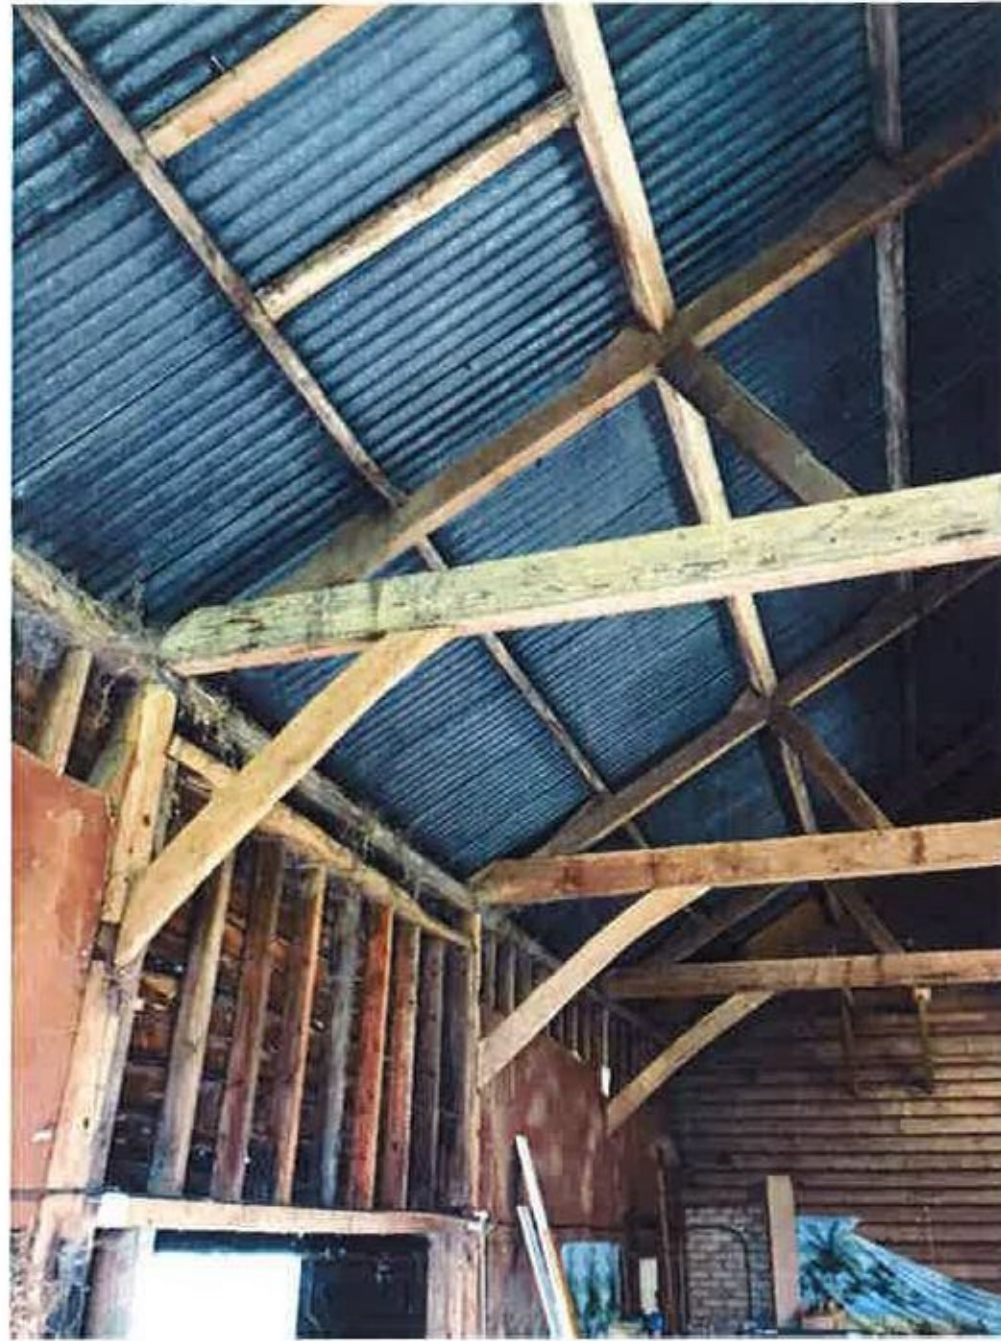
Timber trusses are constructed from modern machine cut timber.

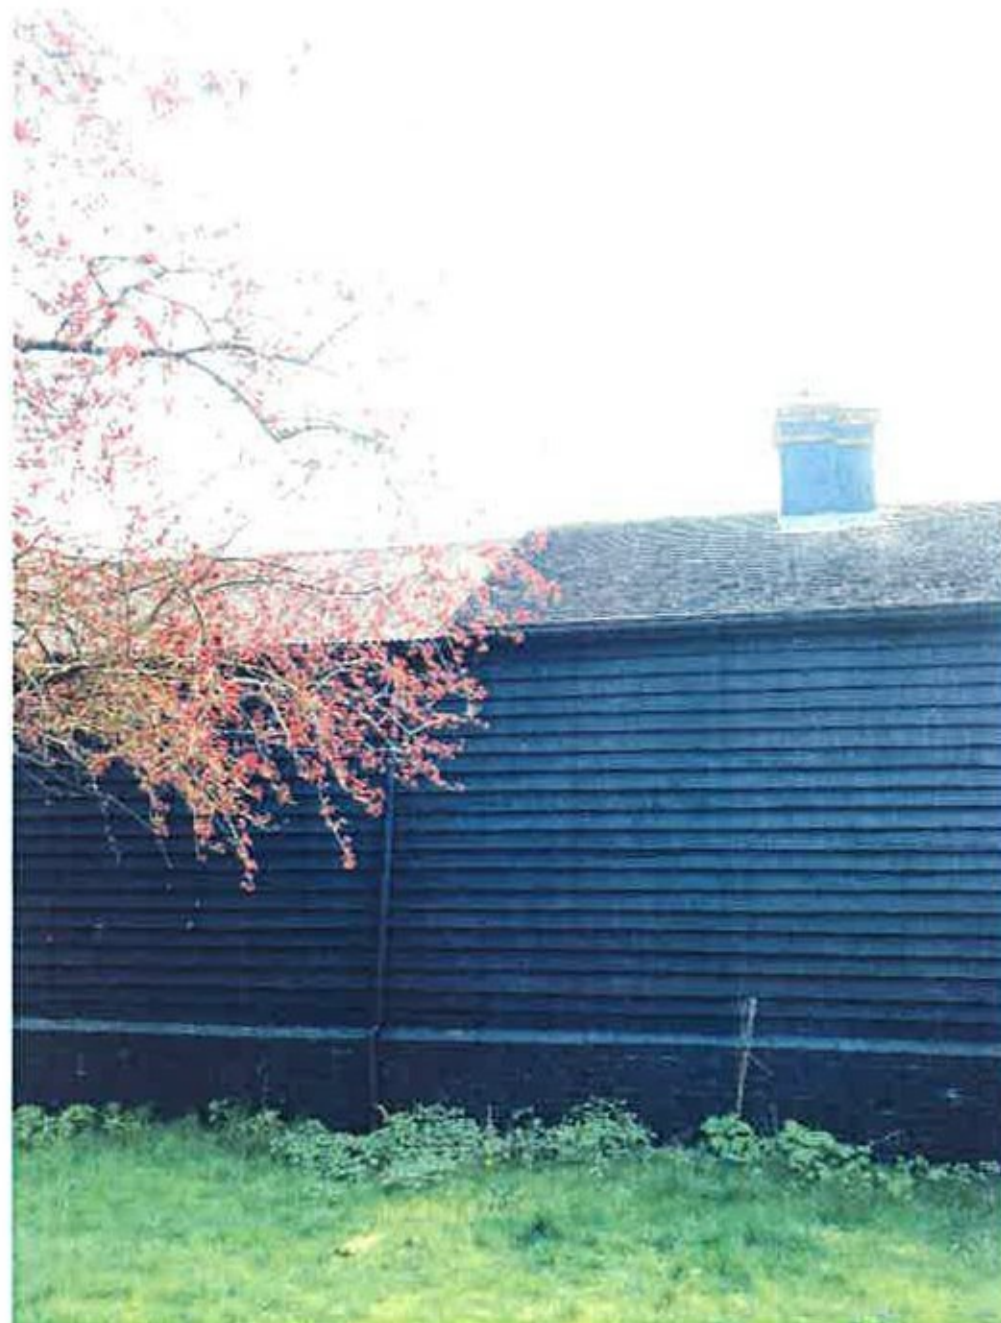
Plain tiled roof on the cottage, Corrugated roof sheeting to the barn.

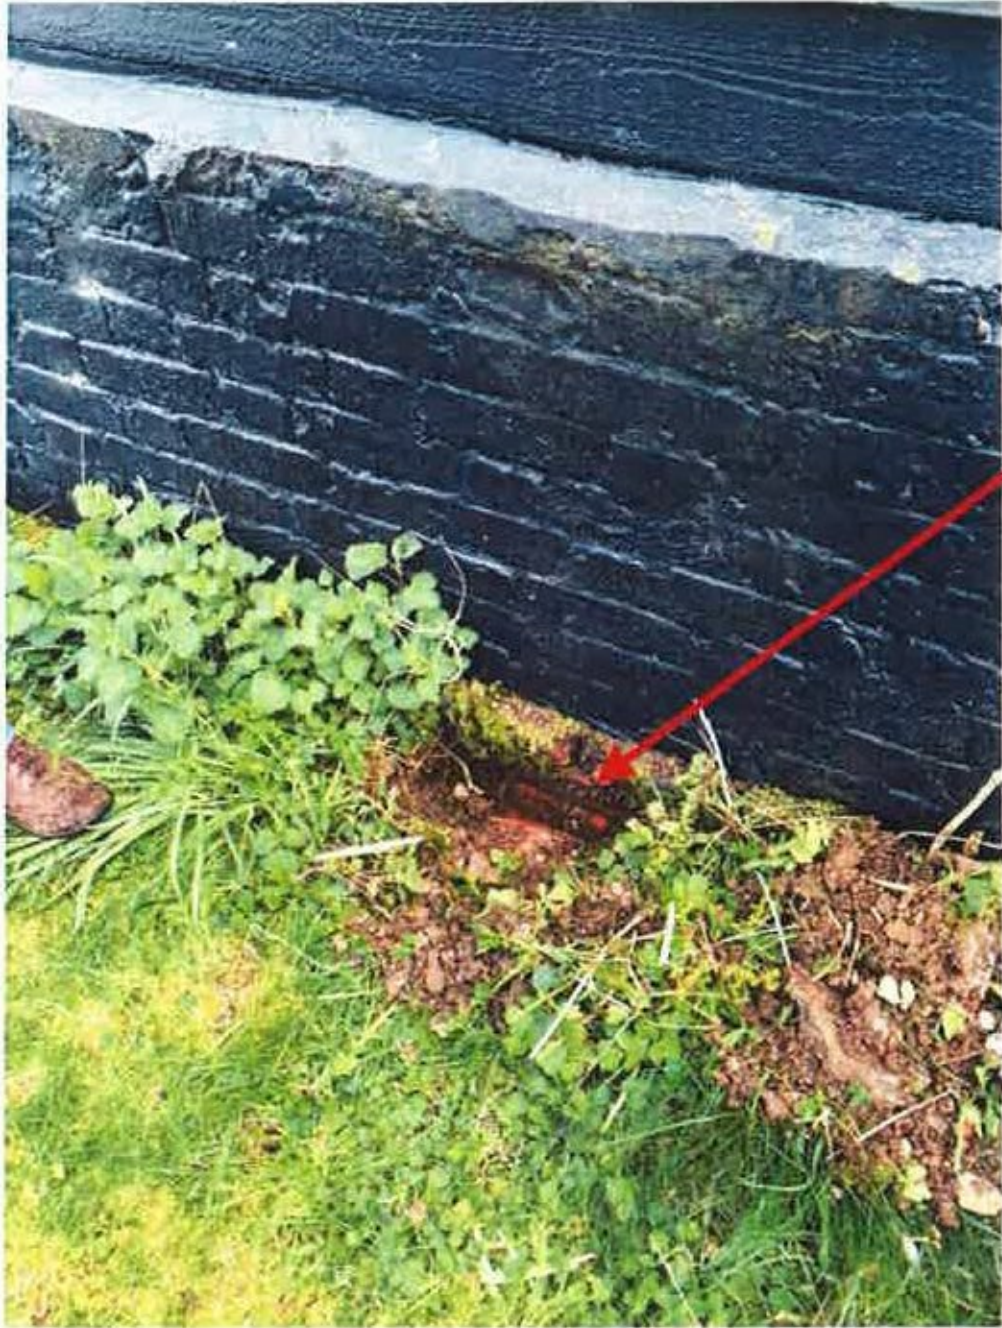
compromise, as the barn would be very energy inefficient. Structurally, this building has very shallow foundations which is the cause of a lot of the cracking observed.

Very shallow foundations (brick spread).
