Green Barn, Old Farm,
Mousley End, Hatton,
Warwickshire. CV35 7JQ.

Limited Structural Report

Issue Date: 14 December 2020

Ref: 20135

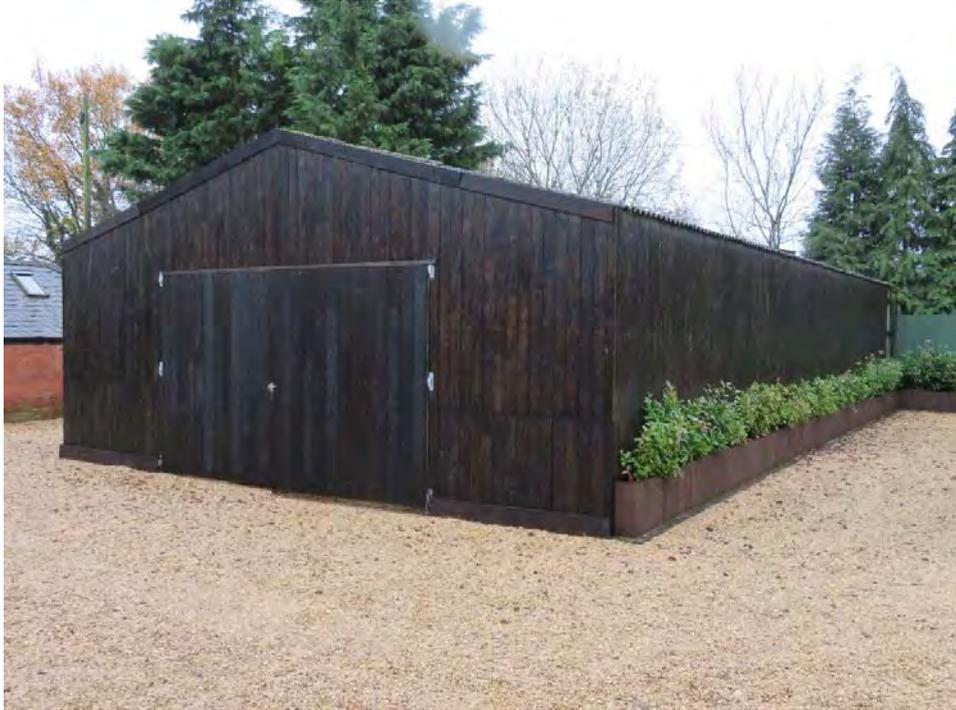
Photograph 1: Front/Side elevation (nearest dwelling).

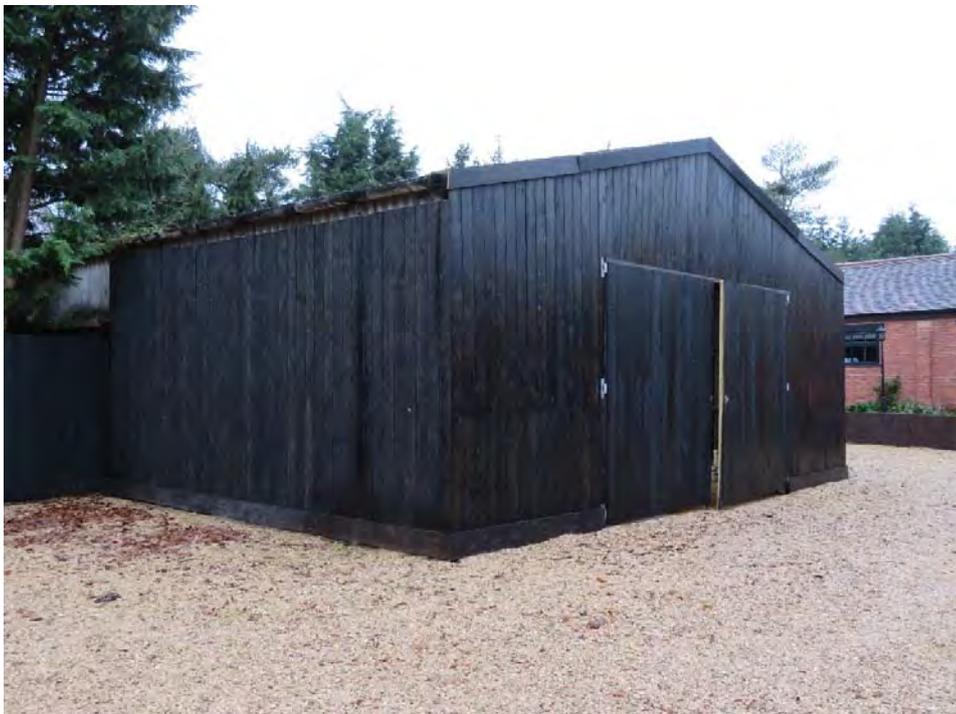
Photograph 2: Front/Side elevation (nearest road).

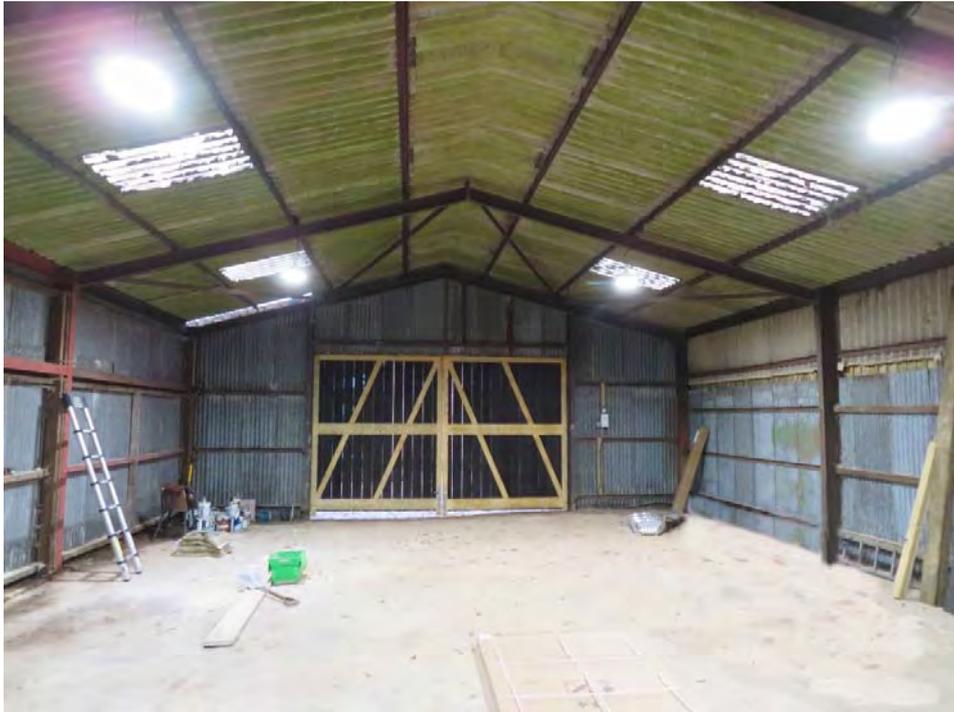
- 3.1 There is no lateral bracing present. Although there is a wind girder present within the first bay, located at the front of the barn, no bracing is present to enable the lateral forces to be transferred down to the foundations. *Lateral bracing can be generated by introducing members within a bay of the frame as cross bracing where the members act only in tension, a single diagonal member where the member is subjected to both tension and compressive forces or by portal bracing.*

- 4.1 It is unclear the original use of the barn, although it could have been used to house cattle and/or for general agricultural use.
- 4.2 The barn is structurally unstable as no lateral bracing is provide in the plane of the barn.
- 4.3 The condition of the slab has deteriorated in a couple of locations, with deep voids and it would appear the slab has also dropped, relative to other adjacent concrete foundations.

Photograph 3: Wind girder present in first bay.

- 5.1 Introduce longitudinal lateral bracing to frame to enable lateral forces to be transferred down to the foundations in the temporary conditions. This bracing will also be satisfactory for the permanent case. Introducing blockwork walls in the plane of the building, which are to be 'tied' to the existing columns, will also add lateral resistance to the building.
- 5.2 Remove the timber sheeting rails and replace with the original steel sections/rails.
- 5.3 Cut out the delaminated section of steelwork to the corner columns and weld a section to reinstate the area – at present this member has reduced/little resistance to shear.

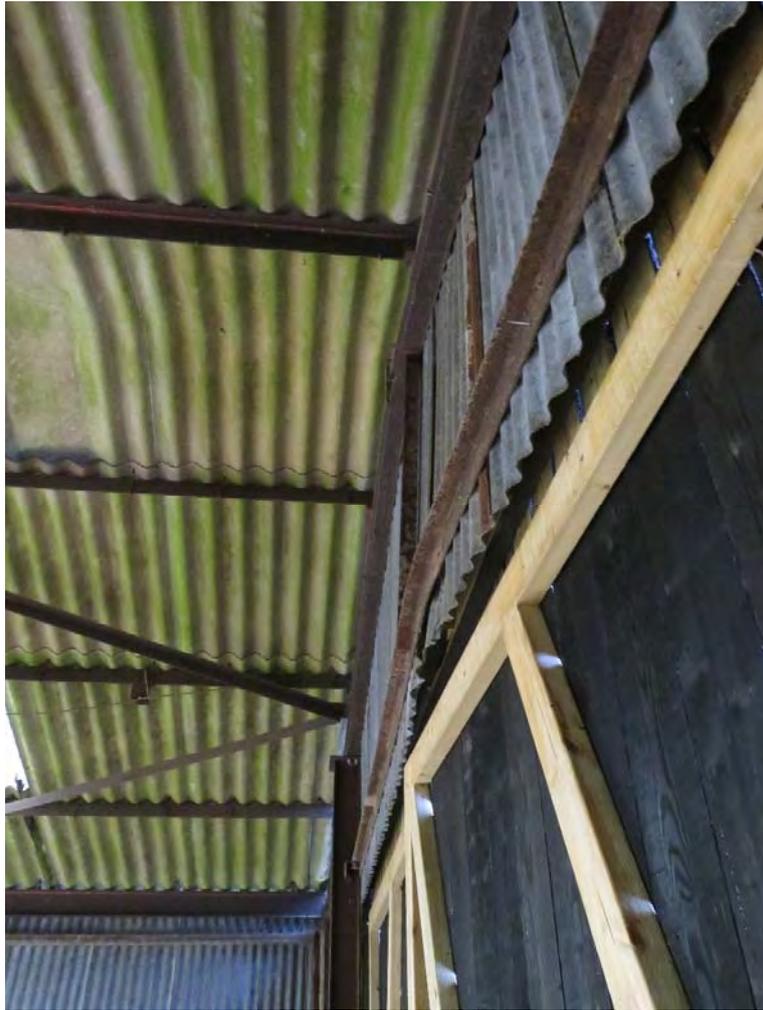
- 3.5 The steelwork at the head of the double doors are deformed.
- 3.6 Some of the original sheeting rails have been replaced with timber sections; the sections have been positioned where the original rails would have been originally constructed/located.

- 4.9 The deformation at the head of the double doors could be attributable to impact damage from a high sided vehicle.

Photograph 4: Deformed/distorted steelwork over head of doors.

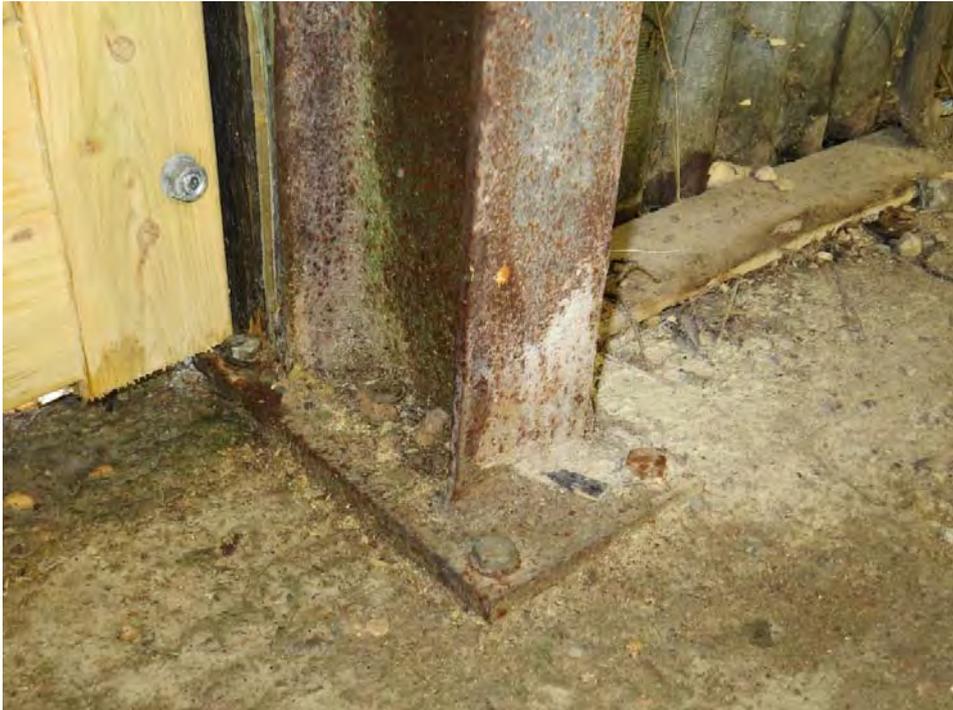
- 3.3 There is clear evidence of recent remedial works in the form of replacement bolts at several connections between the sheeting rails and columns.
- 3.4 The columns located either side of the doorway are built directly off the slab.

- 4.5 The cedar over cladding will be adding additional loading to the frame as a whole and will induce additional deflections under dead loading.
- 4.6 The columns located either side of the doorway are considered not part of the original construction as they have been built off the concrete slab; all other columns have been constructed off a foundation as their assumed baseplates could not be observed.

Photograph 5: Columns adjacent door built directly off slab.

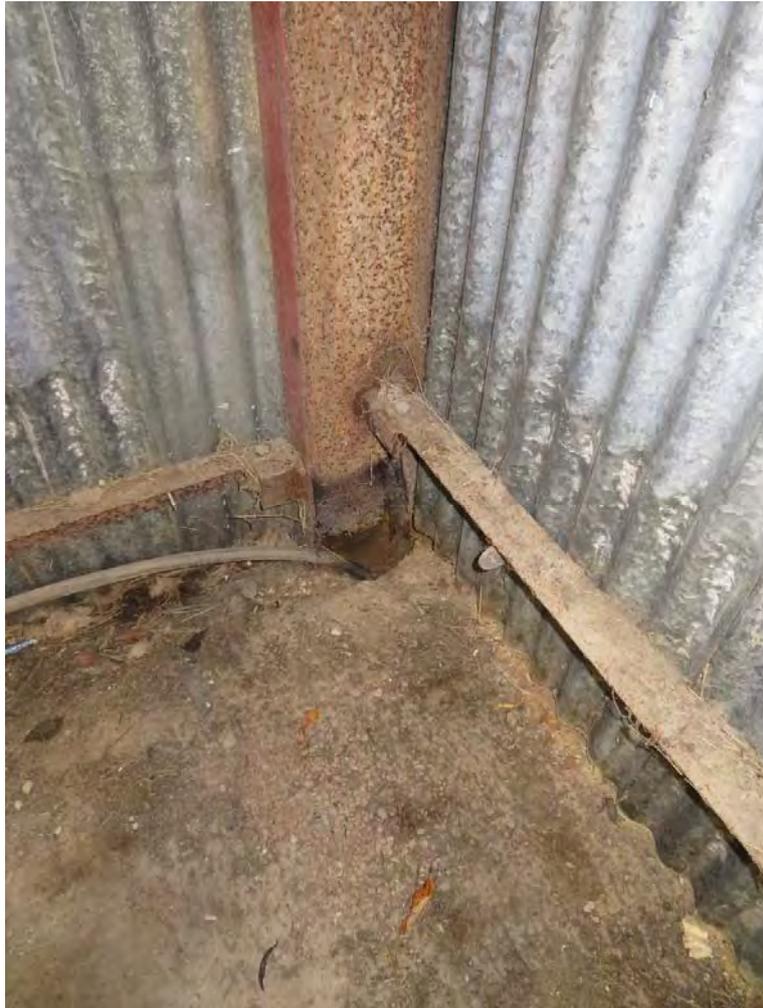
- 3.2 There is some severe degradation to the steel at the base of a corner column. A substantial amount of the web is to the column. The column is located on the elevation nearest the road.

Photograph 6: Delaminated corner column – part of web is missing

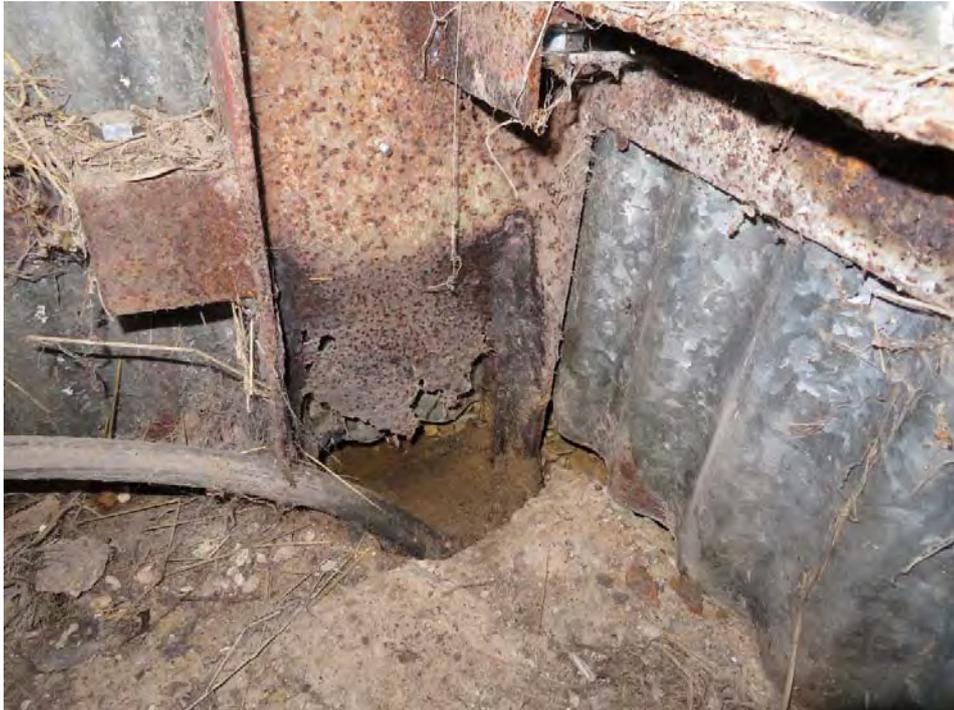
Photograph 7: Delaminated corner column – close up of Photograph: 6.

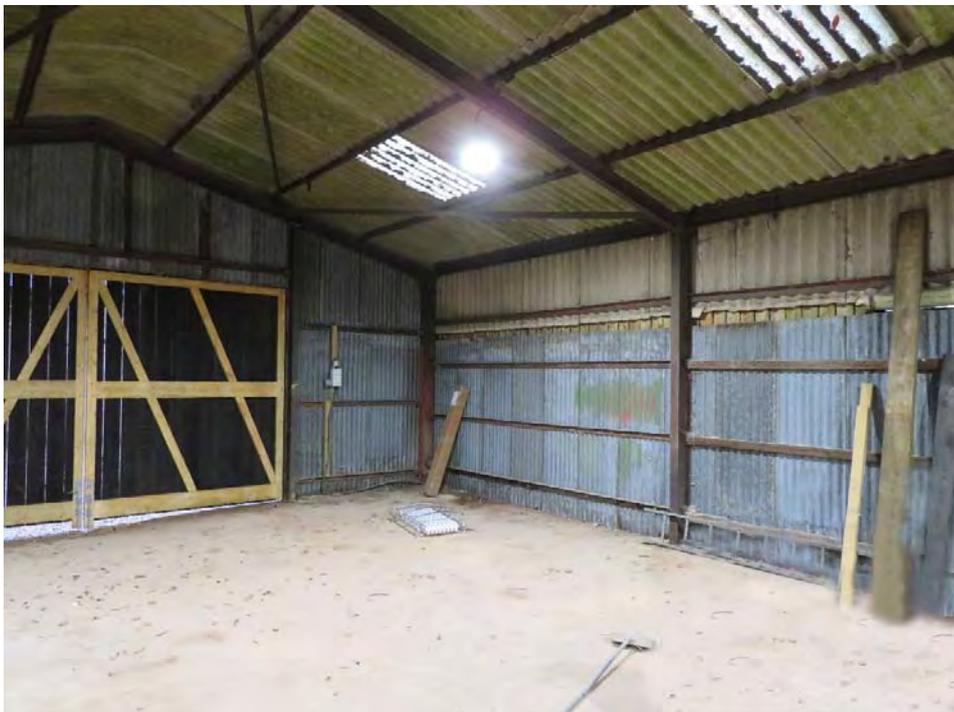
Photograph 8: Partial internal view of barn - nearest road.

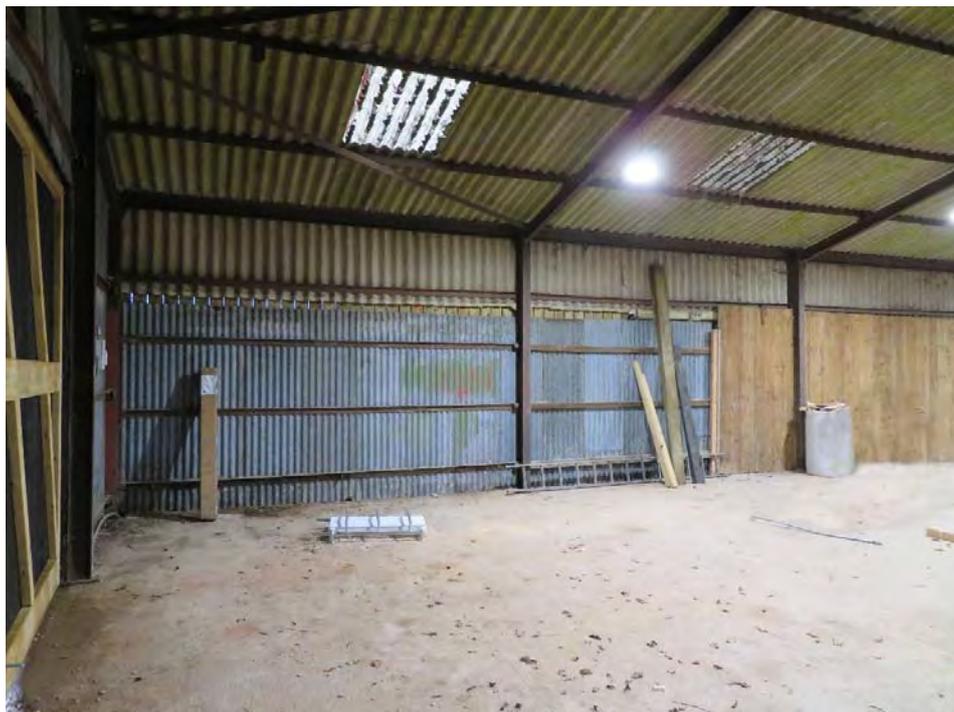
Photograph 9: Partial internal view of barn - nearest road.

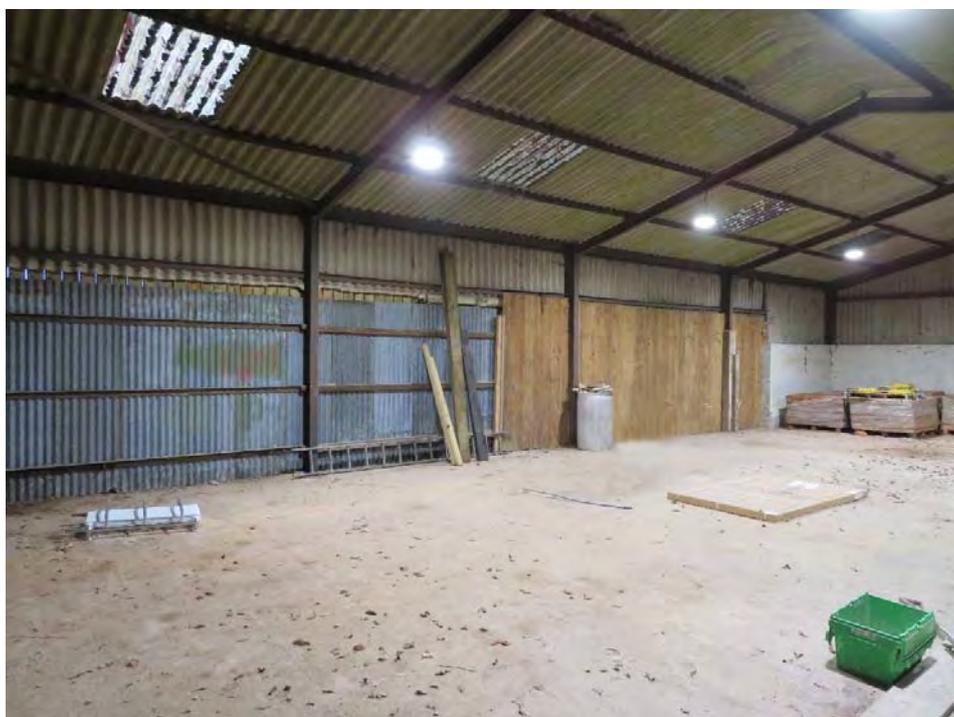
Photograph 10: Partial internal view of barn - nearest road.

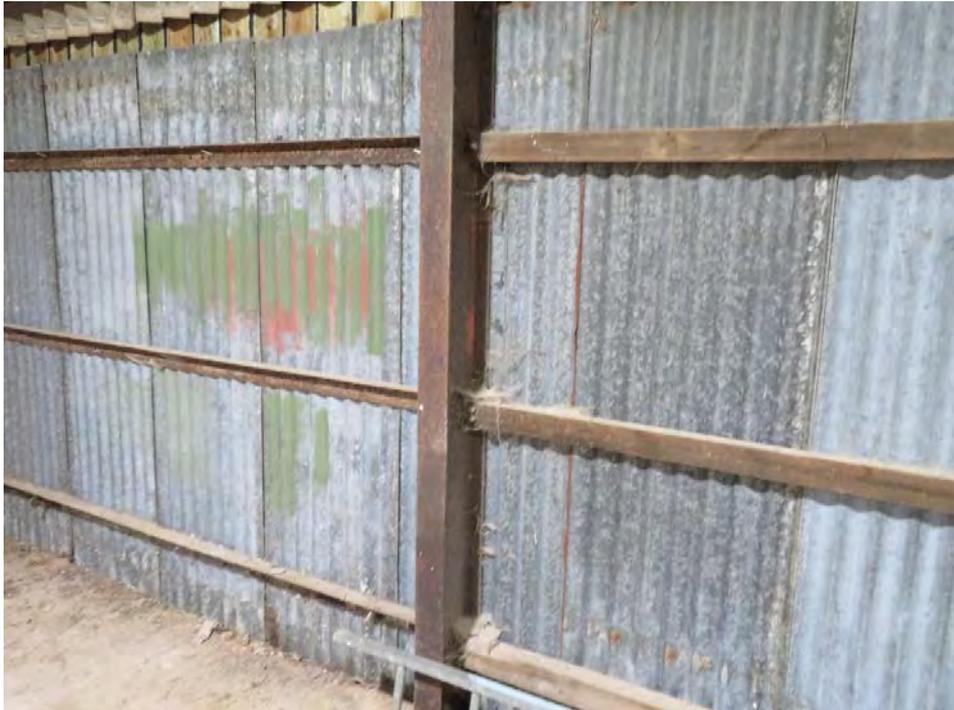
Photograph 11: Steel rail replaced with timber sections.

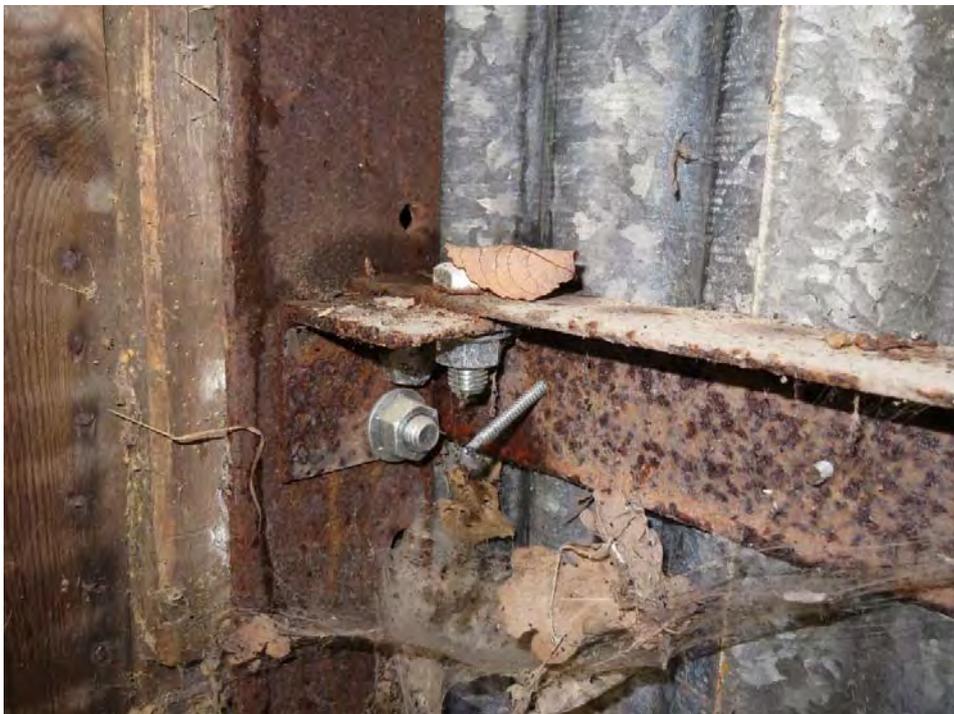
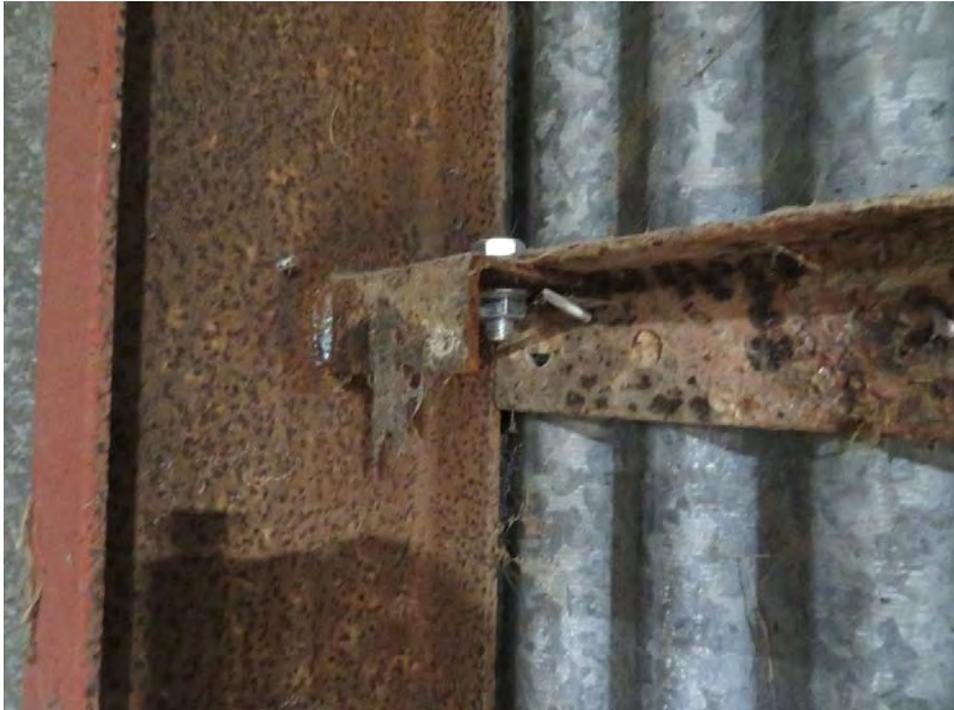
- 4.7 Some of the steelwork connections have been replaced due to steelwork corrosion; the steelwork may not have been provided with adequate paint protection to survive 60 years, if any at all.

Photograph 12: New bolts at rail/column connection.

Photograph 13: New bolts at rail/column connection.

- 5.4 Clean off the rust to the steelwork and assess its condition, then paint the steelwork with a protective corrosive resistance paint. *Specification to be provided when works are to commence.*

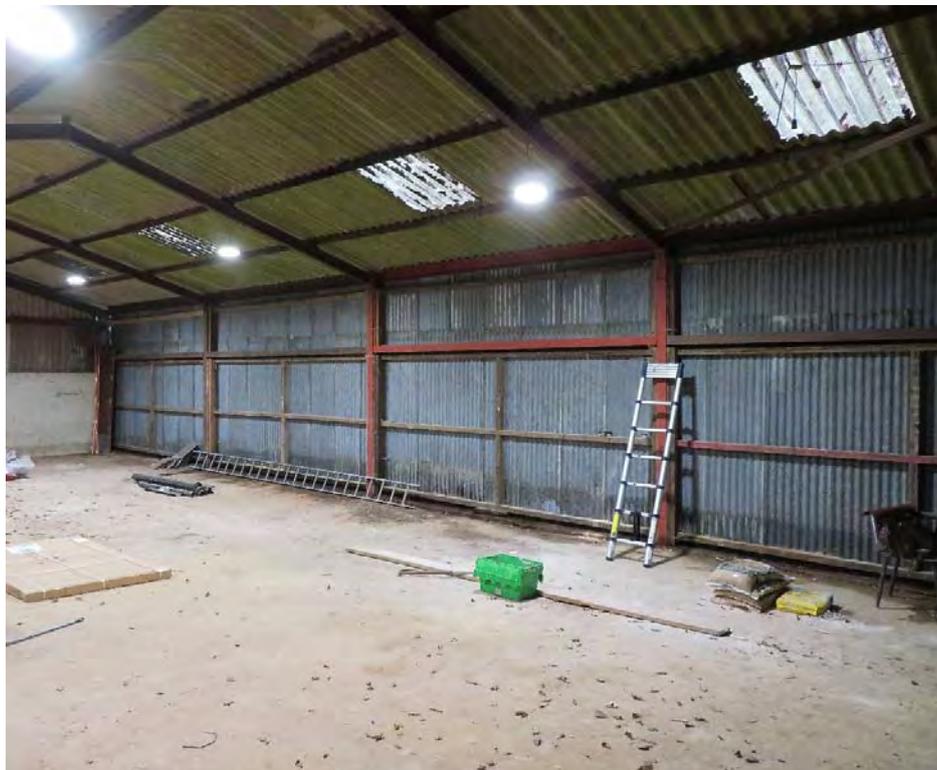
Photograph 14: Partial internal view of barn – nearest dwelling.

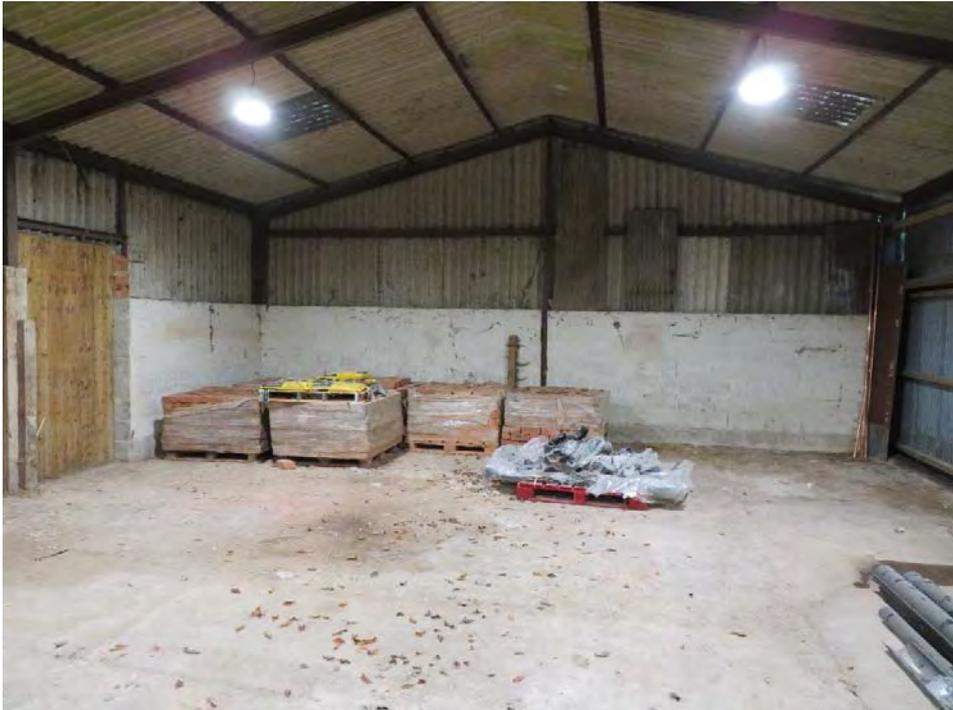
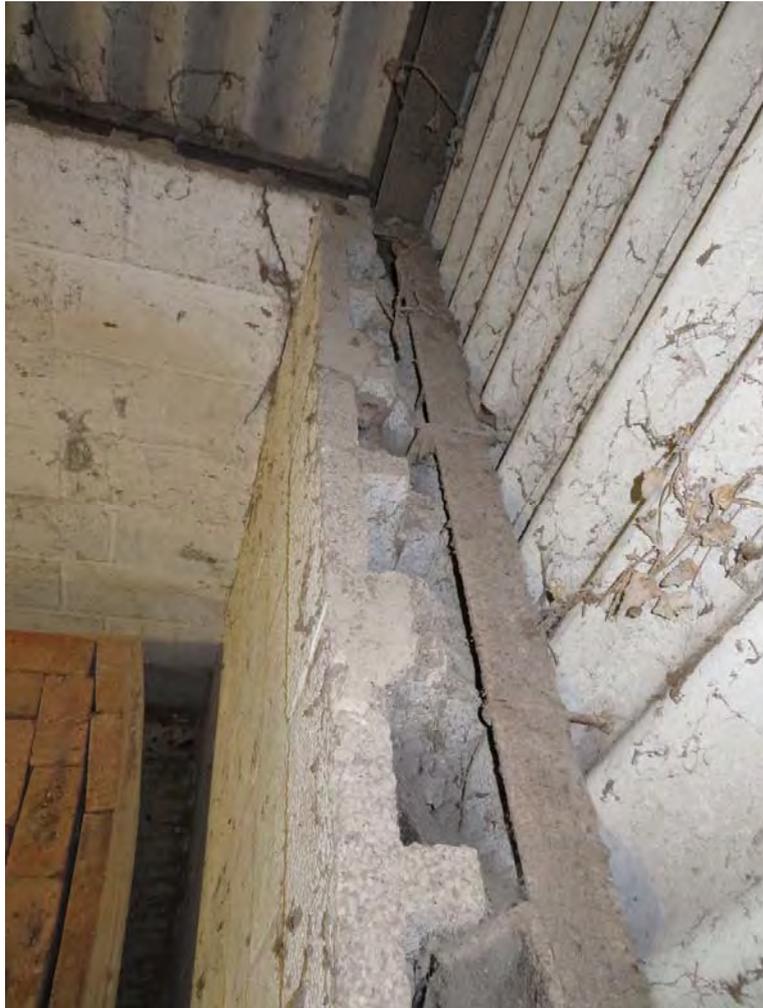
- 3.12 A 215mm thick hollow blockwork wall is present to the rear of the barn and extend around the one side up to the original doors; these doors could not be surveyed due to their location local to the boundary with the adjacent neighbour. It is unclear the reason for this wall. It is unclear if the ground levels are higher on the adjacent land resulting in a retained condition. No reinforcement or concrete were recorded in the voids to the hollow blockwork wall.

Photograph 15: 215mm thick Hollow blockwork wall to rear and side of barn.

Photograph 16: 215mm thick Hollow blockwork wall to rear and side of barn.

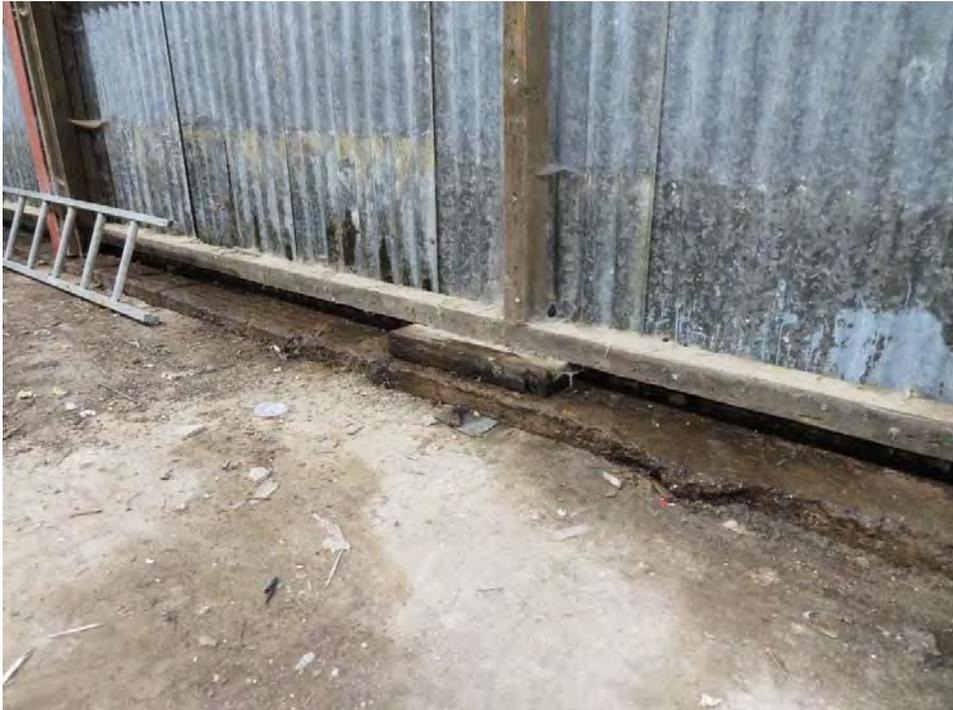
- 3.8 There is a difference of levels to the far side of the slab. What is assumed to be the original foundation is positioned slightly higher than the level of the ground slab. It is considered the foundation is part of the original construction and the infilling slab may have settled over time.

Photograph 17: Difference in levels between assumed original foundations and ground slab.

- 5.6 Break out the existing slab and reinstate with fully designed ground bearing slab with the appropriate joints and insulation. Please note that any excavations are done with care and that all existing foundations are exposed to understand existing formation levels. If the excavations and the earth removal to facilitate the slab construction are lower than the existing foundations, consideration must be given to underpinning the existing foundations to prevent future, instability issues.

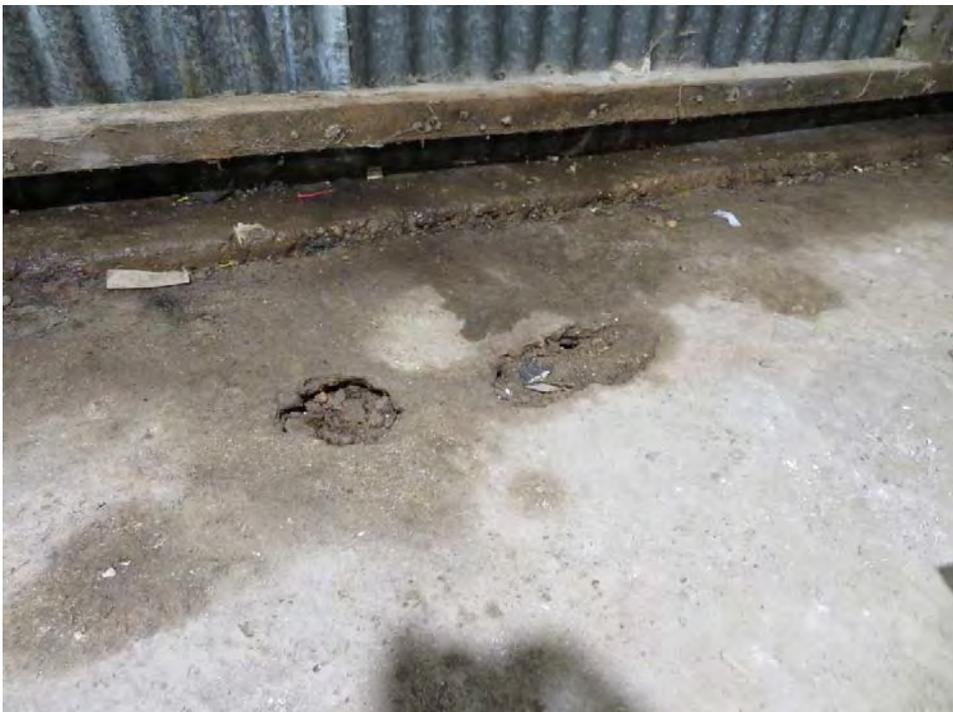
- 3.9 There are voids present to the concrete slab. It is unclear what depth the slab has been constructed with and if any reinforcement is present.
- 3.10 A large proportion of the steelwork displays surface rust; some extreme cases are located sporadically around the barn. The internal environment would be subject to very cold and damp conditions; no form of heating is present. The barn is reasonably well ventilated.

It is unclear what depth the slab has been constructed with and if any reinforcement is present. It is considered this slab has cast to enable the barn to be used for a storage area.

Photograph 18: Voids to ground slab.
