Desbruslais
Chartered Surveyors

BUILDING SURVEY OF

3 Coastguard Cottages
Snowhill
West Wittering
Chichester
PO20 8AT

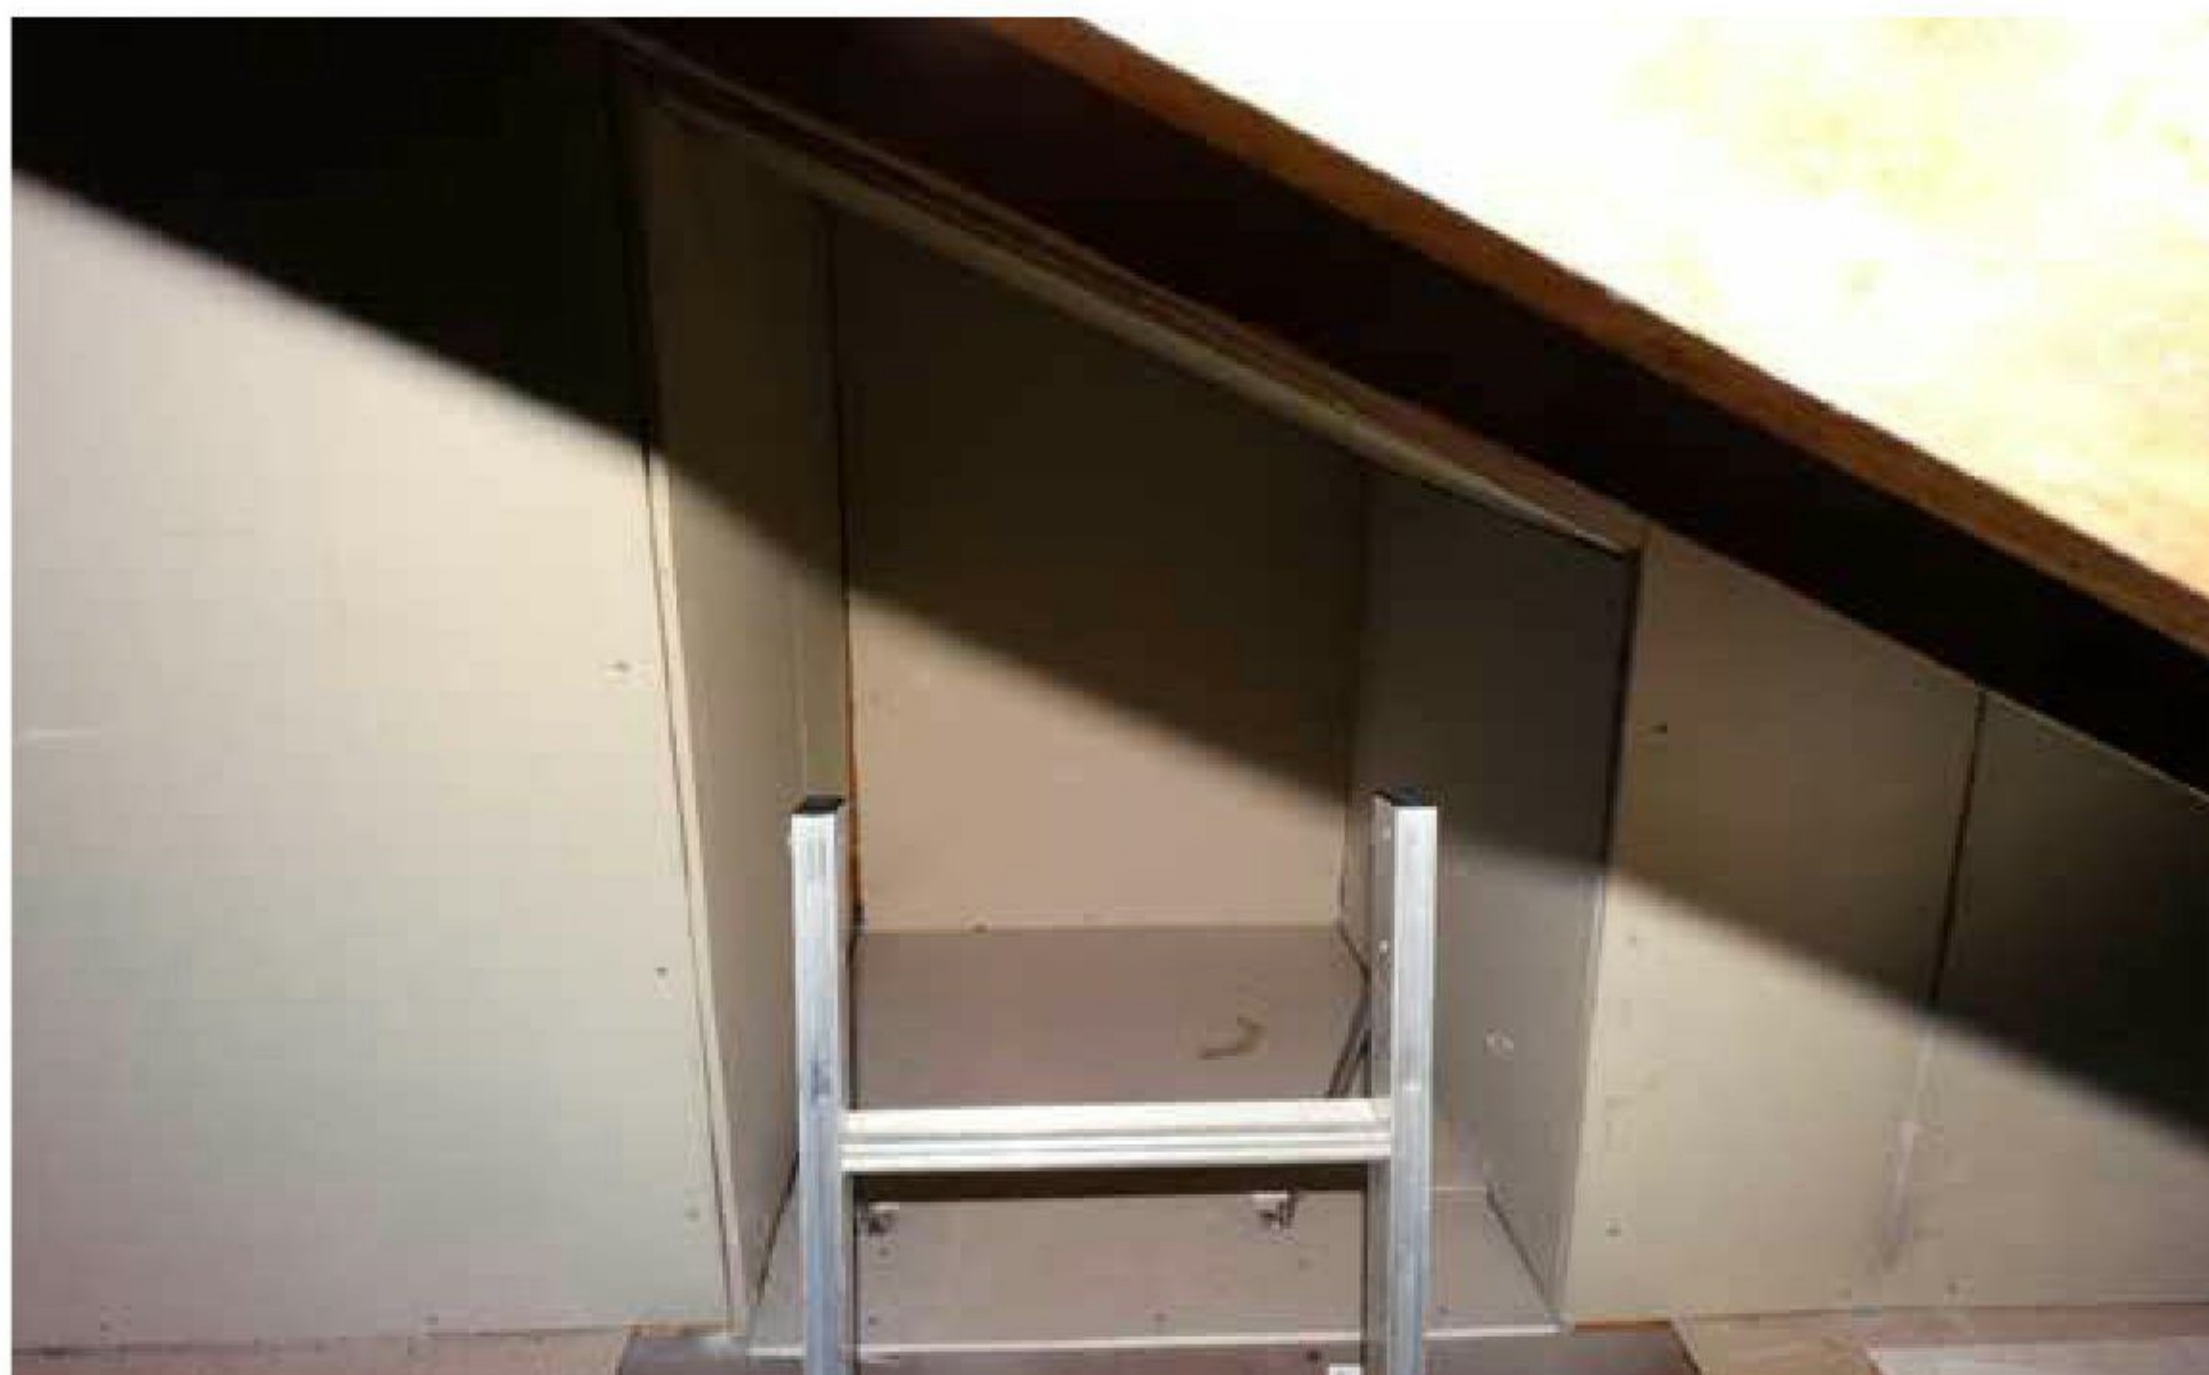
The housing for the loft ladder comprises a flying freehold, albeit a very minor one.

This occurs when one freehold ownership extends above or below another. Your solicitor should confirm the existence of the flying freehold, that it is explicit within the title deeds and that your freehold rights are in place. Ideally, both parties should be fully obligated to each other in respect of rights of access and repair, together with appropriate insurance. This arrangement is known as cross covenanting. However often, for something as small as this, either moving the ladder housing, or having a simple agreement with the neighbour may be all that is needed.

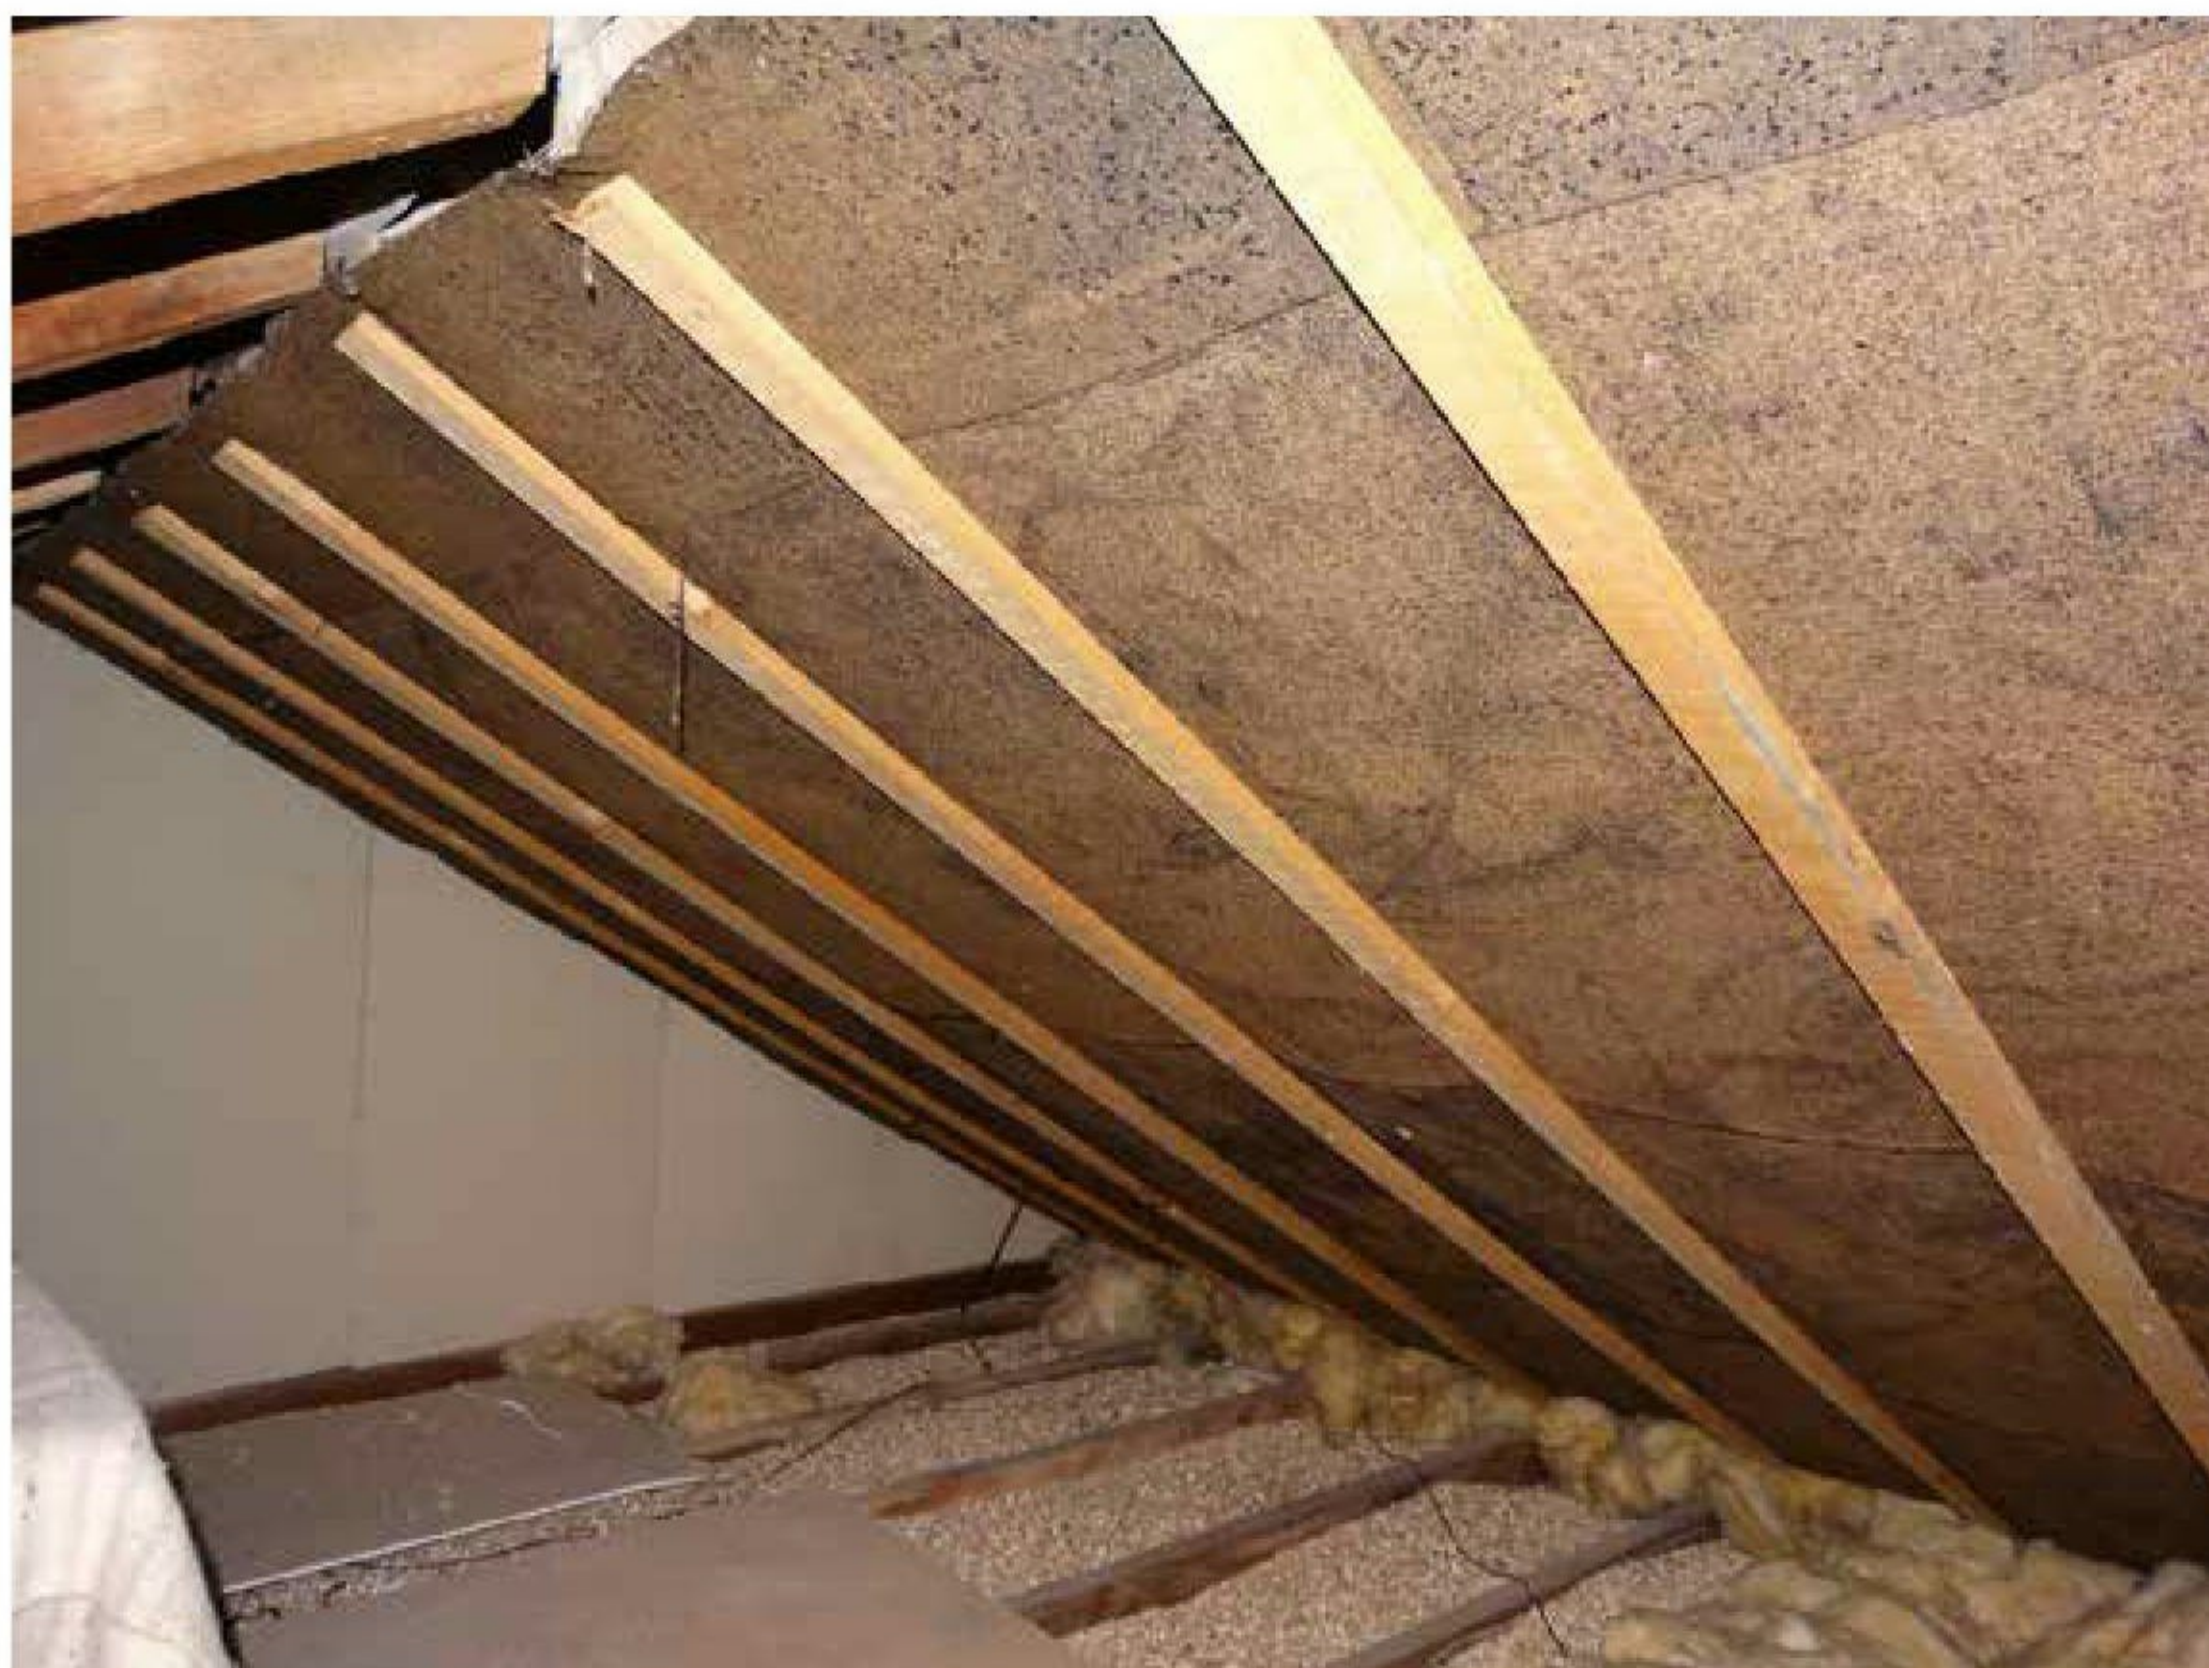
The rafters are mostly of a reasonable size and, indeed, appear likely in many cases to have been replaced on the rear slope. Those of the front slope are clad.

The lack of bracing is not an issue due to the very lightweight roof covering of natural slate. Notwithstanding the listing not permitting it, any heavier tile such as a modern concrete tile would overload the roof structure.

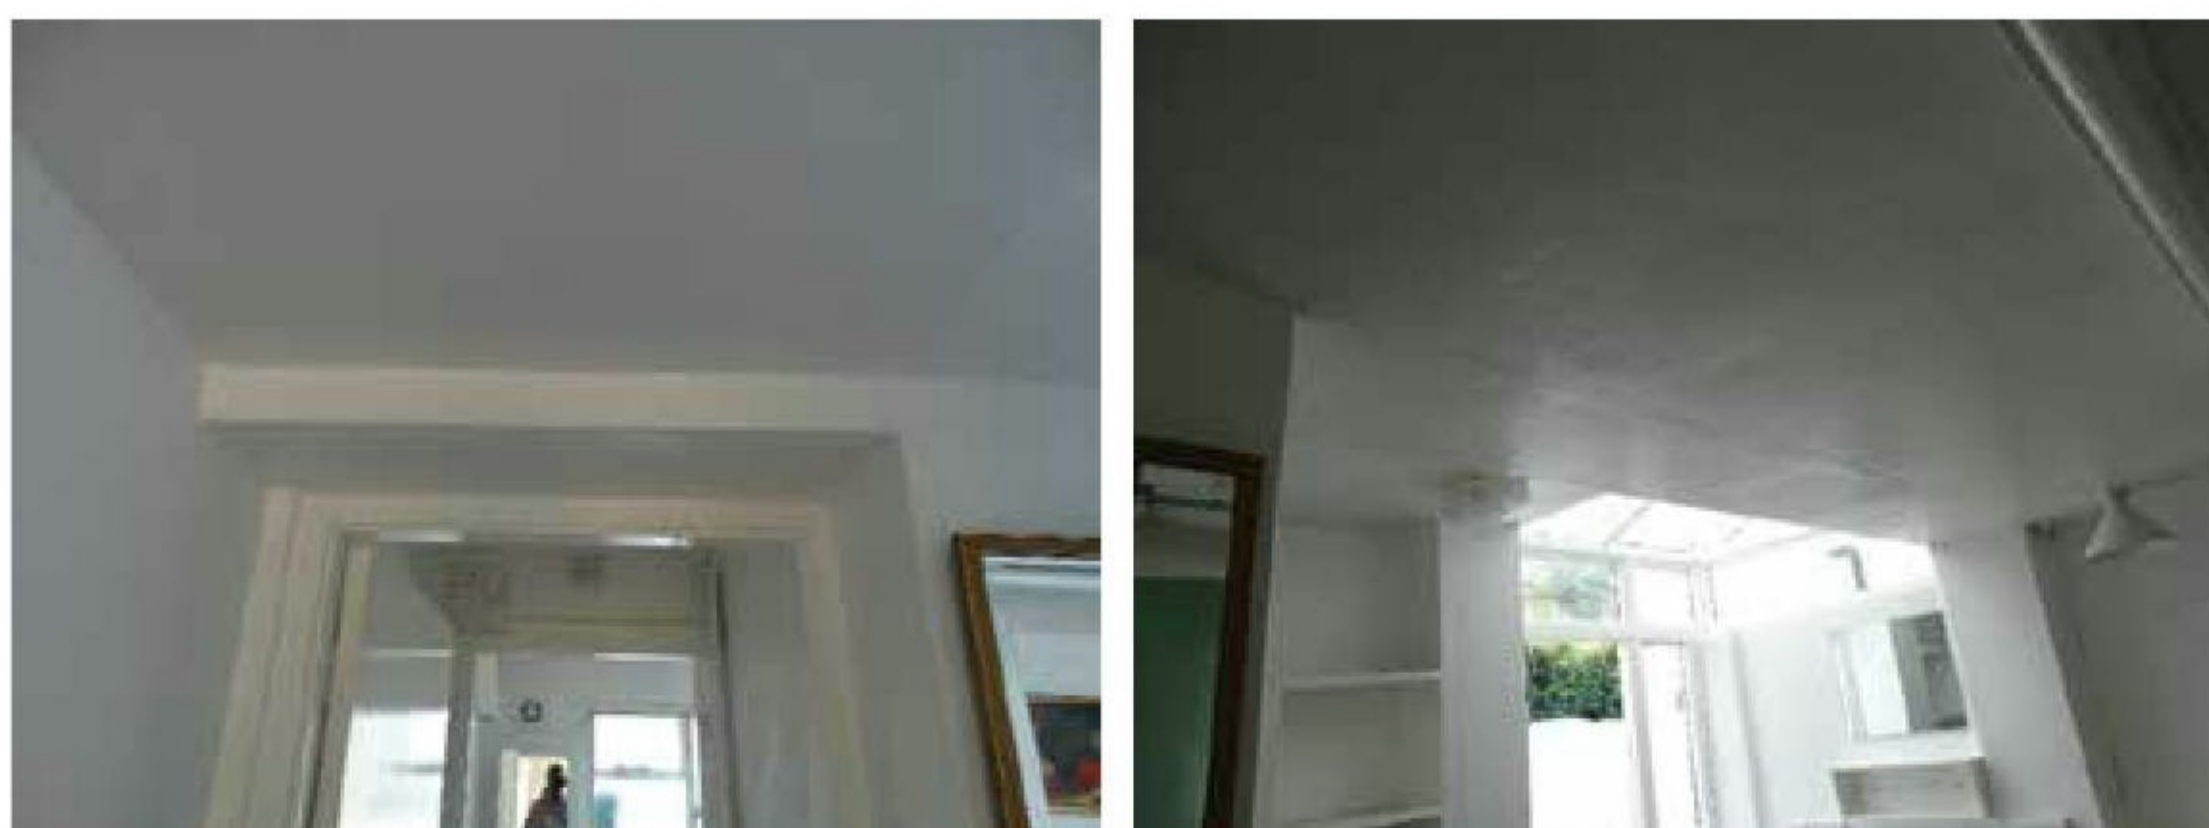
A load-bearing wall has been removed at the rear of the property to allow access to the slightly enlarged kitchen and extension. Projections below the ceiling suggests beams have been installed to support the structures above and there is a structural pier forming part of the partition between the kitchen and the corridor to the bathroom behind. The beams are masked.

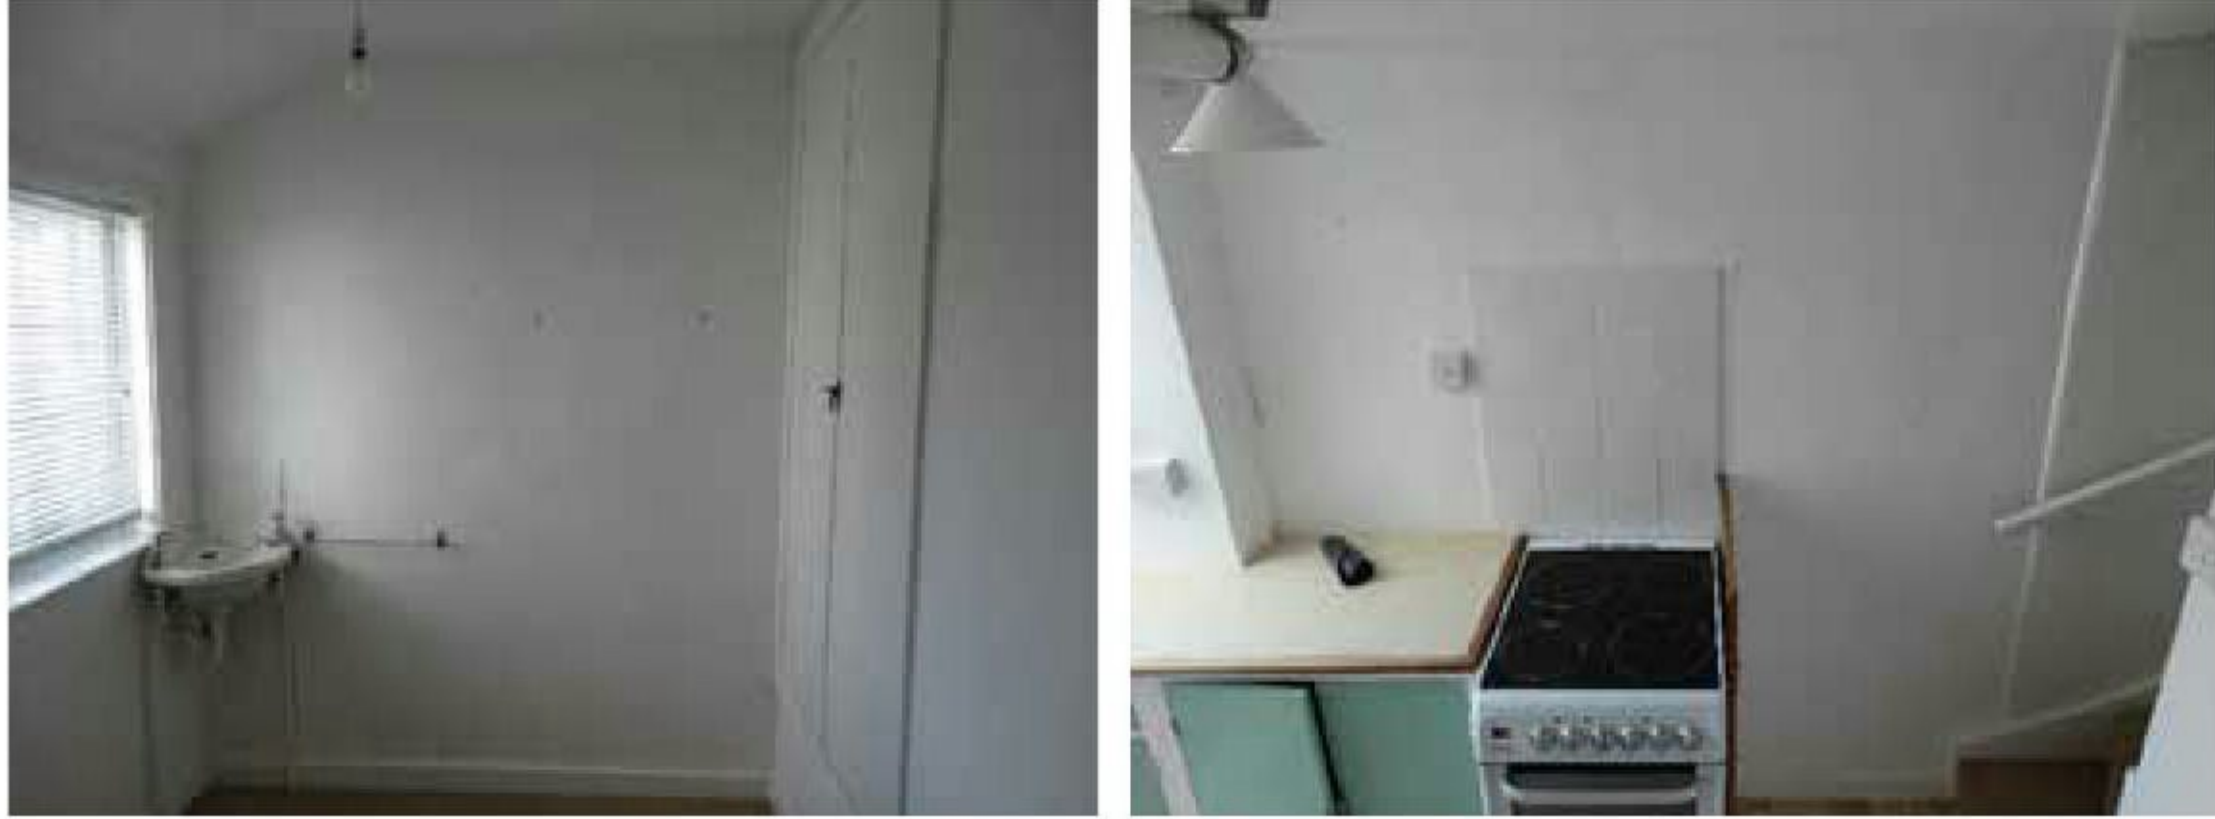
A chimneybreast in the rear part of the house has been removed down through the house. The images below show the position of the former breast.

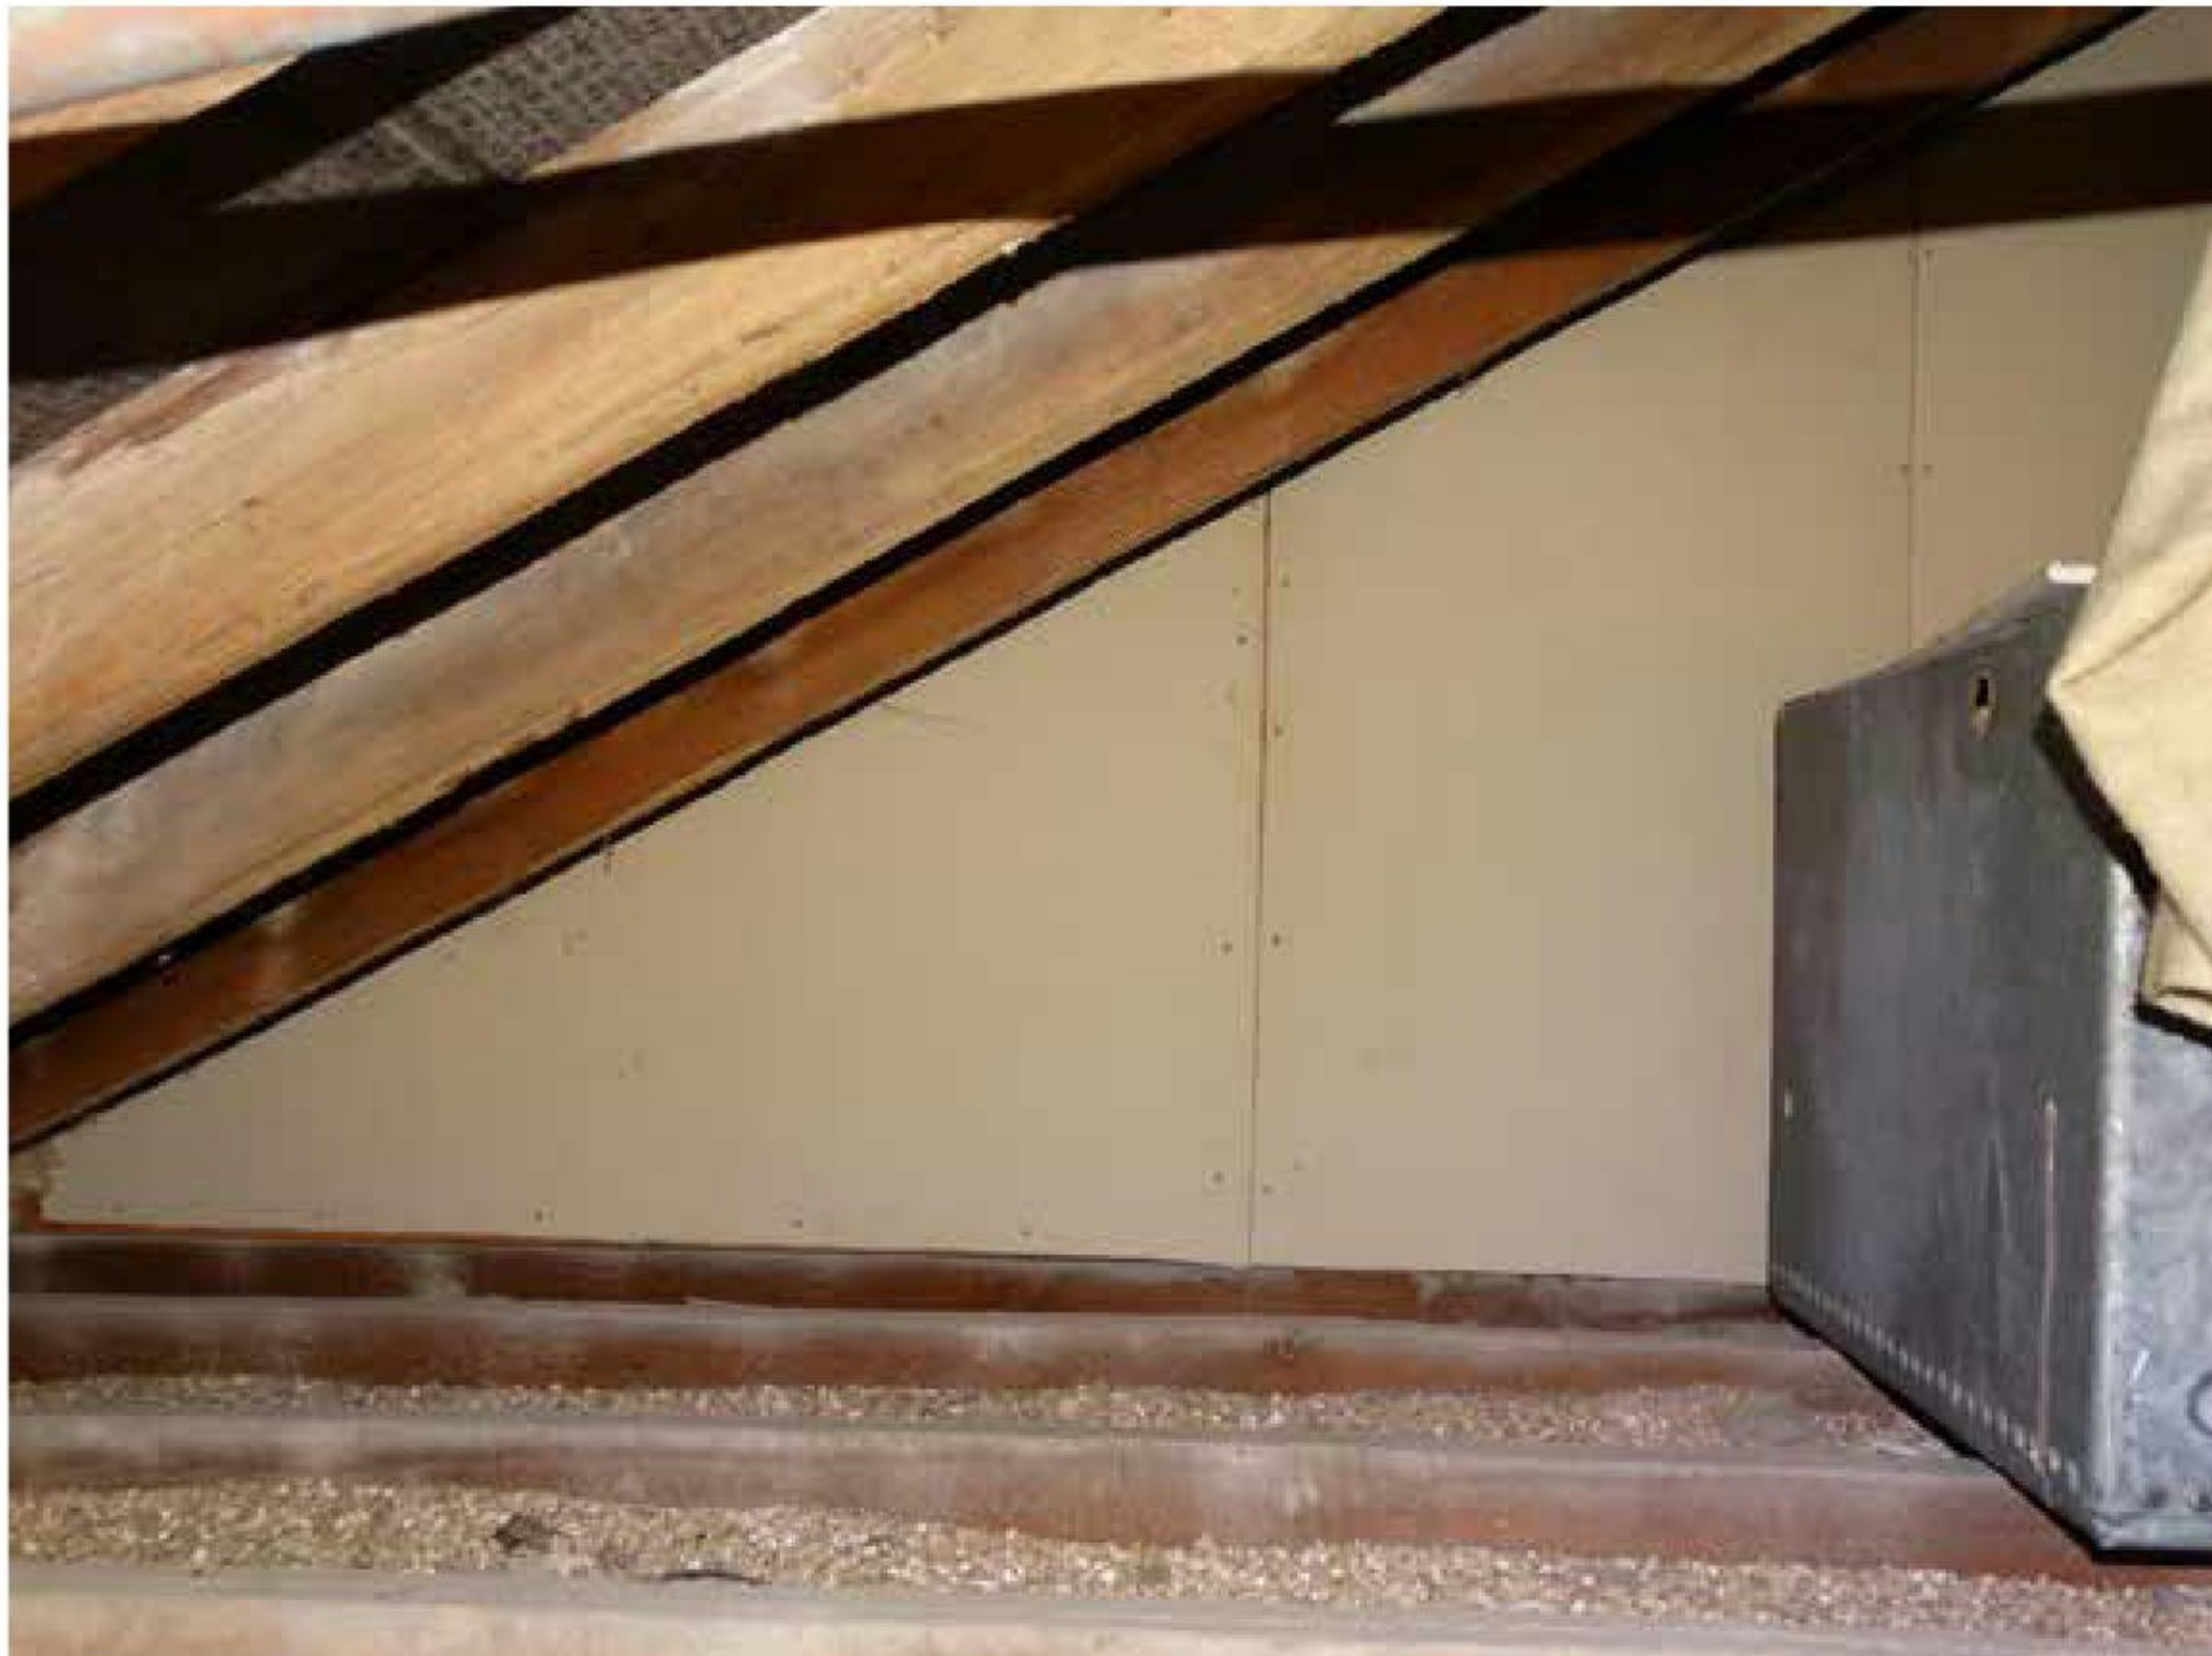
It is not clear how the corresponding structure above is supported, if at all, as the area of the loft where support could be ascertained is now fully plasterboard clad for fire break reasons.

There is no apparent disruption to suggest pending failure and clearly the situation has existed for many years, but ideally the means of support should be checked. If the arrangement is found wanting, additional steps should be taken to ensure stability. This could entail installing a supporting cross beam or bracketing.

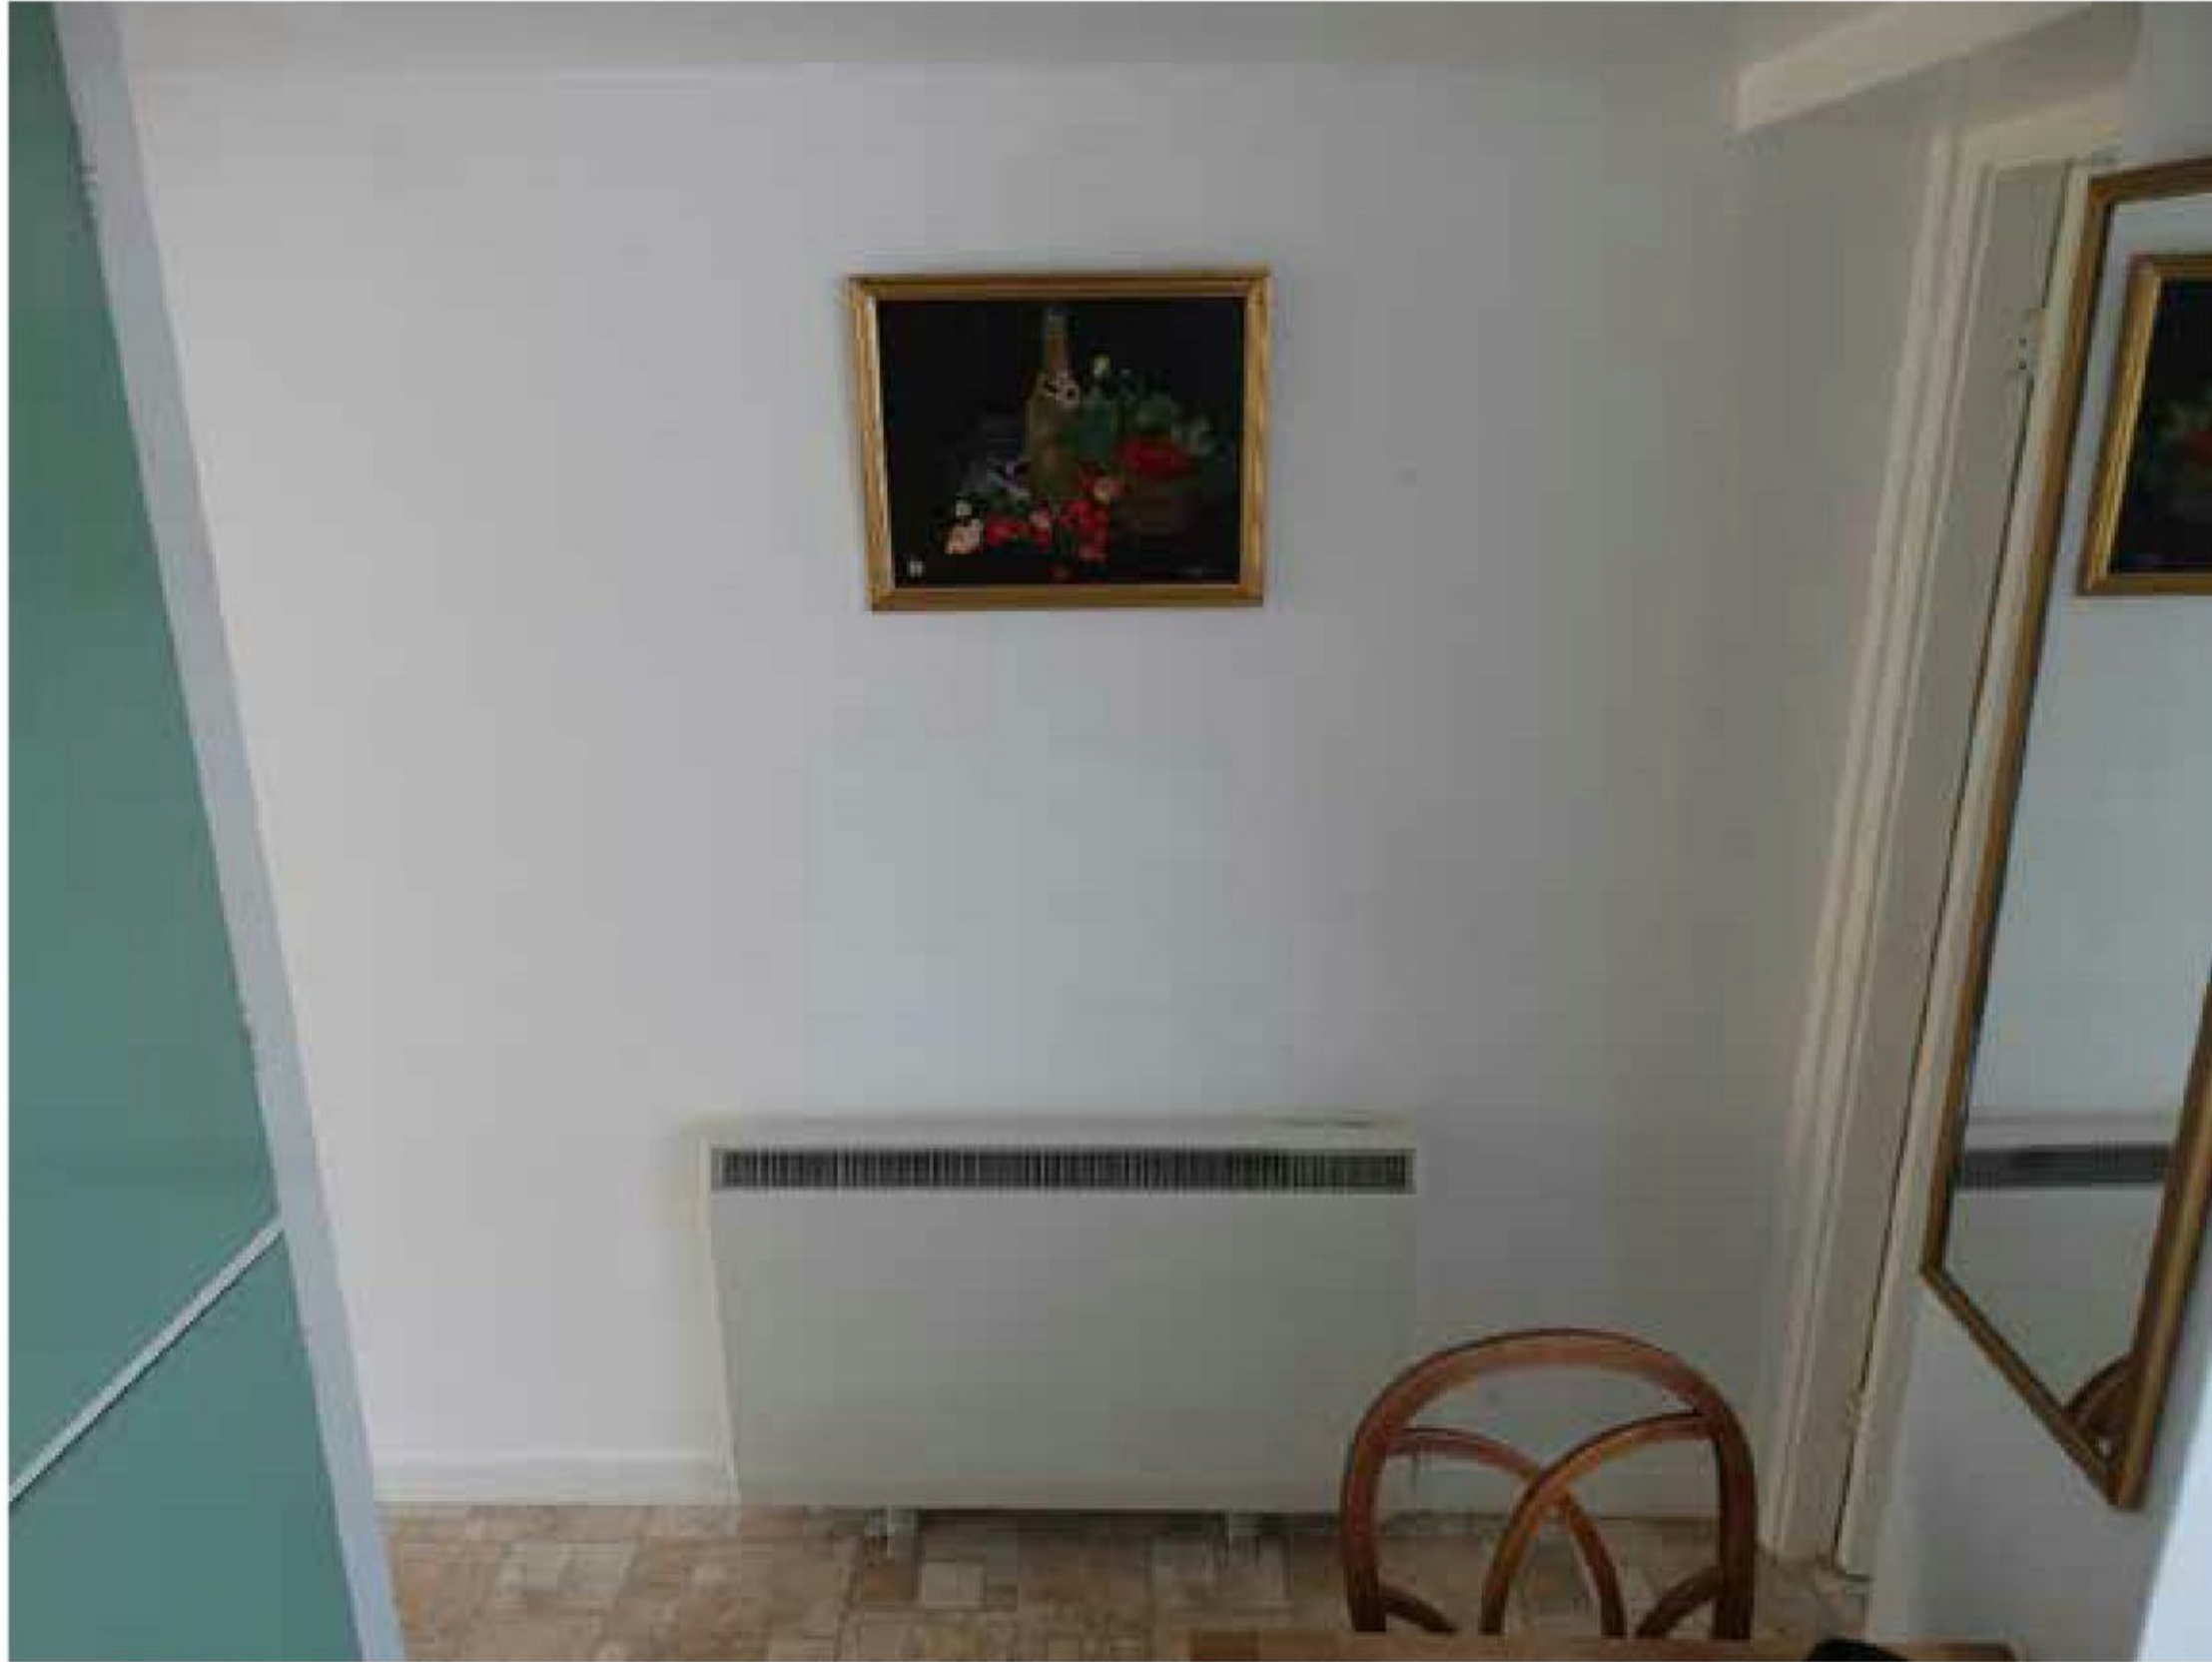
During the 1960s alterations, the layout of the stairs was also changed. The stairs originally rose on the flank wall of the rear room adjacent to the west wall. Indeed, the stair string outline can still be discerned in the plaster. New stairs were inserted laterally in 1962, involving some alteration to floor joisting.

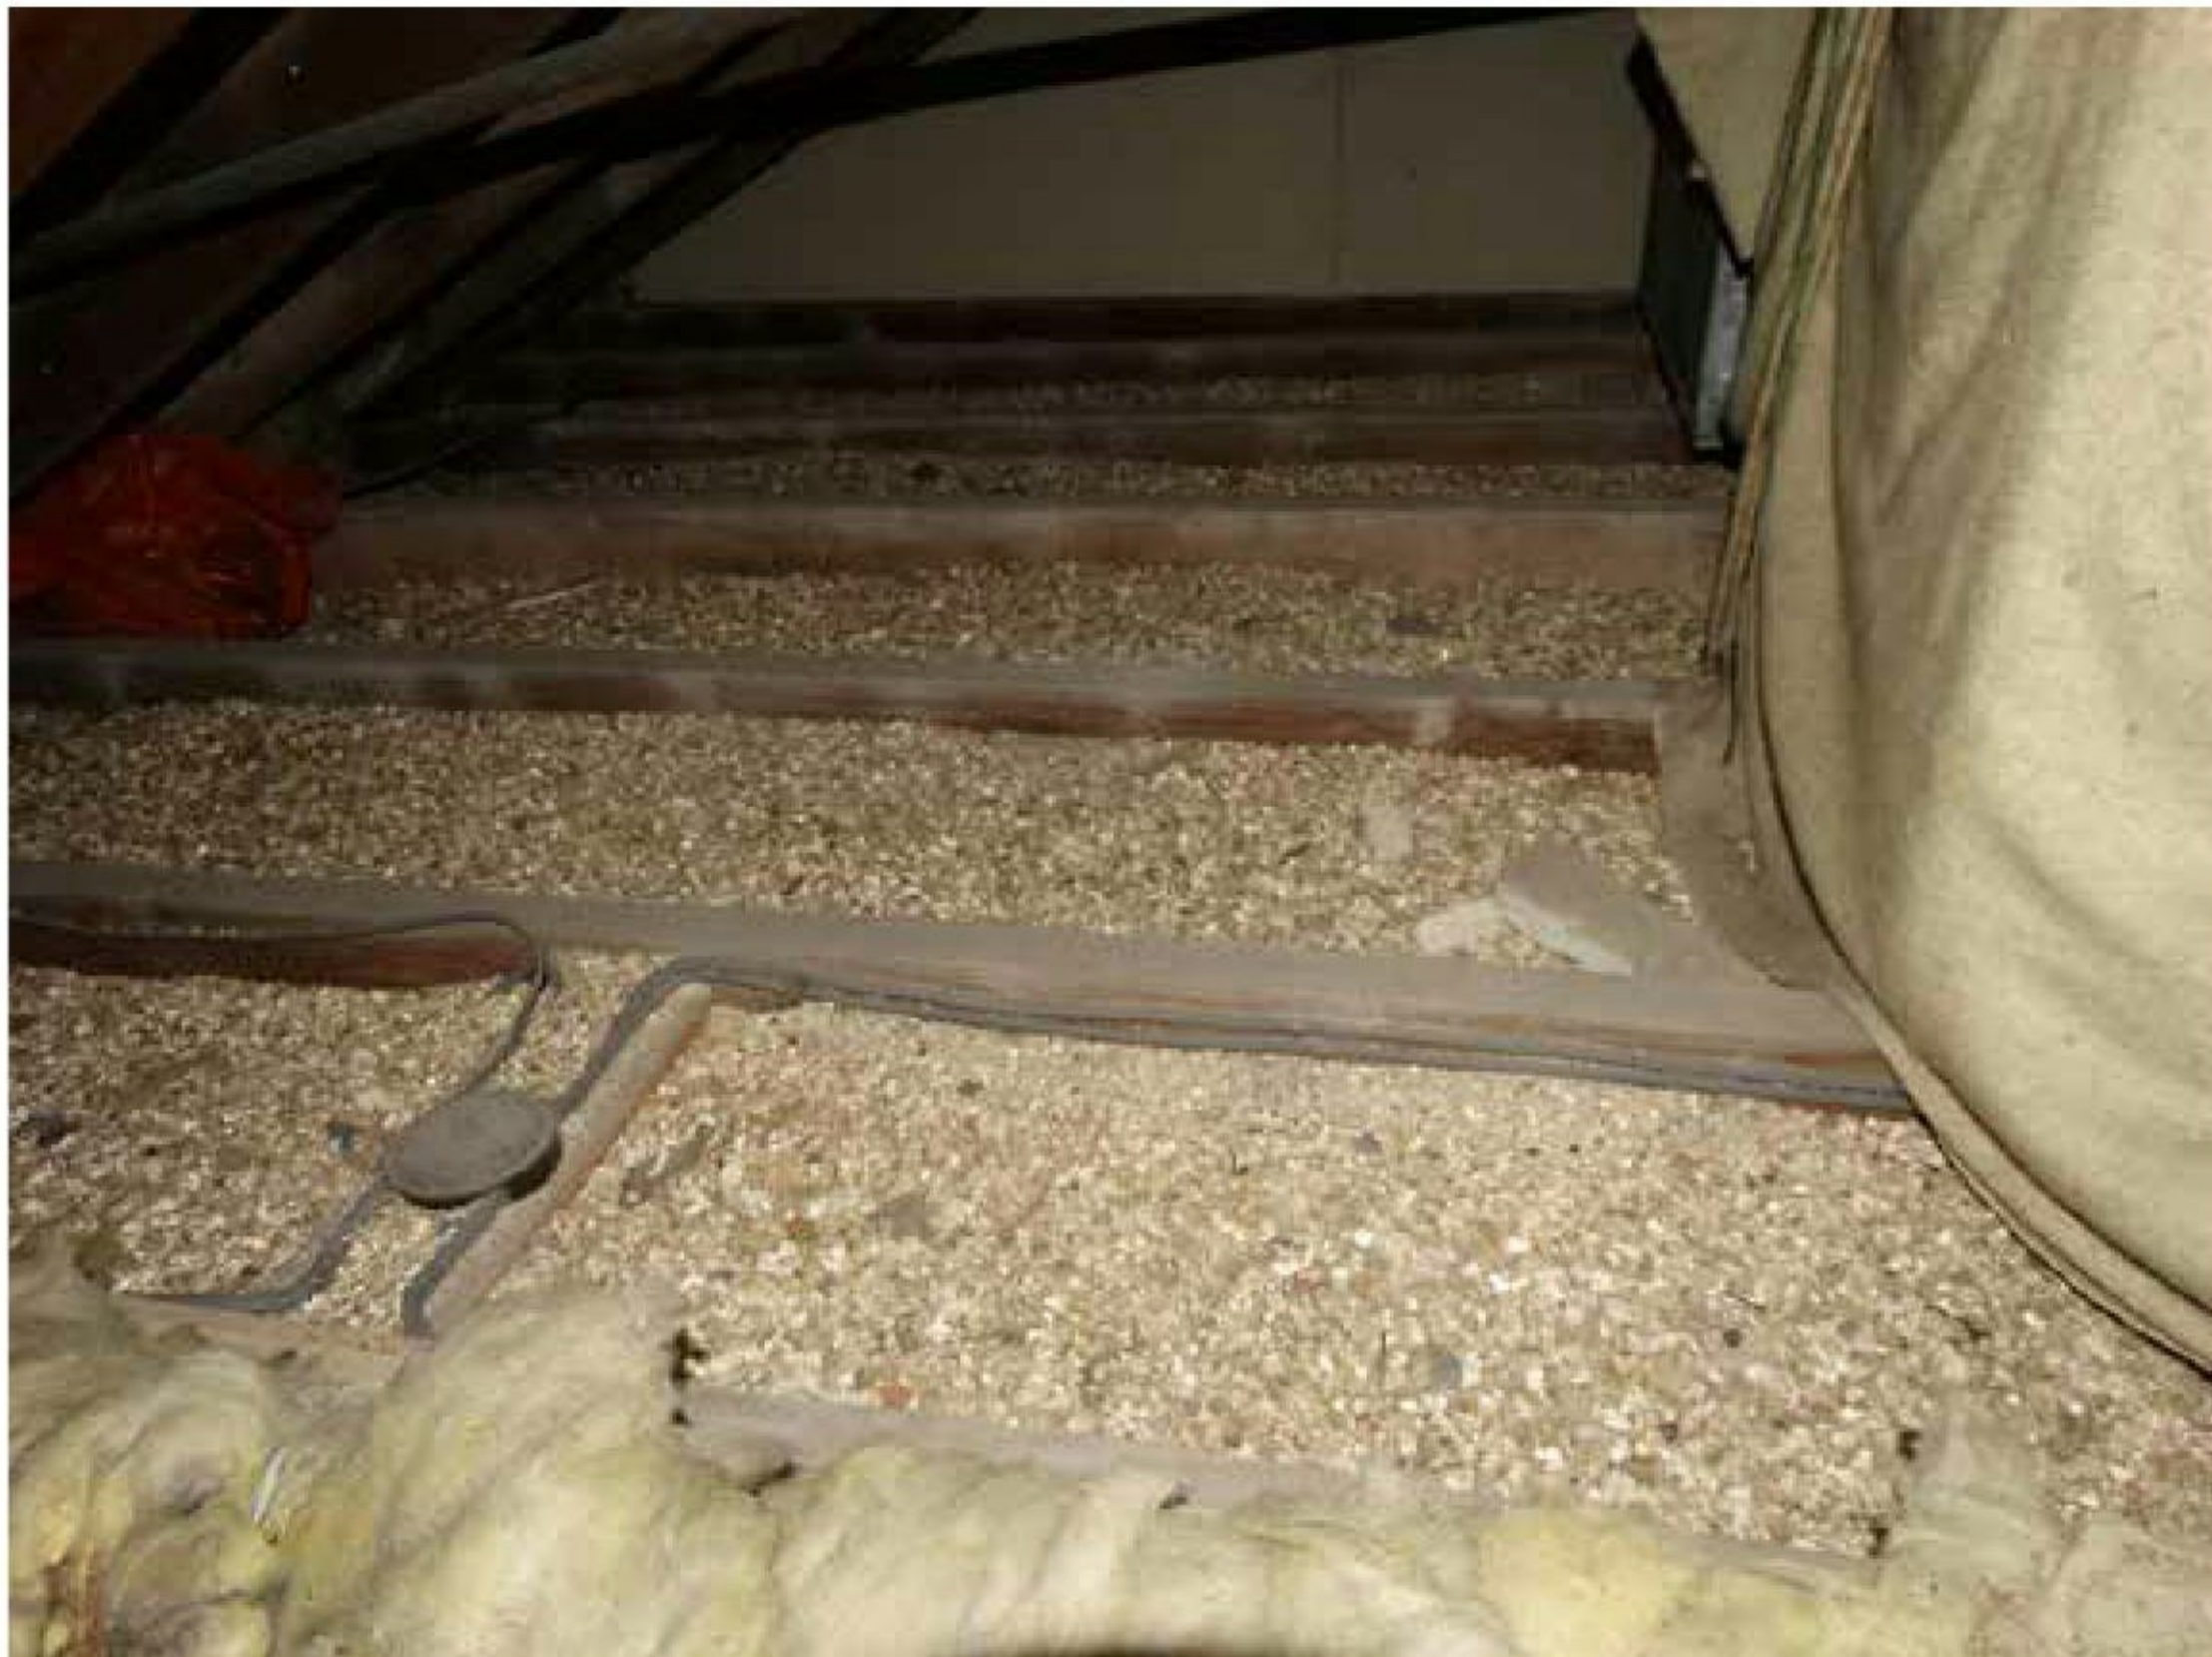
The loose-fill insulation material within the roof void is of a vermiculite type, which has been known in very rare cases to contain elements of asbestos.

The risk is not mentioned in the Asbestos Information Centre website which suggests the risk is extremely low. See our further advice under Section 11. Vermiculite is generally a fairly poor insulator compared to modern materials.
