Desbruslais
Chartered Surveyors

BUILDING SURVEY OF

3 Coastguard Cottages
Snowhill
West Wittering
Chichester
PO20 8AT

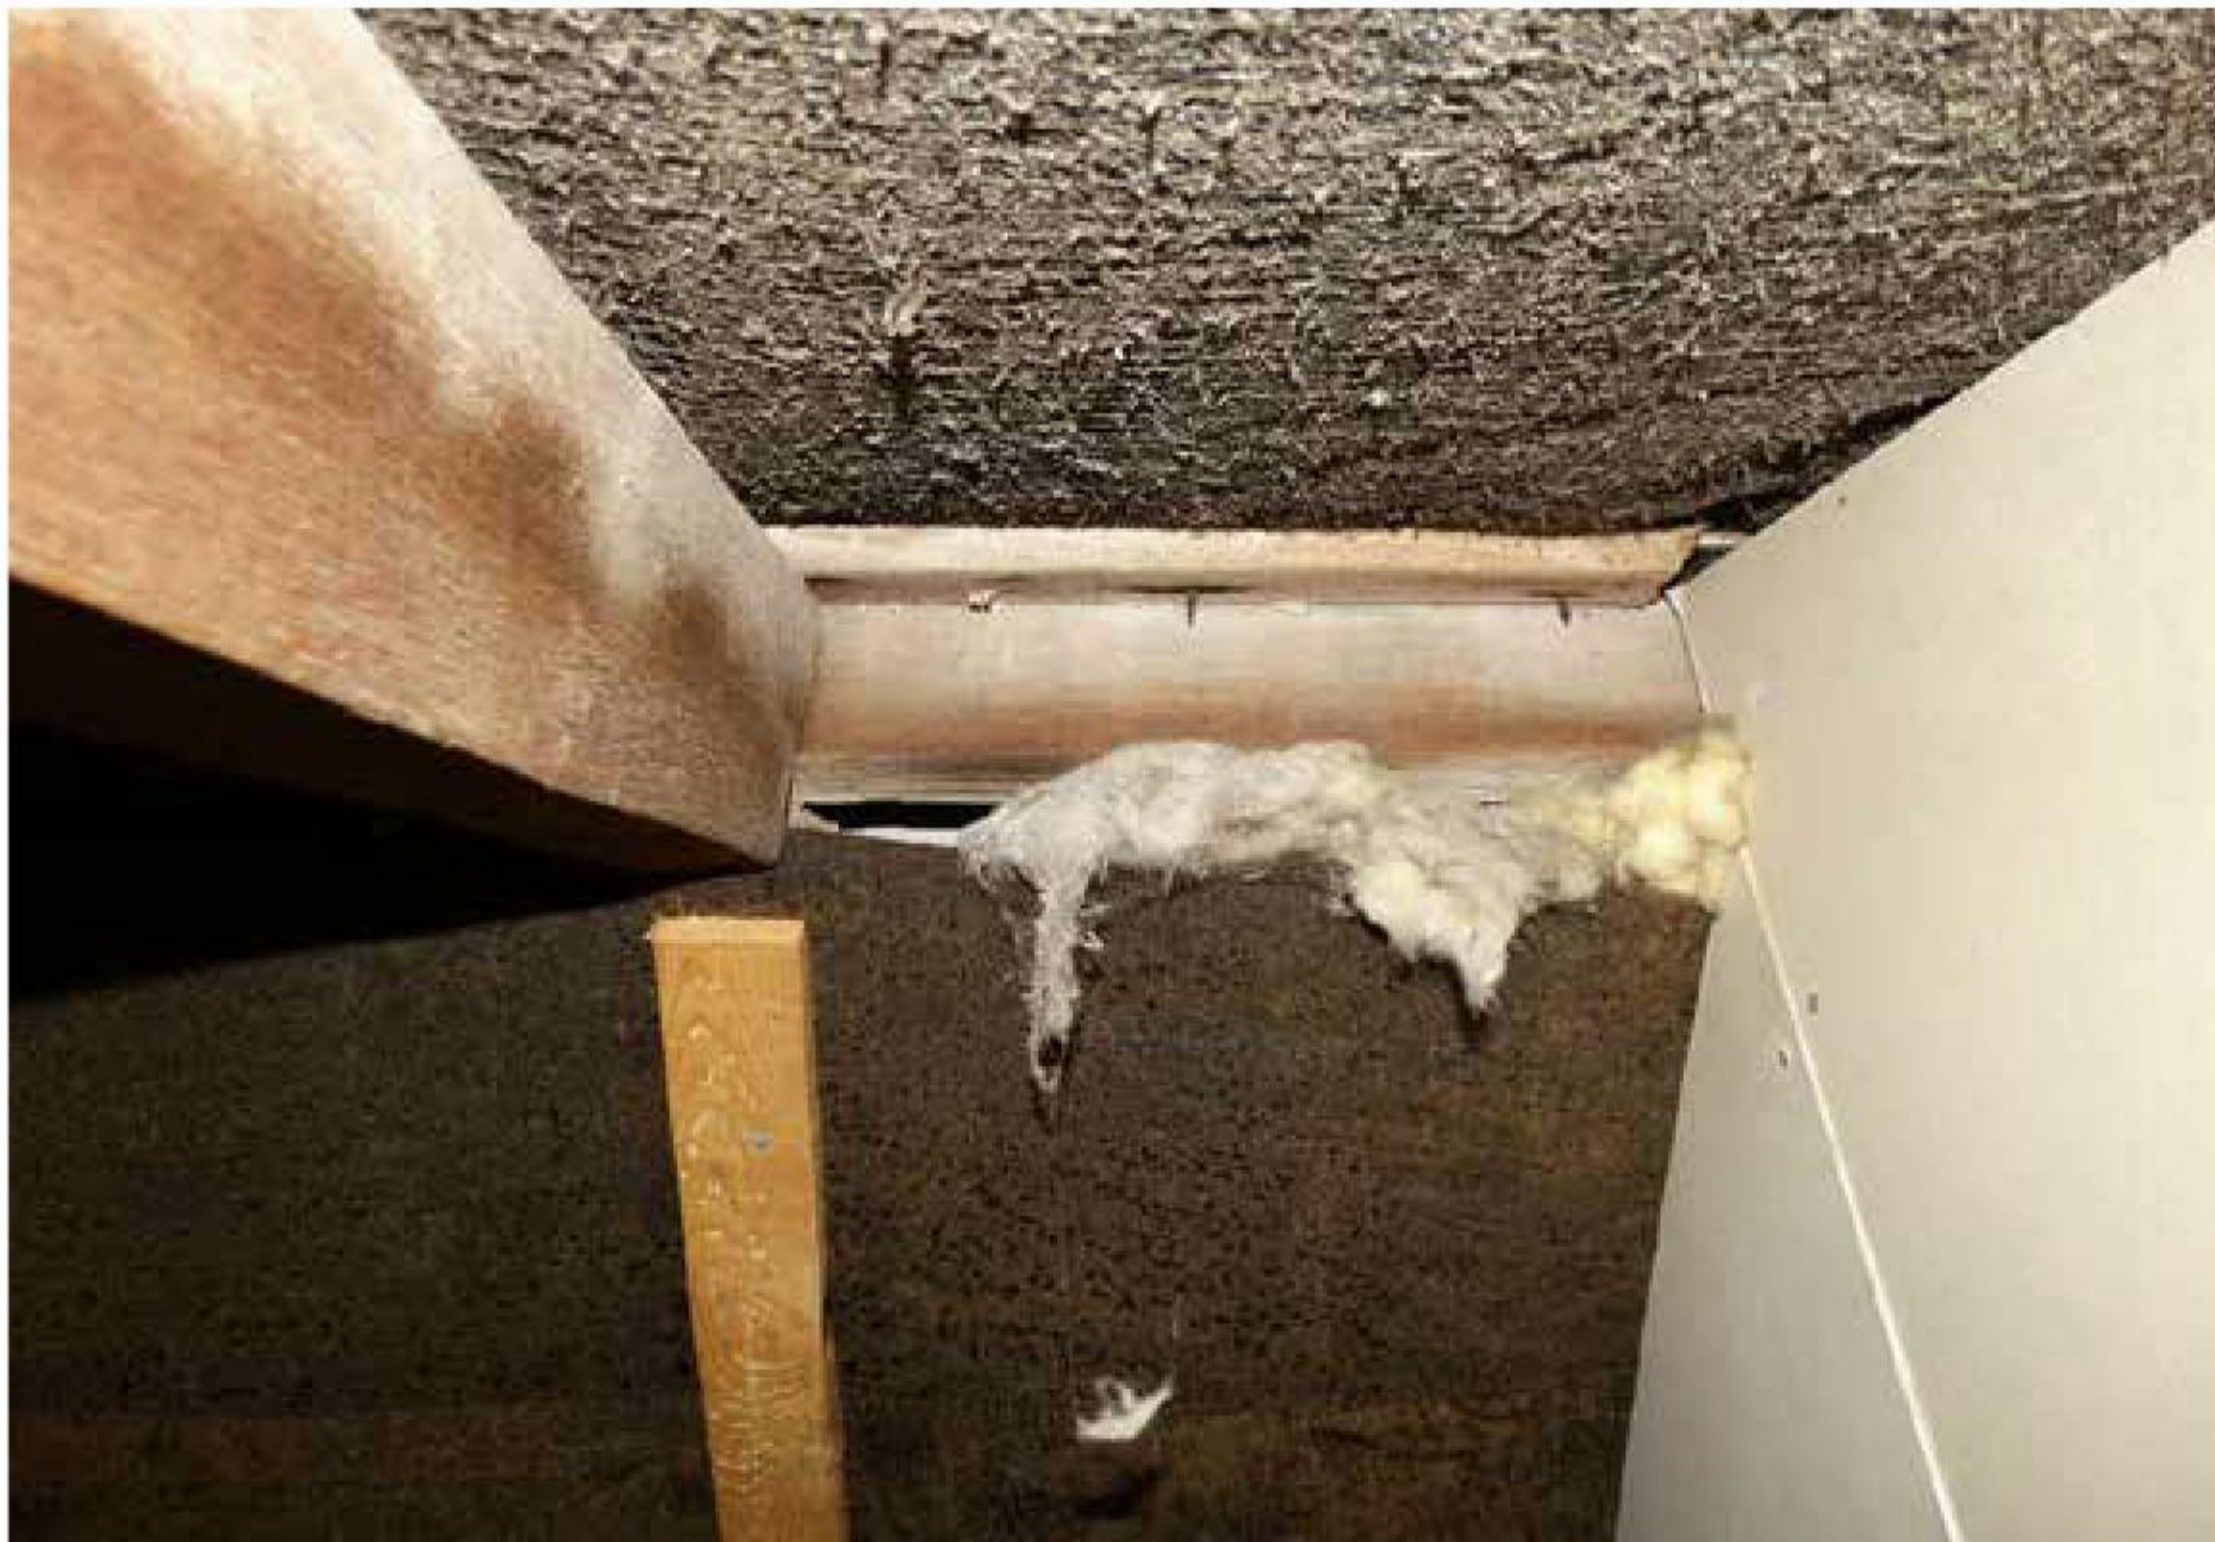
The front slope has been clad with bitumen sarking under the rafters, with an unknown thickness of mineral fibre insulation pushed between the rafters.

This is not a very effective means of insulation, as the roof is not uniformly insulated in this way and heat from the rooms below can still effectively escape elsewhere through the more poorly insulated parts of the loft.

This could be left in place, but additional insulation added to the loft floor to stop heat escaping from the rooms below.

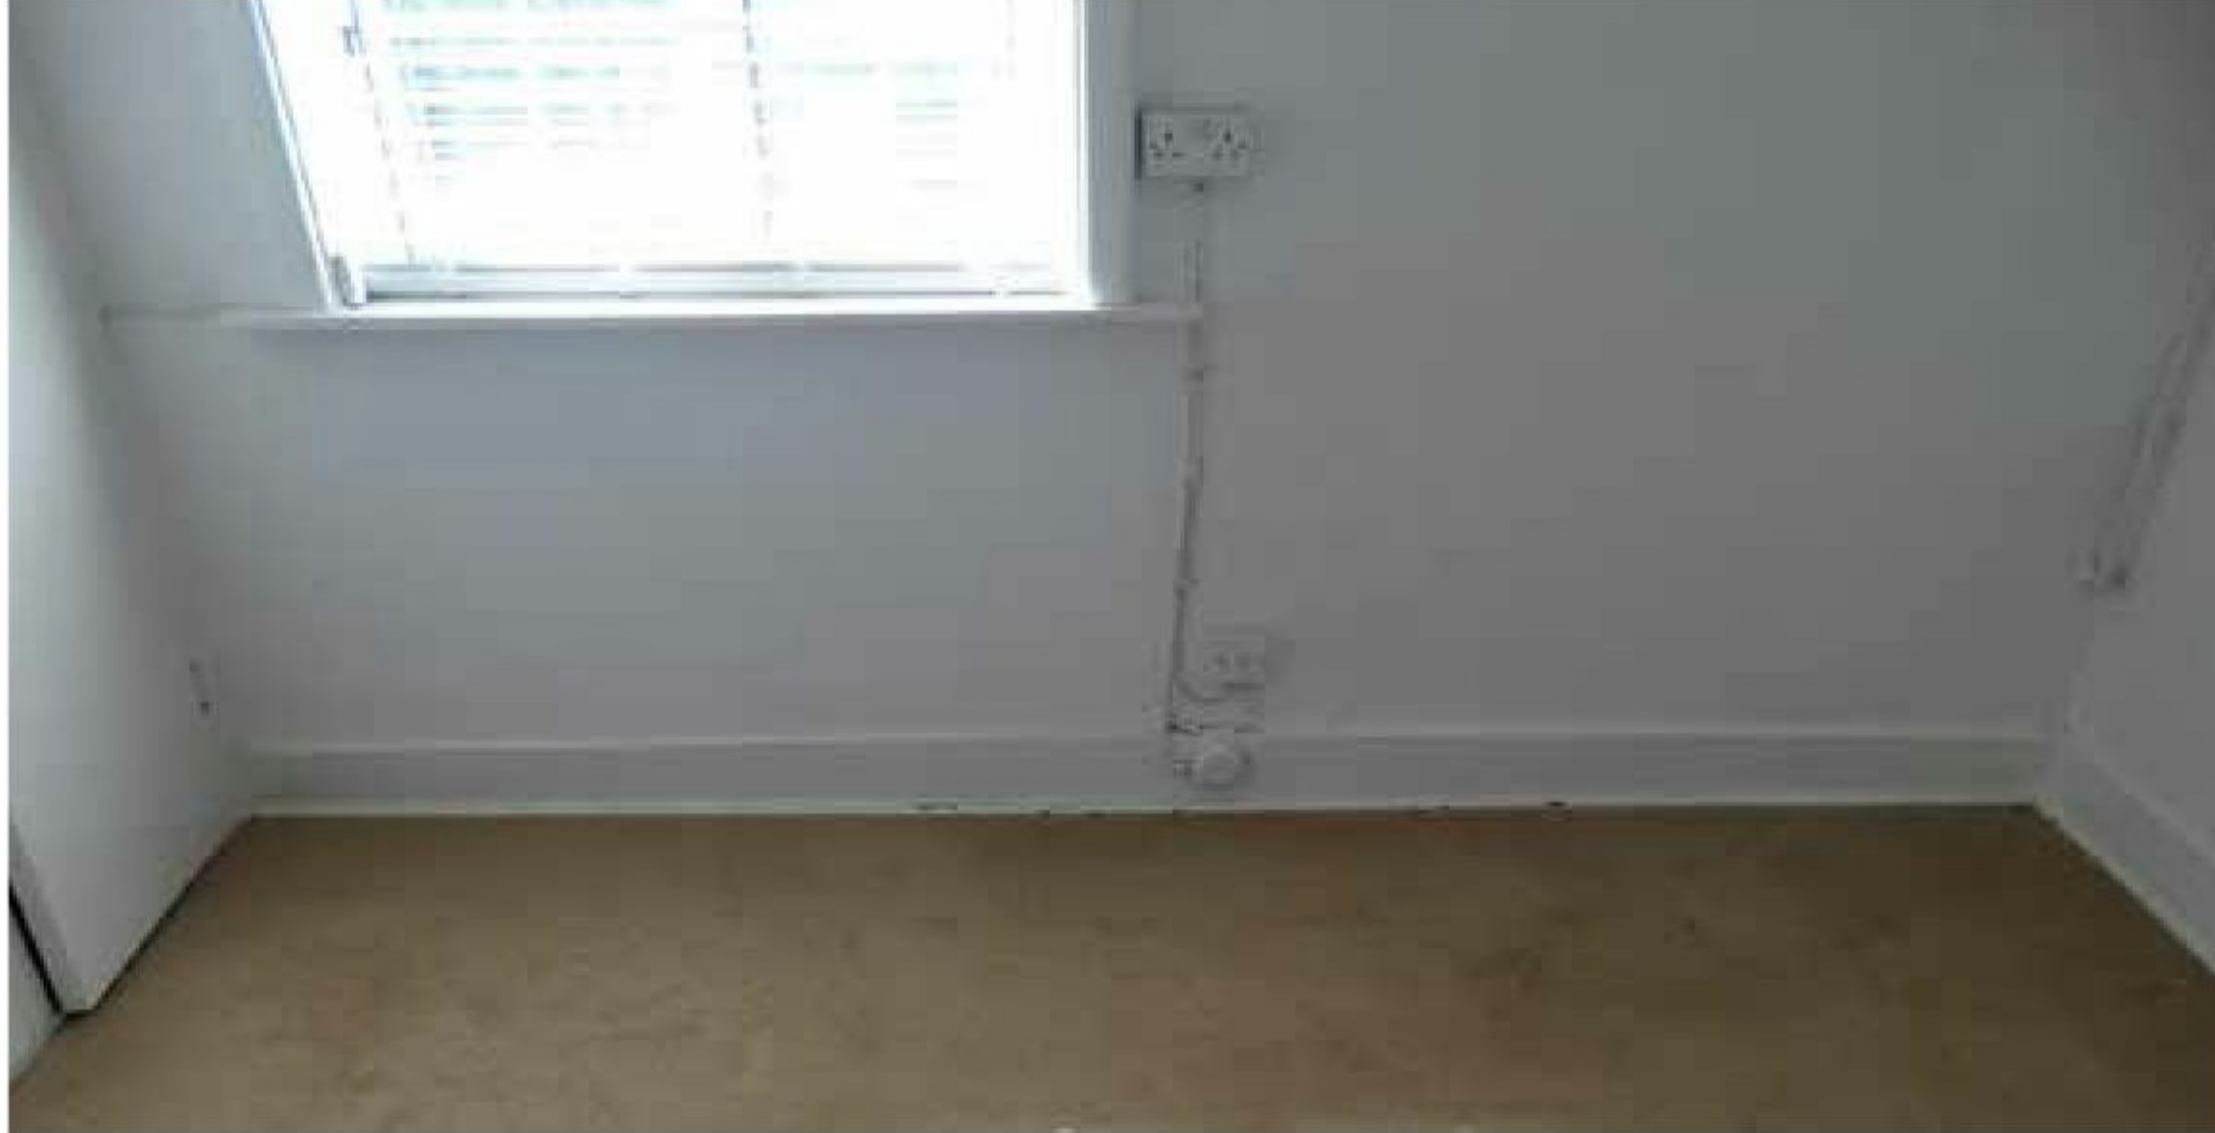
A timber bearing beam has been placed under the floor supporting the front lounge, due to deflection to the joists. This is notable in the front bedroom.

The matter is minor and the floor is fairly solid.

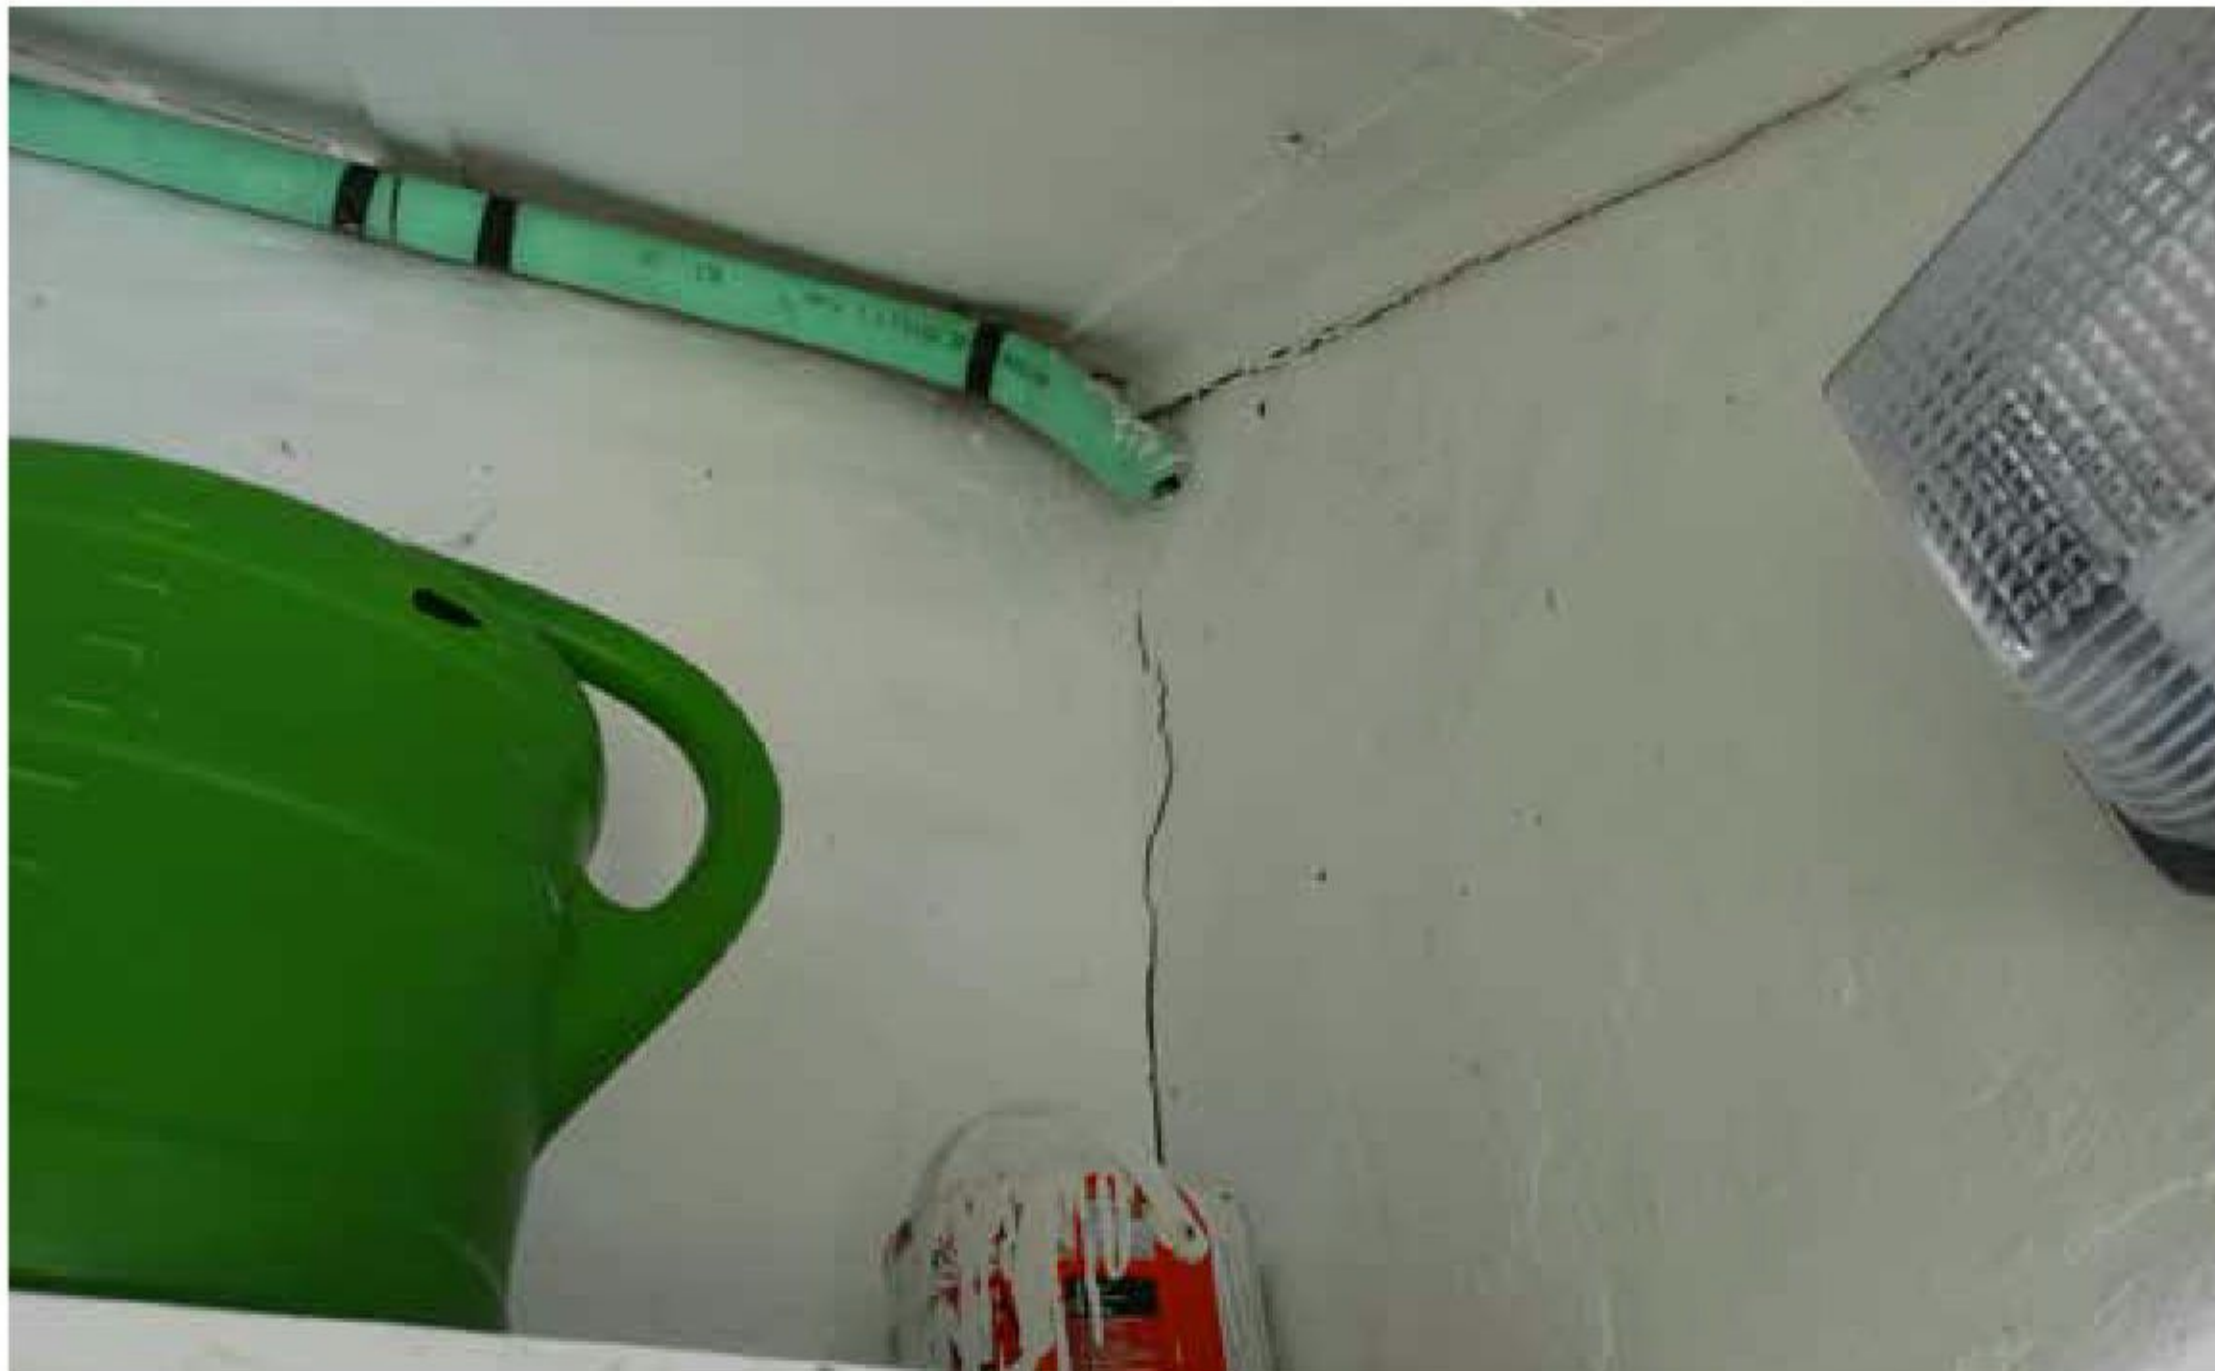
There is also minor separation of the porch store from the main house frontage. This is typical rotation and poor bonding and of no significant consequence.

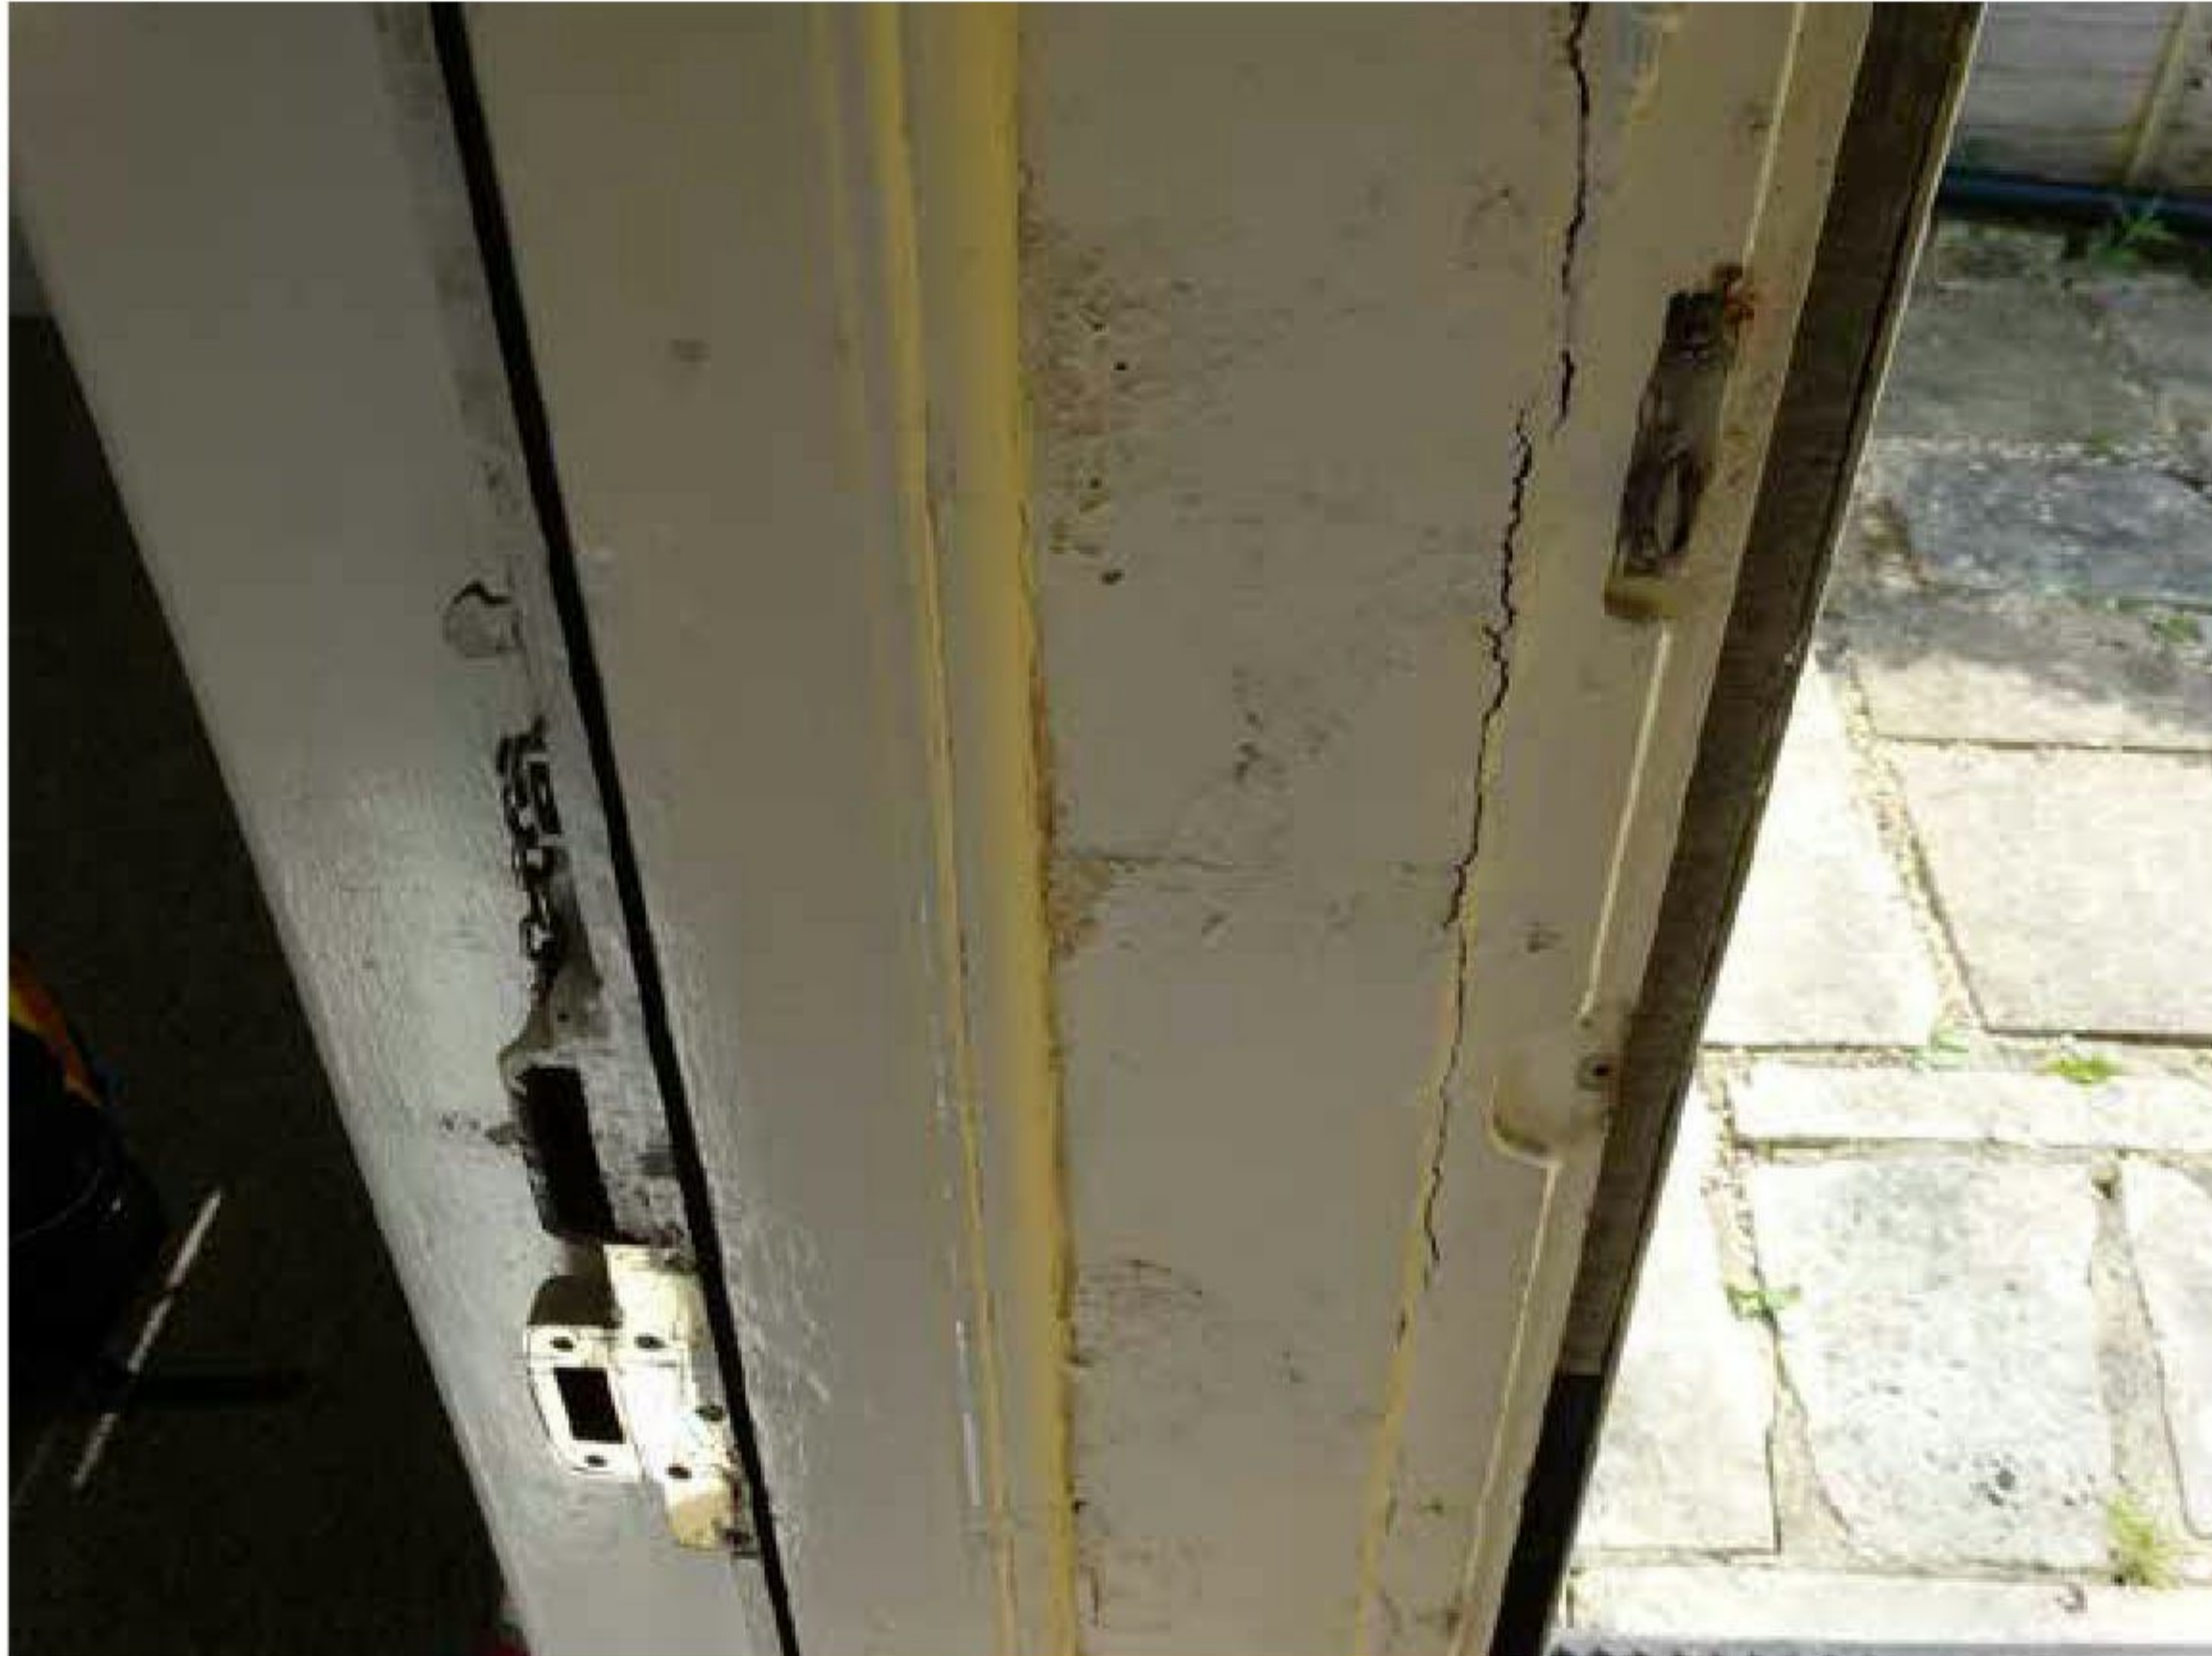
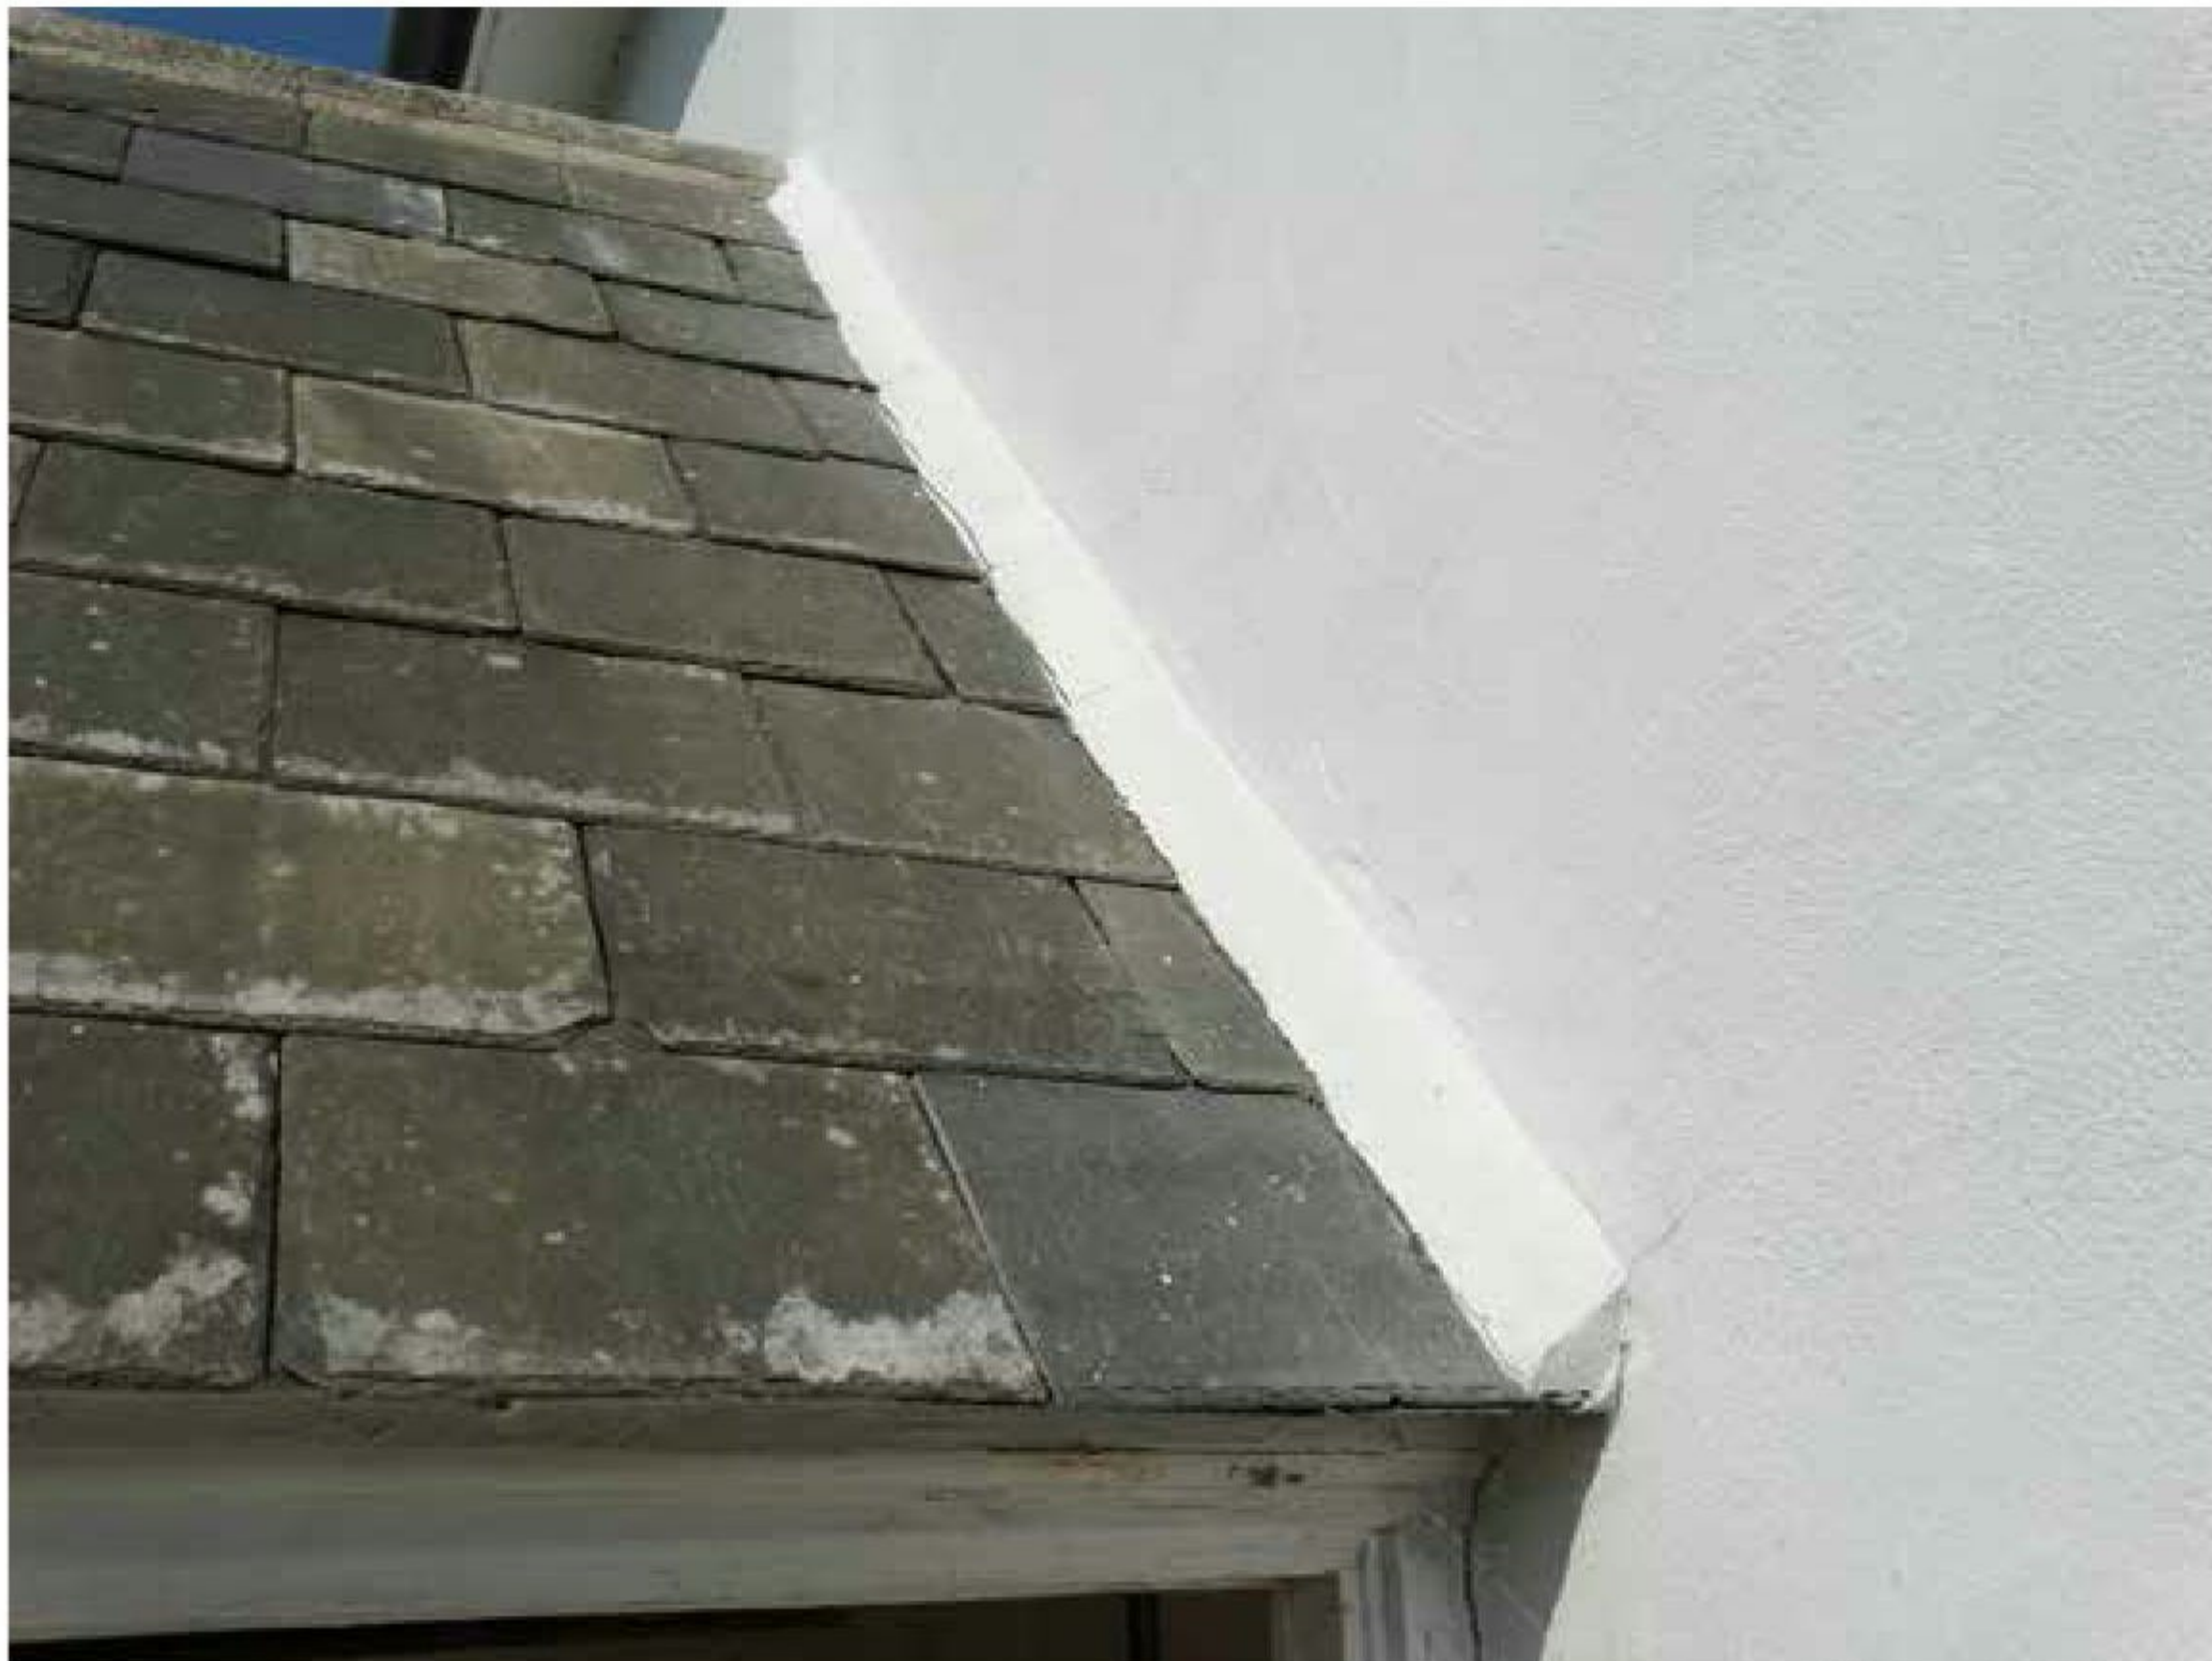
However, the front wall has some low level internal dampness mostly around the front door. When viewing this area, the door reveal is noticeably mottled and there is typical hygroscopic salting and paint disruption from the ceiling junction down.

There is little evidence externally, or internally of an issue due to modern decorative and render materials. The door reveal is, however, lime based. We suspect that the fillet flashing to the porch roof above is allowing a little penetrative dampness into the door head and this is transferring down the wall in this position, evaporating where it can. The fillet looks to be in good visual order, but the area should be checked during wet weather.

The dampness in this position and lower down the wall is hindered by the hard cementitious render which now coats much of the front wall. This material is not usually permitted on listed buildings and is certainly contrary to good practice in building maintenance. Whilst removing it is not always practical, you will have to ensure that the house remains well aired and continue to use evaporative materials inside to allow moisture somewhere to evaporate from the wall.

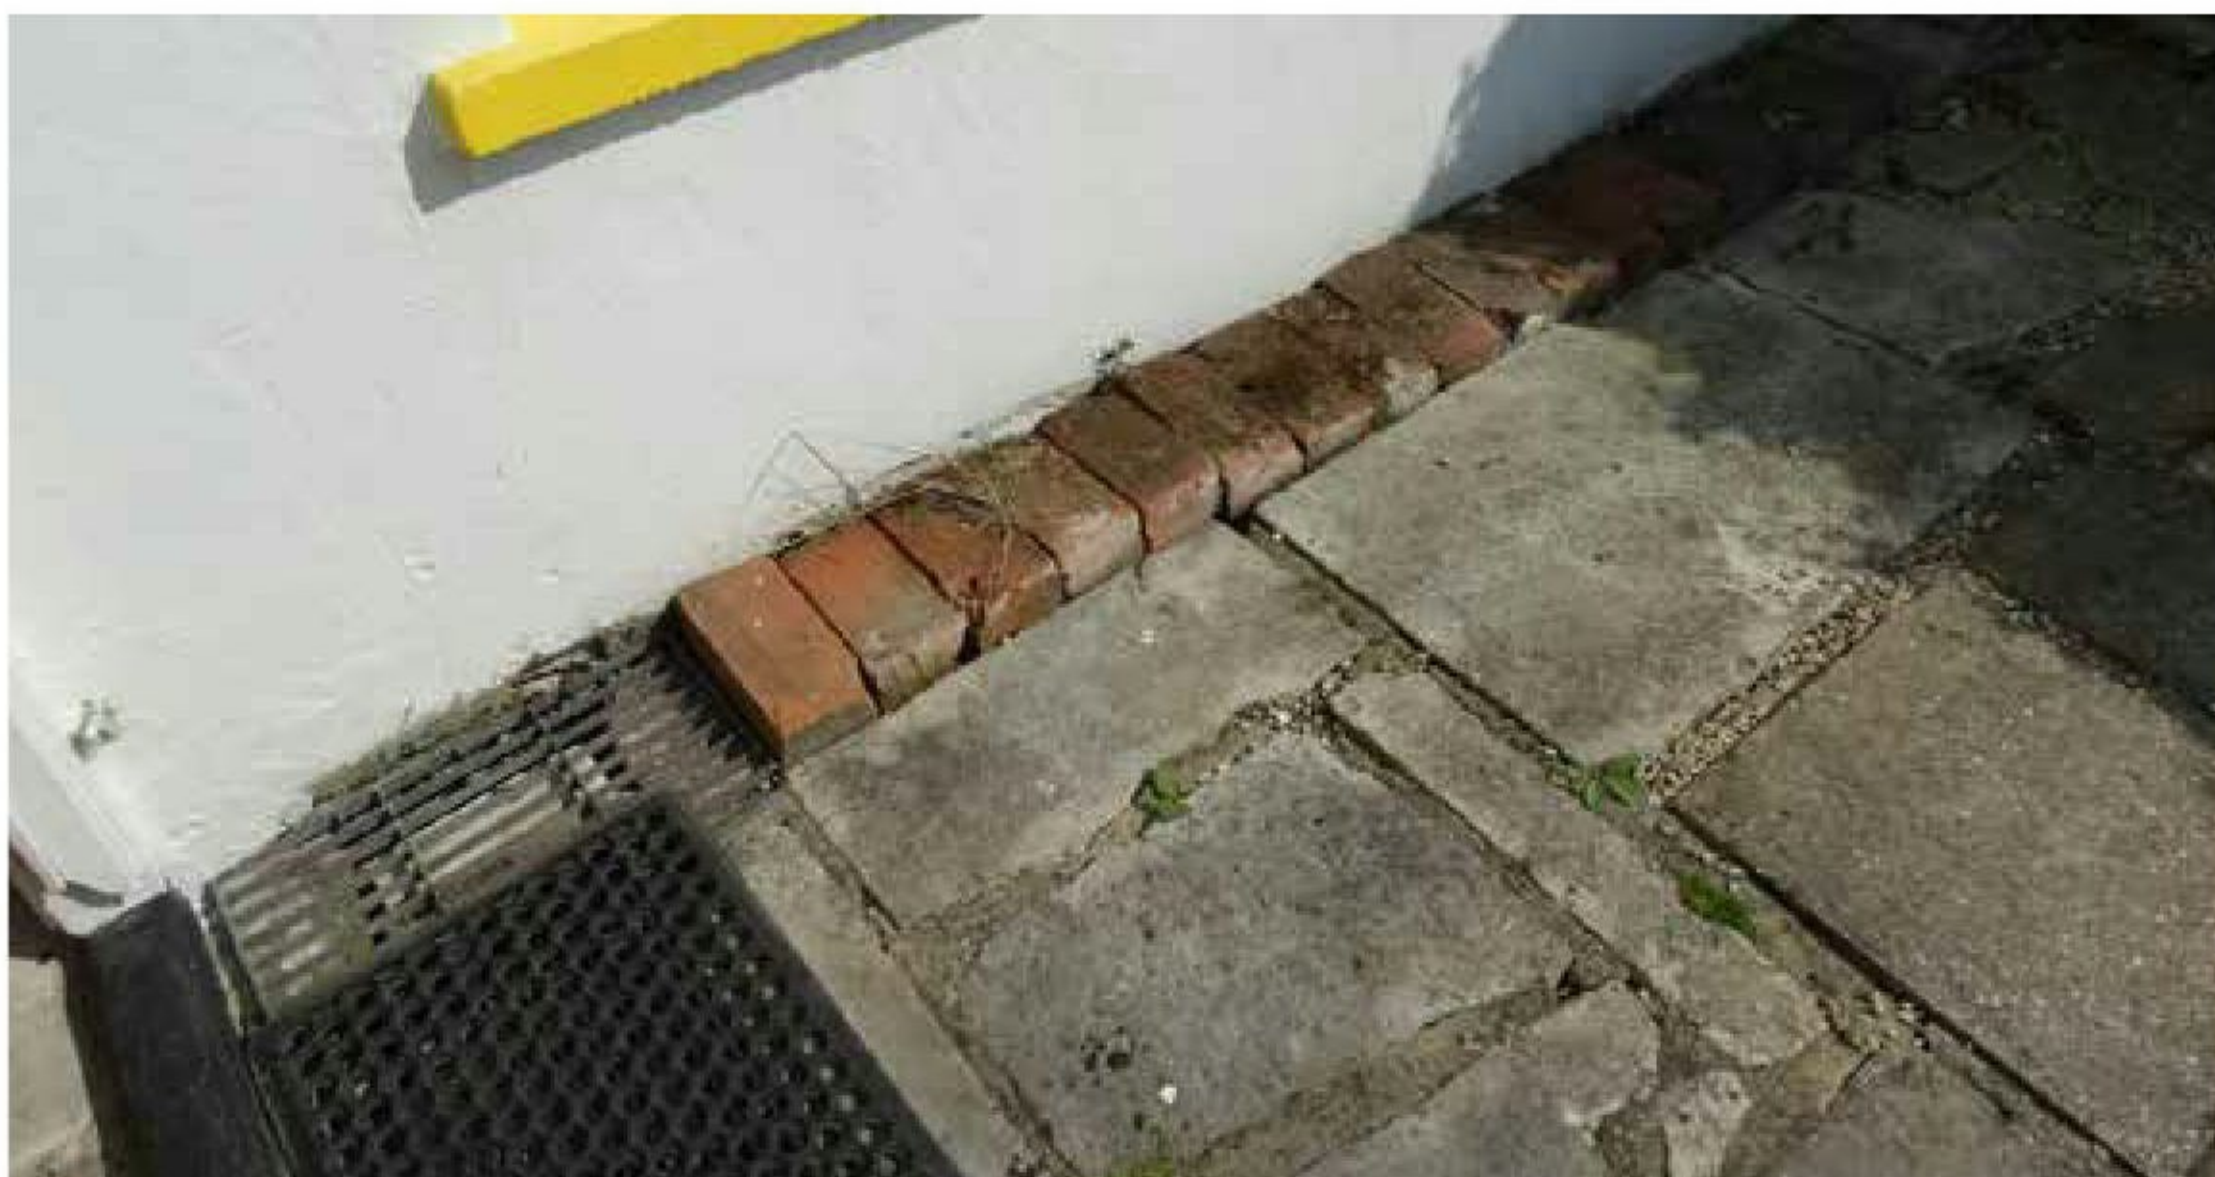
The original part of the property will not likely have any form of damp-proof course (DPC). At the front, the ground level has been kept moderately low, but it is still probably 150-200mm higher than when the house was built (as evidenced by the single air brick visible). A small channel has been dug at the foot of the wall to try and control moisture against the wall.

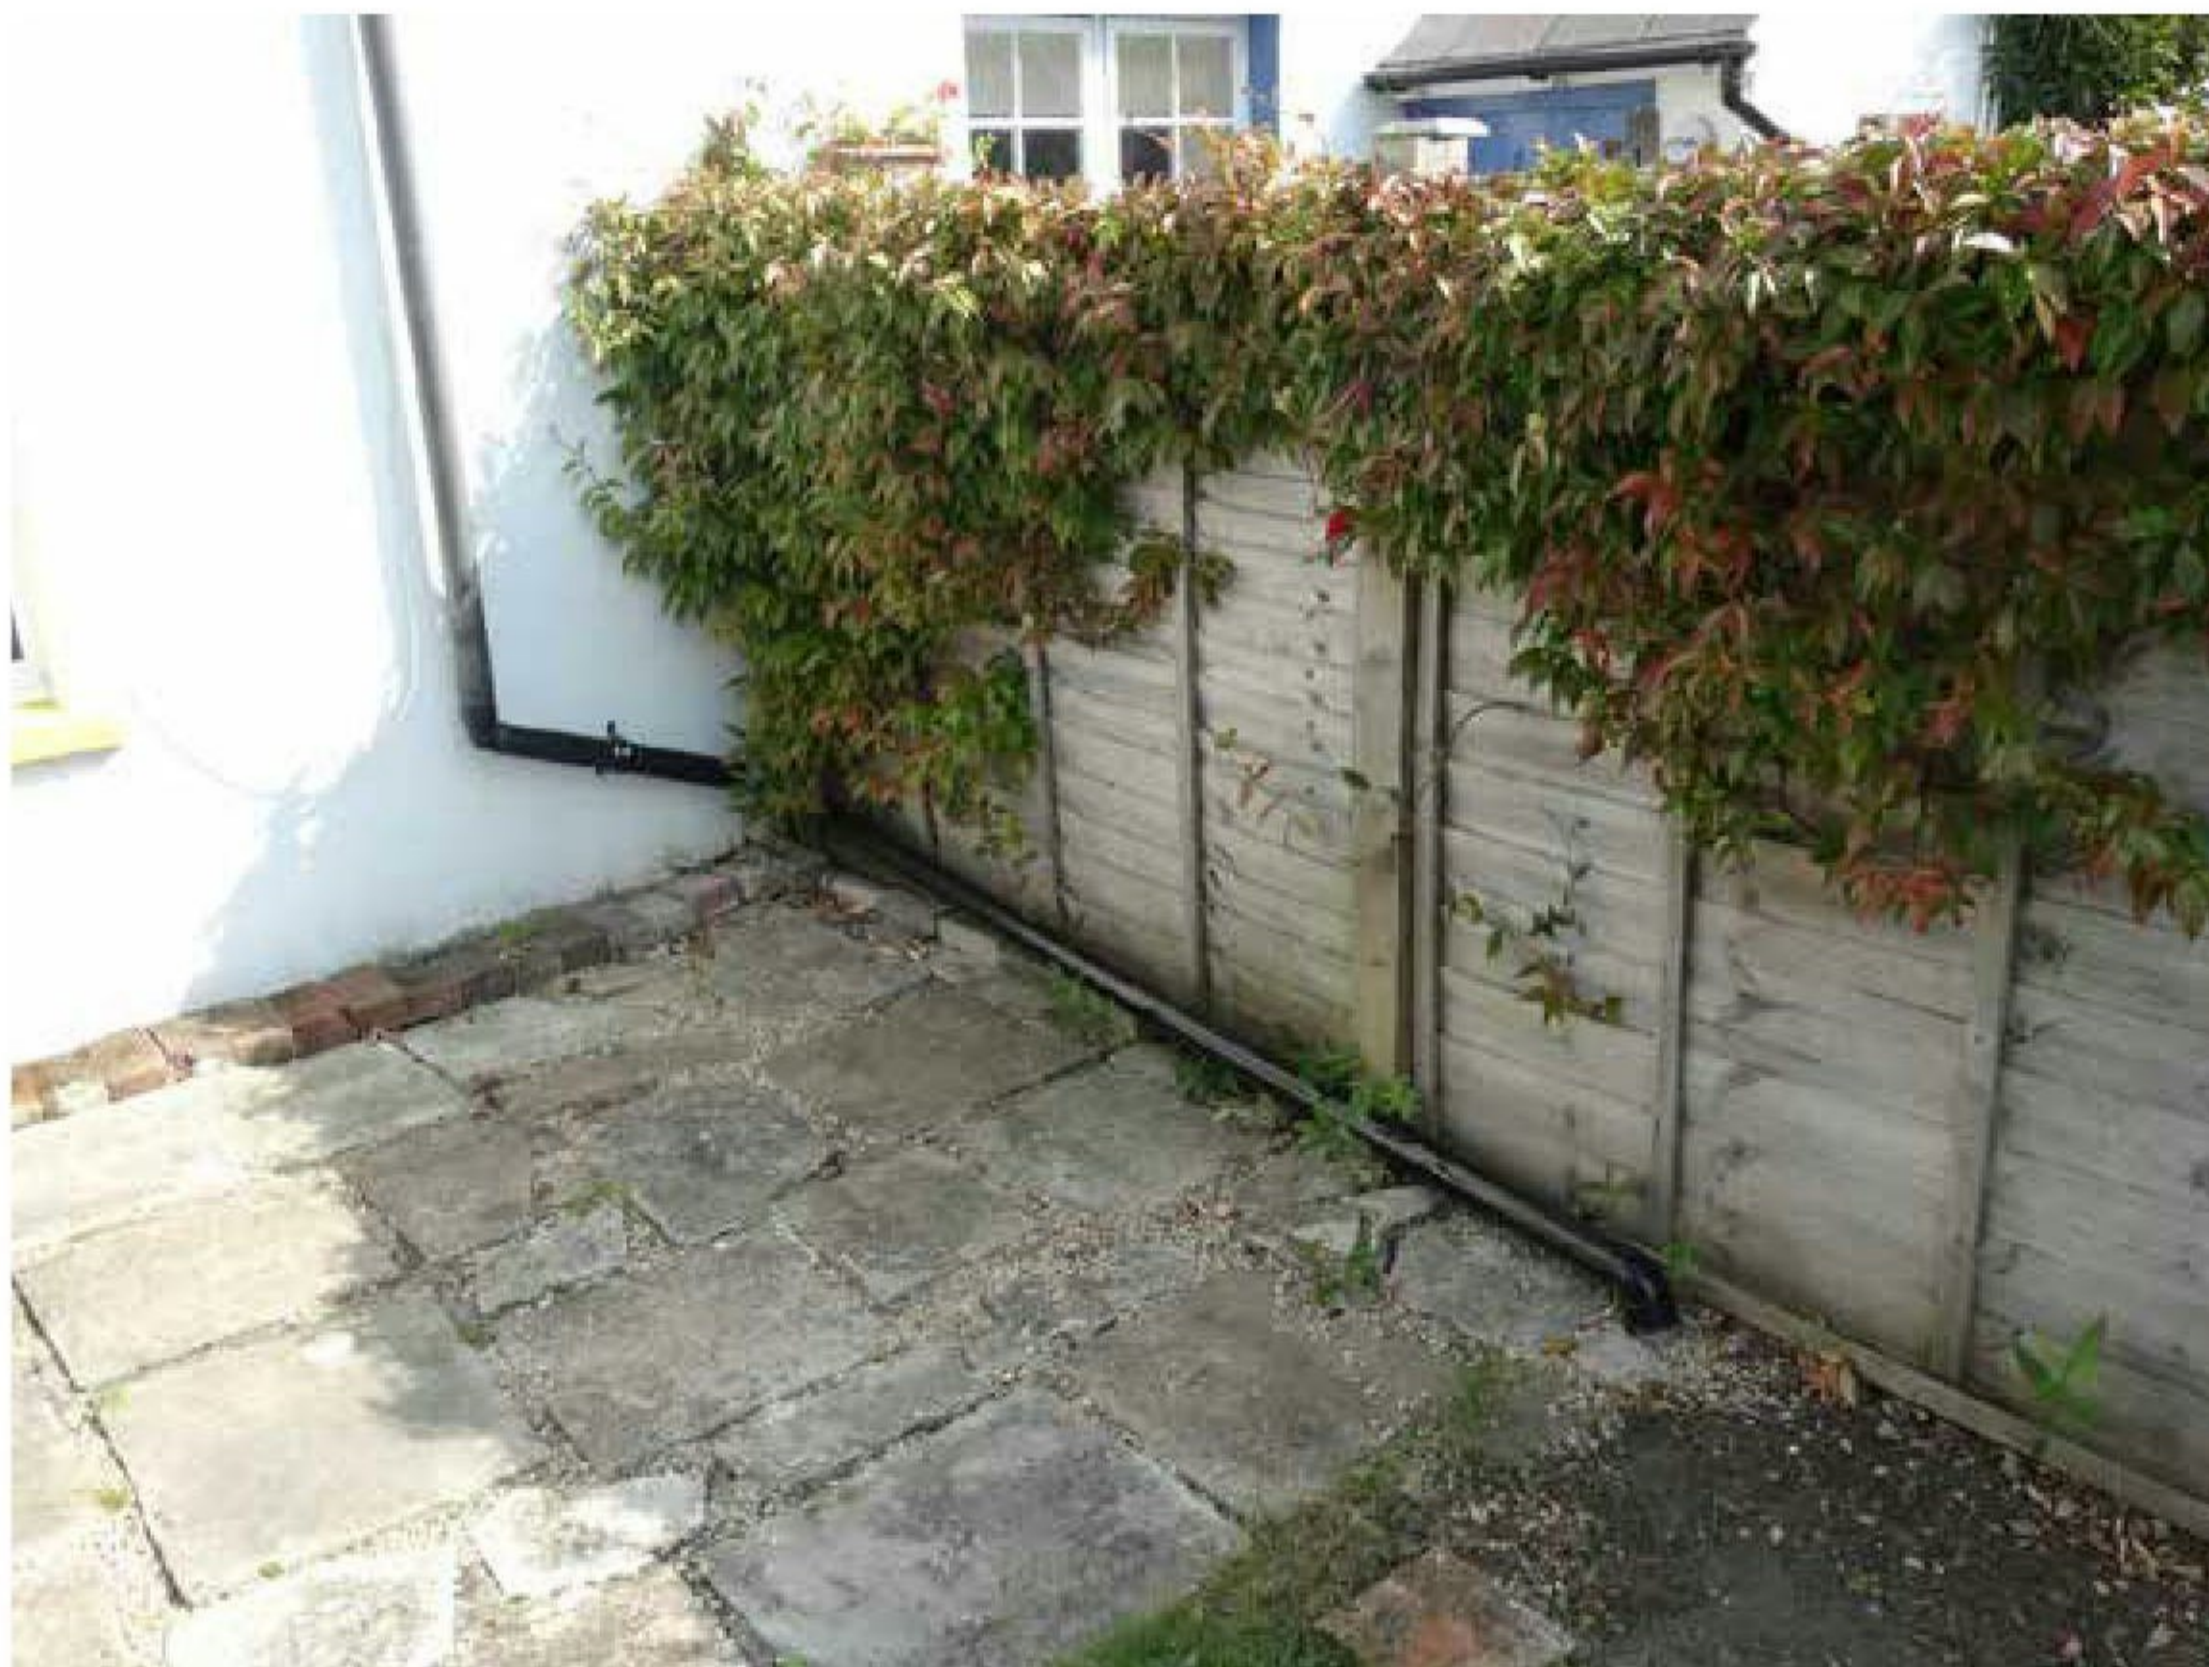
Also, there has been a rather sensible choice to route the rainwater discharge downpipe well away from the foot of the wall, which assists both with the known ground conditions and also the potential for dampness at the base of the wall.
