Desbruslais
Chartered Surveyors

BUILDING SURVEY OF

3 Coastguard Cottages
Snowhill
West Wittering
Chichester
PO20 8AT

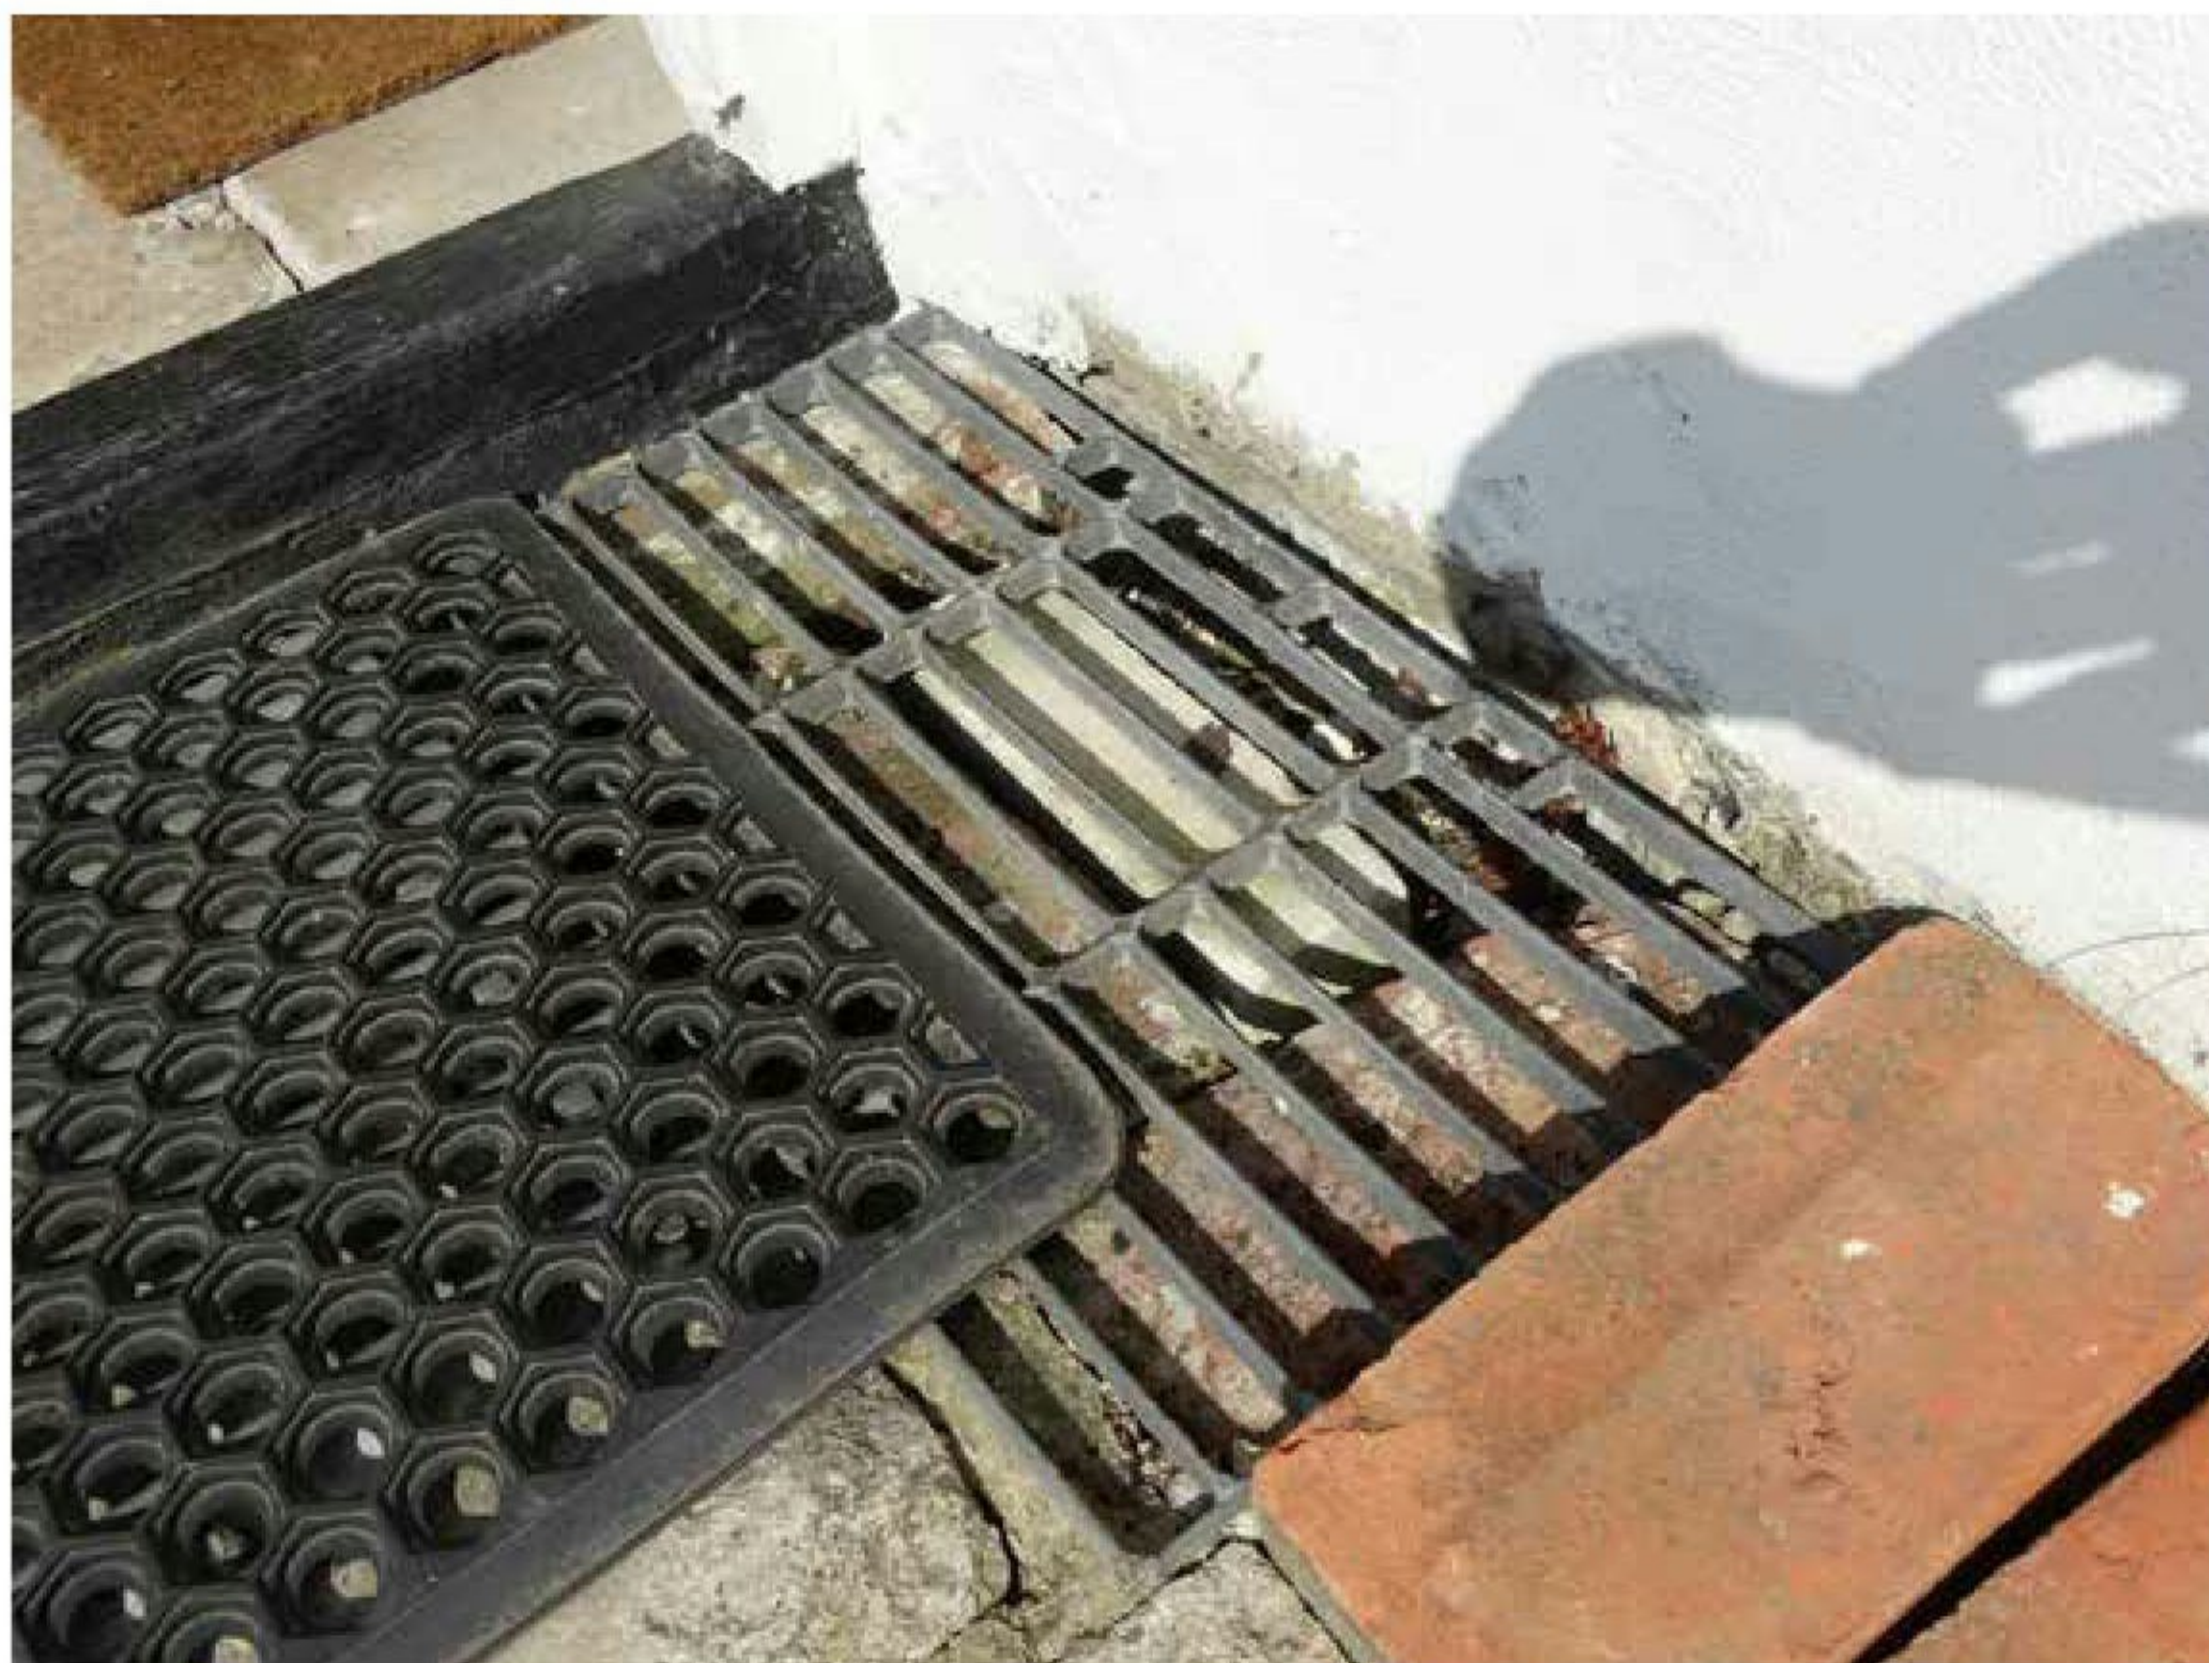
The single air brick is indicative of the floor construction in the front room.

It is a little blocked and obscured and is the single point of air entry to the sub floor.

Dampness and poor ventilation can cause decay in timber floors. The floor is reasonably firm underfoot but certain assurances on the condition cannot be given until the structure is exposed. The risk of a major defect is considered small but a provision for patching would be advisable and in the meantime, additional ventilation is strongly recommended.

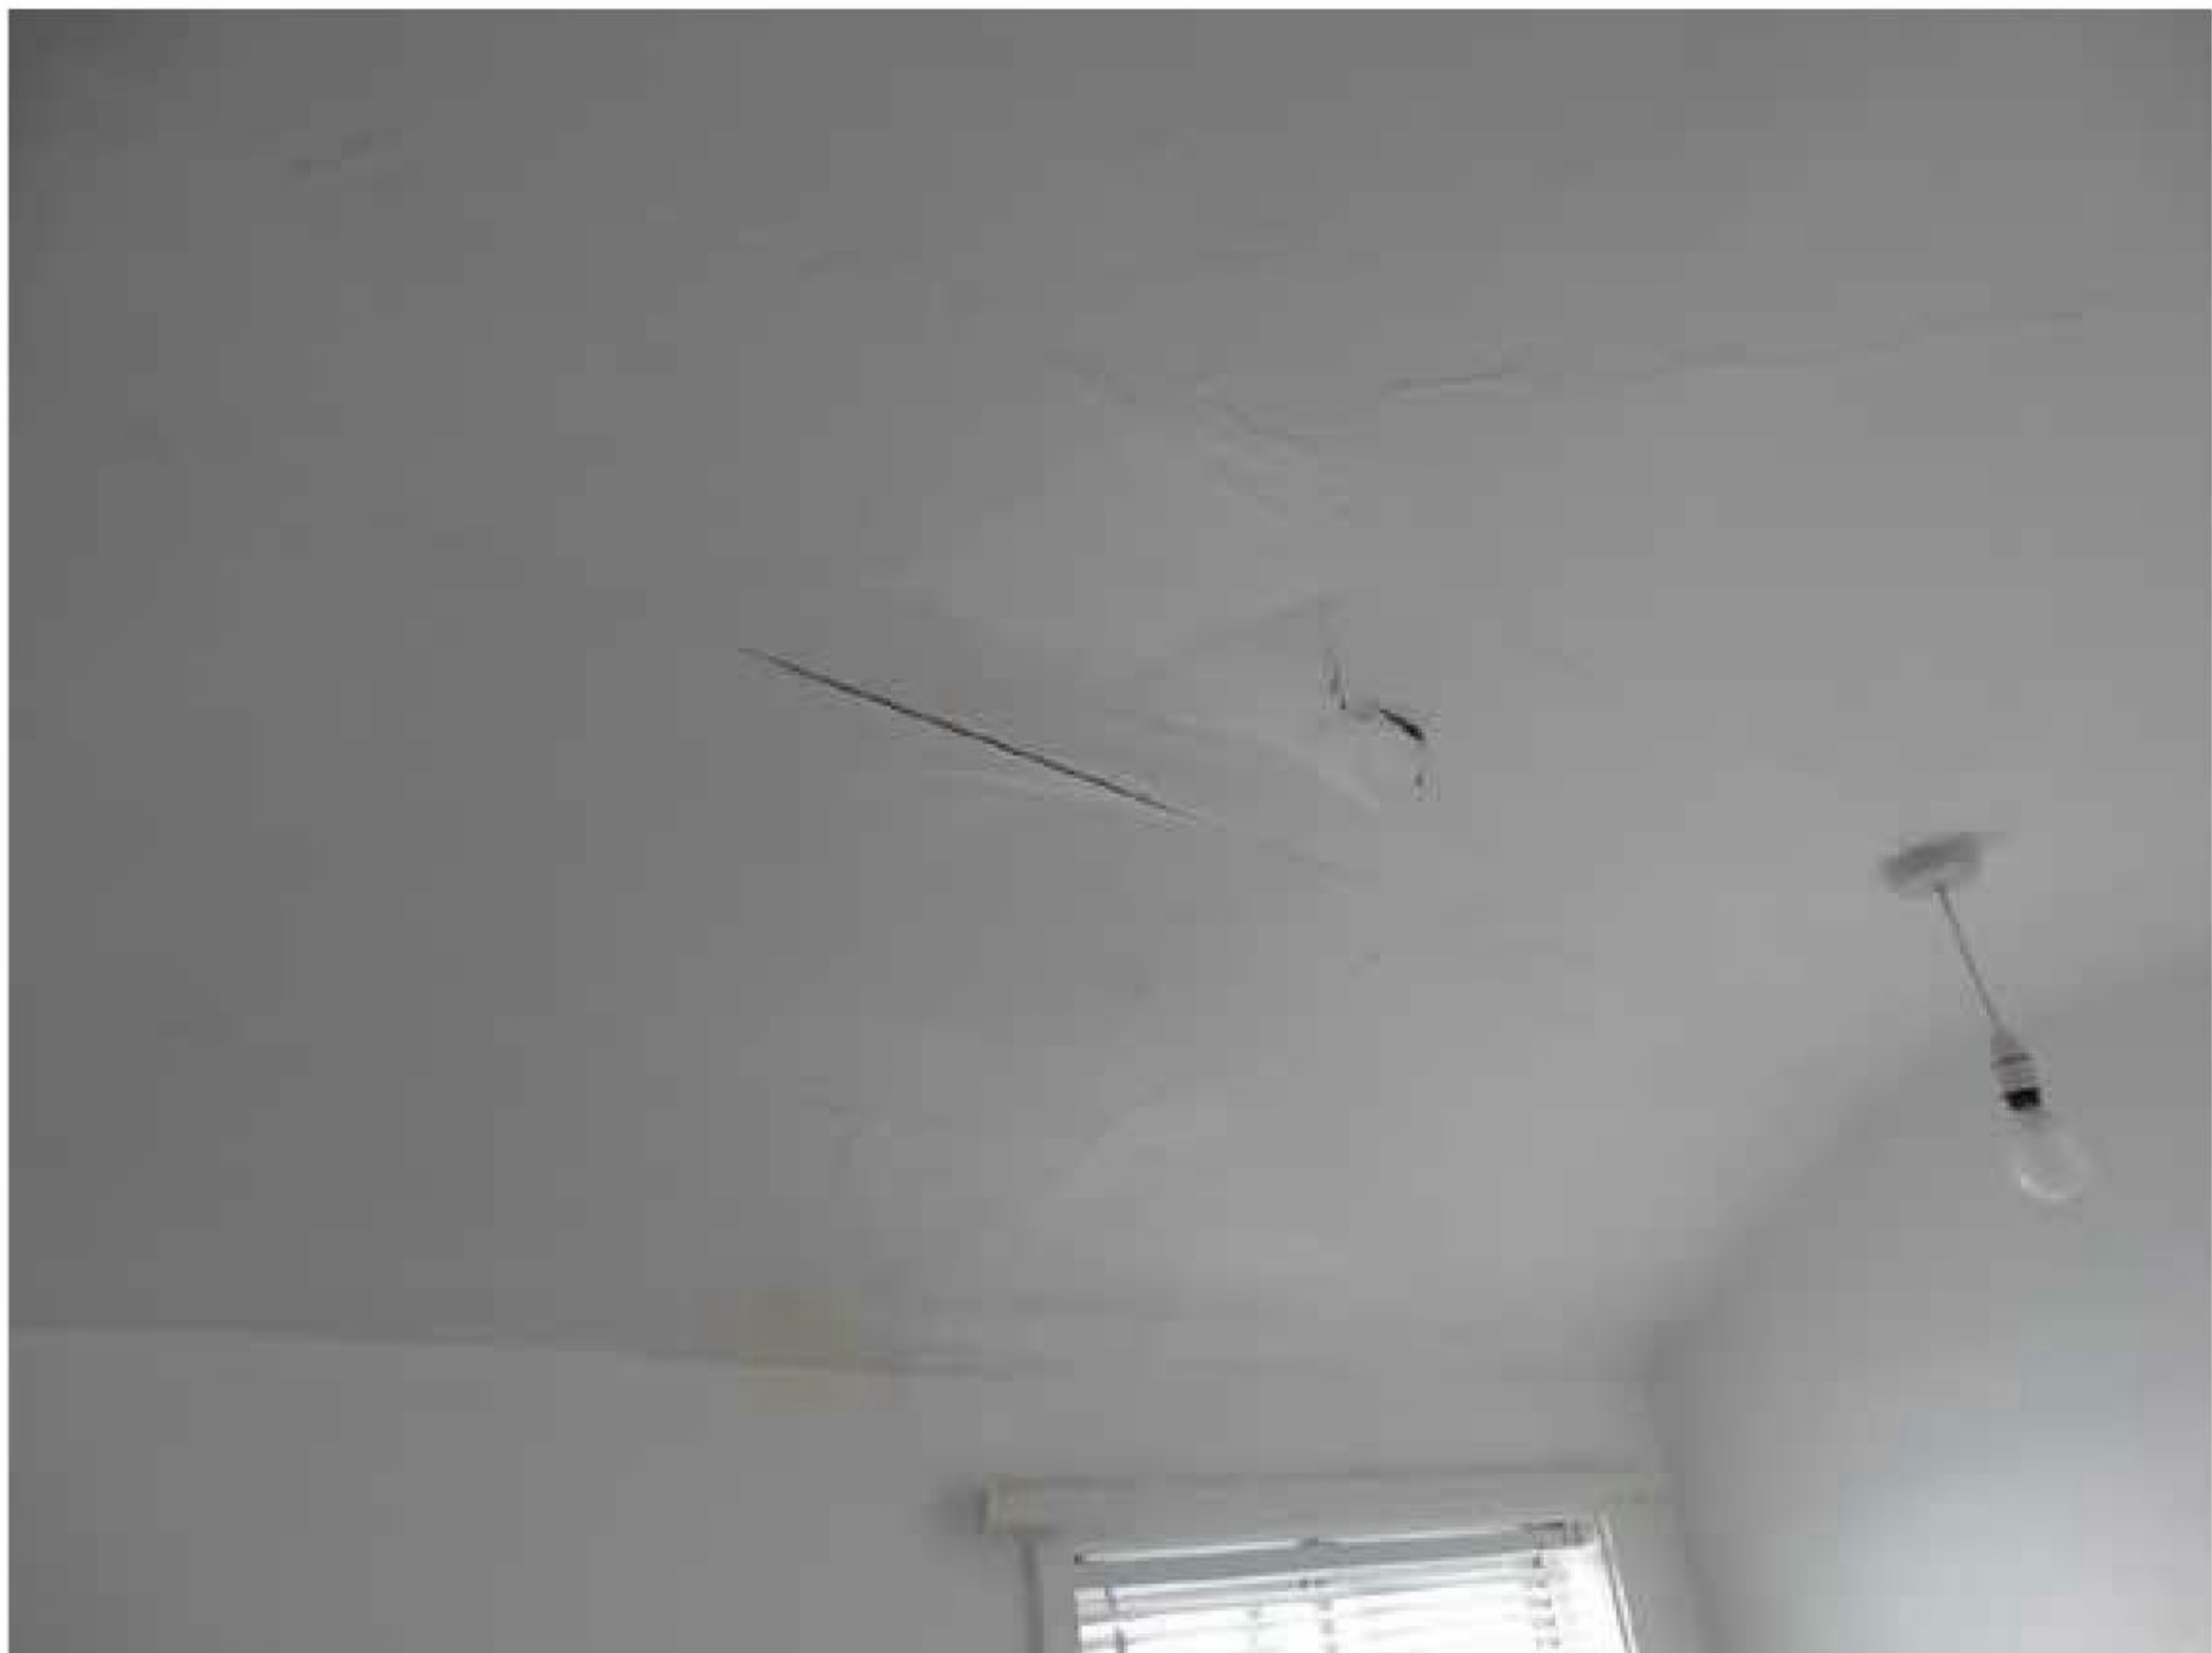
There was a historic roof leak affecting decoration in the back bedroom. The leak has been addressed, but the decorative repair remains unaddressed.

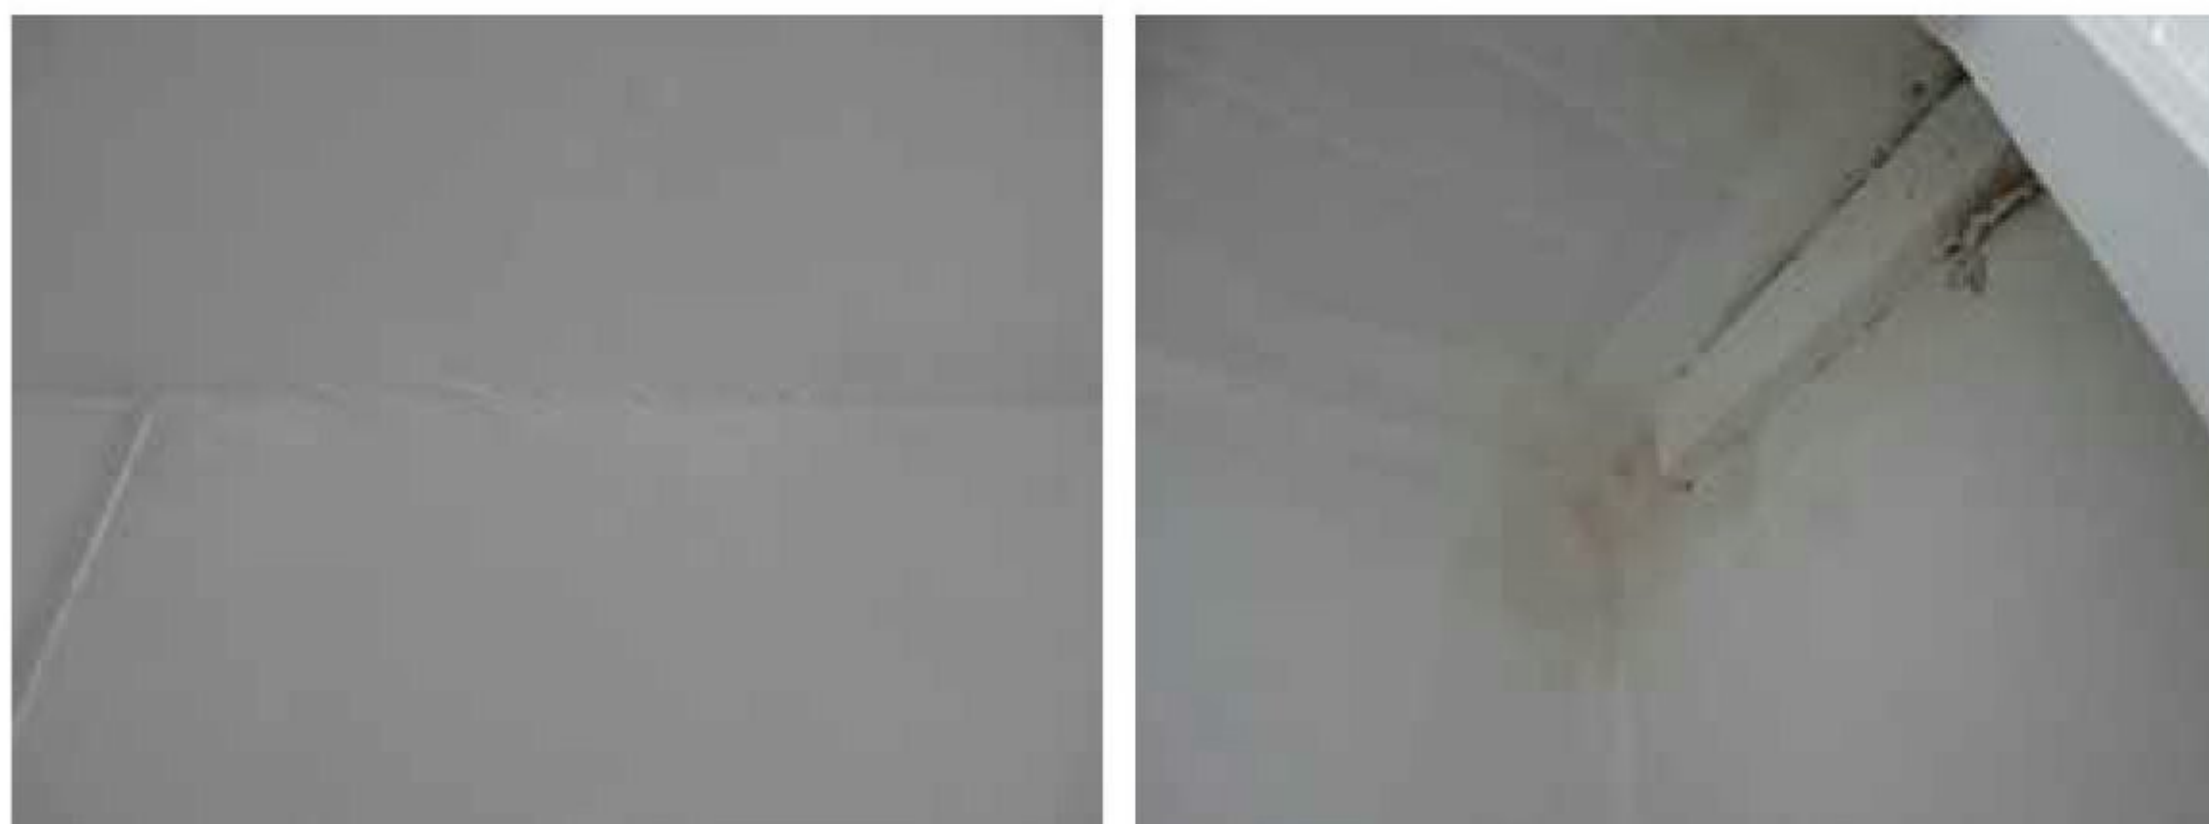
There is also a small amount of penetration around the top of the first floor chimney breast.

This will very likely be related to seepage from around the flashing detail, or leaks from the flaunching. As the internal area within the loft void was clad in this position little can be ascertained from inside. If the situation persists, you will need to gain access within the void and external access close to the chimney stack to investigate the matter further.

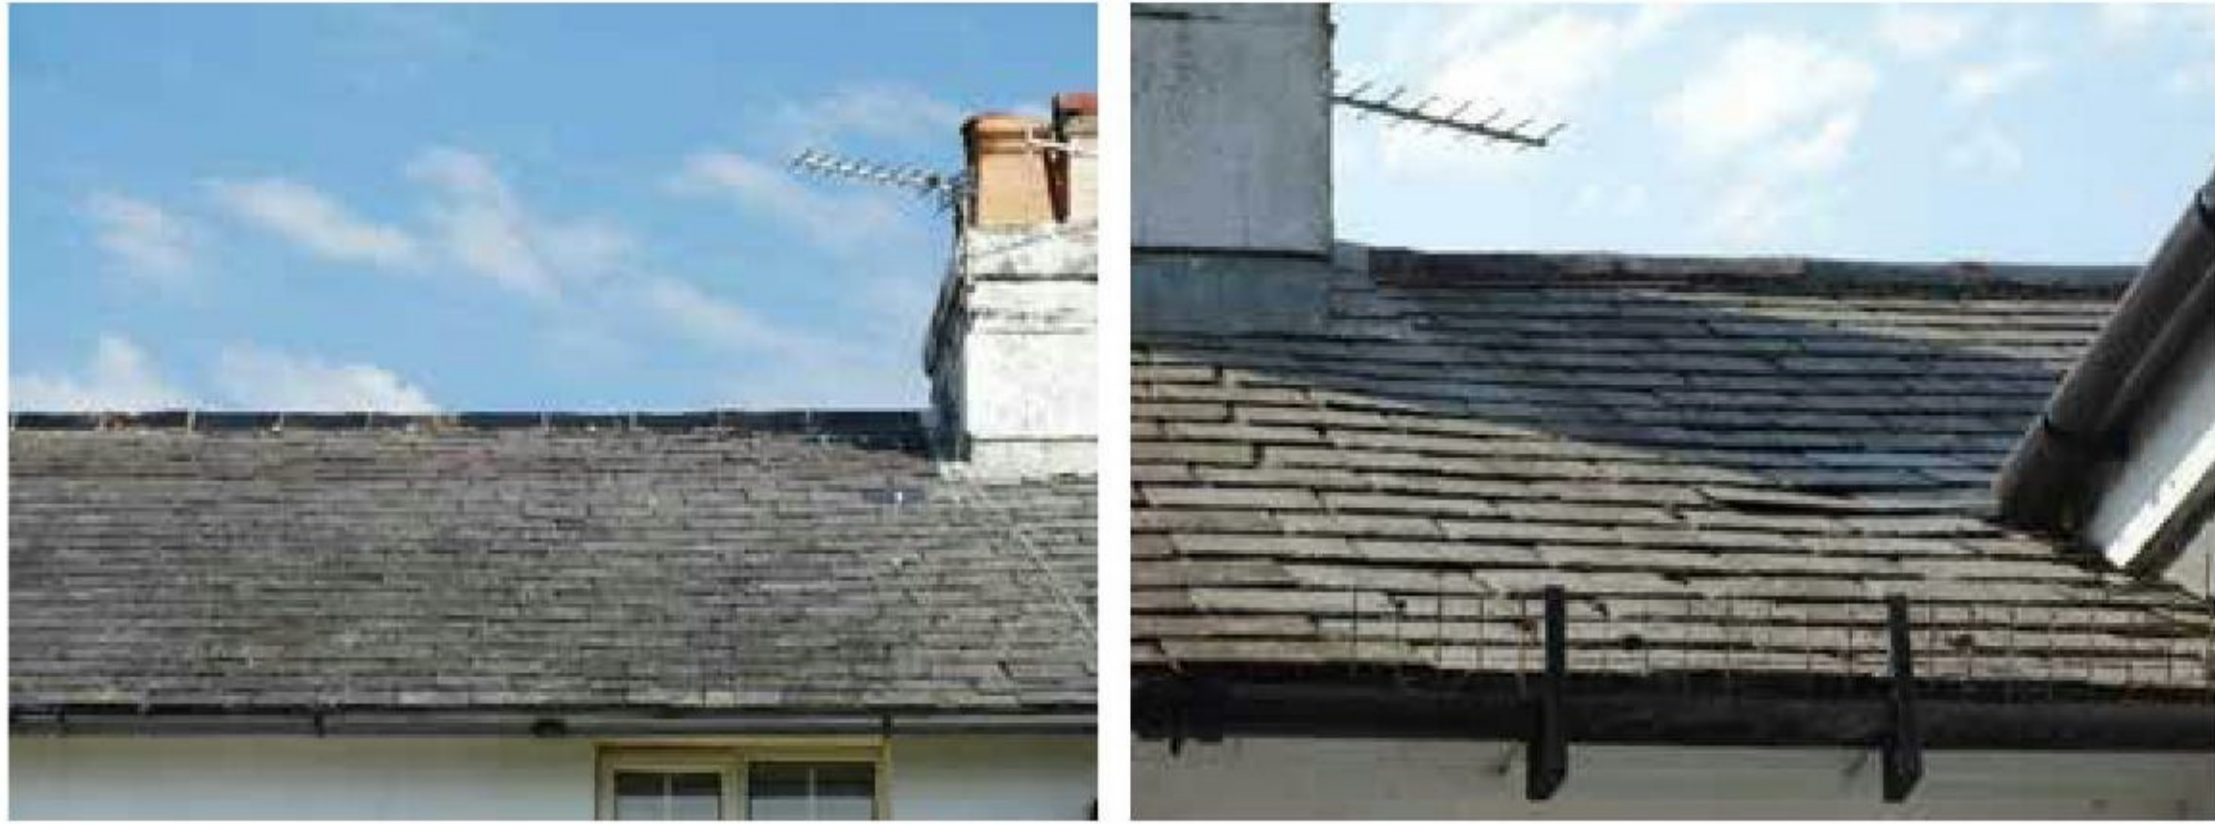
The main roof is covered in natural slate.

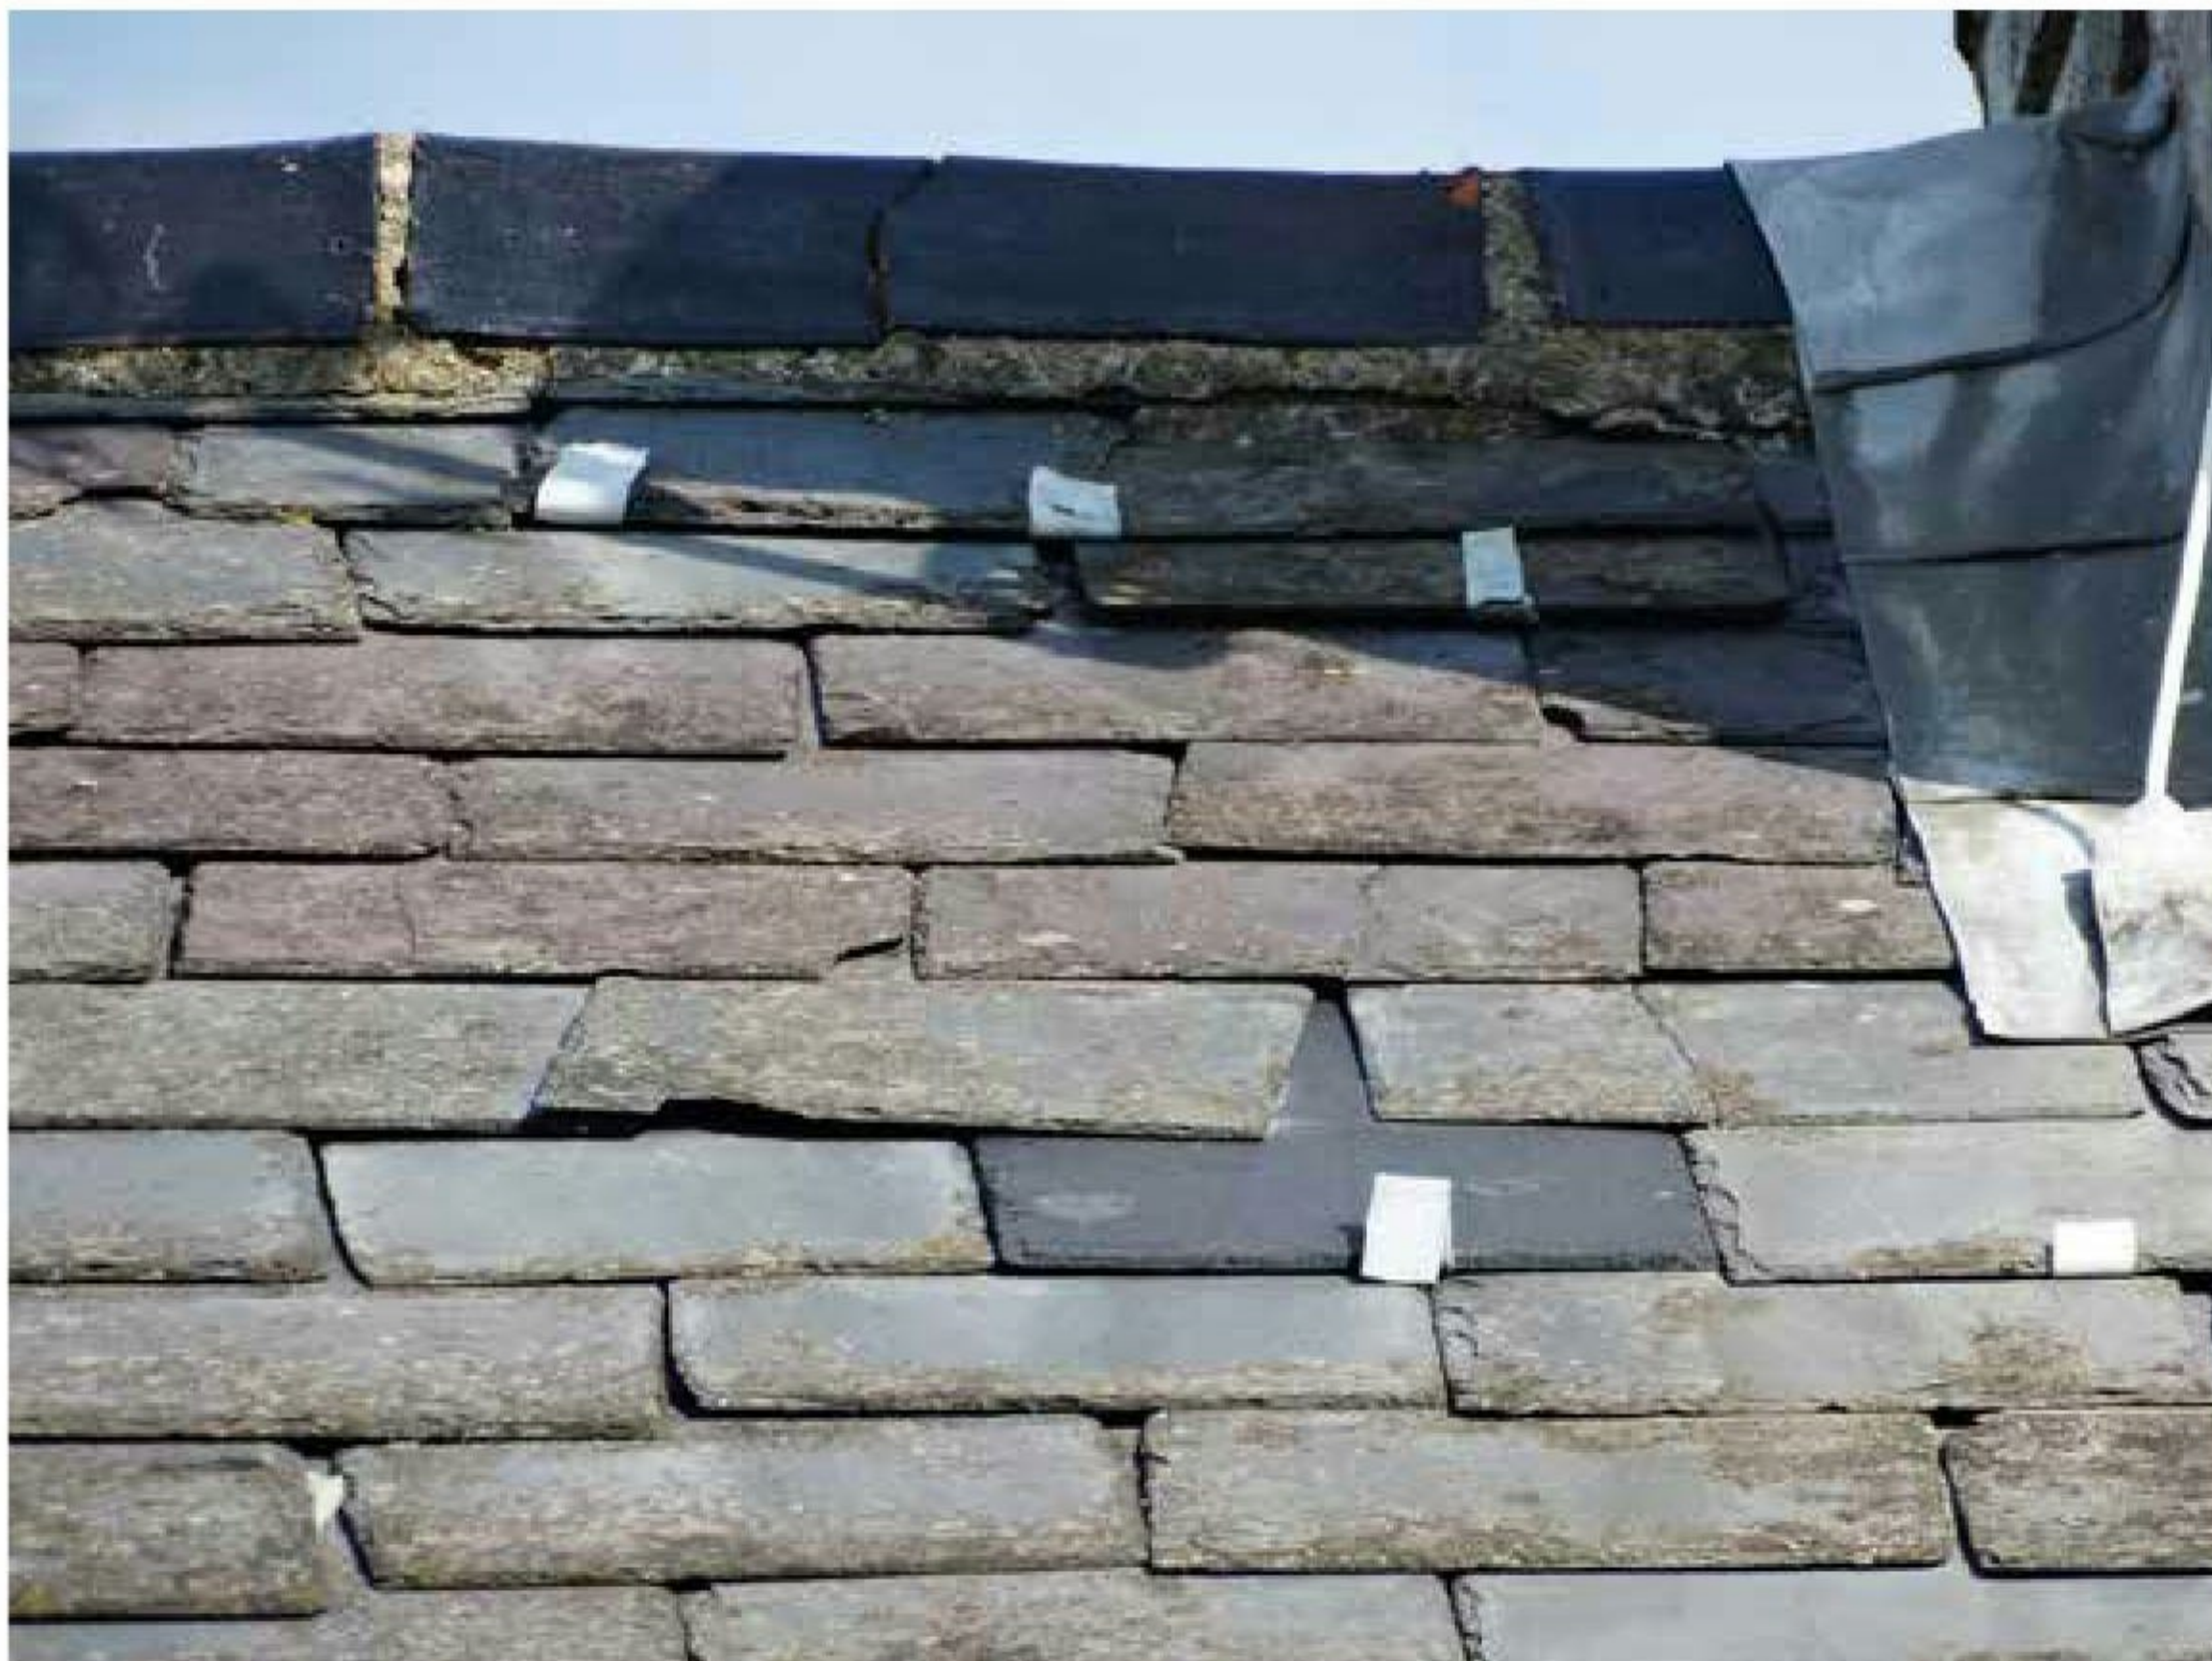
The condition is fair, but with signs of a number of past repairs (below) which are now somewhat poorly clipped with loose tingles (the clips holding the re-inserted slates in place).

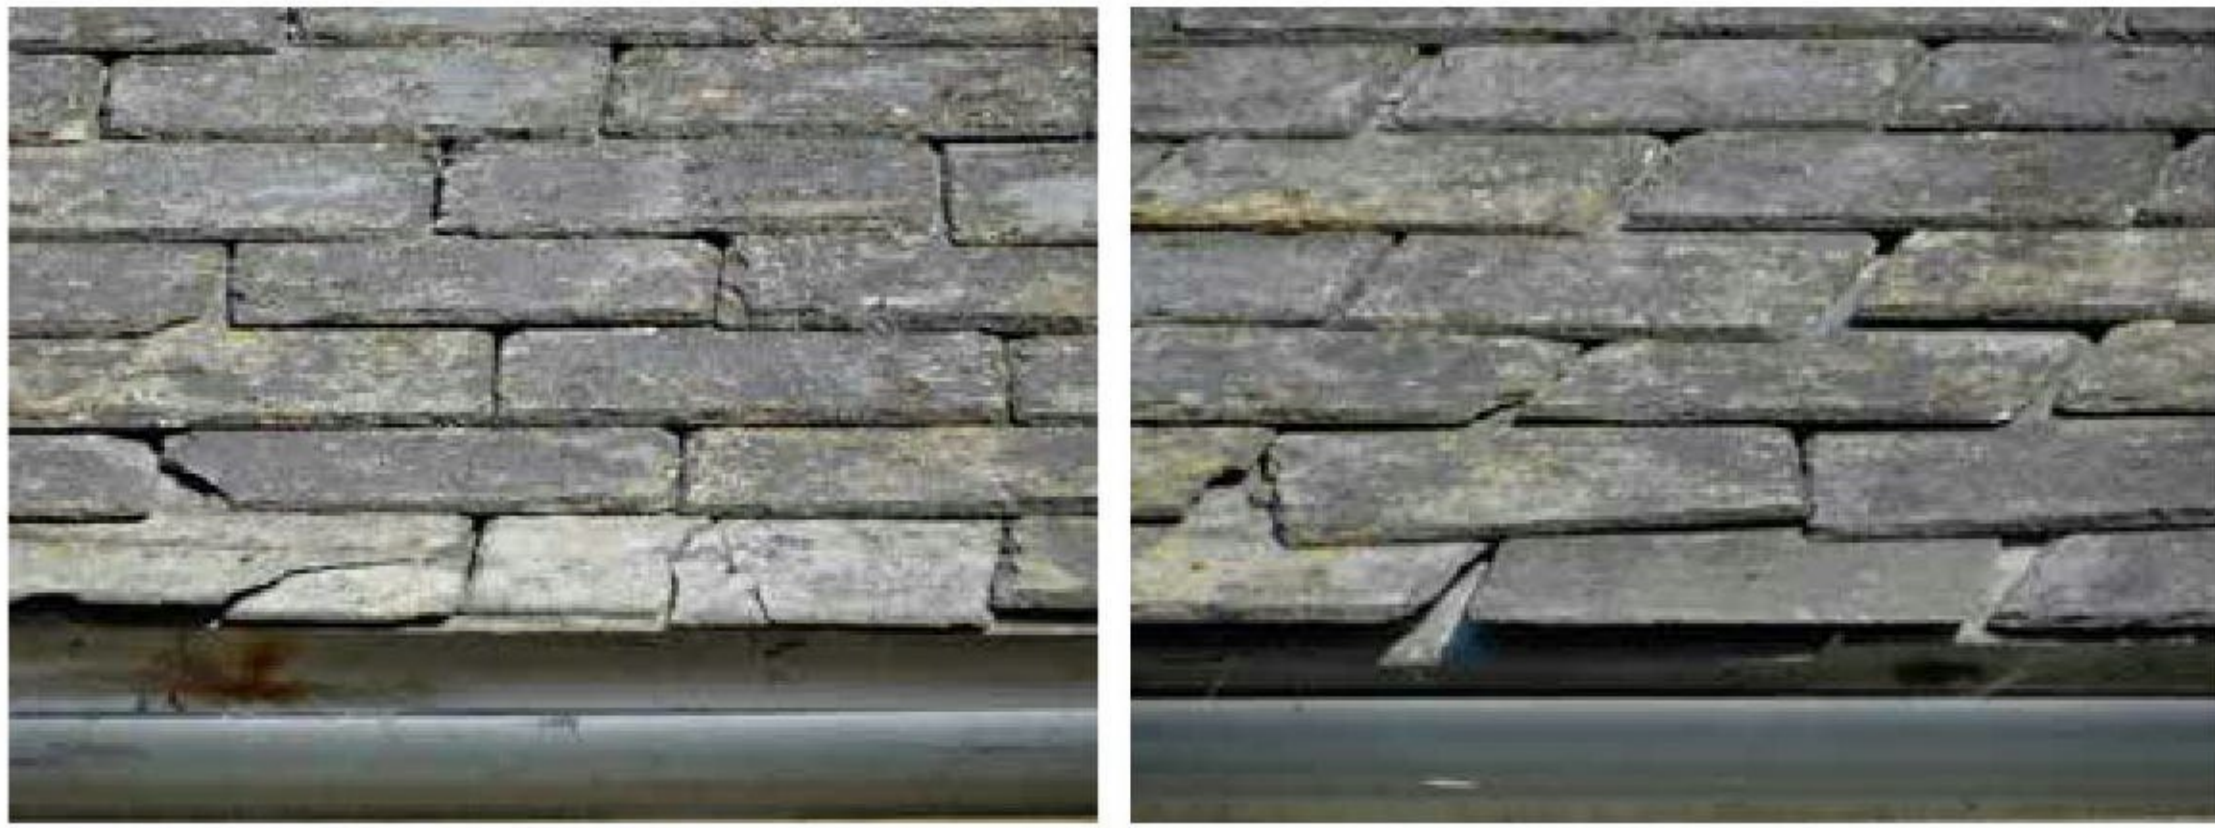
The lower eaves also have evidence of moderately severe wind damage, with disrupted slates and shattered examples along the eaves.

The roof does not require wholesale replacement, although the cladding and sarking does disguise the condition of the nails in this instance which can, in coastal areas, suffer from a little nail sickness/corrosion.

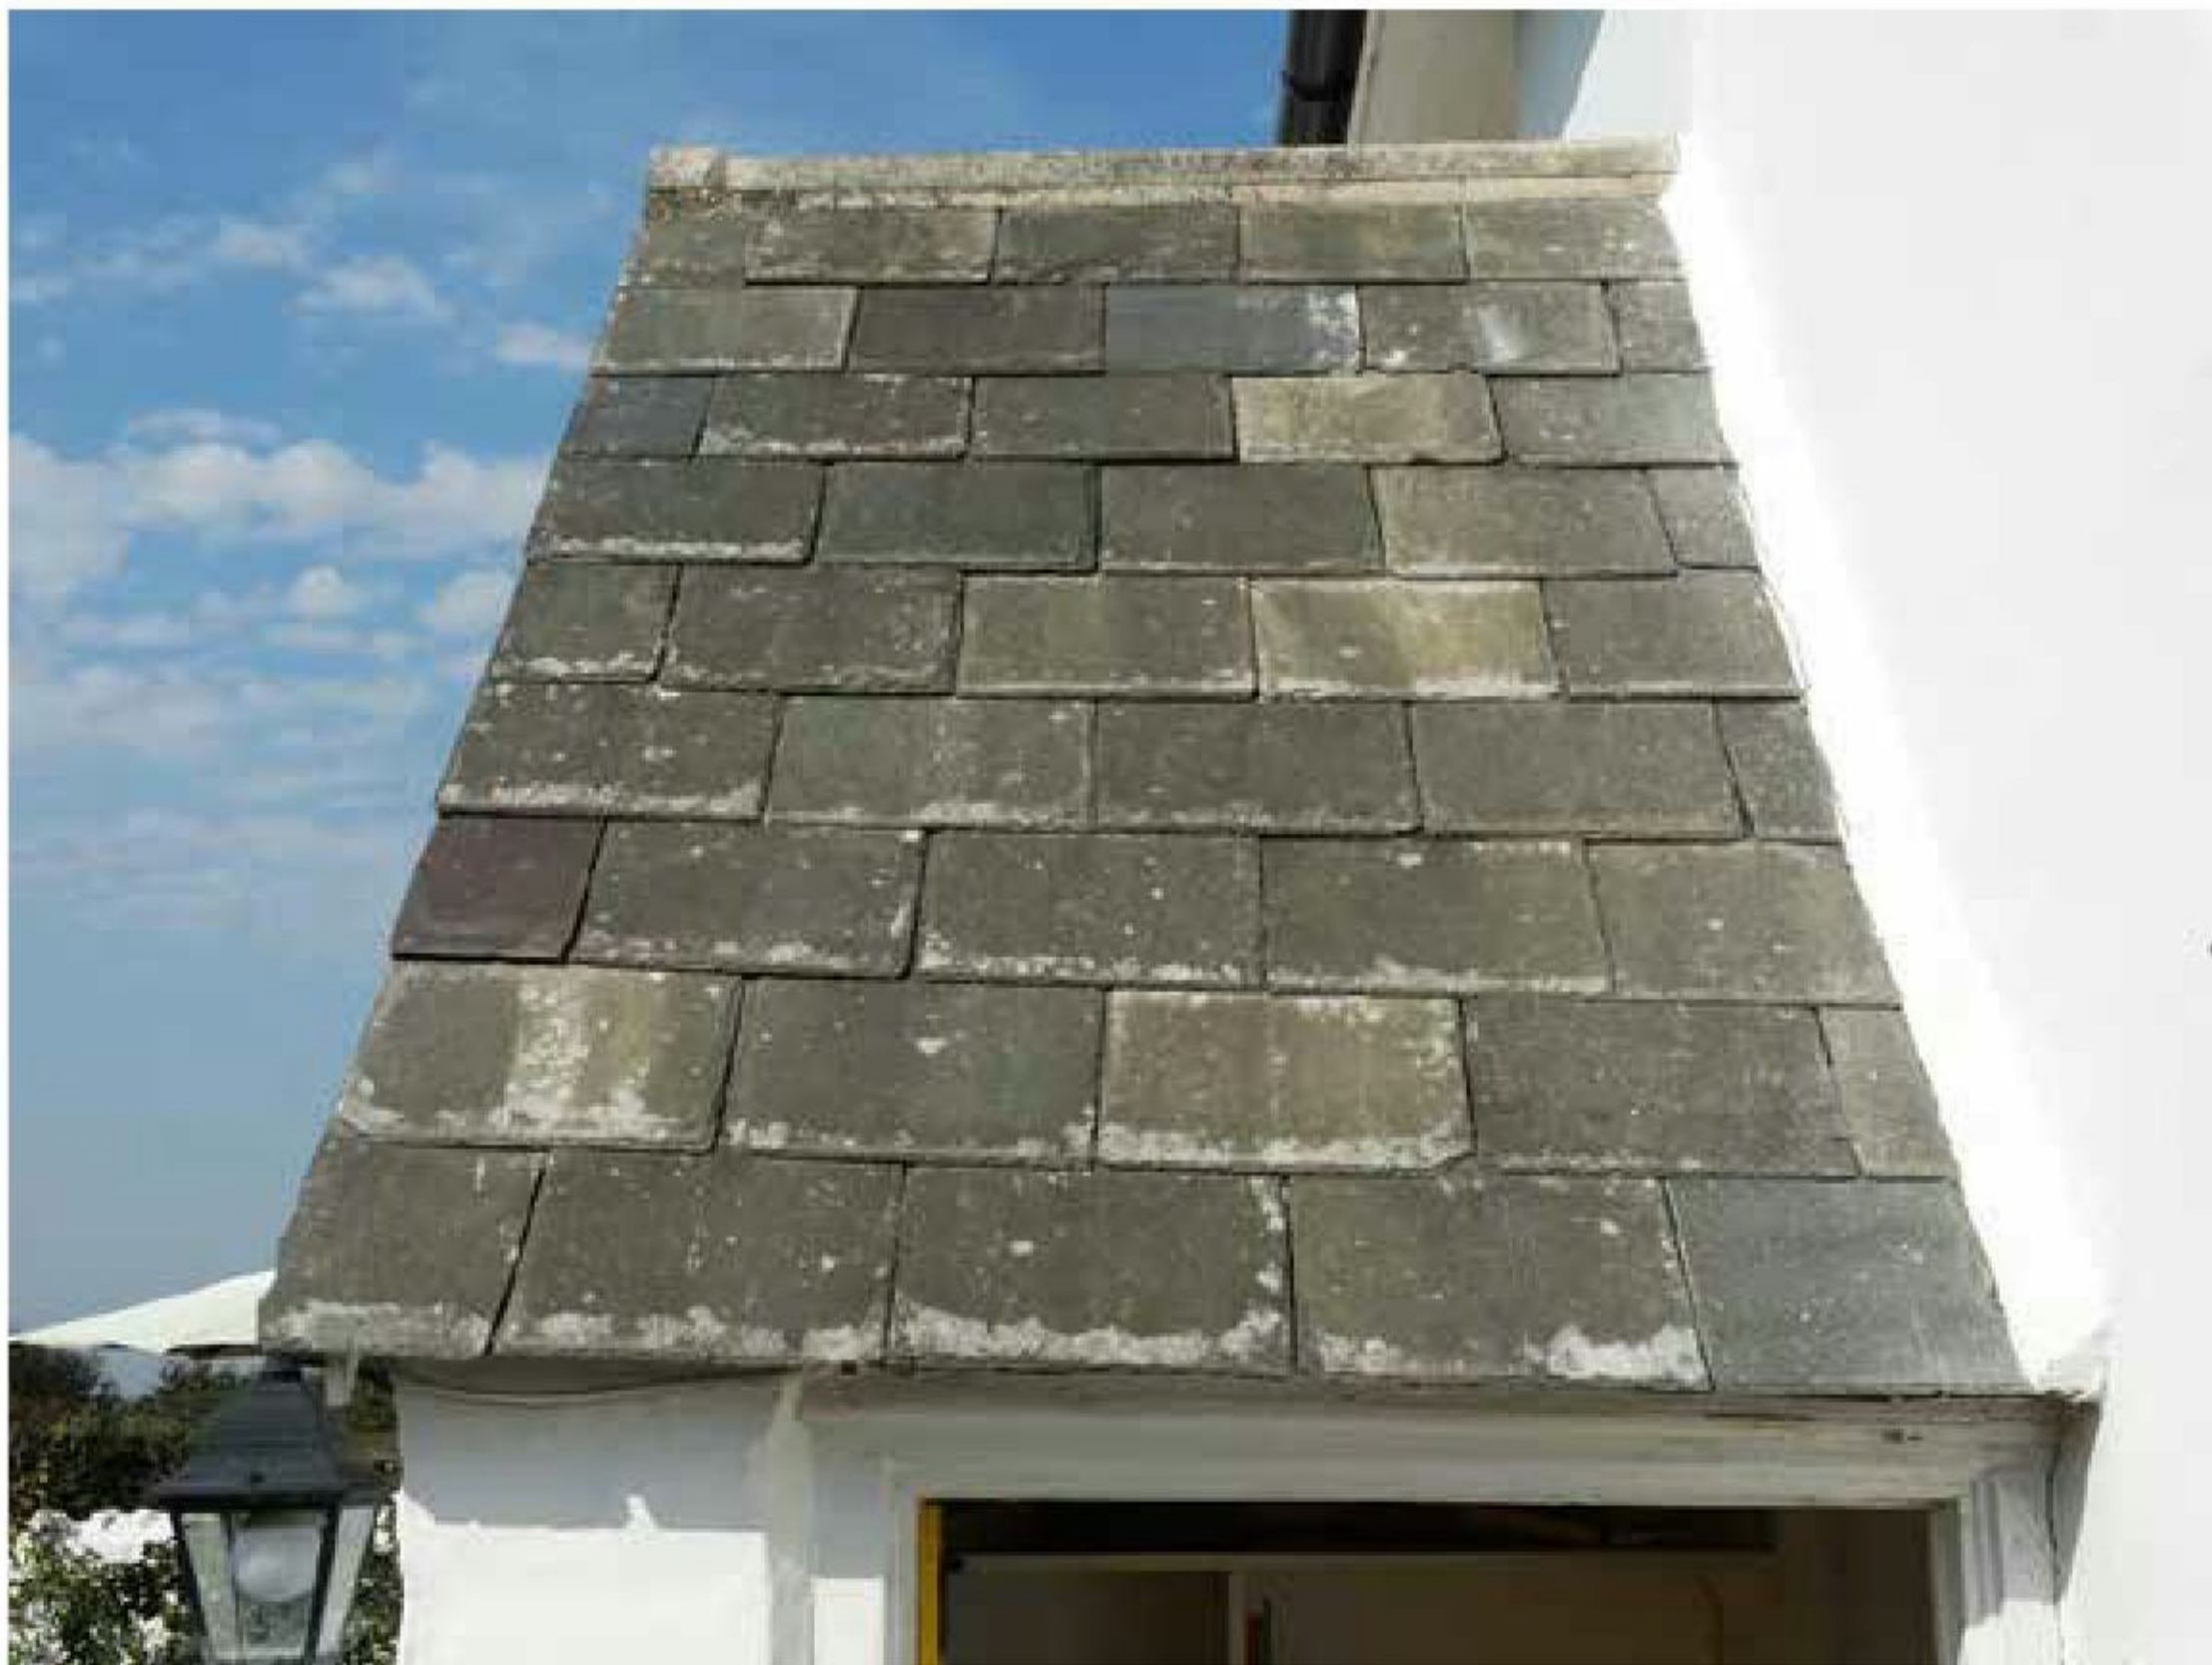
The porch roof is also slated and remains in acceptable condition.
