Desbruslais
Chartered Surveyors

BUILDING SURVEY OF

3 Coastguard Cottages
Snowhill
West Wittering
Chichester
PO20 8AT

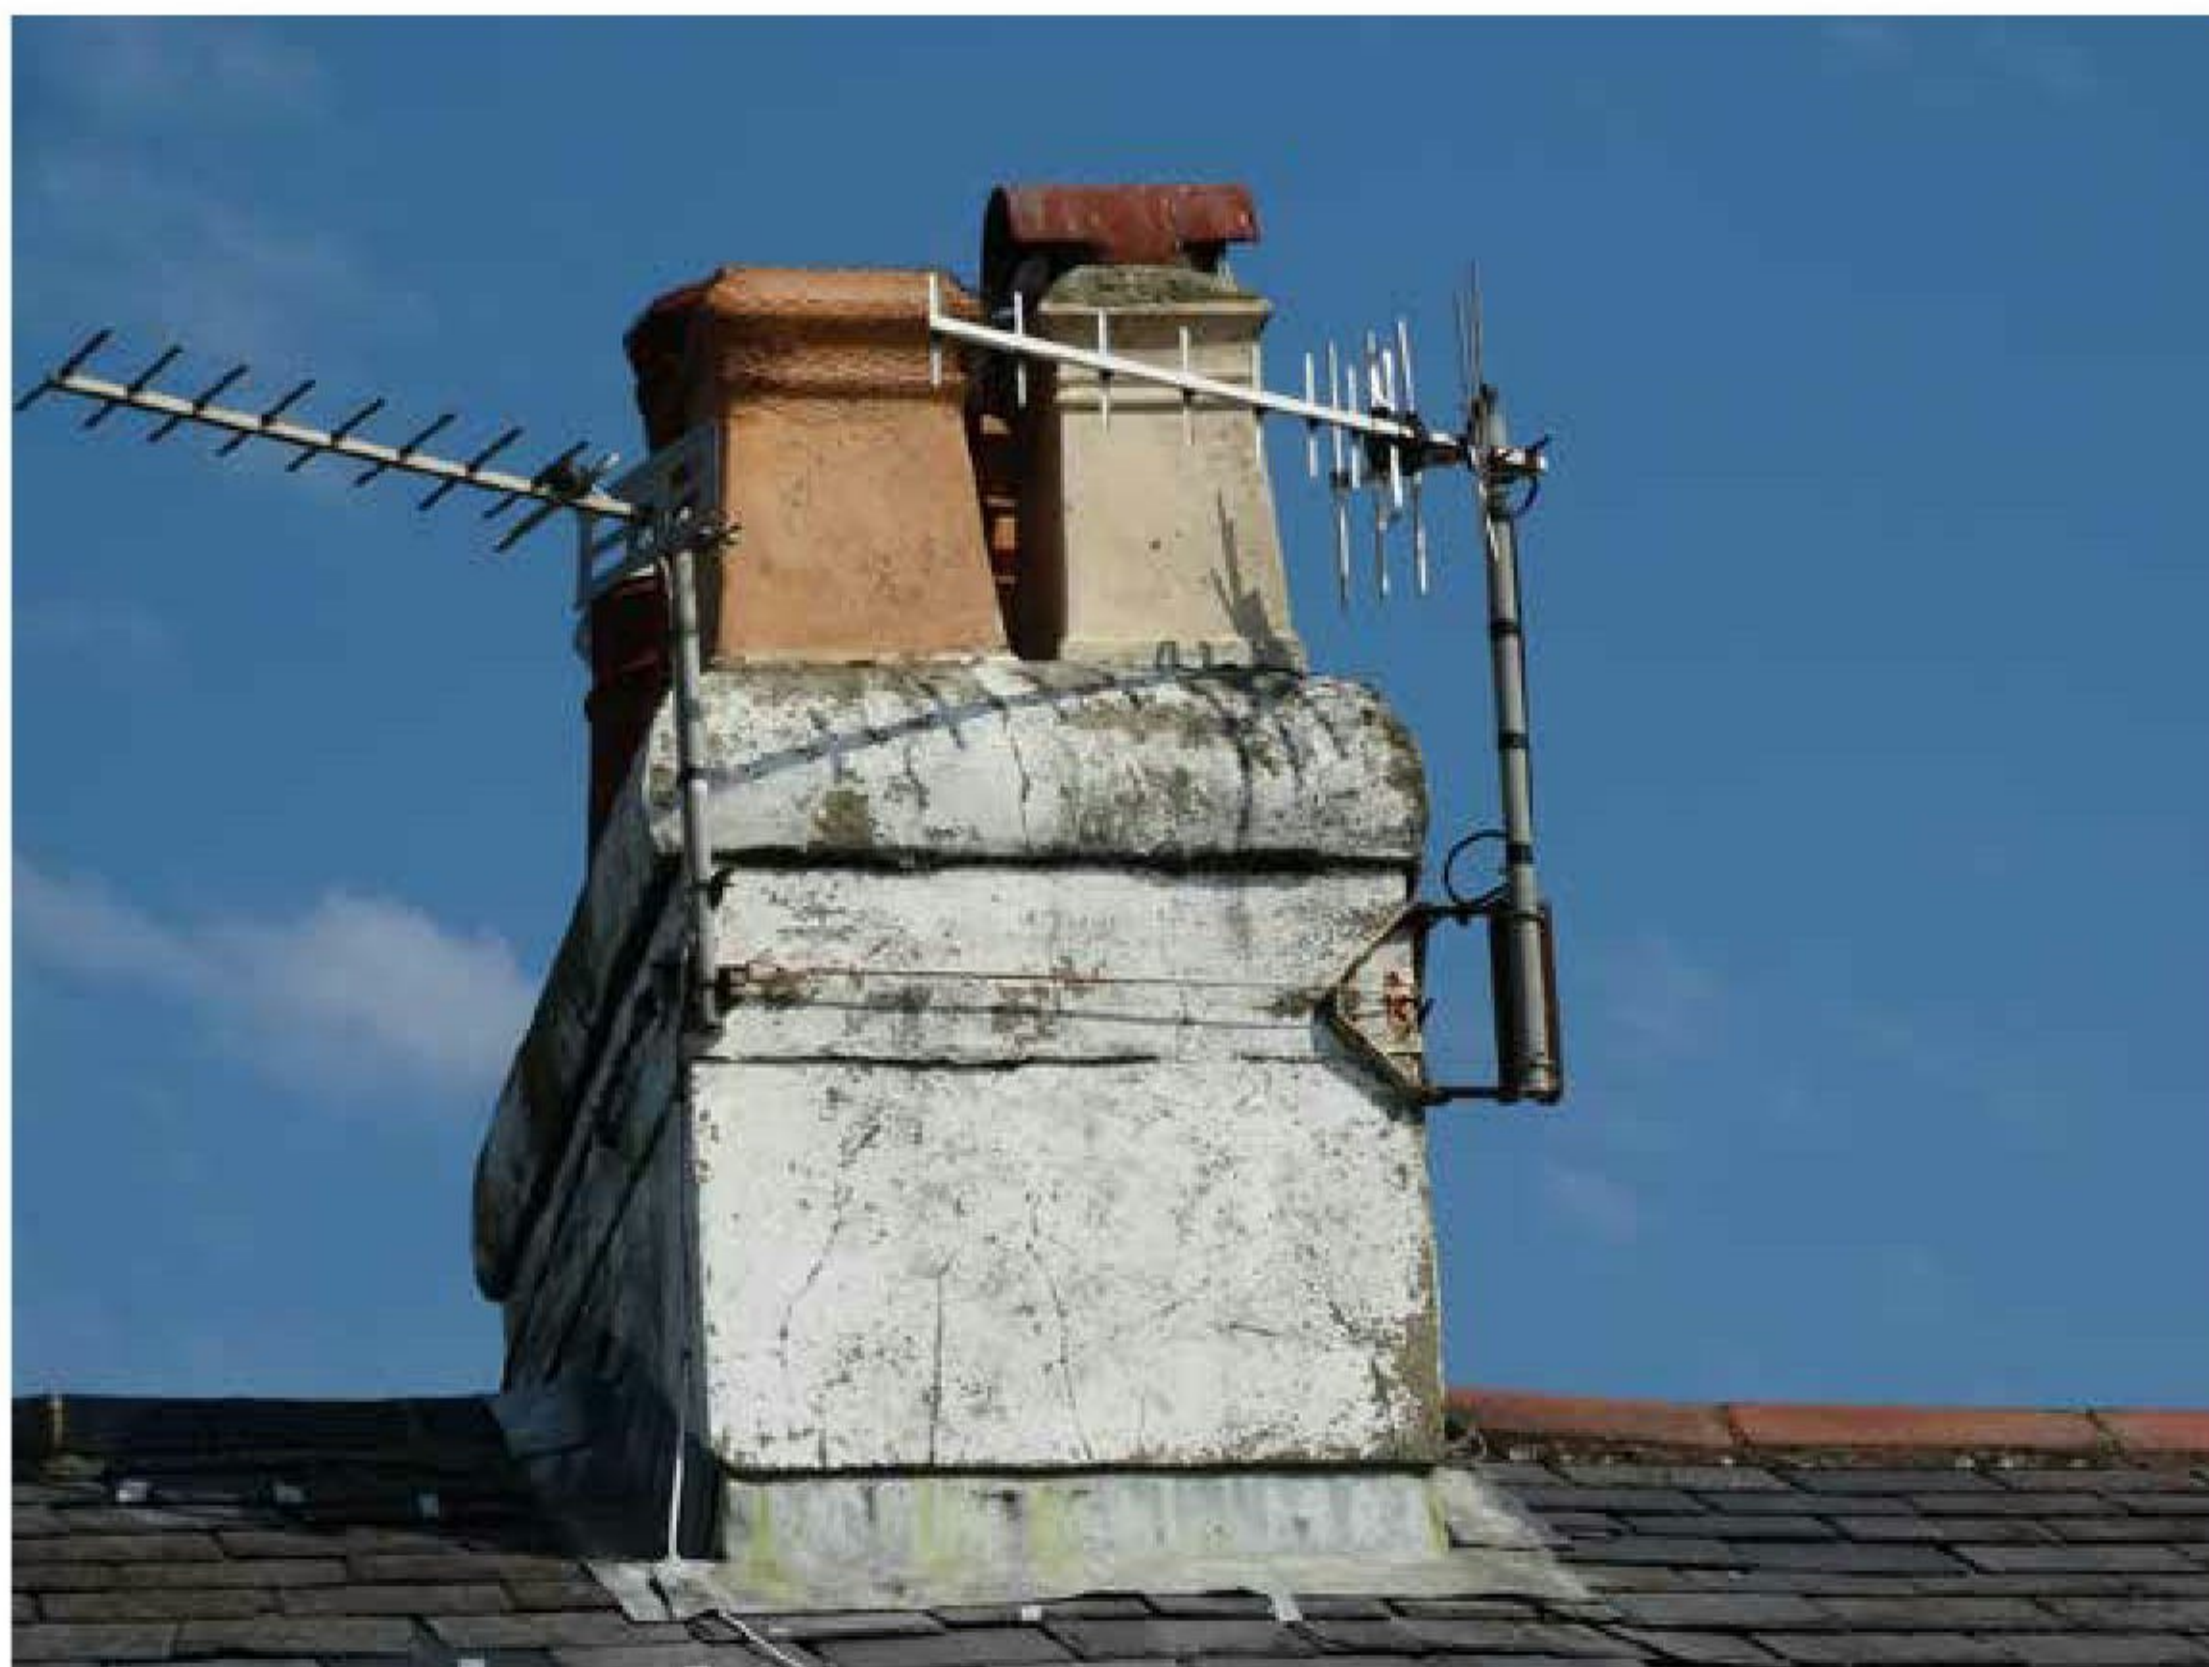
The property is served by a central stack. It remains generally plumb and free from significant distortion and twisting.

Some flues are open to the elements. Appropriate terminals should be connected to allow continued use where required, but to prevent rain penetration and nesting by birds, which would hamper use of the fireplaces and trap moisture in redundant flues.

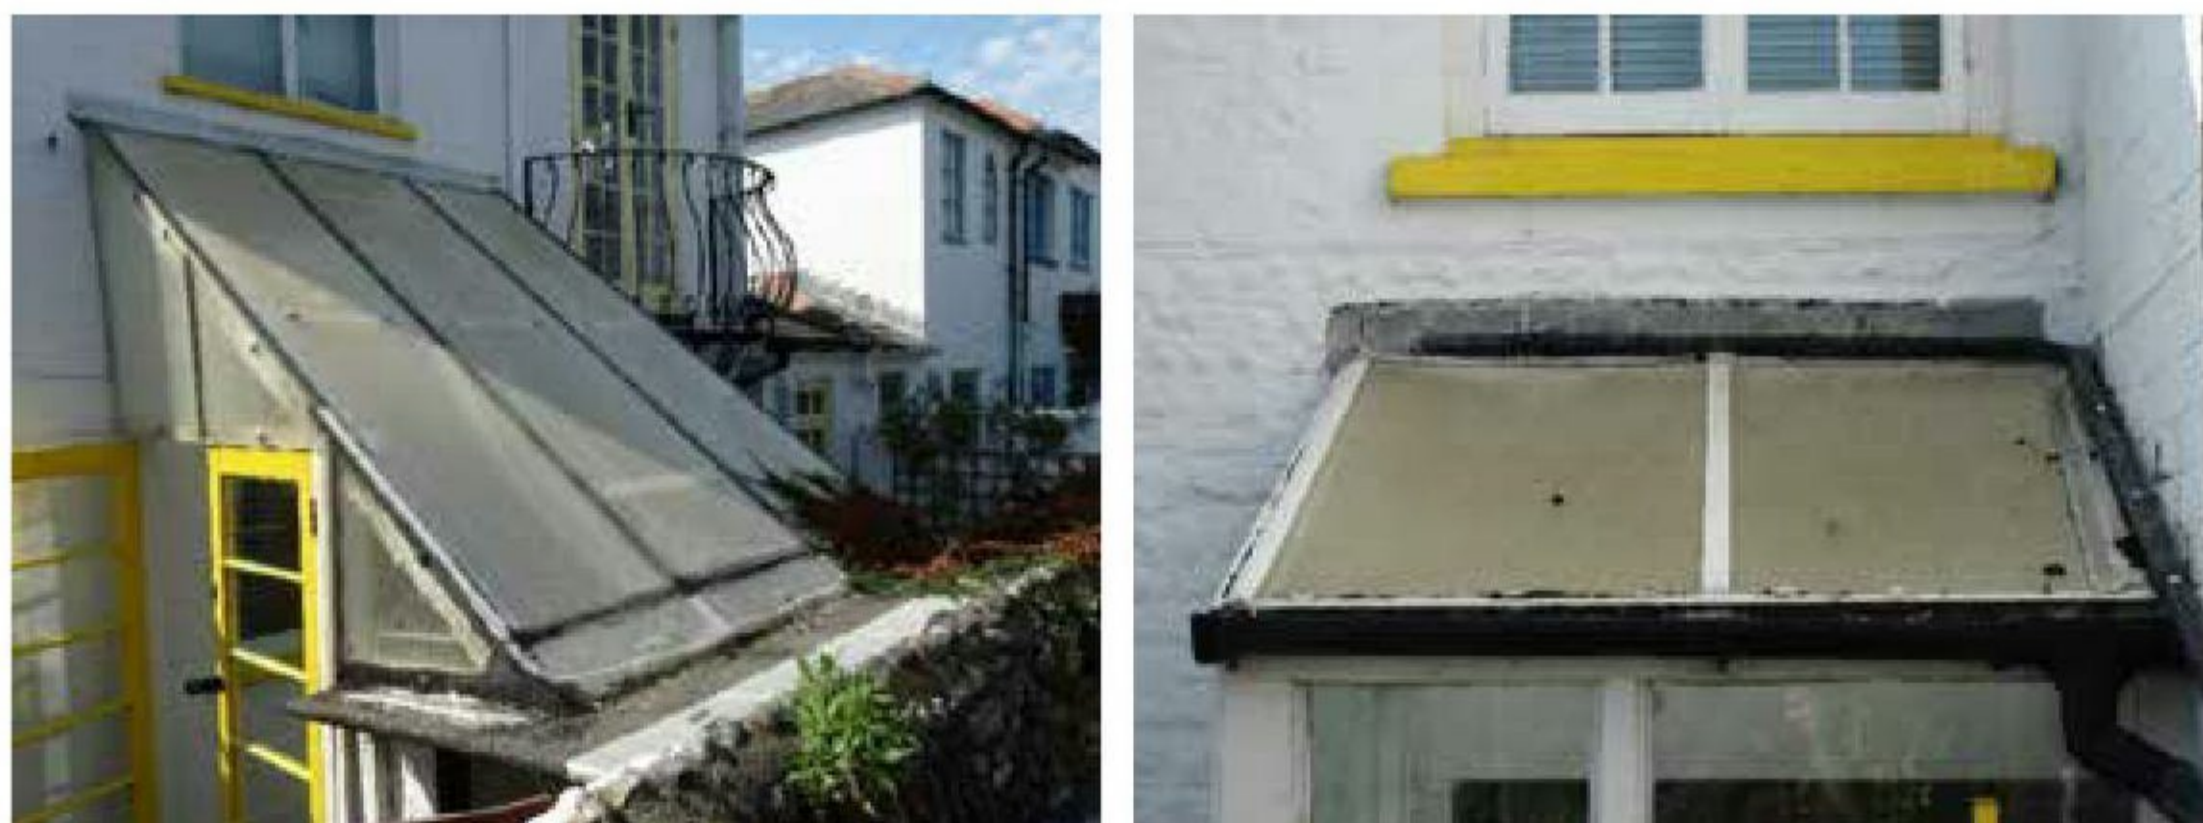
Plastic roofs often leak at the junction to the wall and the need for repairs in this position should also be anticipated occasionally.

The vertical sections of polycarbonate glazing to the utility are poorly sealed with bitumen to the lower parts where it abuts the wood store against the boundary wall (image above left). Again, whilst the area is dry at present, this repair is rudimentary and cannot be expected to last long.

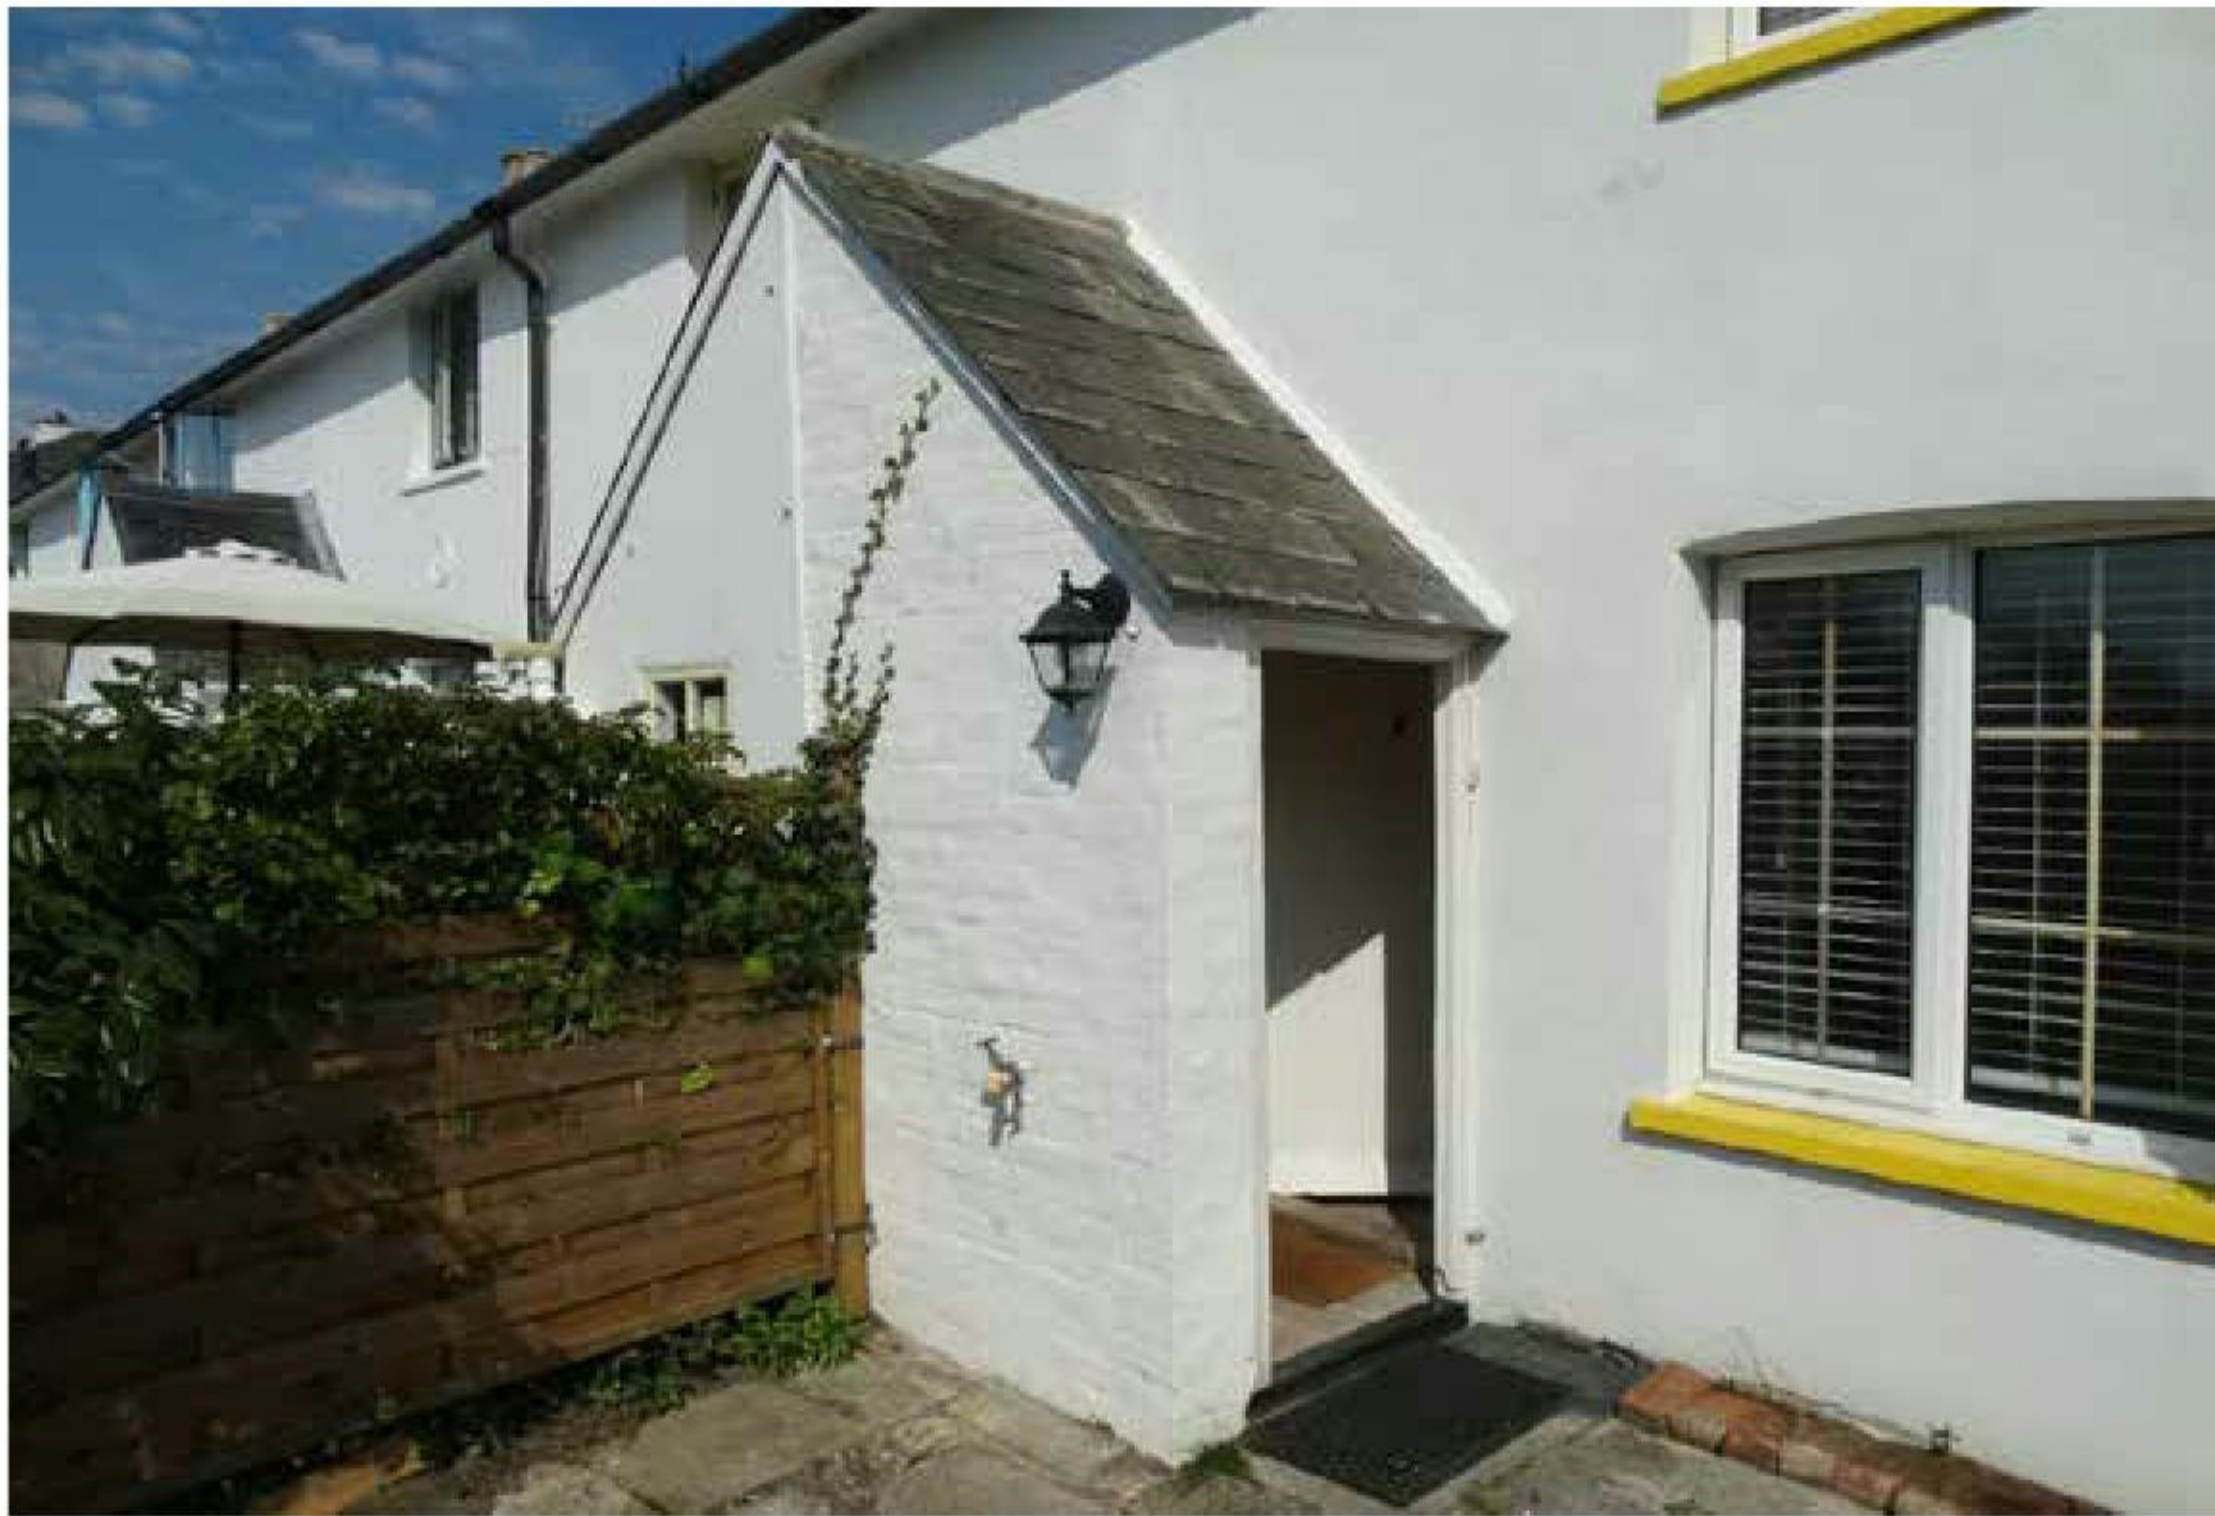
The front porch is, other than the mild separation from the house, in good order.

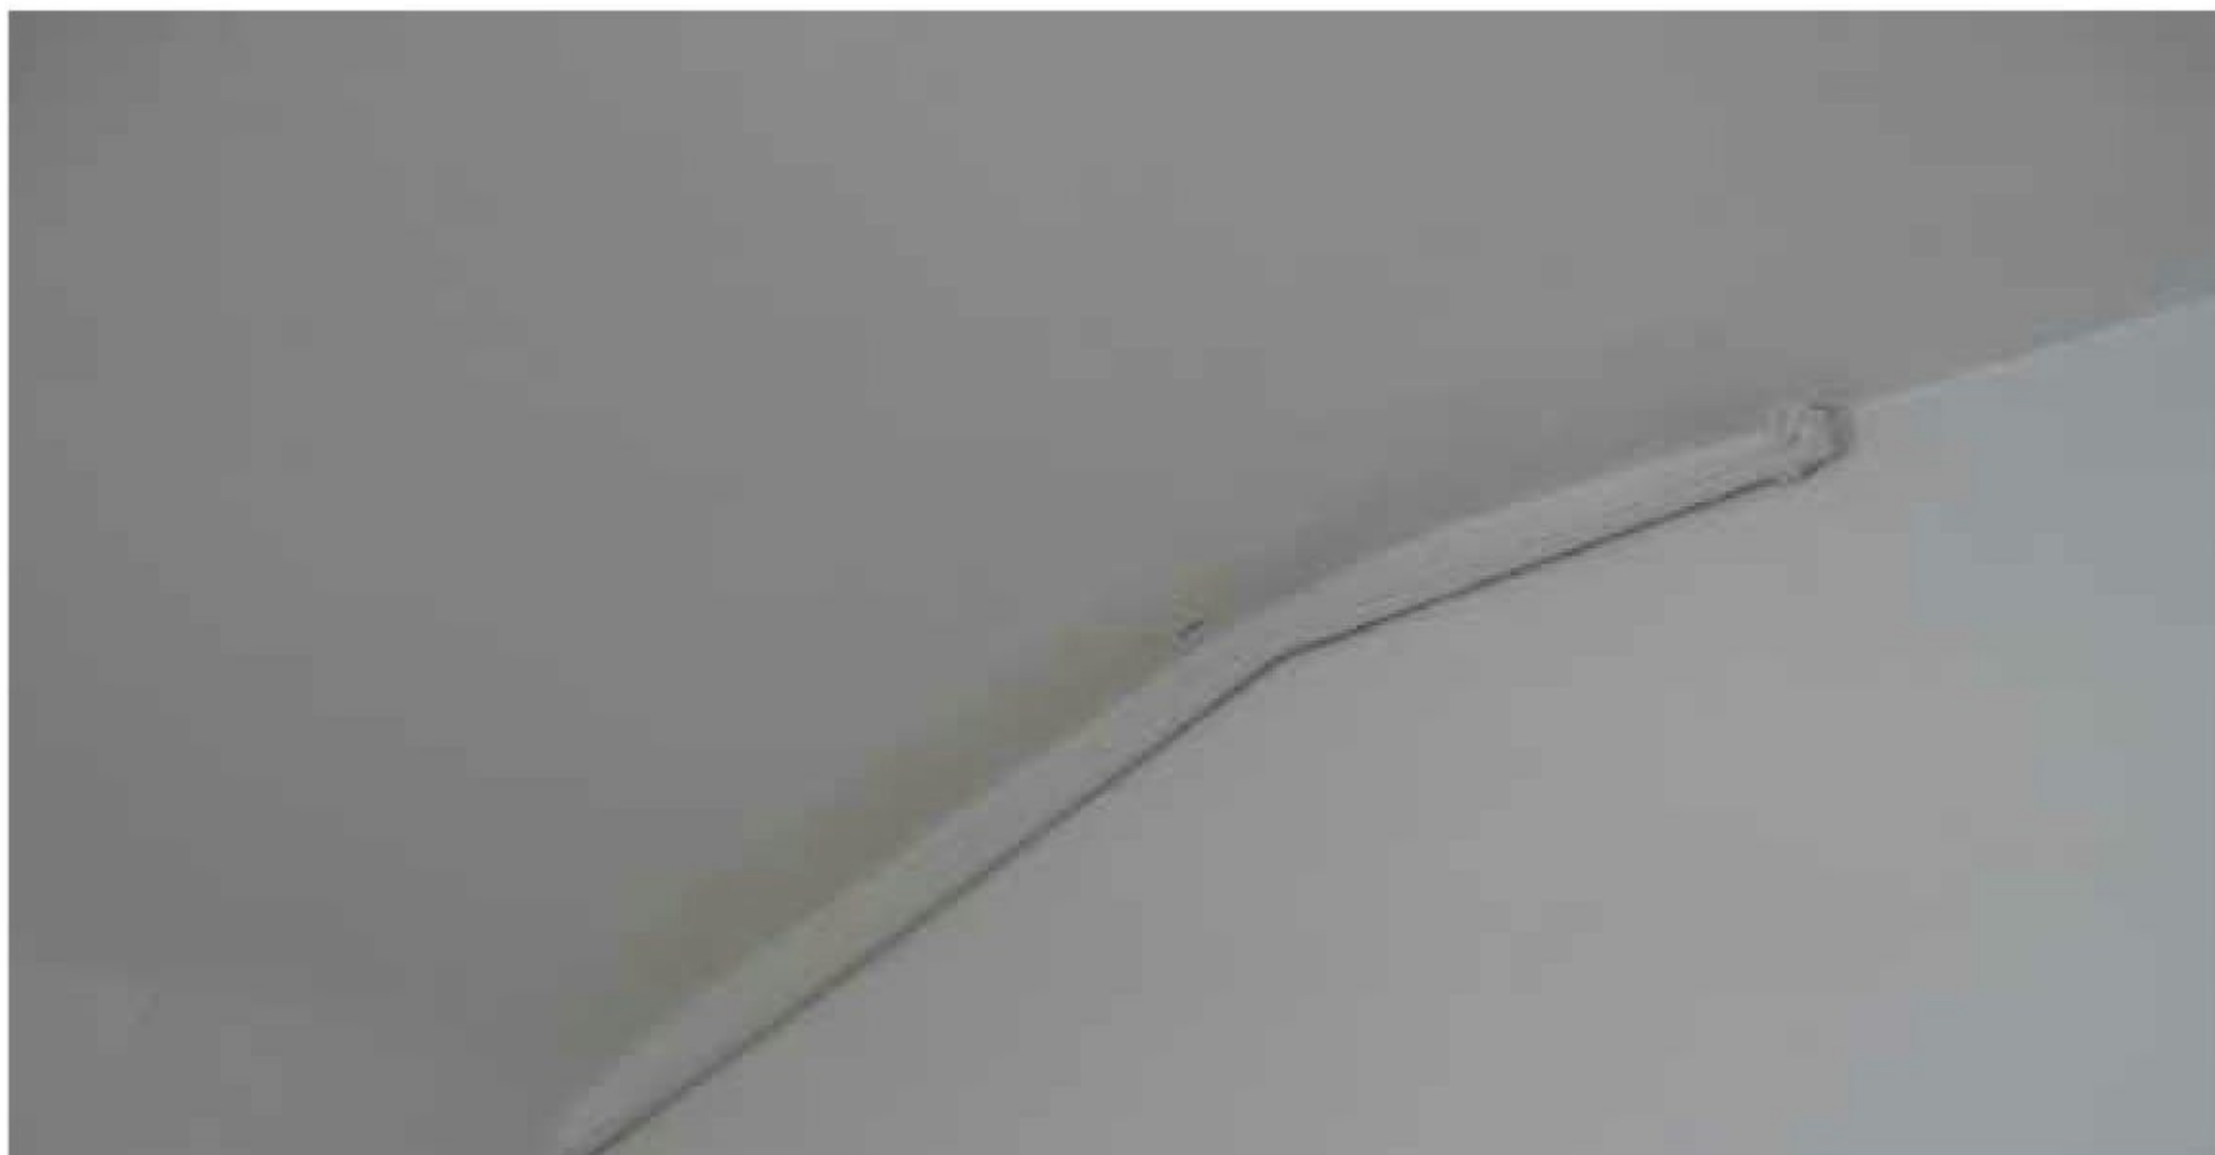
In this instance, no significant loosening is apparent and the plaster would be best left undisturbed. There are some very minor loose areas in the front bedroom that may need localised stabilisation in the future (below).

If you carry out major changes, or for example install spotlights, you may need to replace or overlay with plasterboard.

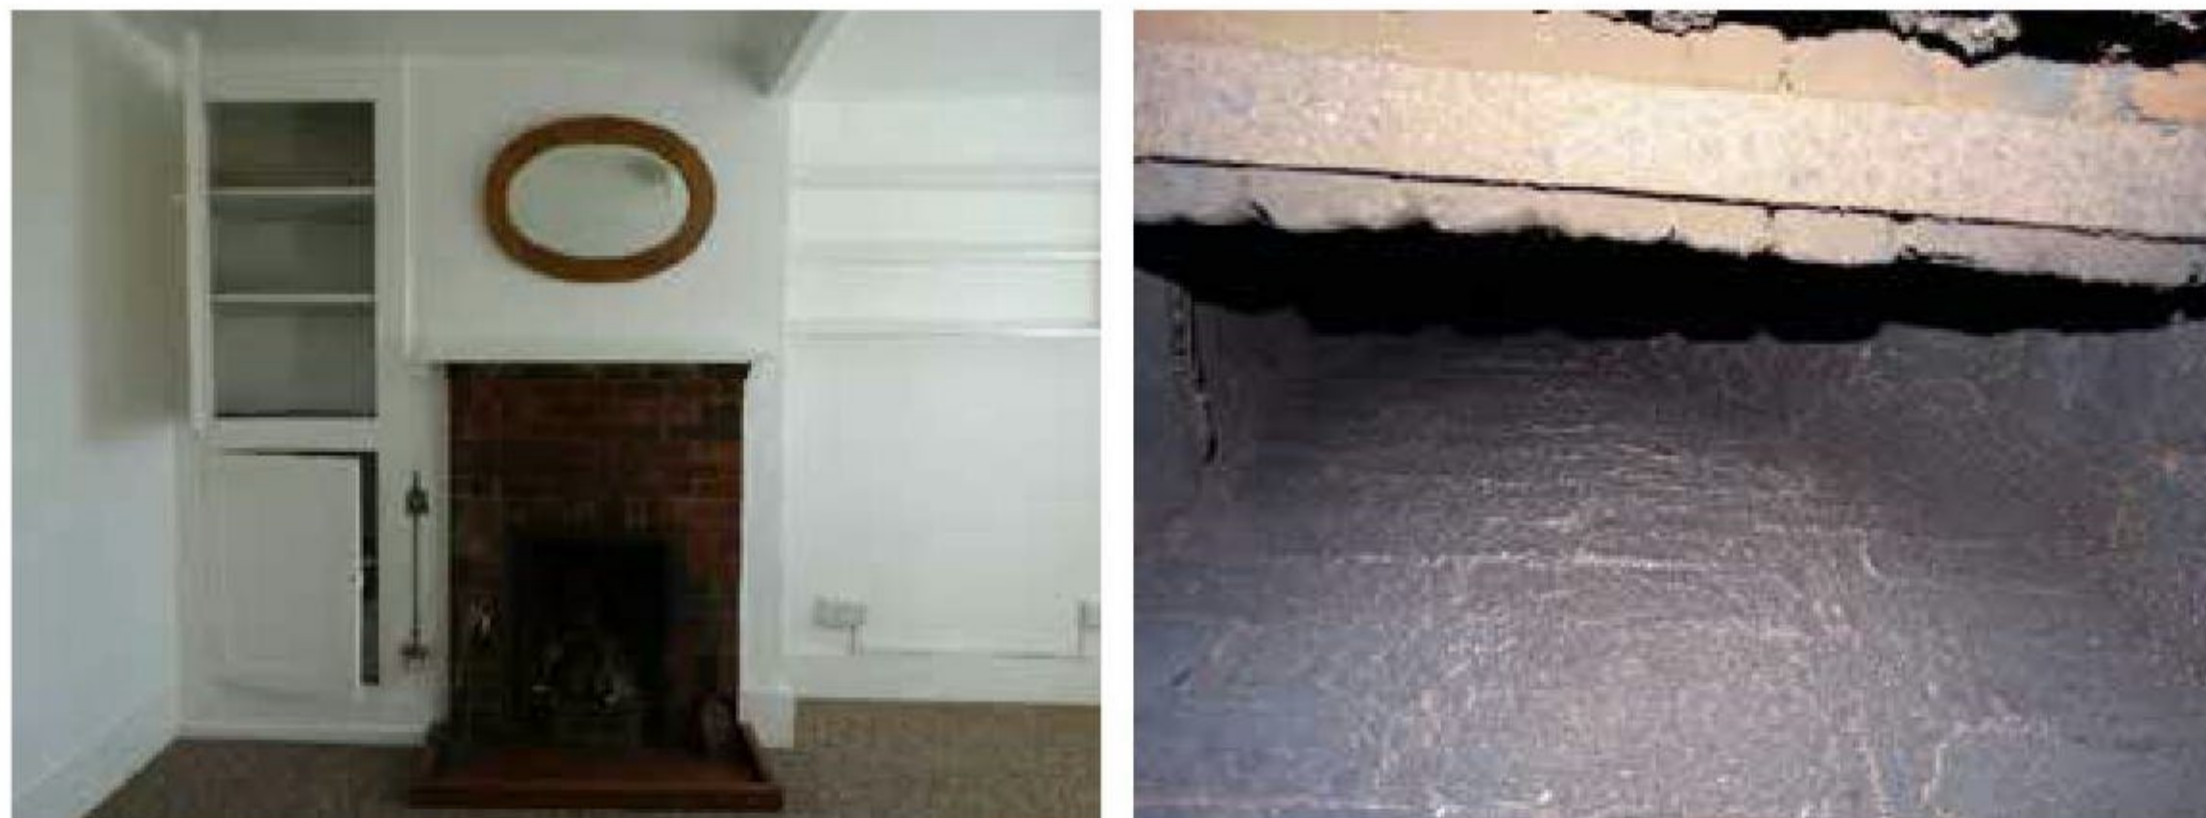
Only the front examples are in place. The ground floor example is open and in use. The flue shows moderate soot build up, but no serious issues.

Soot staining over the fireplace aperture suggests the fire smokes a little. This often arises where the chimneybreast is against a cold outer wall, especially if north facing, or (as in this case) there is insufficient draw from the stack above. Various steps can be taken to address that matter, for example, the provision of insulated lining or a motorised cowl fan. If the problem persists we recommend approaching a certified Heating Equipment Testing and Approval Scheme tradesman.

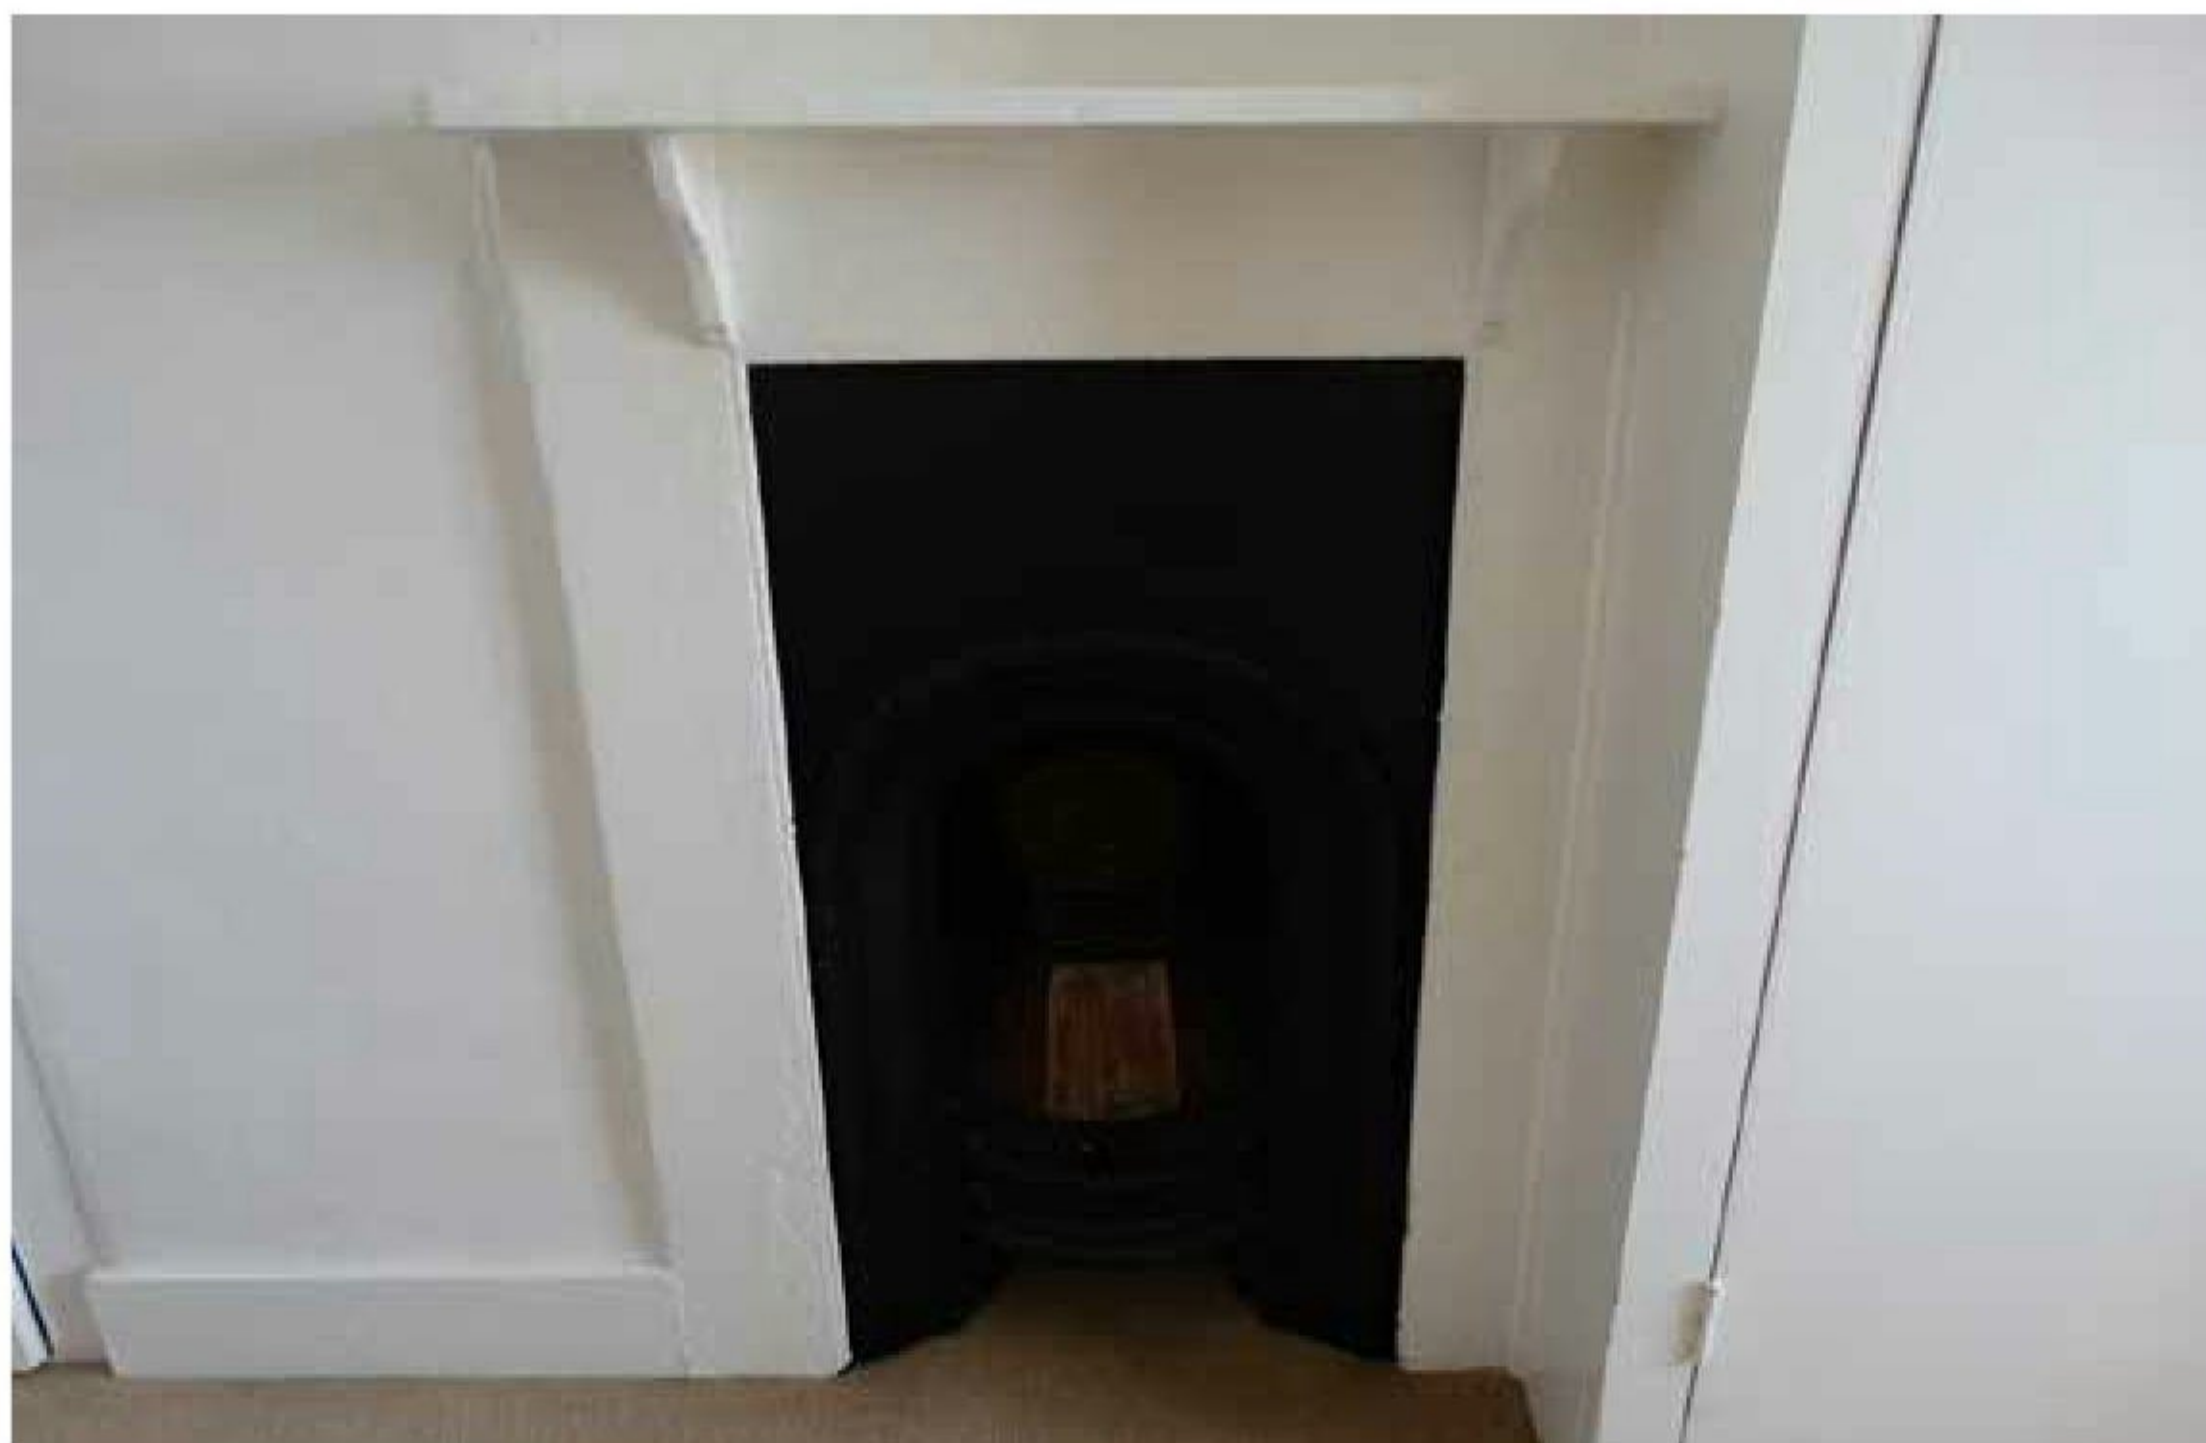
The upper floor example is now decorative and has not been used for many years.

The first floor fireplace has a damper that has been closed for some time. No attempt was made to open it due to the risk of falling debris. It would, however, be advisable to sweep flues periodically as any trapped debris and nesting material will potentially give rise to internal damp staining.

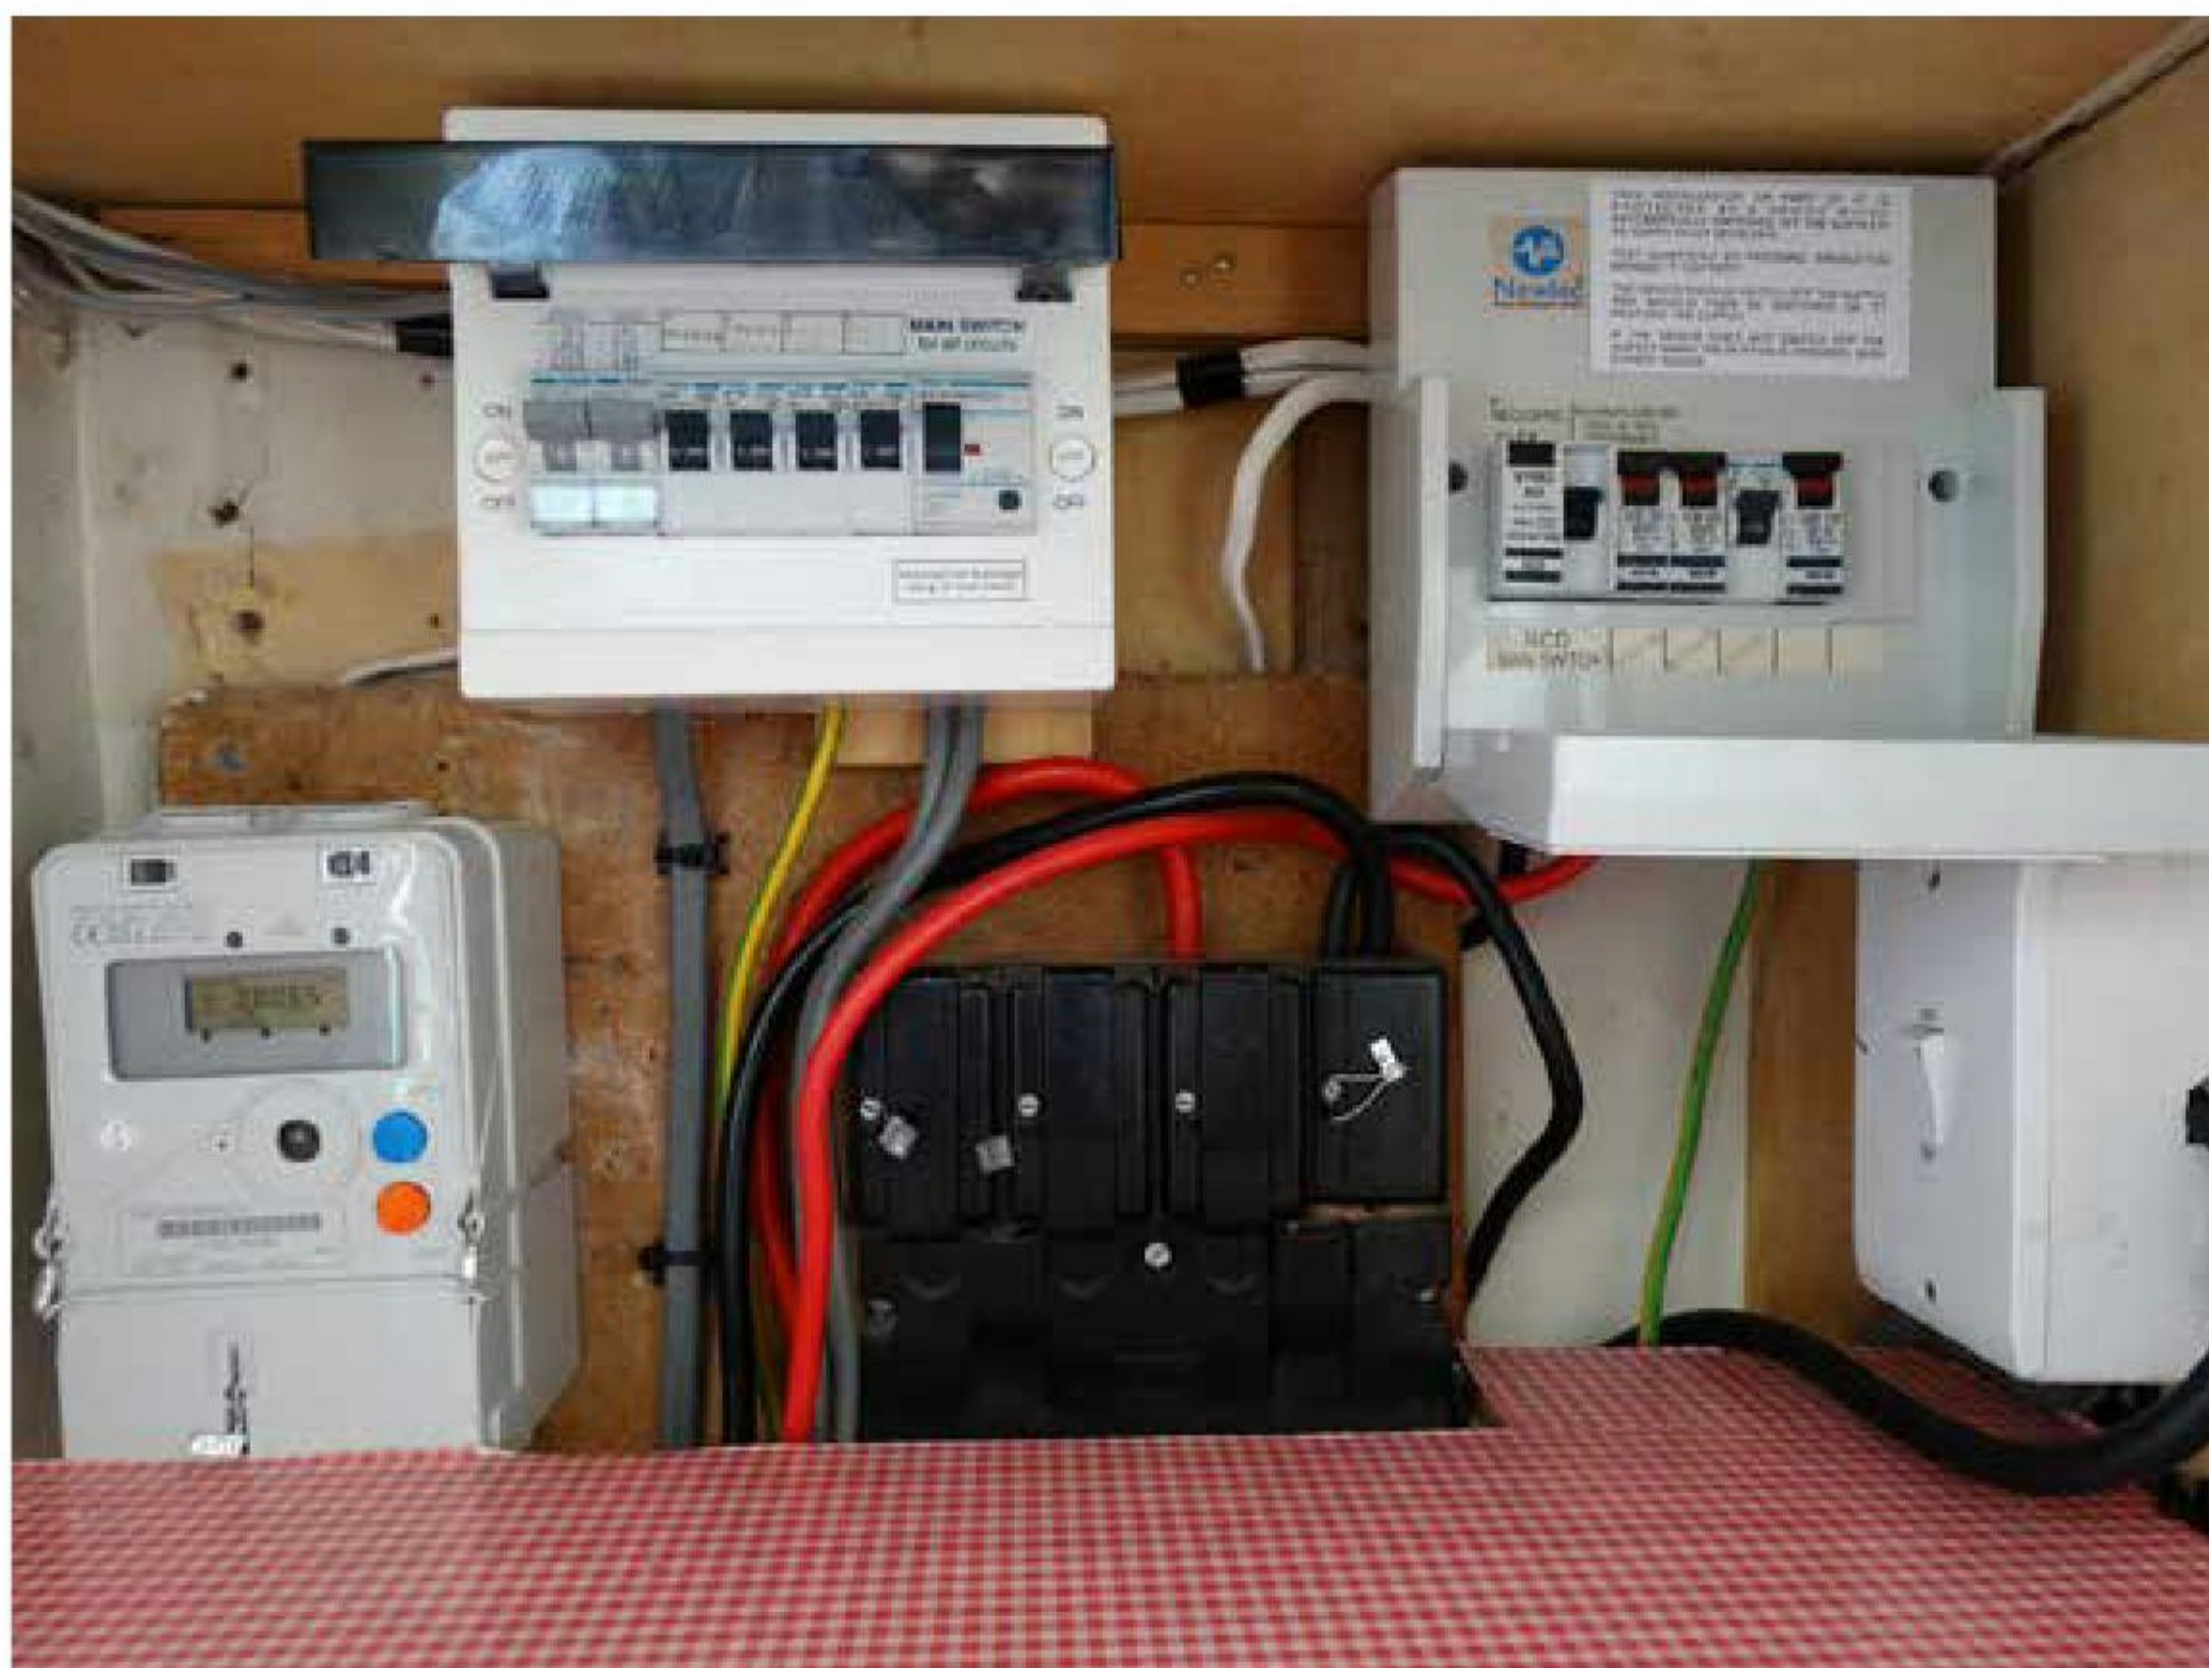
The property has a typical domestic single-phase 230/240-volt electrical supply.

This is a fairly modern installation with two small plastic (as opposed to entirely up-to-date metal cased) consumer units incorporating residual and miniature circuit breakers, PVC-sheathed cabling where visible.
