Desbruslais
Chartered Surveyors

BUILDING SURVEY OF

3 Coastguard Cottages
Snowhill
West Wittering
Chichester
PO20 8AT

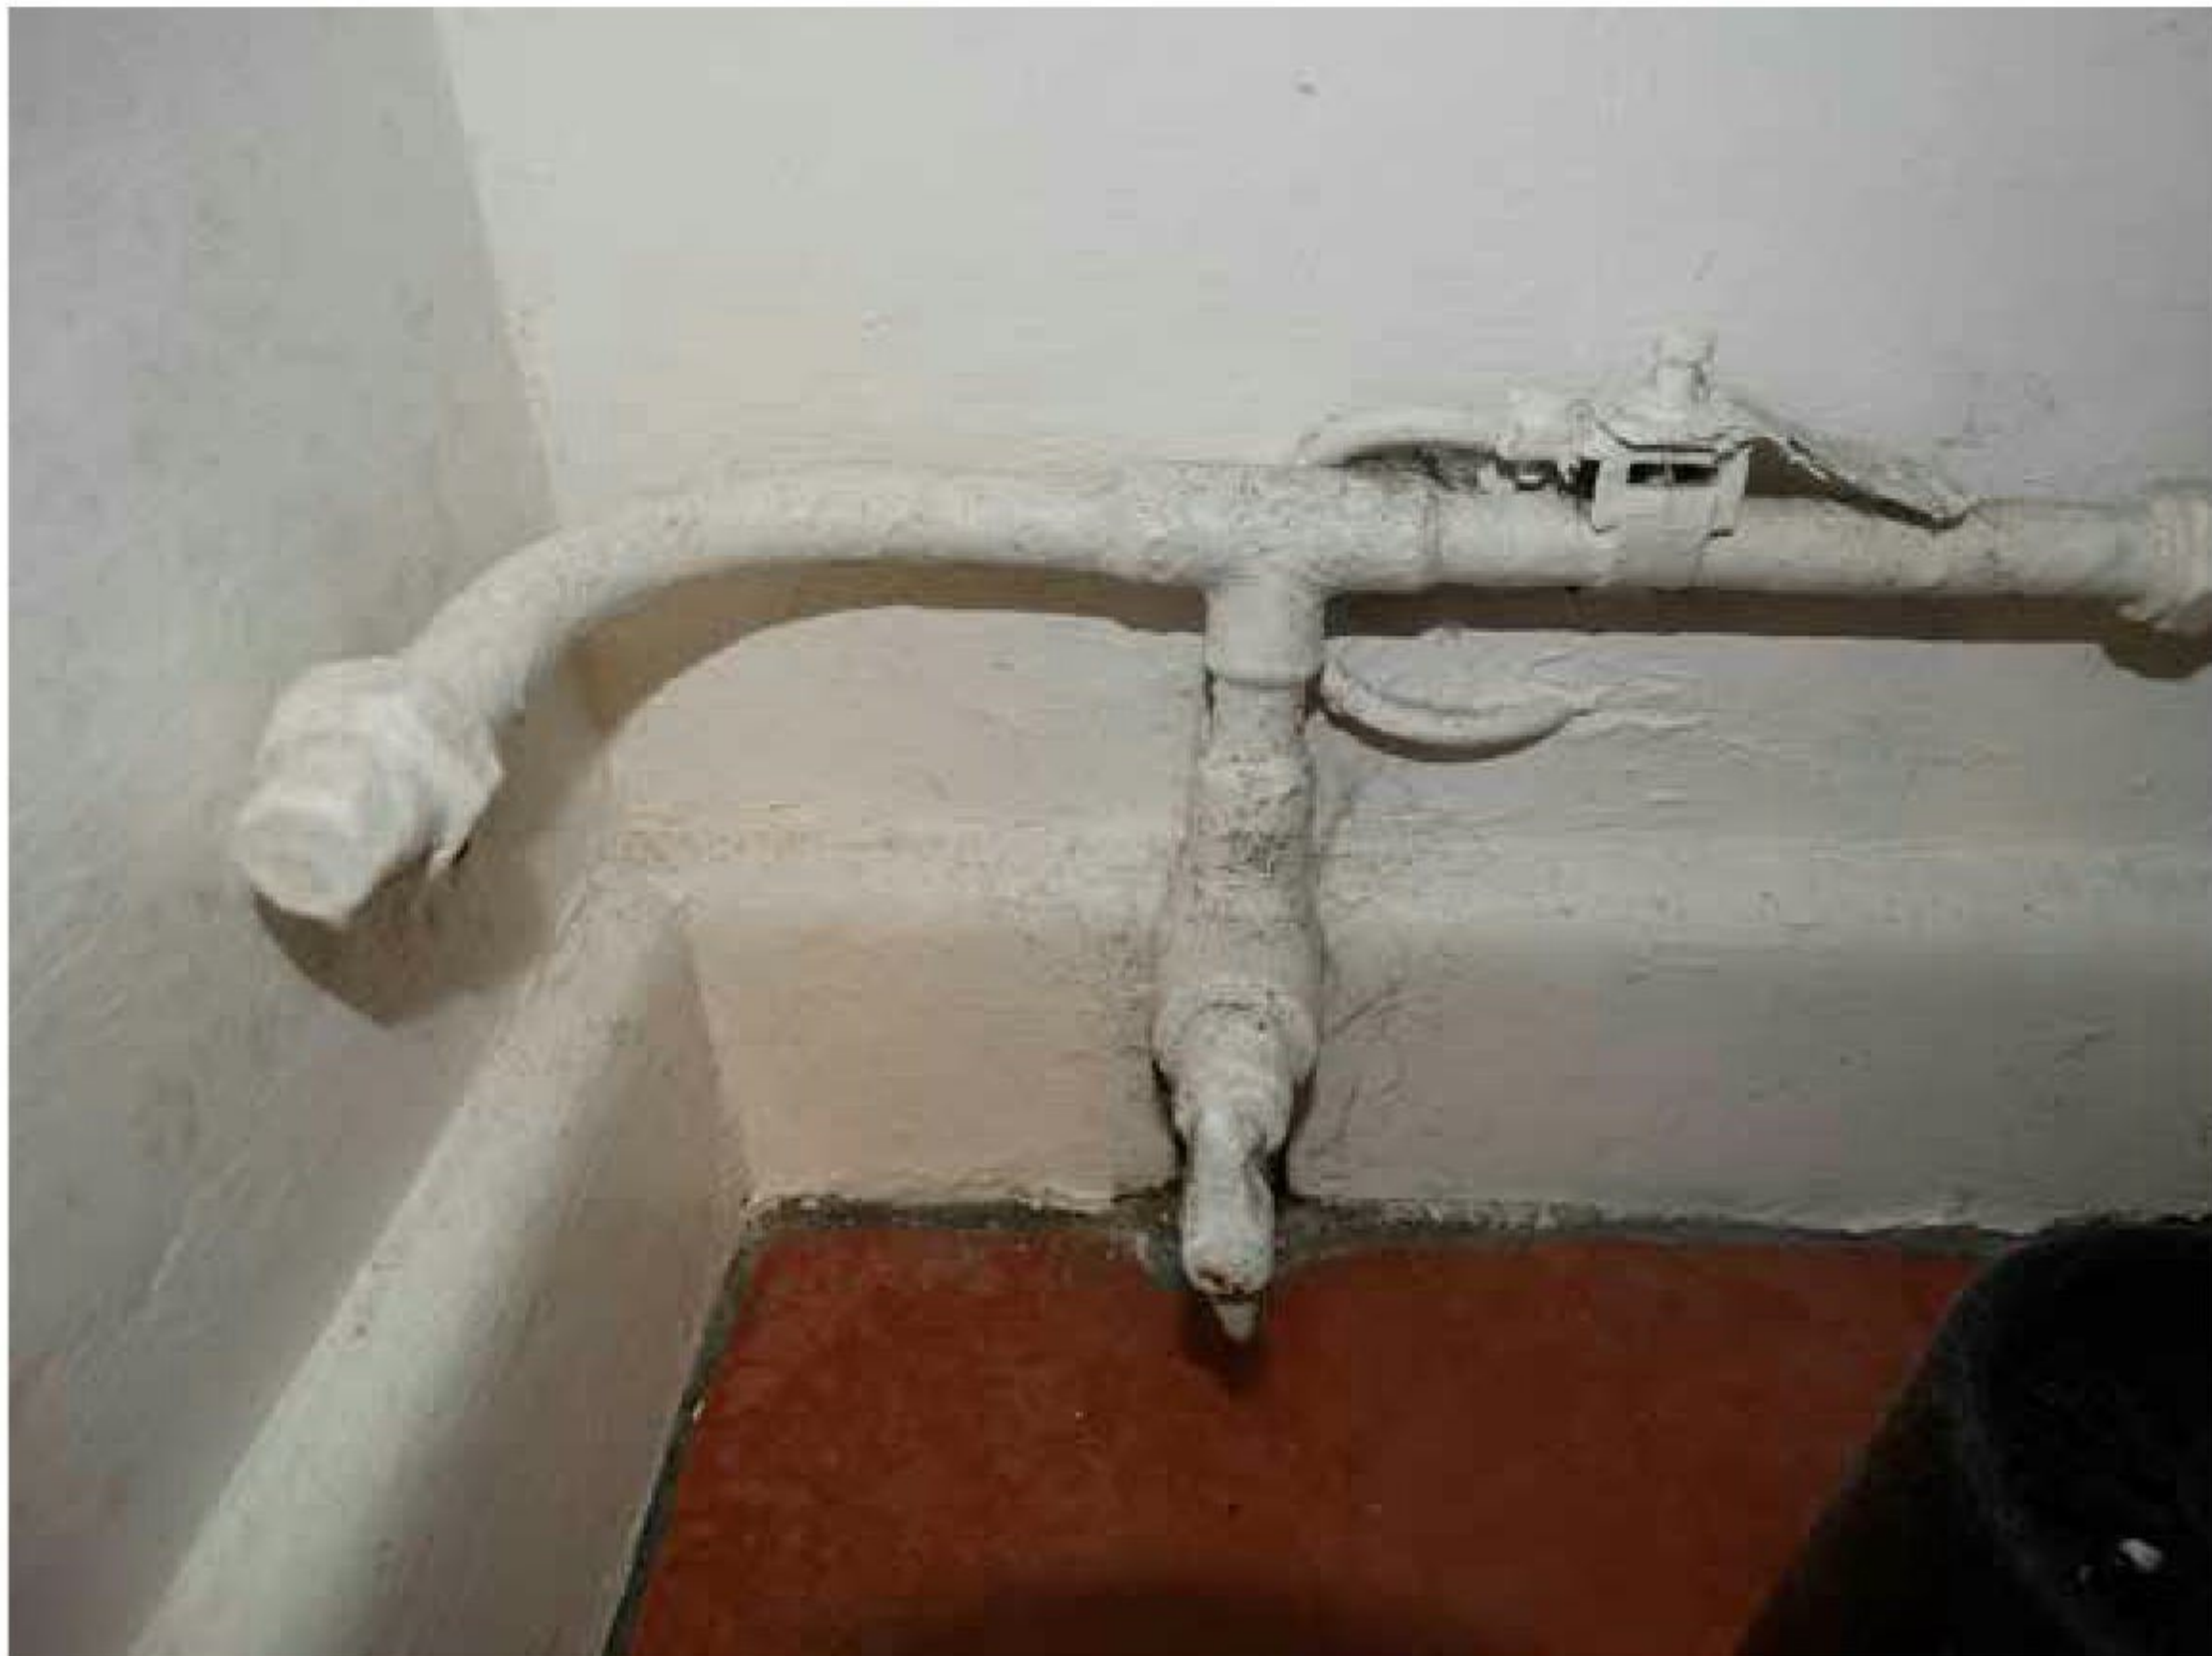
The internal isolation valve is in the bathroom under the WC.

The incoming water main at the stopcock is copper, but the actual incoming main material is not visible. It probably comprises cast iron, as it rises within the 1960s extension. You should allow for replacement with plastic.

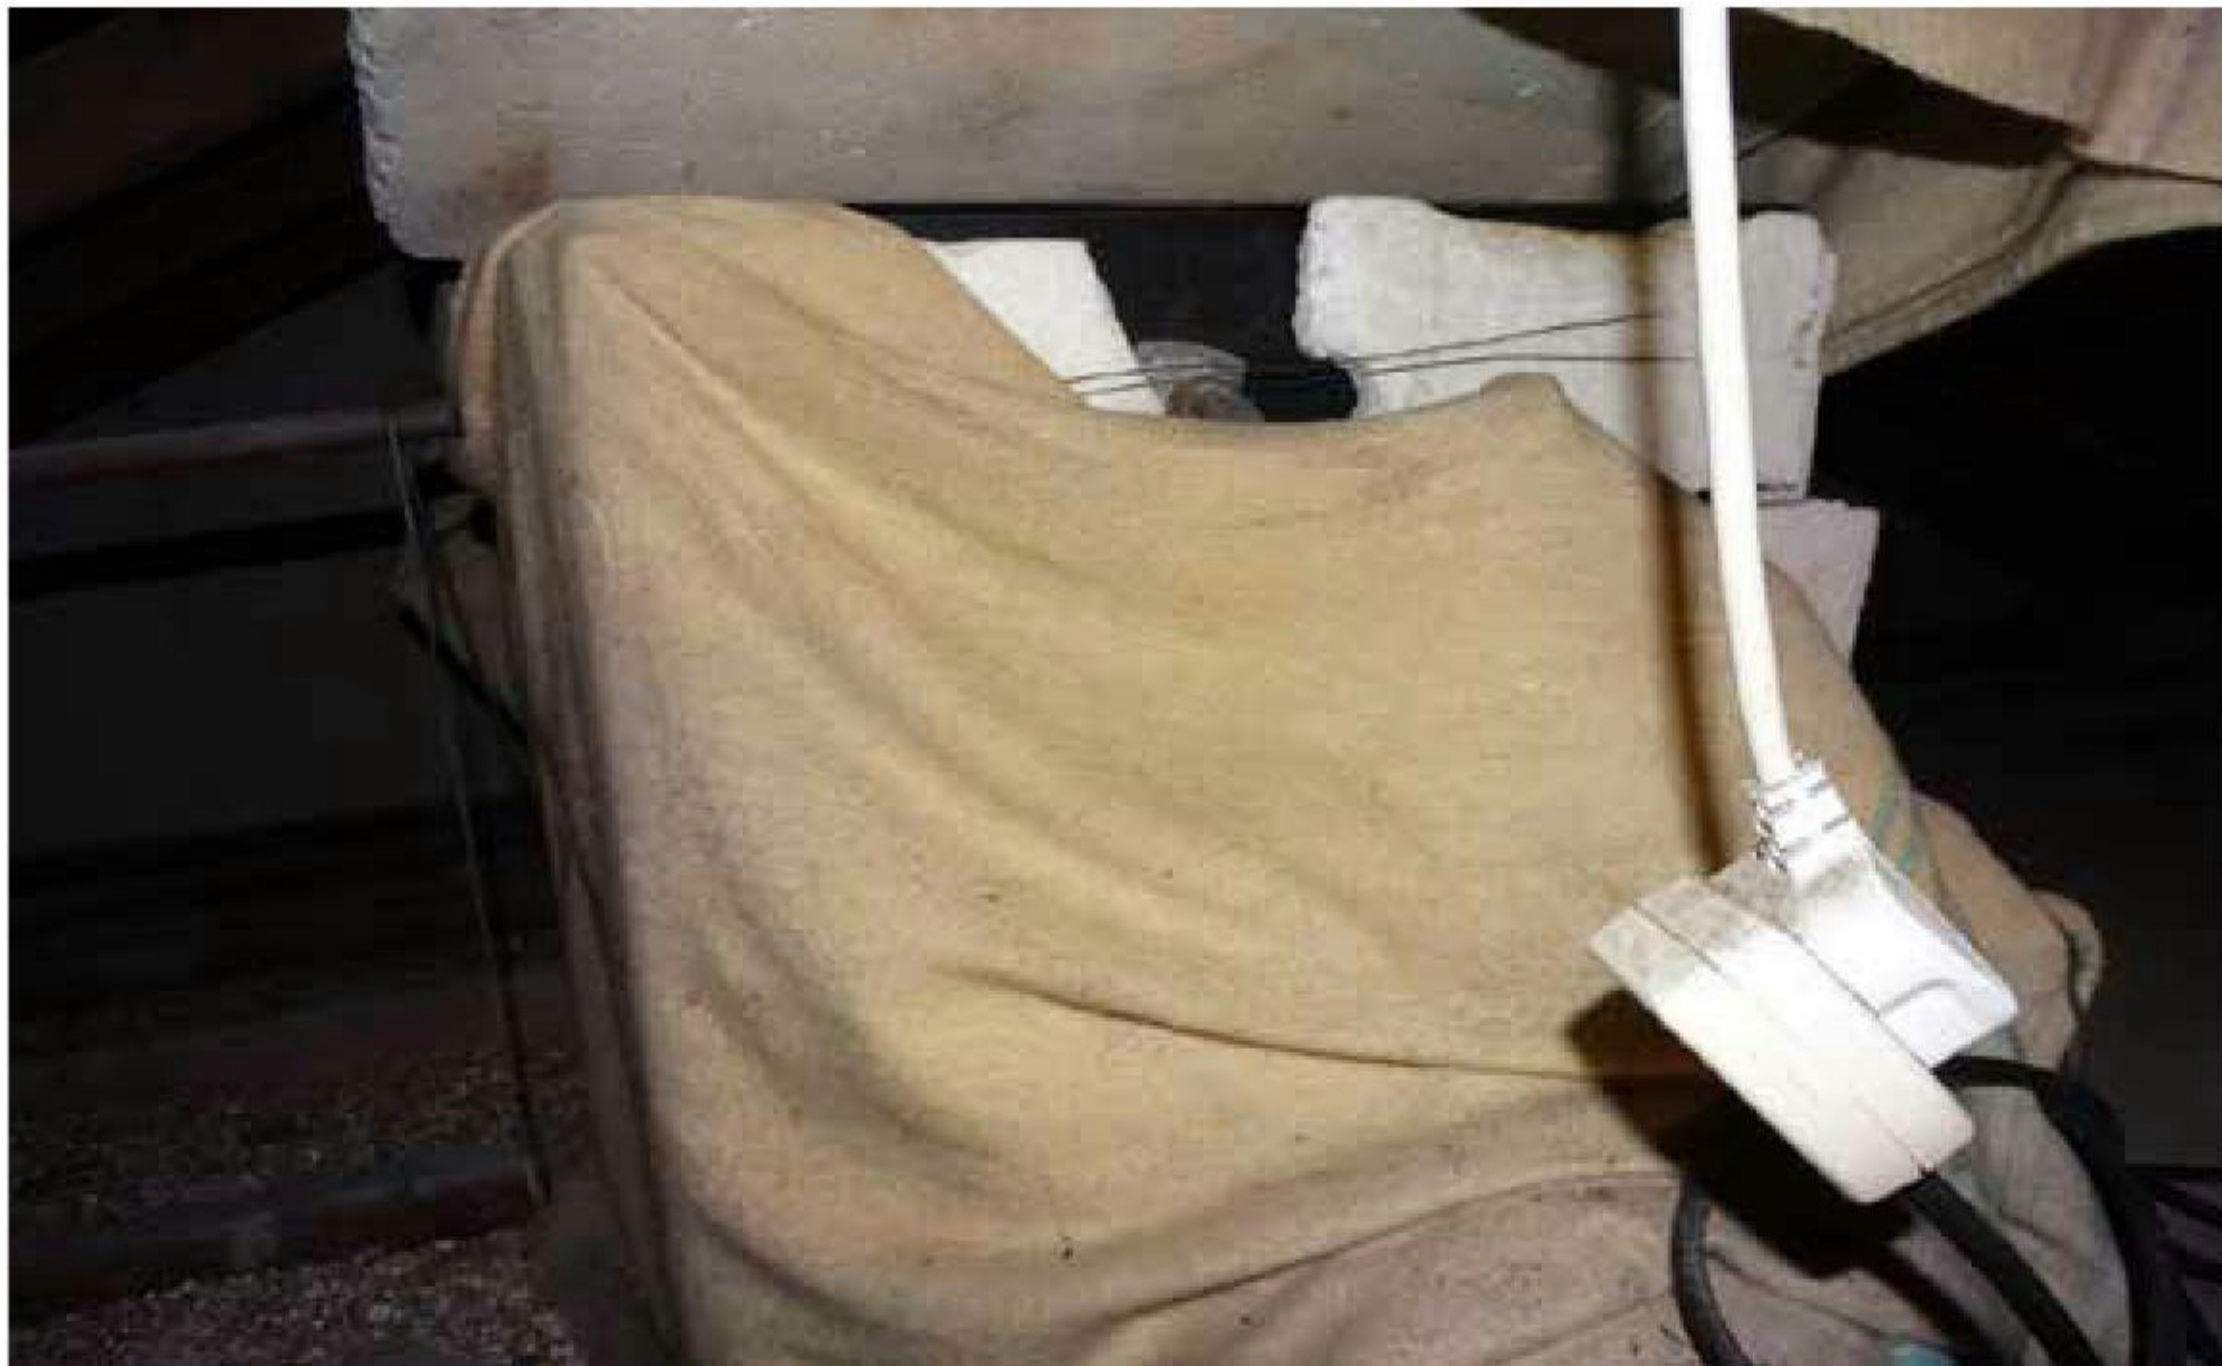
Where visible the installation comprises copper distribution pipework with a plastic header tank with overflow pipe. The tank is basic and does not have a lid. The tank should be drained, cleaned and lidded and the overflow connection checked, as this is a common area of leaks and water damage.

Depending on your plans for the heating system as set out in the next section, there may be the potential to remove roof tanks entirely.

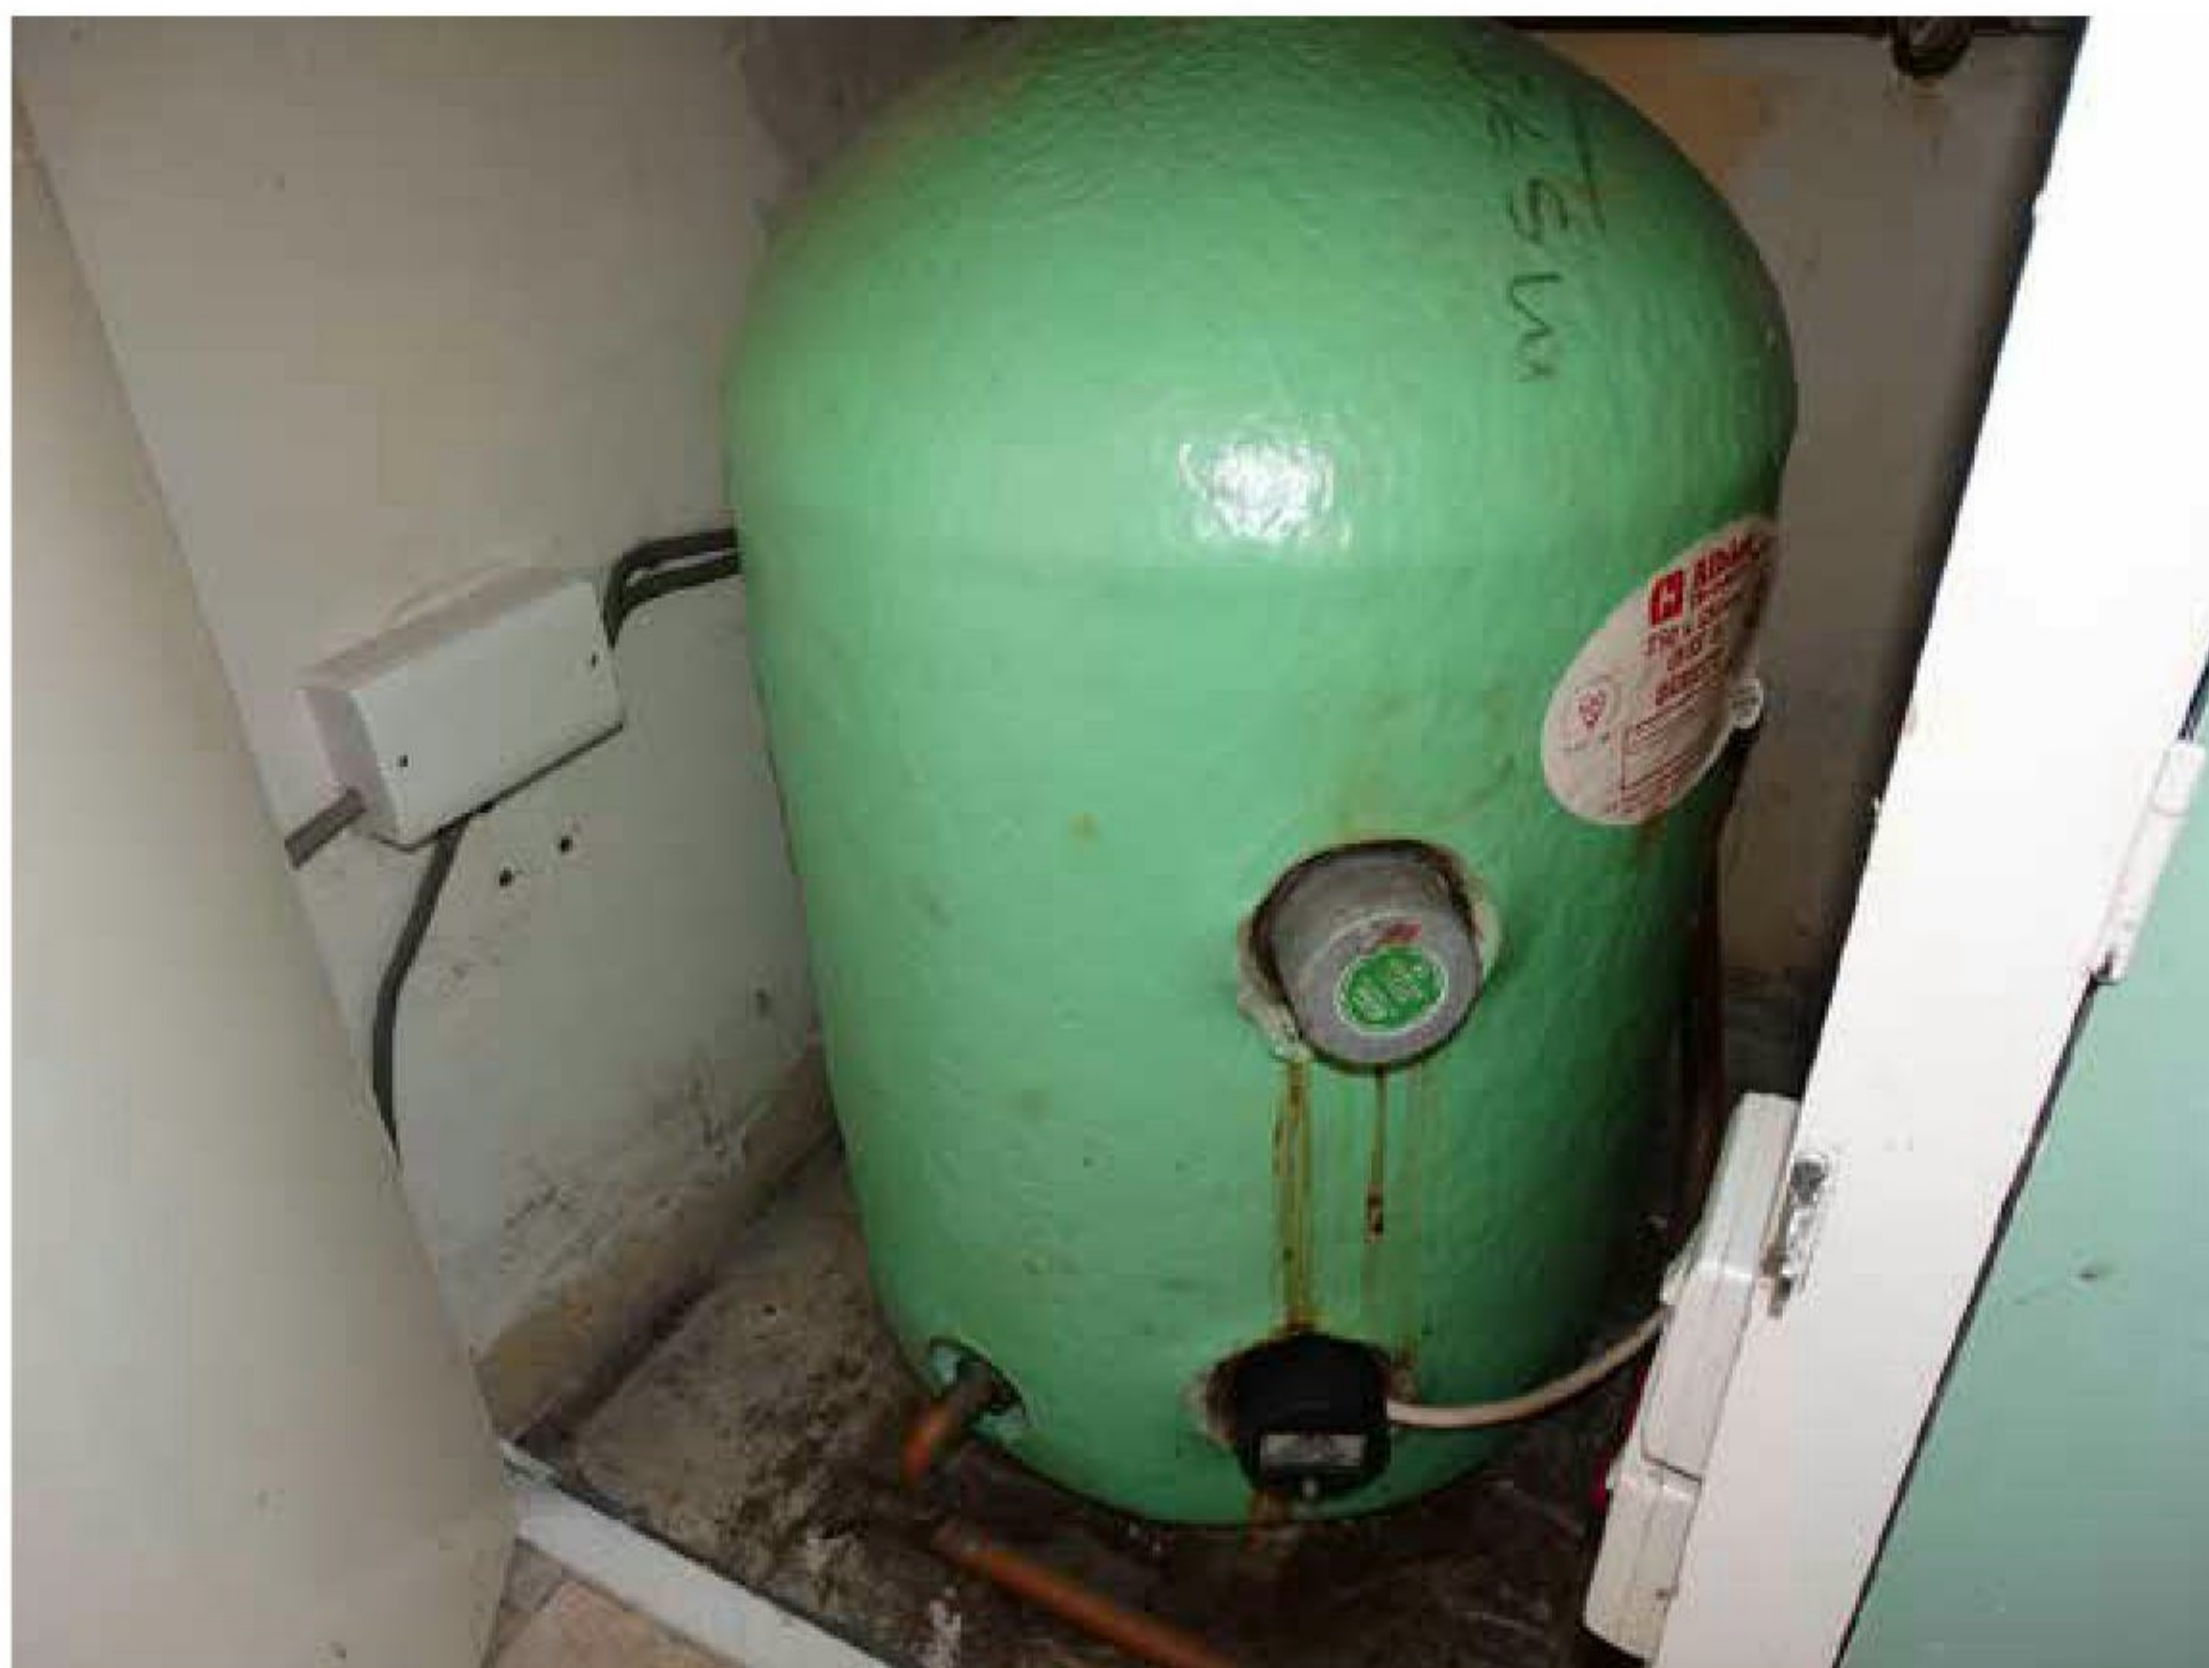
Hot water is via a tiny immersion heater under the worktop in the kitchen.

The capacity will be very limited and the pressure is limited.
