# **Arboricultural Report**

**Boscastle House, Boscastle, North Cornwall.**

Date: 28<sup>th</sup> November 2015

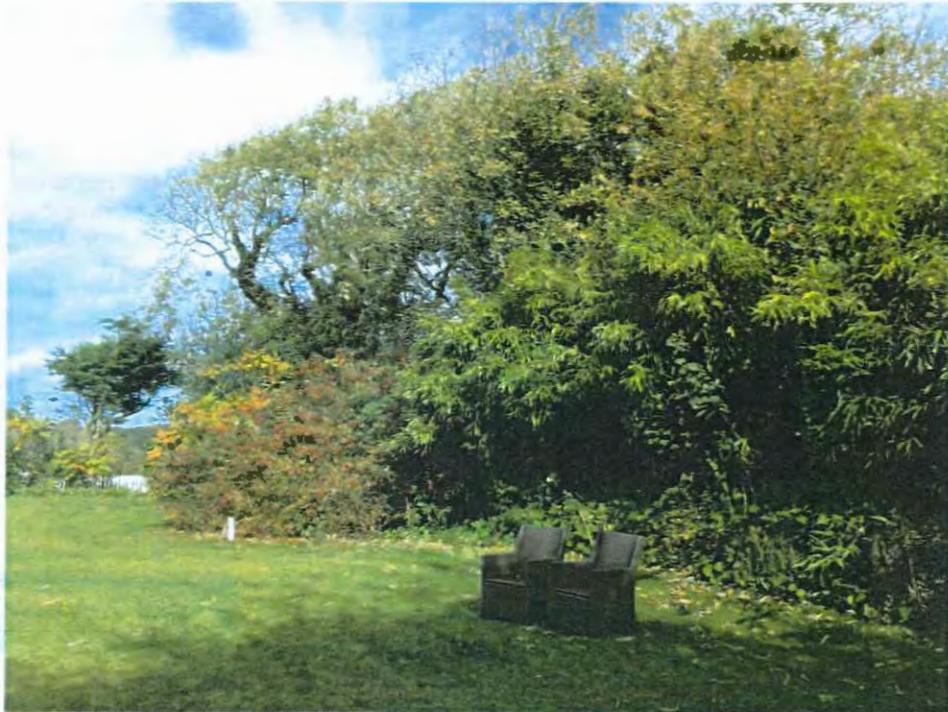
Fig 1: the trees on the eastern croquette lawn, ash (T4) and sycamores (T5 and T6)

| Tree Number | Species<br>(MS=Multi-stemmed) | Height (m) | Stem Dia. (mm) | Branch Spread (m)<br>N E S W | Ht Crown Clear (m) | Age Cla | RPA Radius (m) | Physiological Condition | Structural Condition | Management Recommendations | Est. Remain Yrs | Cat Grade |
|---|--|---|---|---|---|---|---|--|--|---|---|---|
| T4 | Ash<br>( <i>Fraxinus excelsior</i> ) | 13 | 800 (est) | 4-4-4-4 | 5 | M | 6.3 | Good | Asymmetrical crown –due to prevailing wind? Ivy on main stem | Remove ivy | 40+ | B1,2 |
| T5 | Sycamore MS<br>( <i>Acer pseudoplatanus</i> ) | 12 | 550 | 5-8-5-5 | 4 | M | 6.6 | Good | Coppiced in the past? Broken limb at base. Heavy ivy growth | Remove ivy | 40+ | B1,2 |
| T6 | Sycamore MS<br>( <i>Acer pseudoplatanus</i> ) | 12 | 390 | 3-3-3-3 | 5 | M | 4.8 | Good | Heavy ivy growth<br>Tall drawn form | Remove ivy | 40+ | C1,2 |

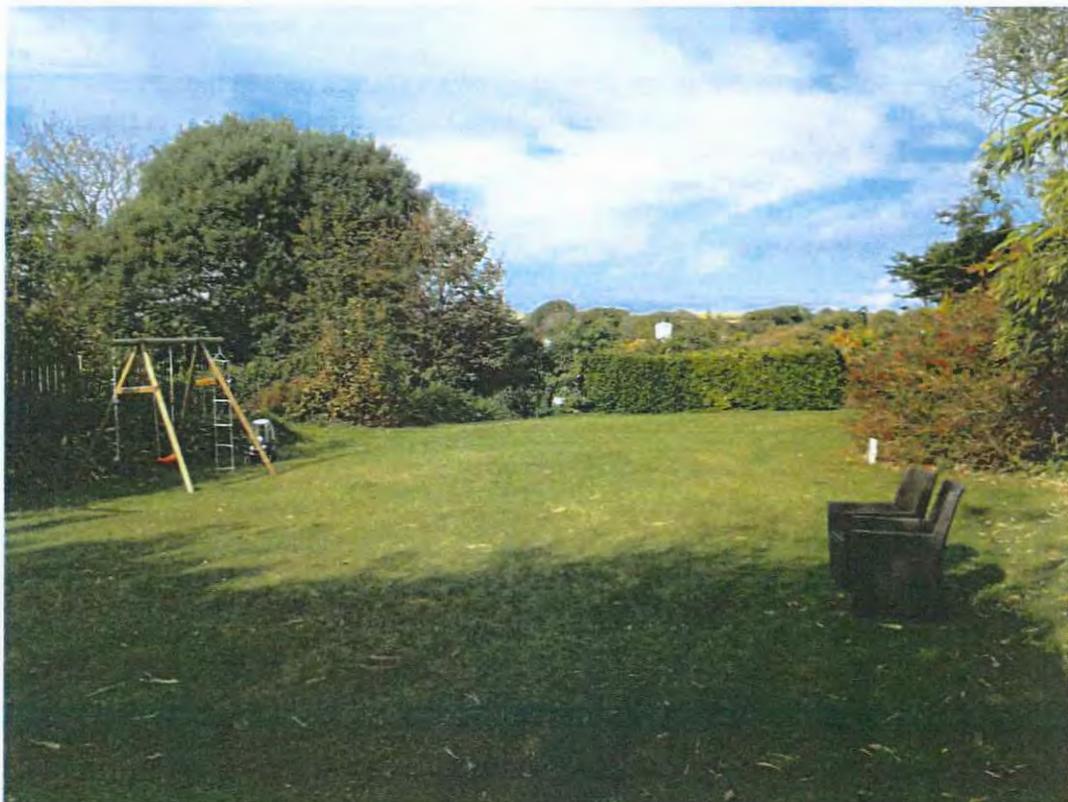
Fig 2; View north down the lawn with the Holm oak (T1) to the left

| Tree Number | Species<br>(MS=Multi-stemmed) | Height (m) | Stem Dia. (mm) | Branch Spread (m)<br>N E S W | Ht Crown Clear (m) | Age Cla | RPA Radius (m) | Physiological Condition | Structural Condition | Management Recommendations | Est. Remain Yrs | Cat Grade |
|---|--|---|---|---|---|---|---|--|--|---|---|---|
| T1 | Holm Oak<br>( <i>Quercus ilex</i> ) | 11 | 660 | 3-5-9-3 | 3 | M | 7.8 | Ganoderma fungal bracket at base – currently not significant | Asymmetrical crown –due to prevailing wind? Some deadwood in crown | None - growing out of hedge bank | 20+ | B1,2 |

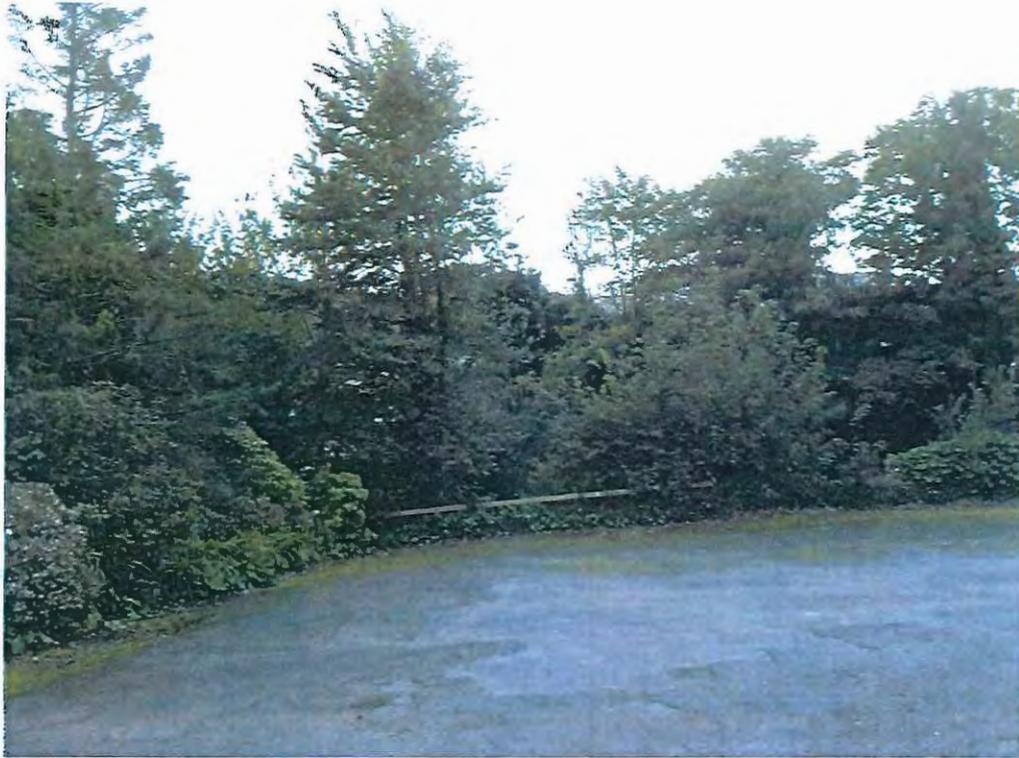
- 5.4 The trees on the southern boundary are a mix of younger sycamores (T13), a semi-mature elm and a large sycamore stump (T11). Whilst contributing some screen value to the site none are considered significant enough to affect the proposed development. Removal of the regenerating stump (T11) is recommended.

Fig 3 The southern boundary, where the proposed new entrance is to be constructed, Elm (T12) central and the sycamore stump (T11) to the right

| Tree Number | Species<br>(MS=Multi-stemmed) | Height (m) | Stem Dia. (mm) | Branch Spread (m) N E S W | Ht Crown Clear (m) | Age Cla | RPA Radius (m) | Physiological Condition | Structural Condition | Management Recommendations | Est. Remain Yrs | Cat Grade |
|---|--|---|---|---|---|---|---|--|--|---|---|---|
| T11 | Sycamore MS (Acer pseudoplatanus) | 3 | 800 | 2-2-2-2 | 1 | M | 9.6 | Good | Felled/coppiced tree | Lost in proposals | 40+ | C1,2 |
| T12 | Elm MS (Ulmus sp) | 10 | 300 | 2-2-2-2 | 2 | SM | 3.6 | Good<br>Will probably succumb to Dutch Elm Disease | Good | Lost in proposals | <10 | C1,2 |

- 6.3 The proposed new driveway and parking area will has some impact on the trees and vegetation in the southern half of the site. The construction of the new entrance onto Doctors Hill will require the removal of the large stump (T11) – recommended anyway due to poor form and trees (T12) and (T13) (see section 5.4). It is also recommended to remove the Norway spruce (T10) – poor vitality and the Lawson’s cypress (T9) – poor form. The new car parking area will impact on the coppiced sycamore (T8). The most pragmatic approach would be to fell and remove this tree and replant the section with a more appropriate tree for the location e.g. whitebeam or rowan. The shrubs and small trees of group (G2) will need to be removed in the proposals, but this is not seen as a significant constraint on any development.

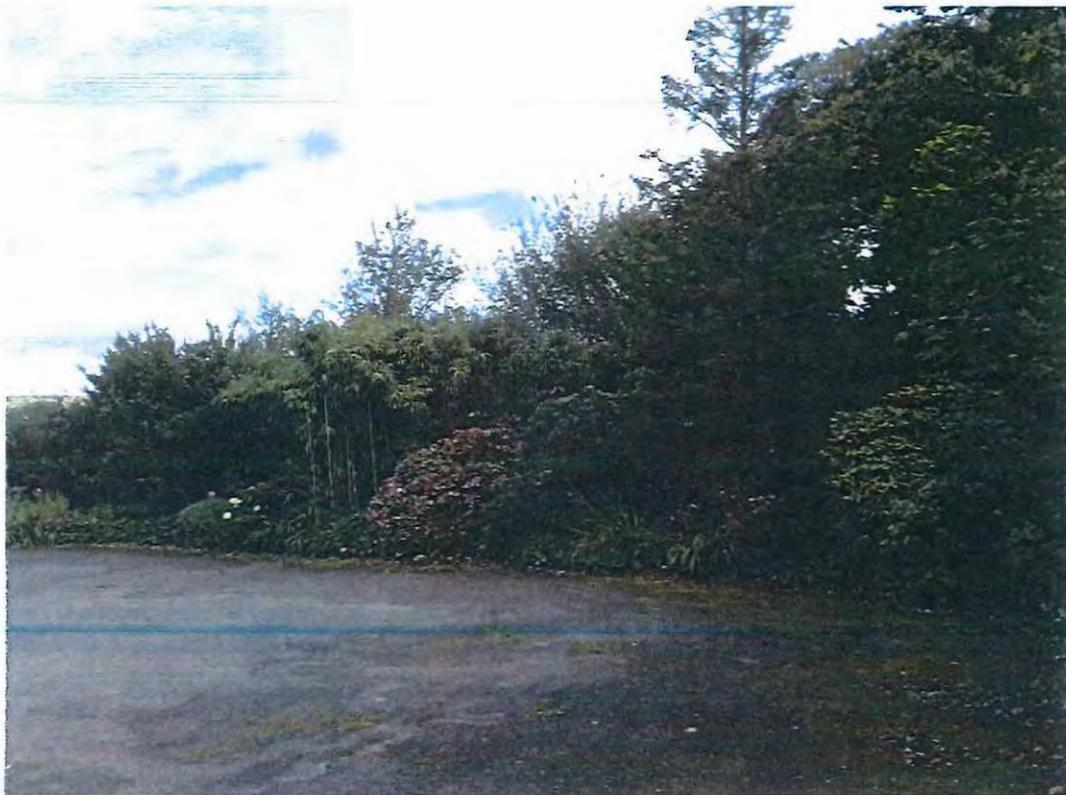
Fig 4: General view of group (G3), by the existing car park

| Tree Number | Species<br>(MS=Multi-stemmed) | Height (m) | Stem Dia. (mm) | Branch Spread (m) N E S W | Ht Crown Clear (m) | Age Cla | RPA Radius (m) | Physiological Condition | Structural Condition | Management Recommendations | Est. Remain Yrs | Cat Grade |
|---|--|---|---|---|---|---|---|--|--|---|---|---|
| G3 | Sycamore, Elm MS | 10 (av) | 500 (av) | 4-4-4-4 (av) | 5 (av) | M | 7.2 | Good | Heavy ivy growth | Remove ivy | 40+ | B1,2 |
