## **APPENDIX C**

**UP AND UNDER SURVEY UU4779/SHS/SEPT 2016-09-15  
(Extract only)**

**CR ENGINEERING REPORT REPLACEMENT SPACE  
HEATING BLOCKS EFAG AND EFAH**

JAB THE VISUAL INSPECTION & CONCRETE TESTING  
- STOURPORT-ON-SEVERN HIGH SCHOOL

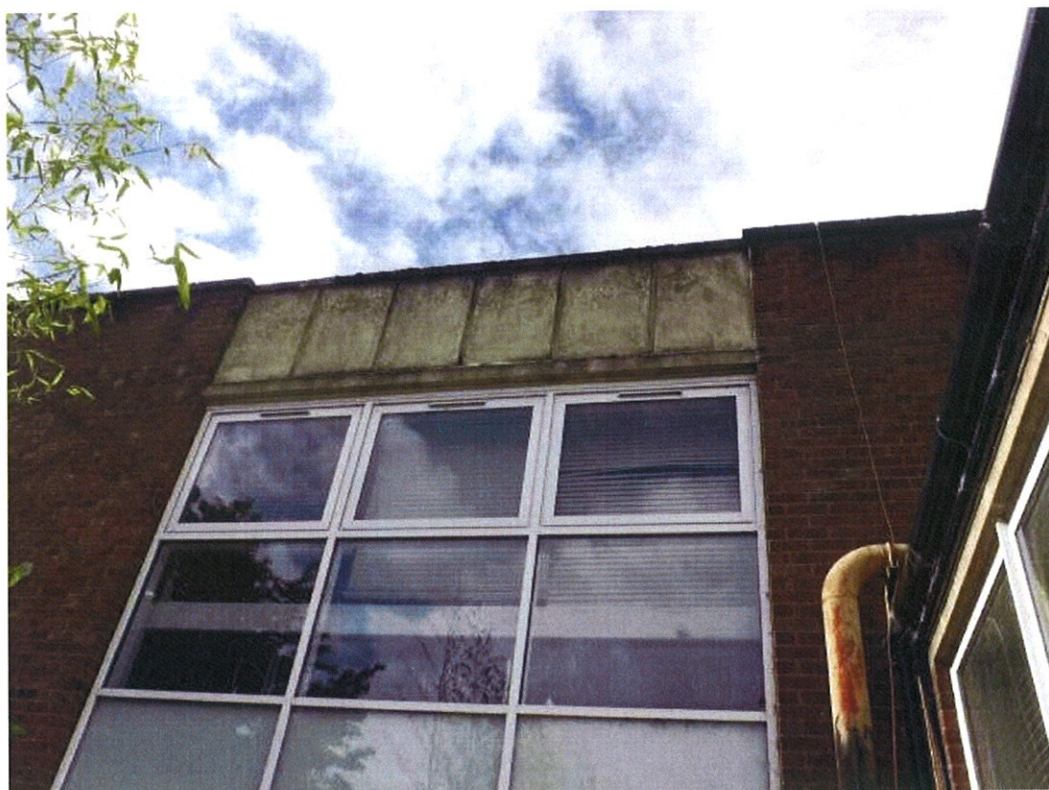
Photo 14: General view showing side elevation (Kingsway). Note the paint flaking.

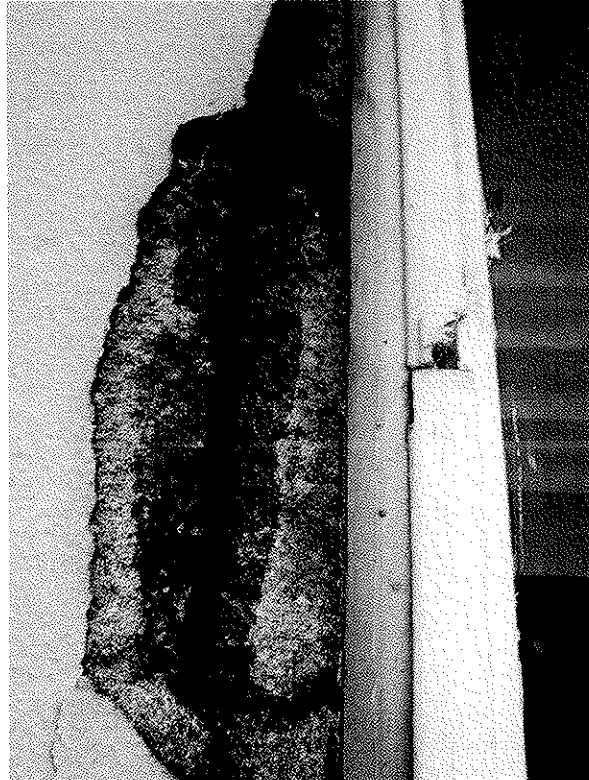
- 4.1 No movement was detected to any of the concrete panels during tactile inspection.
- 4.2 Three areas of spalling showing exposed reinforcement were noted to the north face of the internal side elevation. The largest of these defects were found to measure 150x440x40mm. Corrosion with pitting was noted to the reinforcement at these locations.  
*Refer to photo: 15.*

Photo 15: Detailed view showing an area of spalling with exposed reinforcement measuring 150x440x40 at the internal side elevation.

- 6.1 In the main, the defects noted would not appear to threaten the stability or integrity of the structure. However, durability appears to be compromised.
- 6.2 Areas of spalling appear to be caused by corrosion of the reinforcement which is likely due to shallow cover combined with failure of the protective paint system. Investigation results support this conclusion, as the deterioration of the concrete appears to have occurred in localised areas only.
- 6.3 Consideration should be given to undertaking localised concrete repairs in addition to complete re-painting of the panels to improve durability.

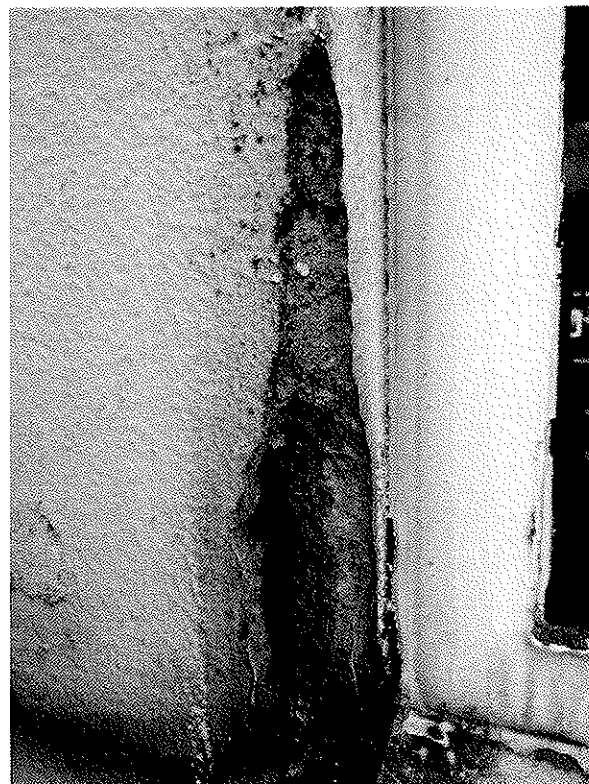
Areas of spalling and exposed reinforcing noted throughout the structure showed concrete cover to be significantly thinner than that noted at the test locations. The area of spalling with exposed reinforcement with the shallowest depth measured 250x200x4mm.

Photo 16: Detailed view showing an area of spalling with exposed reinforcement measuring 250x200x4mm at the internal side elevation.

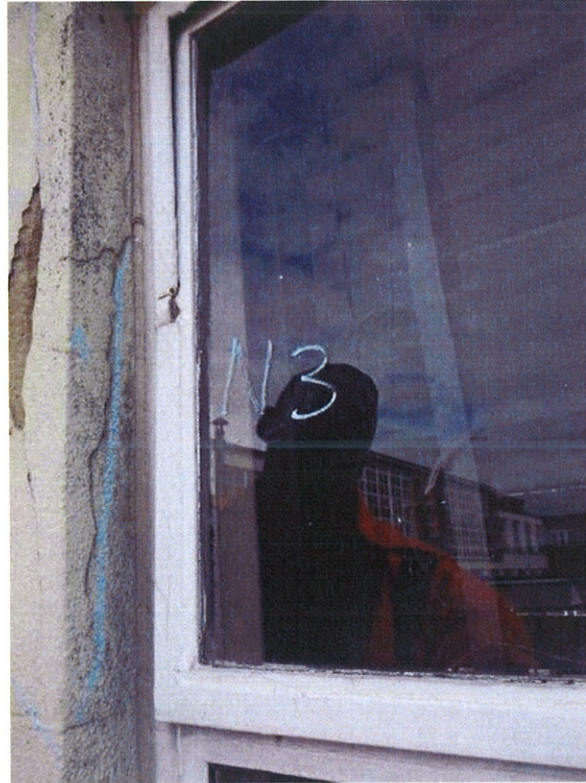
Photo 17: Detailed view showing an area of spalling with exposed reinforcement measuring 45x550x25mm at the internal side elevation.

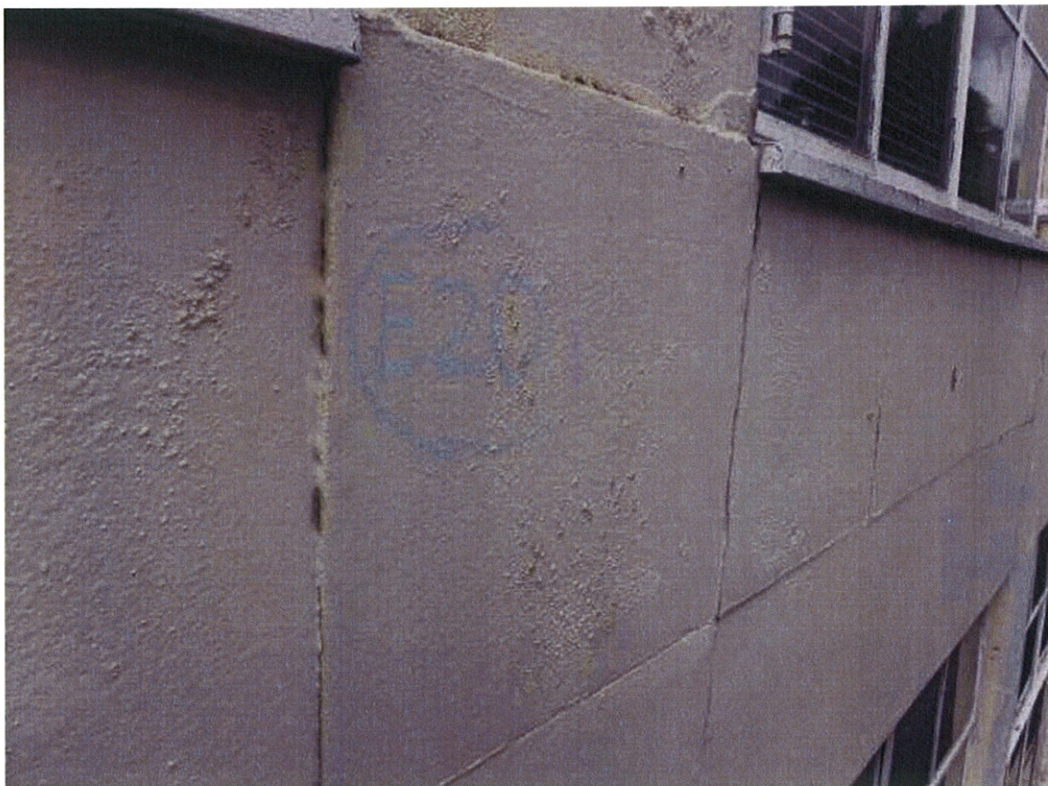
Photo 18: View showing a misaligned panel by up to 8mm on the front elevation, towards the south.

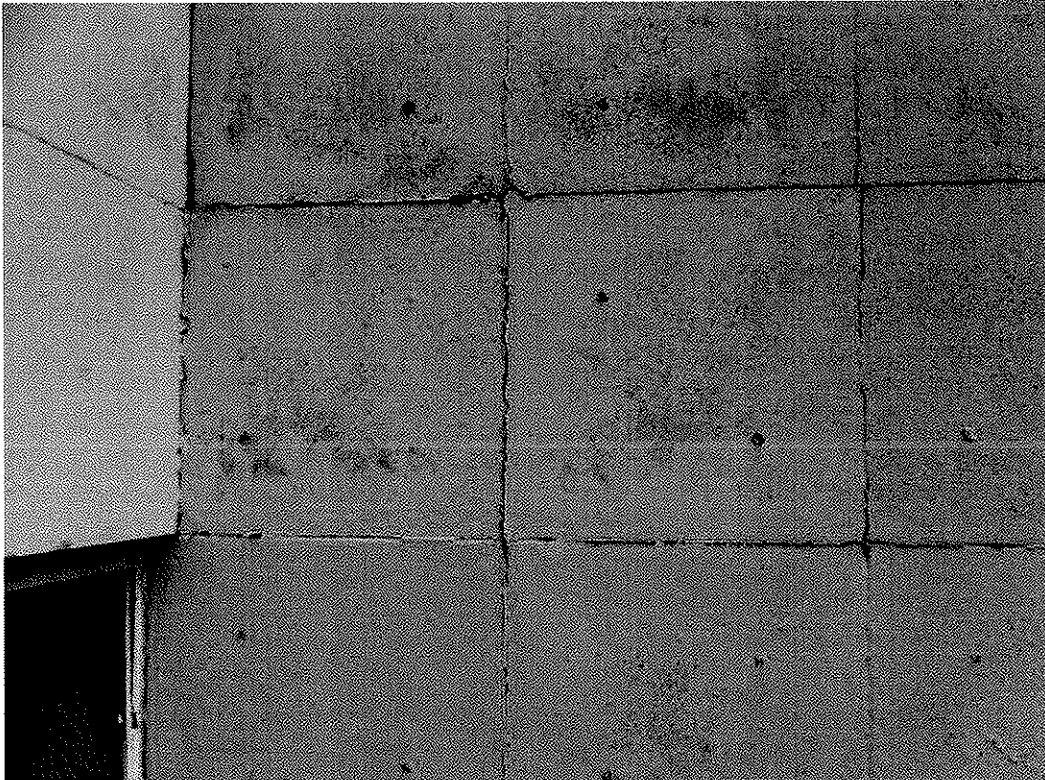
Photo 19: General view showing cracks to the paint at the panel joints typical throughout the structure.

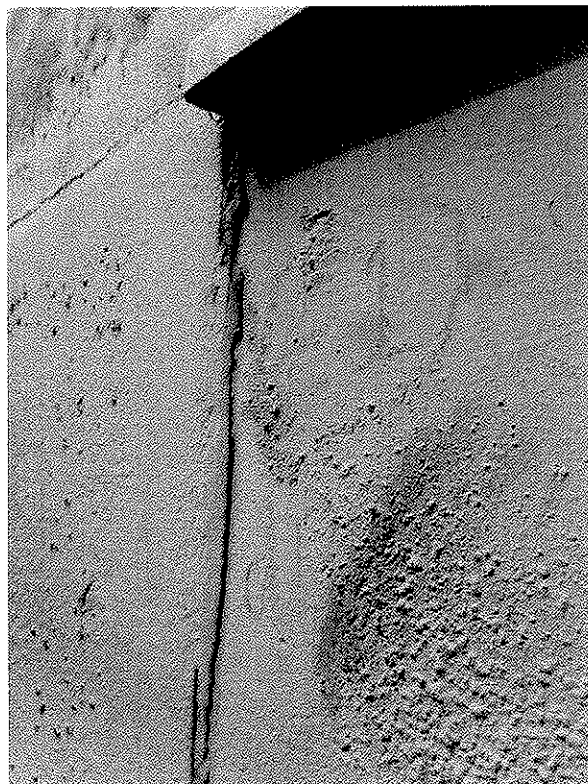
Photo 20: View showing a misaligned panel by 5mm to the front elevation which were typical throughout the structure.

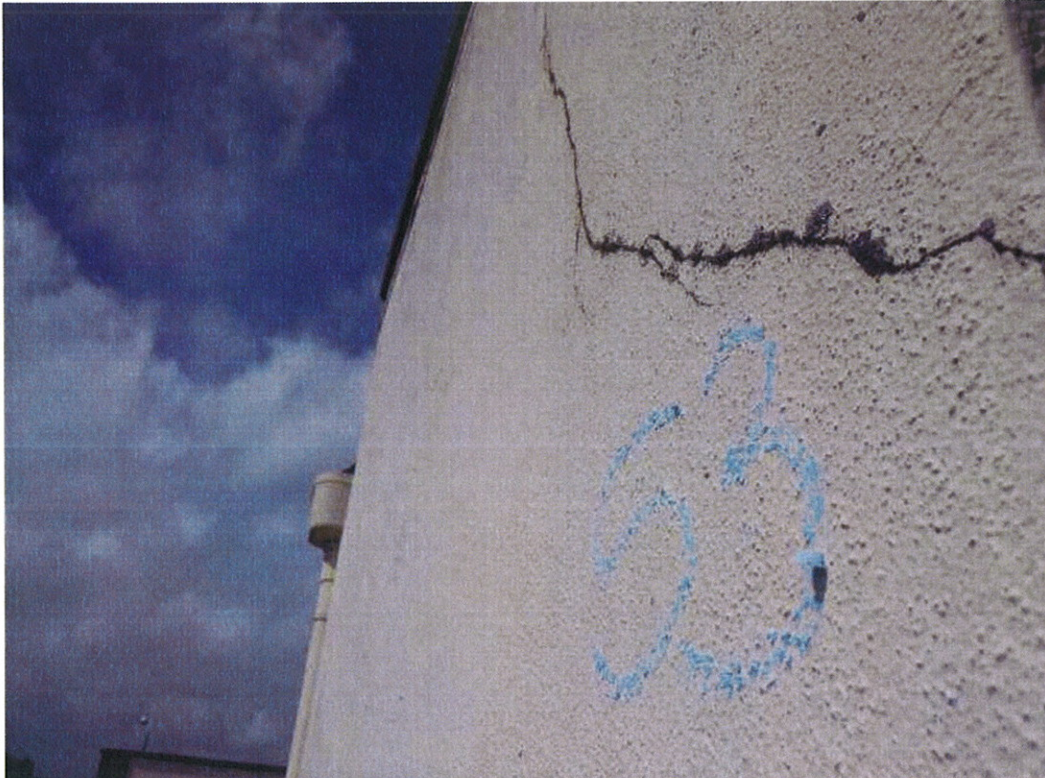
Photo 21: View showing a multi-directional crack measuring 500x1mm to side elevation D (Windermere Way).

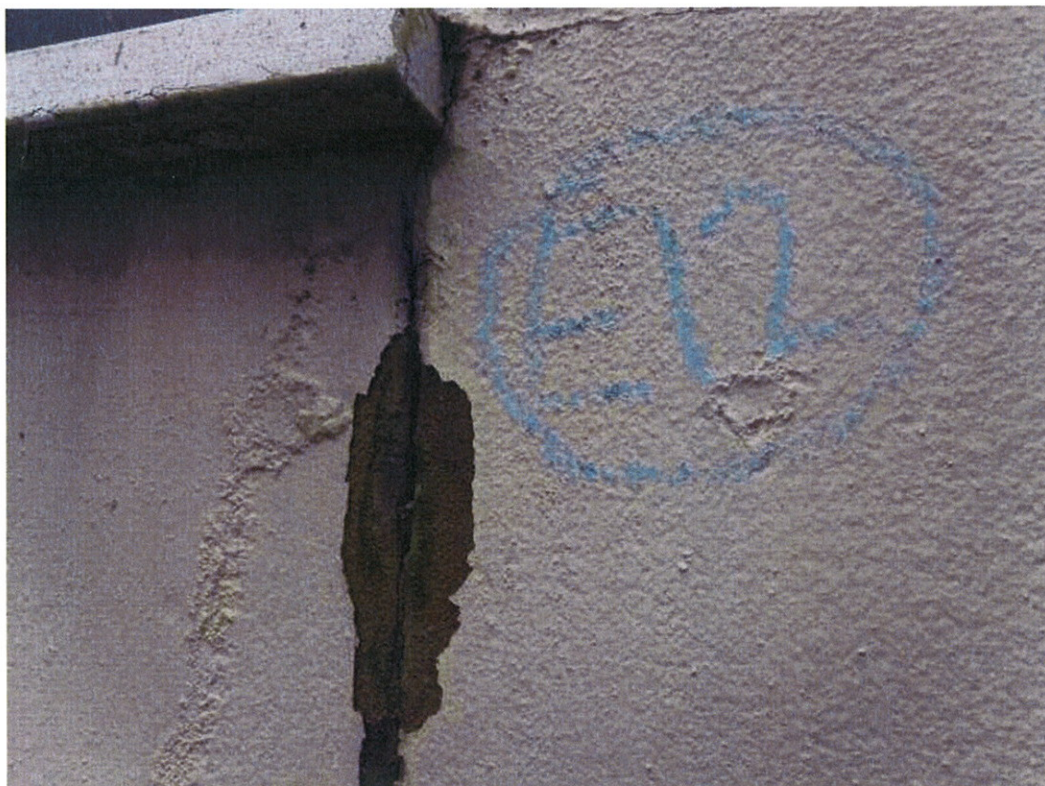
Photo 22: View showing joint mortar loss to the front elevation measuring 100x5x60mm.

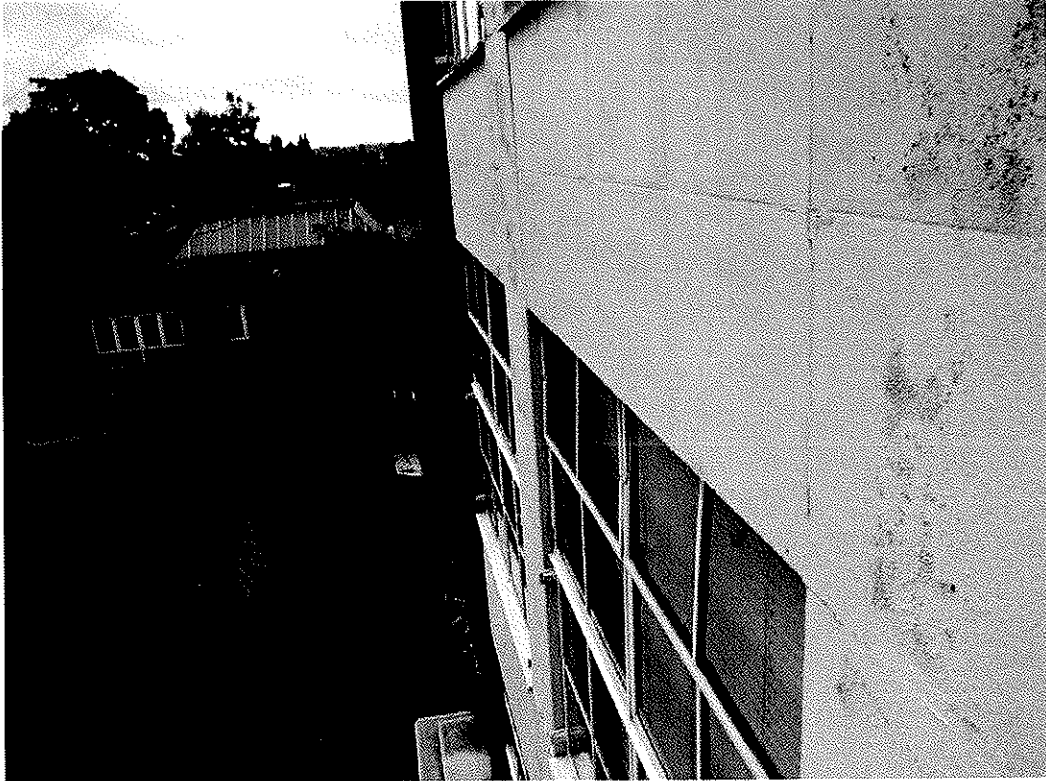
Photo 23: General view showing paint flaking at front elevation B, typical throughout the structure.

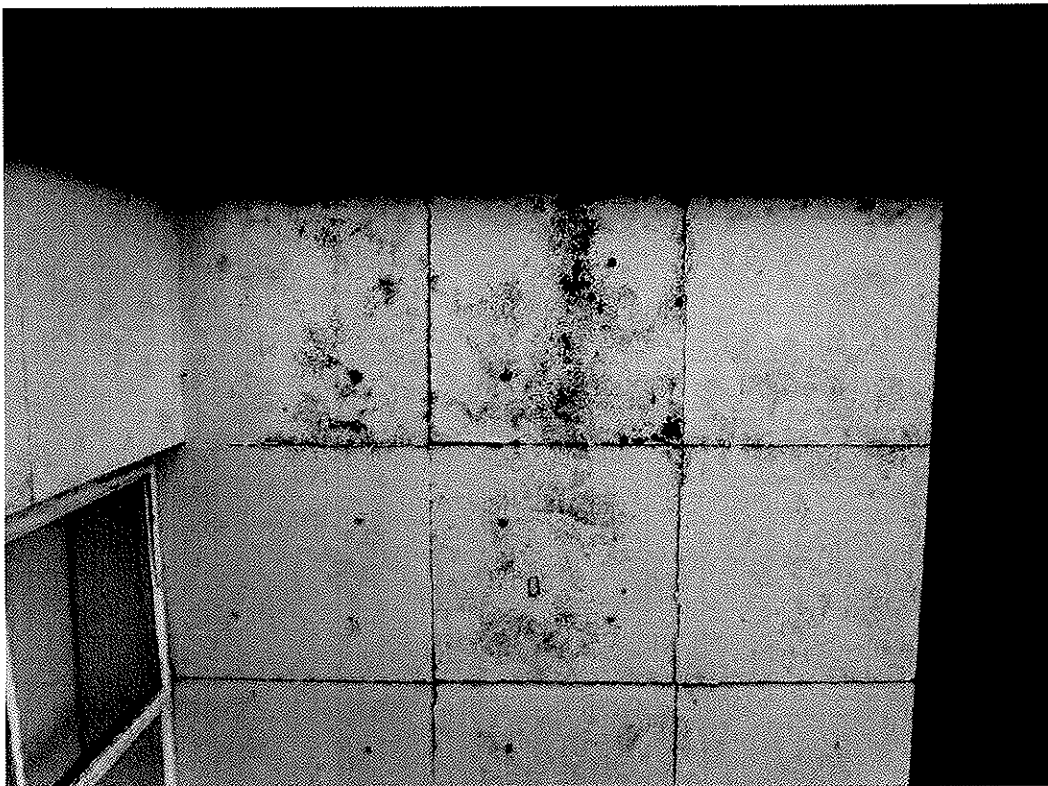
Photo 24: View showing paint flaking to front elevation C.

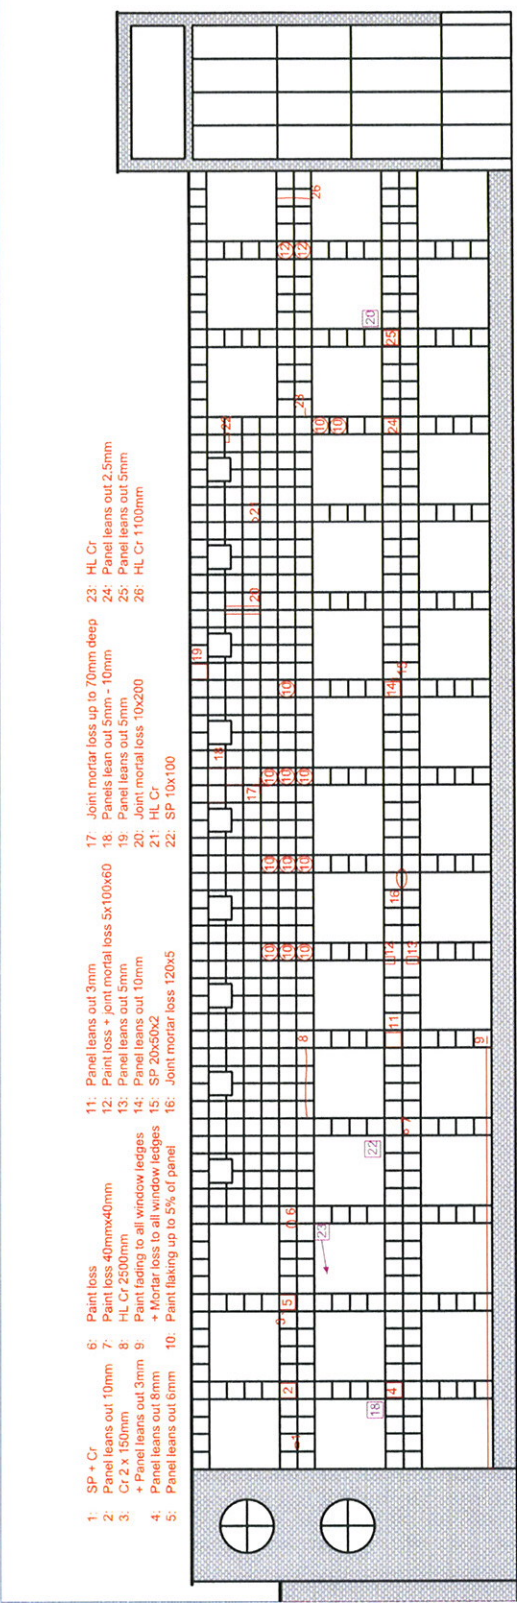
FRONT ELEVATION

Notes:  
Paint HL cracking at approx. 80% of panel joints

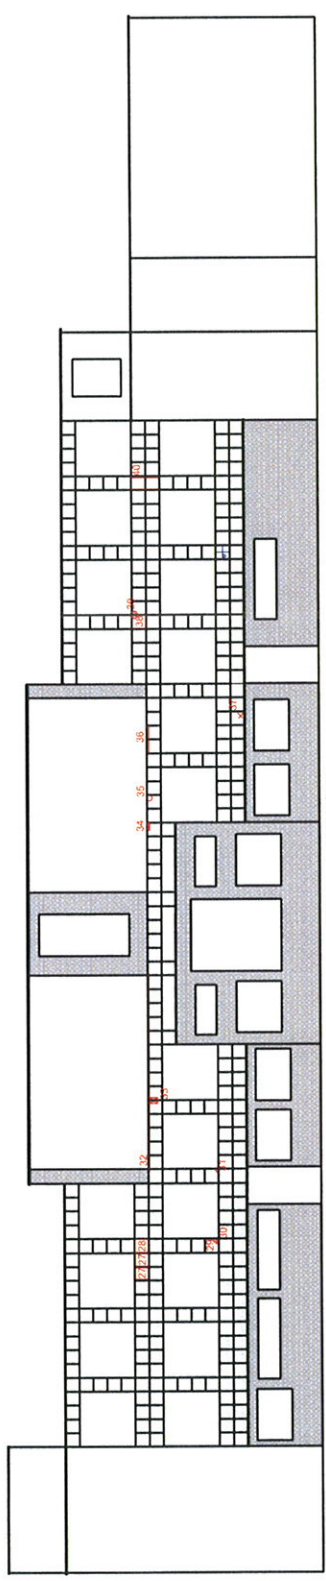
REAR ELEVATION

Notes:  
Paint HL cracking at approx. 80% of panel joints

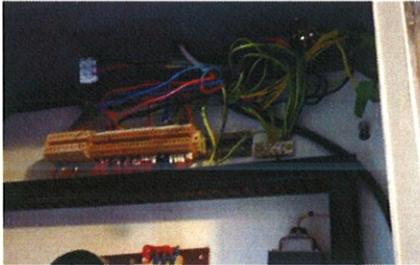
Both blocks have extremely poor and to some extent dysfunctional space heating systems. The Music block has a single heating boiler serving a mix of heat emitters mostly in poor condition. There is no up to date gas safety system. The Drama block features a very dilapidated hot air unit in the roof void. There is no up to date gas safety system in this space either.

Music block heating controls wiring

The proposal is for a new motor control panel including touch screen based control system so that the school can have local control over the settings / times. The touch screen will be the same as that recently installed in the main block boiler room.

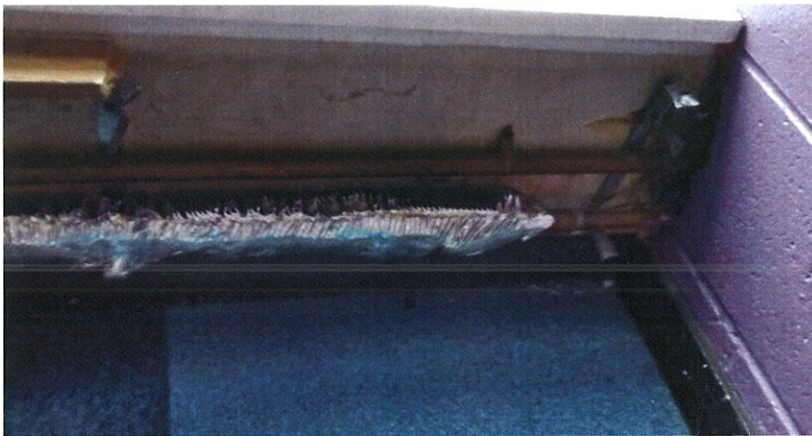
Music block heat emitters

Completely remove existing Music block space heating installation and replace with conventional two pipe heating system.

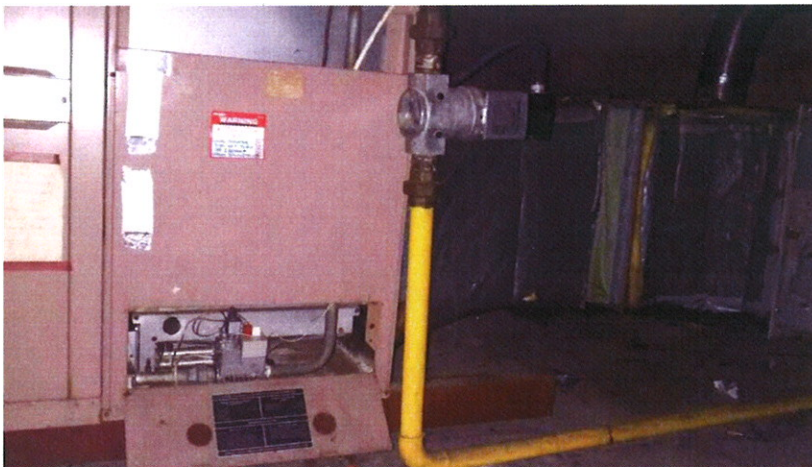
Drama block hot air heating plant

Completely remove existing Drama block space heating installation and replace with conventional two pipe heating system served via a pair of buried heating mains from the proposed boiler plant in the Music block.
