Taylor Wimpey West Midlands

Demolition Asbestos Survey

Windemere Grange
The Stourport High School and Sixth Form Centre
Coniston Crescent
Burlish Park
Stourport
DY13 8JU

1470438-01 (Revision 1)

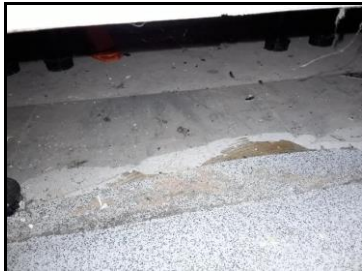
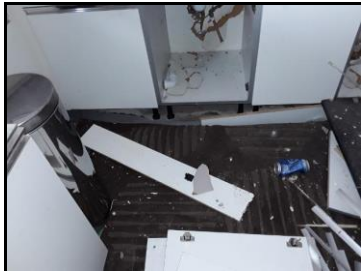
Building	Caretakers House	Floor	Ground Floor	Room	Kitchen (009)
Item / Description	Grey floor tiles and adhesive			Quantity	8m ²
Accessibility	Occasional Disturbance

Material	Vinyl and Adhesive				
Condition	Low (1)				
Sample Number	S46354				
Surface Treatment	Composite (0)				
Identification	Chrysotile				
Material Score	3				
Priority Score	0				
Total Risk Score	3				
Recommendations	Remove prior to demolition. Work on this material will require a trained and competent person working to an appropriate risk assessment and method statement and is unlikely to require licensed contractors and 14-day notification prior to commencement.				
Further Details	-

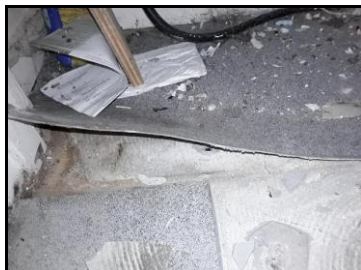
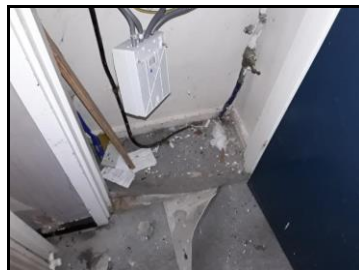
Building	Caretakers House	Floor	Ground Floor	Room	Store (010)
Item / Description	Grey floor tiles and adhesive			Quantity	1m²
Accessibility	Occasional Disturbance

Material	Vinyl and Adhesive				
Condition	Low (1)				
Sample Number	As Sample S46354				
Surface Treatment	Composite (0)				
Identification	Chrysotile				
Material Score	3				
Priority Score	0				
Total Risk Score	3				
Recommendations	Remove prior to demolition. Work on this material will require a trained and competent person working to an appropriate risk assessment and method statement and is unlikely to require licensed contractors and 14-day notification prior to commencement.				
Further Details	-

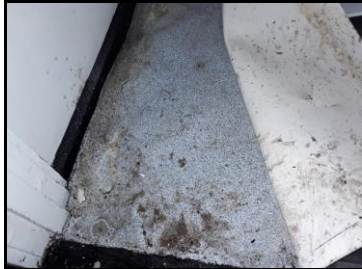
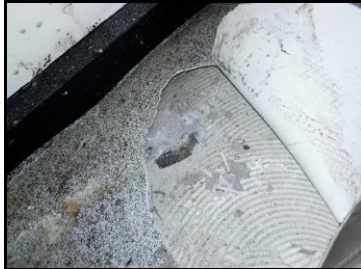
Building	Caretakers House	Floor	Ground Floor	Room	WC (011)
Item / Description	Bitumen to floor screed			Quantity	2m²
Accessibility	Occasional Disturbance

Material	Bituminous Product				
Condition	Low (1)				
Sample Number	As Sample S46355				
Surface Treatment	Composite (0)				
Identification	Chrysotile				
Material Score	3				
Priority Score	0				
Total Risk Score	3				
Recommendations	Remove prior to demolition. Work on this material will require a trained and competent person working to an appropriate risk assessment and method statement and is unlikely to require licensed contractors and 14-day notification prior to commencement.				
Further Details	-

Caretakers House				
Risk	Floor	Room	Item / Description	Recommendation
Very Low	Ground Floor	WC (011)	Bitumen to floor screed - Bituminous Product	Remove prior to demolition. Work on this material will require a trained and competent person working to an appropriate risk assessment and method statement and is unlikely to require licensed contractors and 14-day notification prior to commencement.
Very Low	Ground Floor	Lobby (012)	Bitumen to floor screed - Bituminous Product	Remove prior to demolition. Work on this material will require a trained and competent person working to an appropriate risk assessment and method statement and is unlikely to require licensed contractors and 14-day notification prior to commencement.

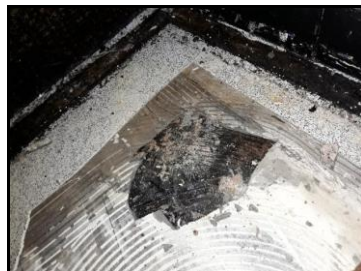
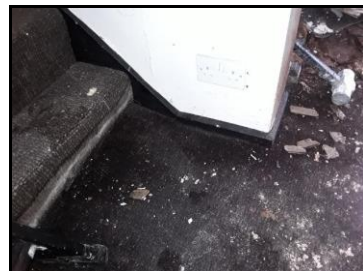
Building	Caretakers House	Floor	Ground Floor	Room	Lobby (012)
Item / Description	Bitumen to floor screed			Quantity	8m²
Accessibility	Occasional Disturbance

Material	Bituminous Product				
Condition	Low (1)				
Sample Number	S46355				
Surface Treatment	Composite (0)				
Identification	Chrysotile				
Material Score	3				
Priority Score	0				
Total Risk Score	3				
Recommendations	Remove prior to demolition. Work on this material will require a trained and competent person working to an appropriate risk assessment and method statement and is unlikely to require licensed contractors and 14-day notification prior to commencement.				
Further Details	-

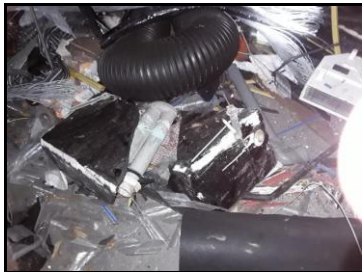
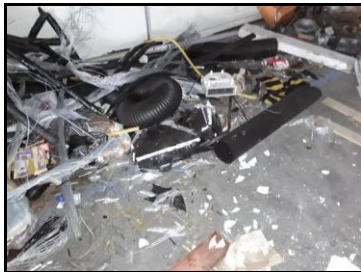
Building	Caretakers House	Floor	Ground Floor	Room	Outbuilding (015)
Item / Description	Toilet cistern			Quantity	1no
Accessibility	Occasional Disturbance

Material	Composite / Reinforced Plastics / PVC				
Condition	High (3)				
Sample Number	S46344				
Surface Treatment	Composite (0)				
Identification	Amosite				
Material Score	6				
Priority Score	0				
Total Risk Score	6				
Recommendations	Remove prior to demolition. Work on this material will require a trained and competent person working to an appropriate risk assessment and method statement and is unlikely to require licensed contractors and 14-day notification prior to commencement.				
Further Details	On floor. Poor condition

Caretakers House				
Risk	Floor	Room	Item / Description	Recommendation
Low	Ground Floor	Outbuilding (015)	Toilet cistern - Composite / Reinforced Plastics / PVC	Remove prior to demolition. Work on this material will require a trained and competent person working to an appropriate risk assessment and method statement and is unlikely to require licensed contractors and 14-day notification prior to commencement.
Very Low	Ground Floor	Kitchen (009)	Grey floor tiles and adhesive - Vinyl and Adhesive	Remove prior to demolition. Work on this material will require a trained and competent person working to an appropriate risk assessment and method statement and is unlikely to require licensed contractors and 14-day notification prior to commencement.
Very Low	Ground Floor	Store (010)	Grey floor tiles and adhesive - Vinyl and Adhesive	Remove prior to demolition. Work on this material will require a trained and competent person working to an appropriate risk assessment and method statement and is unlikely to require licensed contractors and 14-day notification prior to commencement.

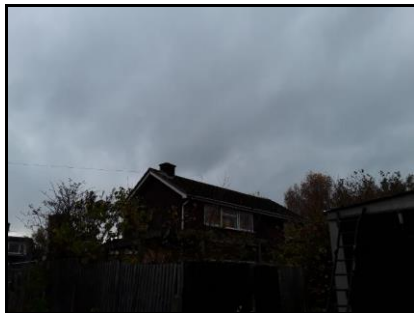
Caretakers House			
Floor	Room	Description	Reason not accessed / no access agreed with
External	External (EXT)	Limited Access Gained to Roof	Inspected as far as reasonably practicable using ladders and garage roof access.

Building	Caretakers House	Floor	External	Room	External (EXT)
Item / Description	Roof			Quantity	-
Accessibility	-

Material	Limited Access Gained				
Condition	-				
Sample Number					
Surface Treatment	-				
Identification	-				
Material Score	0				
Priority Score	0				
Total Risk Score	0				
Recommendations					
Further Details	Inspected as far as reasonably practicable using ladders and garage roof access.

Until such time as limited / no access areas can be inspected and any suspect materials contained within have been sampled and analysed by a competent person, in accordance with HSG264, these areas should be presumed to contain asbestos.
