ARBORICULTURAL IMPLICATIONS ASSESSMENT

LEY HOUSE
MARPLE BRIDGE
STOCKPORT

Author: R. Pearce
Date: 10 January 2021
Ref: PAC.AIA.01.21

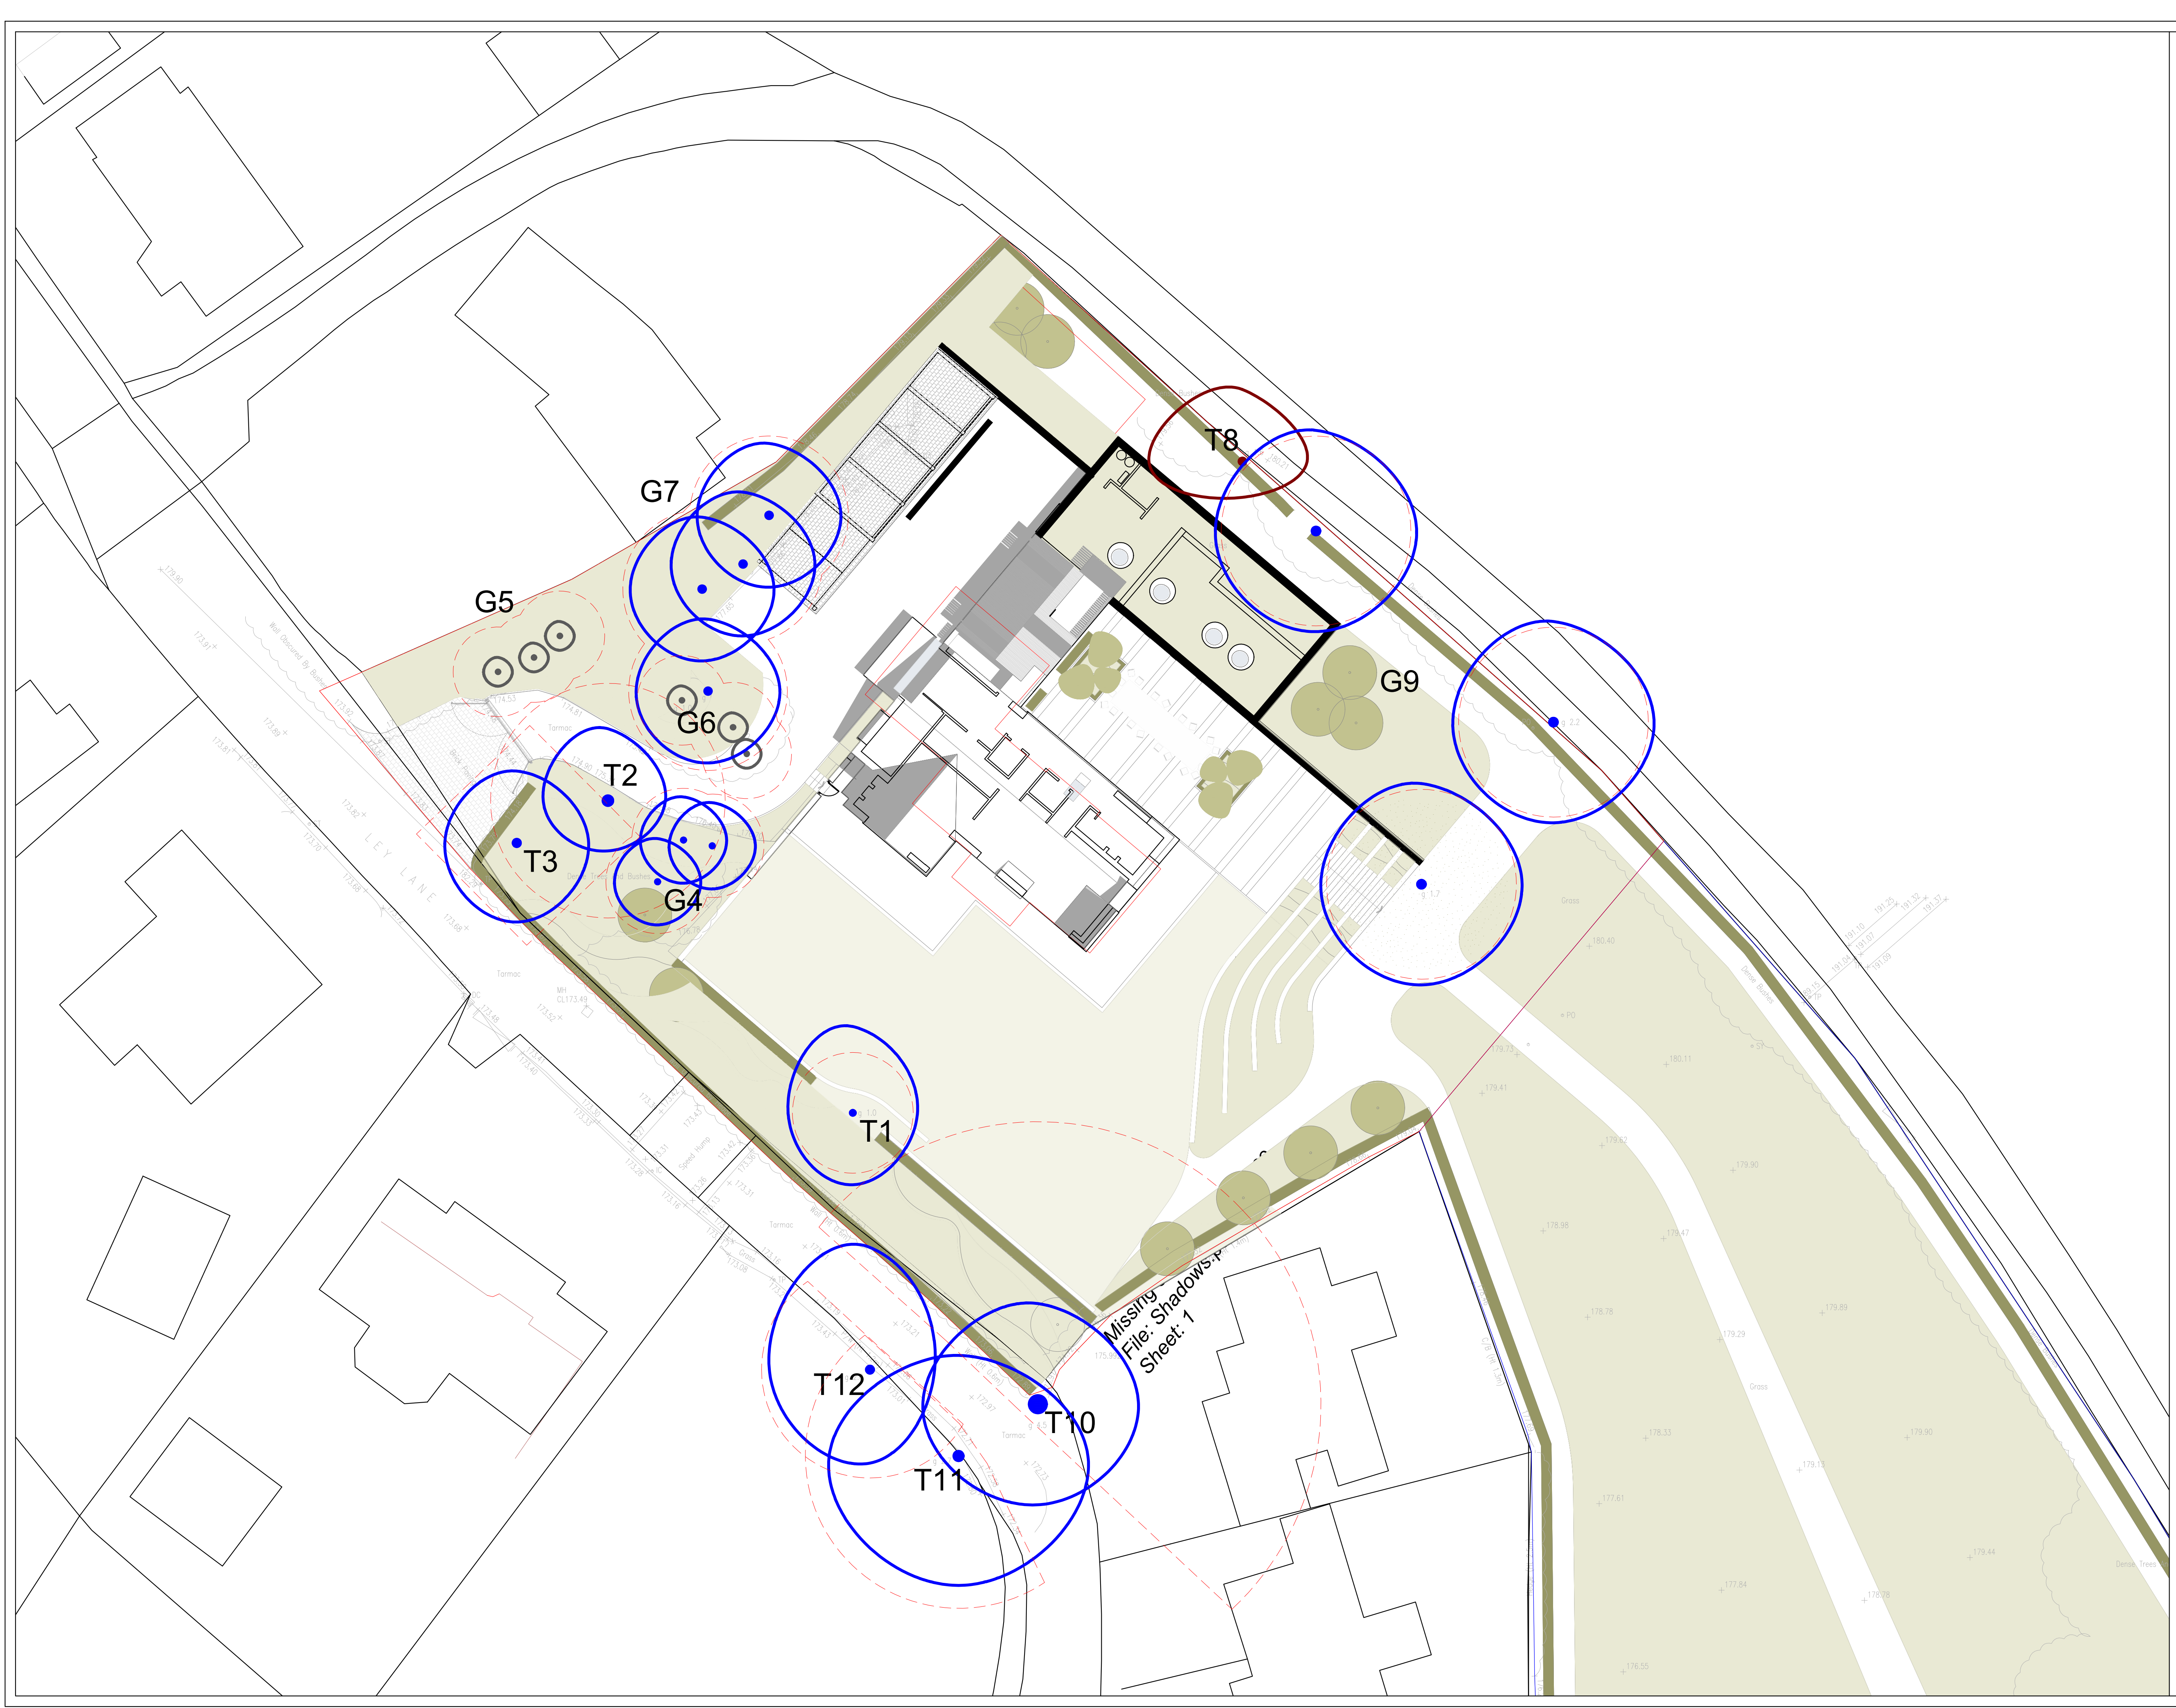
Drawing Title:
AIS Plan

Tree No.	Root Protection Area identified in Table 2 of BS 5837:2012	Distance to Proposed Hard Standing (m)	Distance to Proposed Development (m)	Can the Tree/s be Successfully Retained
T1	20m ² = circle with a radius of 4.2m	12.30	19.10	Yes
T2	209m ² = circle with a radius of 8.16m	12.46	16.35	Yes as outlined in section 5.2 & 5.3 below
T3	118m ² = circle with a radius of 6.12m	18.65	22.84	Yes
G4	41m ² = circle with a radius of 3.6m	5.15	9.6	Yes as outlined in section 5.2 & 5.3 below
G5	31m ² = circle with a radius of 3.12m	20.94	22.42	Yes
G6	46m ² = circle with a radius of 3.84m	0.9	8.8	Yes as outlined in section 5.3 below, x2 trees to be removed for development.
G7	94m ² = circle with a radius of 5.46m	3.75	10.50	Yes as detailed in section 5.2 & 5.4 below
T8	100m ² = circle with a radius of 5.64m	11.45	11.85	No
G9	137m ² = circle with a radius of 6.6m	14.18	17.10	Yes – x1 tree to be removed for development.

T10	652m ² = circle with a radius of 14.4m	27.70	31.64	Yes
T11	191m ² = circle with a radius of 7.8m	32.40	36.20	Yes
T12	113m ² = circle with a radius of 1.36m	29.60	32.70	Yes

Trees to be retained		Trees to be removed	
	With No Impact	With detailed construction	Due to Condition	Due to Development
Tree No.	T1, T3, G5 Part of G9, T10, T11 & T12	T2, G4, part of G6 & G7	T8	Part of G6 & Part of G9

- 5.2.1 To accommodate the proposals, it will be necessary to prune some of the retained trees, in order to provide suitable access and working distances for pedestrians and vehicles. This is known as 'access facilitation pruning' this is relevant to T2, G4 and G7 all of which require 3m crown lifts.

- 5.3.1 As shown above, the Impact Table raises concern of the proximity of the development driveway and car parking to T2, T3, G4, G5 and G6 and the effect the proposals would have on the Safe Useful Life Expectancy of the trees.
- 5.3.2 Proposed hard surfaces are present within the RPA of T2, T3, G4, G5 and G6. In this case the proposed surface is situated within the footprint of existing hard surfacing. Where this is applicable, the existing surface should be retained in situ to prevent damage to tree roots. If required, it may then be resurfaced as appropriate, providing that the base is retained and no excavation takes place within the RPA.

- 5.4.3 As you can see from the table above the proposed structure does not exceed 20% of the RPA.
- 5.4.4 To facilitate the development and prevent significant damage to any tree roots within the RPAs of these trees. Supervised excavation and root pruning should be undertaken by the arboricultural consultant.
- 5.4.5 If the following points are adhered to then the long-term health and retention of G7 (1 tree) will not be adversely affected.
- Excavation must be carried out using hand tools to avoid direct damage to the bark of the roots. It may be possible in some instances to use specialised equipment such as high air pressure machinery to excavate the soil with minimal disturbance to roots.
 - Exposed roots will be wrapped in dry, clean Hessian to prevent the roots from drying out. In hot or dry weather, the hessian should be kept moist. The hessian must be removed before backfilling.
