Project No 10-3030

08 April 2010

Re: "Woodend" Old Wood South, Skellingthorpe, Lincoln – Visual Structural Inspection

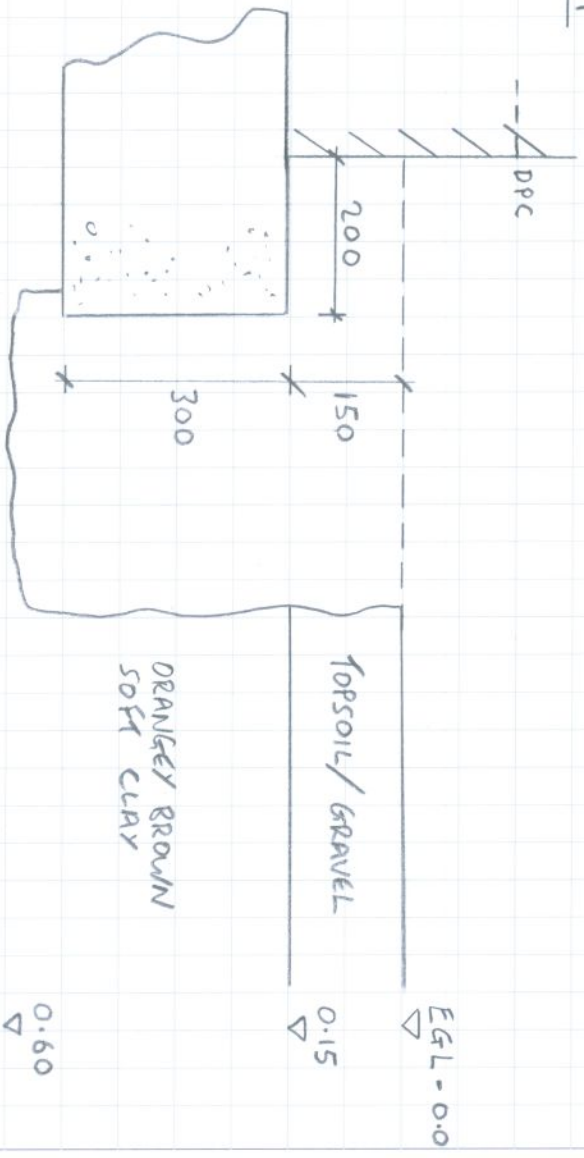
TRIAL HOLE 1

The ground conditions comprise clay of subsoils upon which the building is founded using concrete strip footings. Refer to the trial hole logs and location plan for further details.

The main cause of concern regarding the existing property is the shallow depth (approximately 500mm) at which the existing footings are founded due to the nature of the subsoils and the close proximity of trees.
