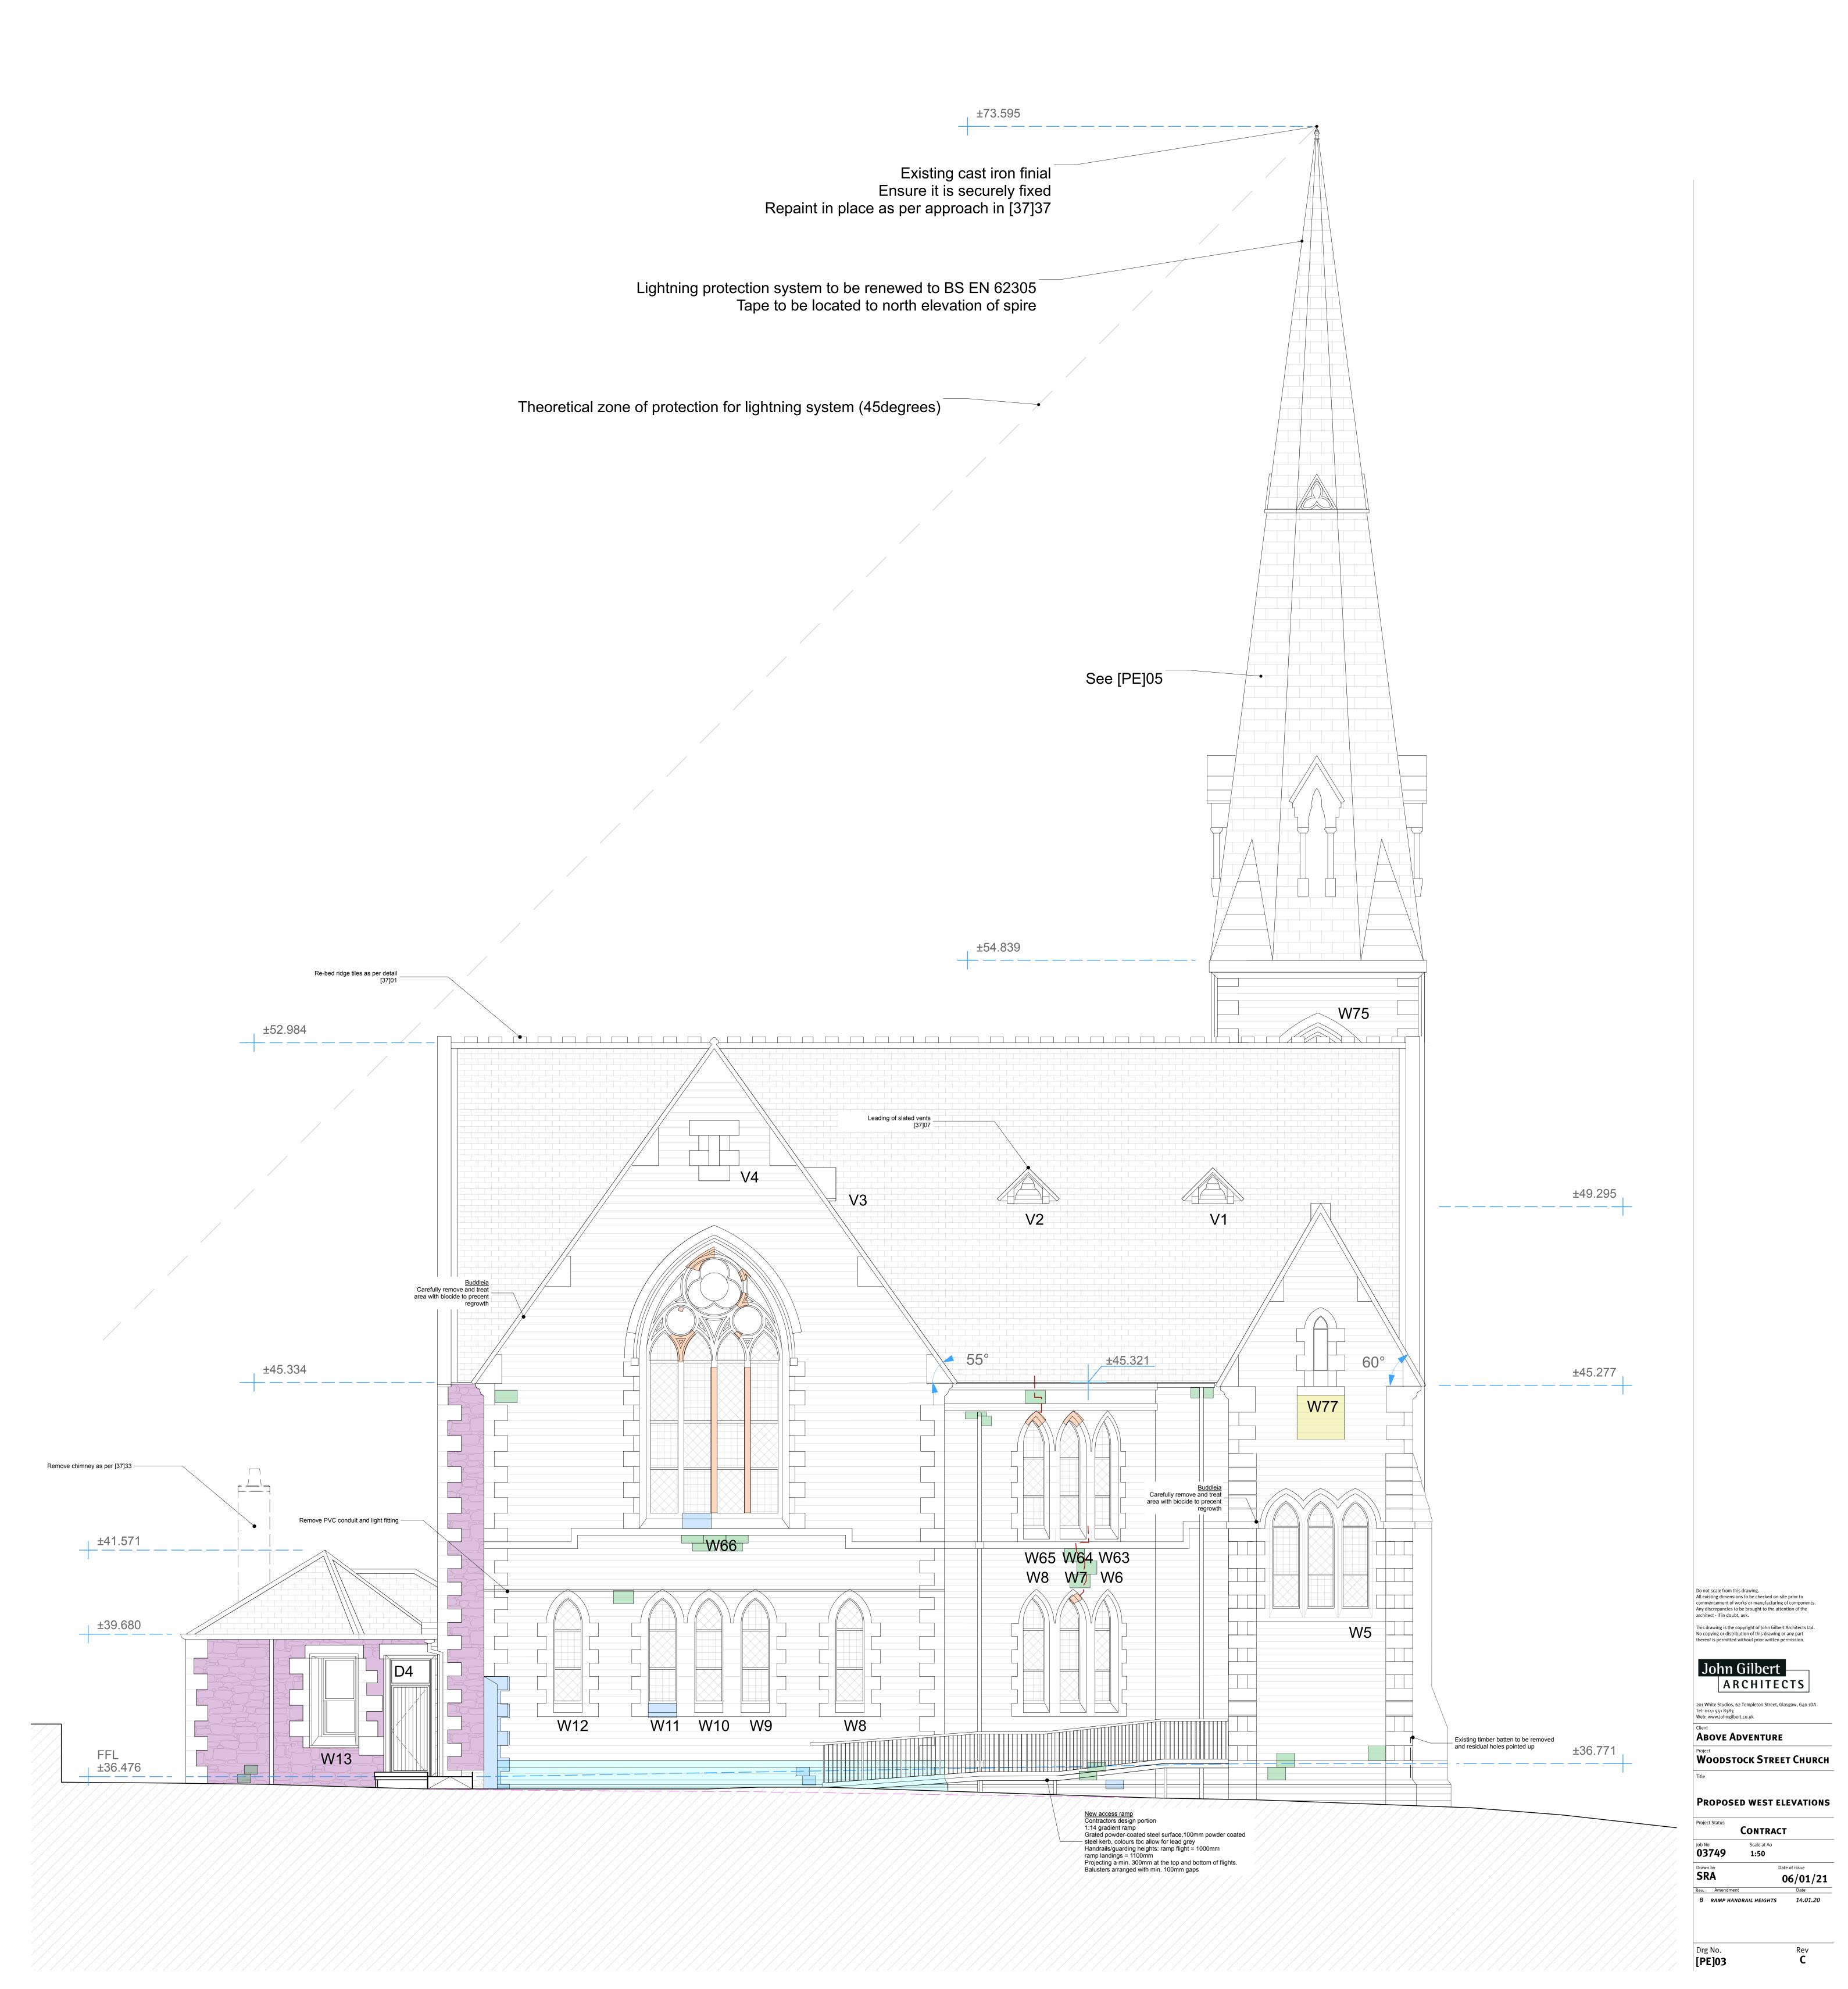
150mm full stone indent		Area requiring repointing 3mm ashlar joint	ALL GUTTERS TO EXISTING BUILDINGS TO BE REPLACED
Ashlar faced		NHL 5	EXISTING SLATE ROOF REPAIRS AS PER [PP]03 AND NBS H62 LEAD REPAIRS AS PER
150mm full stone indent Rubble faced		Window mesh installed	DETAIL SERIES 37 AND NBS H71 STONE INDENTS
Full-stone tracery /	[]	Movement crack to be	GENERALLY A MINIMUM OF 150MM DEEP AND CARRIED OUT IN CORNCOCKLE SANDSTONE - SAMPLE TO BE APPROVED BY CA AND HES ON SITE
moulded / mullion indent		repaired	Full extent of stone repairs and repointing to be agreed on site once scaffold is erected, stone repairs and
Area requiring repointing 6mm Rubble joints NHL 3.5 - 1:2		Zone where service penetrations are acceptable in principle, all new cores require CA and HES sign off	repointing not to commence until sign off for scheme is received from HES.
Area requiring repointing 6mm+ Rubble joints NHL 3.5 - 1:2.5

Area requiring repointing 3mm ashlar joint NHL 3.5
