## ABOVE ADVENTURE

## **WOODSTOCK STREET CHURCH**

## FRONT BOUNDARY WALL **TREATMENT**

Drg No. [90]05 Rev

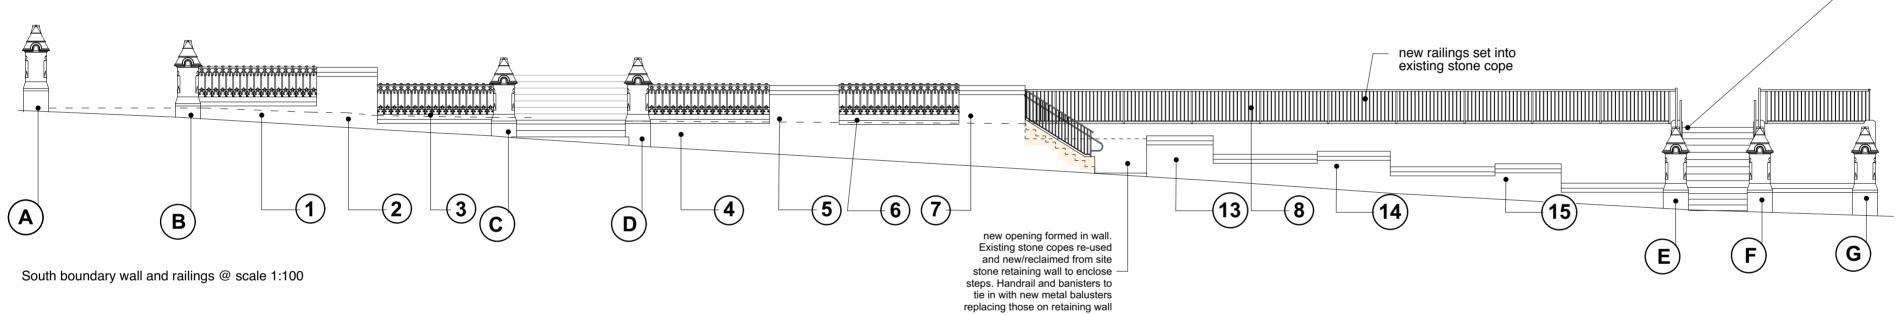
- 1) original cast iron in reasonable condition, clean paint and wire brush, treat any rusted areas with Galvafroid and repaint railings with undercoat and

- 2) Rebed both copes. Reset one stone under cope and repoint wall in matching lime mortar
- 3) Oiginal cast iron railings; Two breaks in balustrade, reweld at joints and reset balustrade. clean paint and wire brush, treat any rusted areas with Galvafroid and repaint railings with undercoat and gloss paint.

- 4) Oiginal cast iron railings; clean paint and wire brush, treat any rusted areas with Galvafroid and repaint railings with undercoat and gloss paint. Point coping and wall under balustrade.

- 5) Carry out stone indent repair to top of cope. Repoint wall under
- 6) Oiginal cast iron railings; clean paint and wire brush, treat any rusted areas with Galvafroid and repaint railings with undercoat and gloss paint. Point coping and wall under balustrade.

- 7) point wall under coping.
- 8) Stone coping 380 wide in good condition, with modern railings set into coping. These metal railings to be removed and replaced with new galvanised railings with saddle back handrail, Twash, primed, undercoated and gloss painted.

- 9) concrete precast steps rise to block paved lánding/ ramp. Handrail and edging poor quality and should be reformed with galvansied steel baulsters and saddle handrail

- 10) Brick wall in reasonable condition but some bricks damaged and require repair. Repointing also required and new vitrified hogroll coping installed to match existing over approx 7 metres

- 11) Original cast iron barleycorn balusters with saddle hadrail. Modern square section handrail welded to original should be removed and new replacement wrought oron handrail installed. 6 new cast iron matching balusters to be set into pockets with molten lead. All metail to be cleaned down, primed, undercoated and gloss painted. At left hand side stone plinth requires indent repair at baluster.

- 12) Original entrance stairway has been repaired in cement, likely applied over original stone steps and stone plinths that support cast iron balusters. These steps will not be used but we recommend that the cement mortar at the plinth walls is entirely removed and any original stone copings restored. The existing steps to remain. The cast iron balusters and handrail to be cleaned down and repainted with undercoat and gloss.

- 13) repoint stone coping and wall under

- 14) indent repair to stone cope. Point cope and
- 15) indent repair to stone cope. Point cope and

Repoint stone upstands Steps to entrance: concrete has been applied to original stone treads. Remove all concrete/ cement screeds and assess stone. Allow for resetting of some stones and some replacements. Allow for indenting of any worn steps. Reform to ensure risers are all the same

existing cast iron balusters cleaned by blasting, repainted as spec and set into pockets in stone treads and leaded into place. SS Pins set into tops of baluster and pinned into handrail
