# Pre-Development BS5837 Tree Survey

Site: Land off Northmoor View, Birmington.

On Behalf of: Vistry Homes.

Reference: BA10077TS

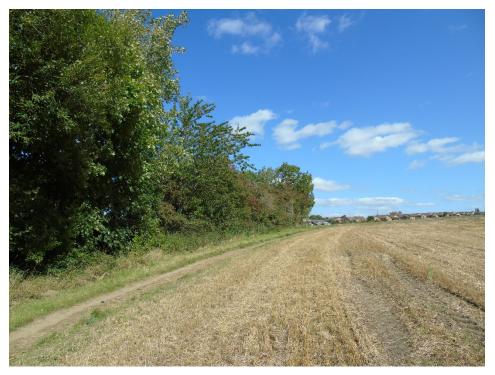
#### The photograph below shows G1 and H2 in location.

G1 and H2 are growing close to the boundary and appear to have had very little management to date with H2 an informal hedge which left unmanaged will only broaden in height and width. G1 and H2 will in the future require cyclic crown lifting over the footpath to maintain clearance. G3 (Ash) borders the scrapyard where the boundary fence is in places tied to the trees where the stems have included the razor and barbed wire. This wire is likely to cause problems to the trees in the future and it is advised that the fence is rebuilt to support itself and the trees 'untied' and any metalwork removed.

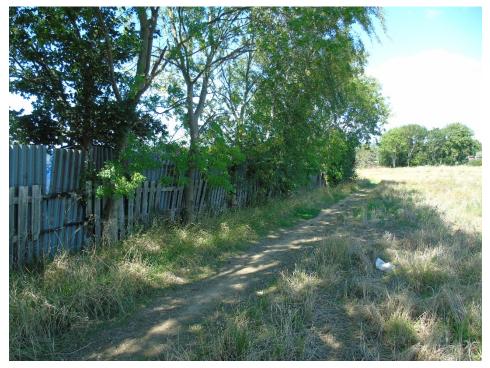
#### The photograph below shows G3 fence to tree proximity.

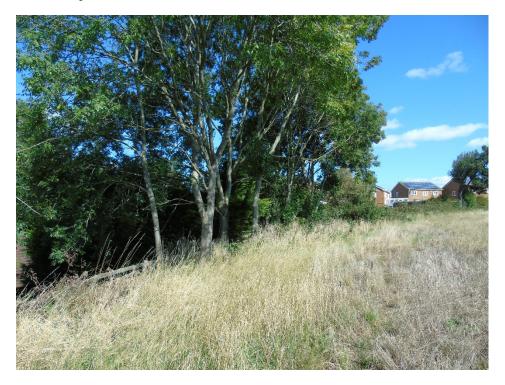
T4-T15 are predominantly Ash trees growing on the northern border between neighbouring properties. The tree forms suggest that most if not all of these trees have been historically 'topped' or coppiced, alluding to them being old hedgerow trees that have been allowed to mature individually due to lack of maintenance. The trees that have evidence of previous reductions at hedge height and are at a slightly greater risk of failing at the unions as the regrowth has naturally weak attachment points. T17 (Ash) is growing on the border between the land and the neighbouring properties. The appearance of the tree suggests a history of pruning back to the boundary as the trees canopy is bias to the south with no inspection possible of the northern stem. If this tree is to be retained it will require 'restoration' pruning to remove some of the end weight to the south in an attempt to balance the crown slightly.

# The photograph below shows T10-T15 in a location close to the boundary.

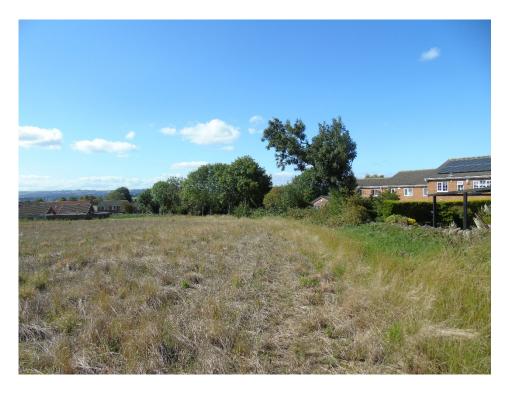
#### The photograph below shows the southern bias of T17 canopy.

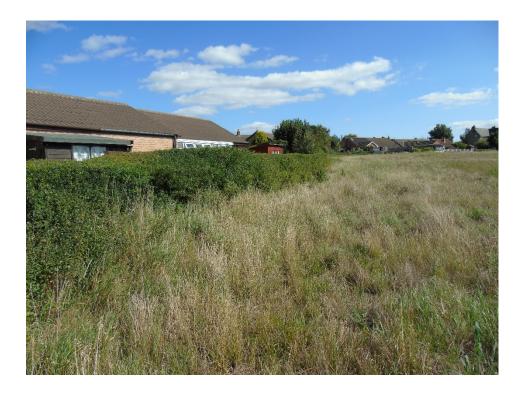
H19-H21 are boundary hedges to the neighbouring properties of various sizes and species. These hedges, on the whole, have been well maintained by the residents and in most cases only require the southern edge to be formalised.

# The photograph below shows an example of the hedges on the northern and eastern boundary.
