OSBORNESCHARTEREDARCHITECTS The Balconies • Hanley Swan • Malvern • Worcestershire • WR8 0DN T: 01684 311303 E: architecture@osbornesarchitects.com F: 01684311255 W: osbornesarchitects.com CLIENT AMBASSADOR THEATRE GROUP PROJECT MANCHESTER OPERA HOUSE TITLE EXISTING & PROPOSED GATE DRAWINGS SCALE 1:20 & 1:50 @ A1 **DATE** JAN 2021 DRAWN TL DRAWING NUMBER 19-143-GA4

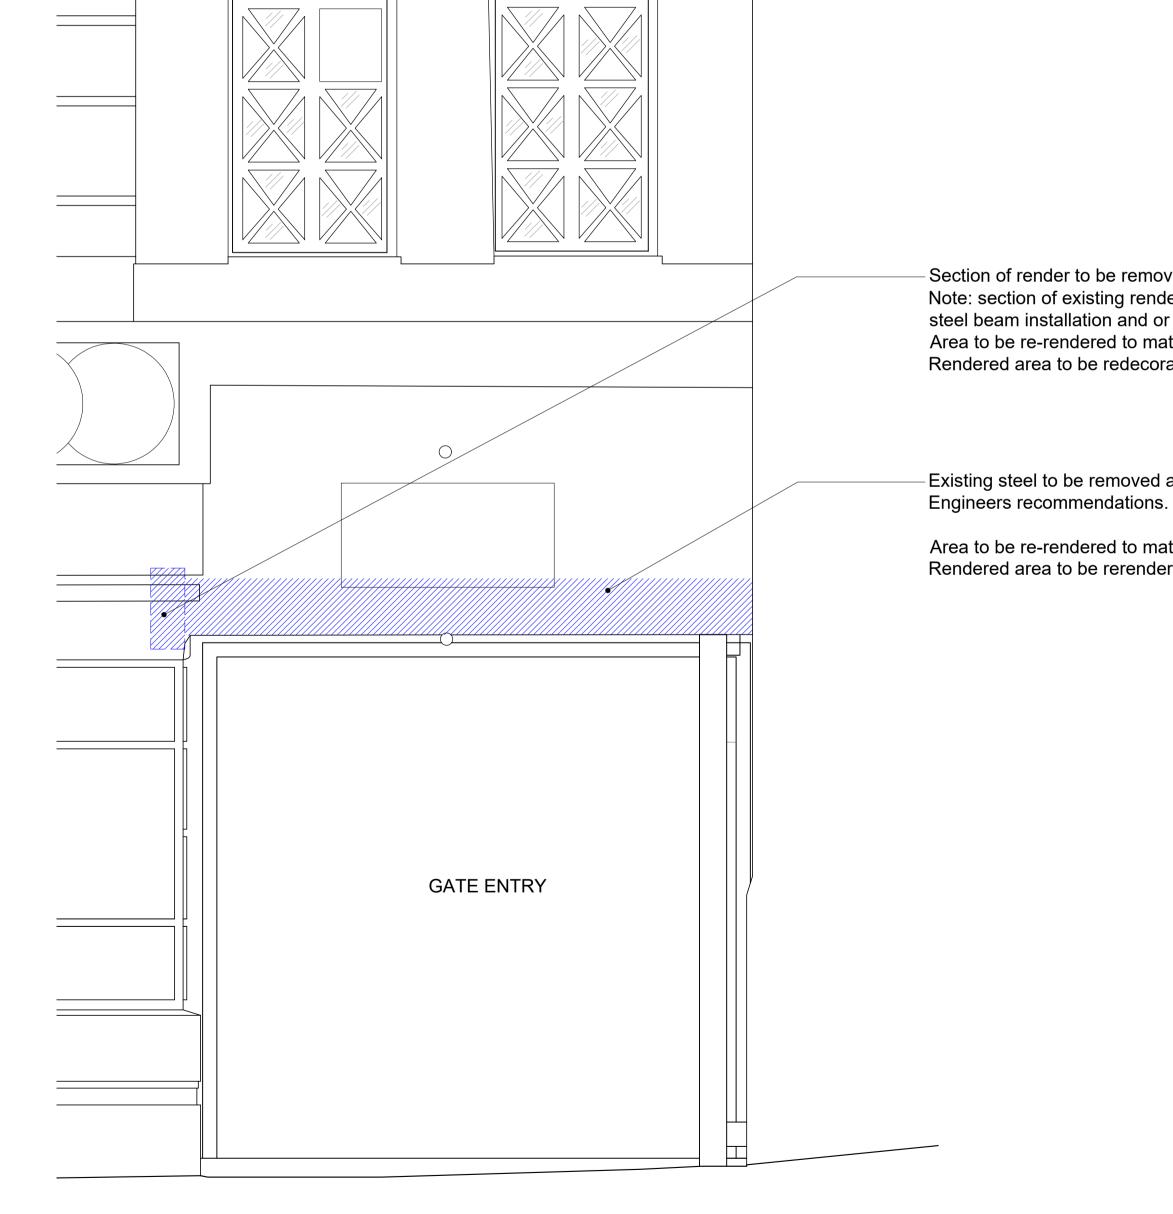
- Temporary prop in place to support corroded steel

– Outline indicates existing corroded steel to be replaced.

– Section of render to be removed to allow bearing for replacement steel. Note: section of existing render shows signs of previous works likely connected to steel beam installation and or repairs.

Area to be re-rendered to match existing where disturbed by steel replacement. Rendered area to be redecorated with paint to match existing.

Existing steel to be removed and replaced with a new steel as the Structural

Area to be re-rendered to match existing where disturbed by steel replacement. Rendered area to be rerendered and decorated to paint to match existing.
