HBL ASSOCIATES
**PHASE 1 COMPLETION REPORT &
RECOMMENDATIONS**

**STALLS BAR LIGHTWELL STEELWORK
MANCHESTER OPERA HOUSE**

AMBASSADOR THEATRE GROUP

HBL Ref: 8283

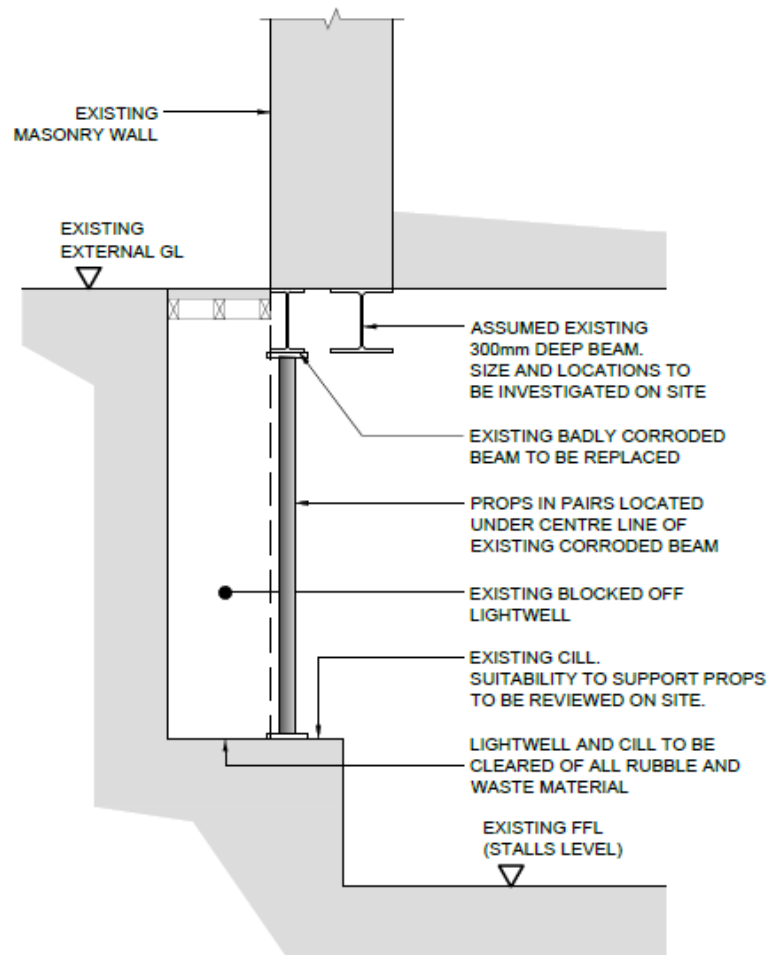
- 3.1. Phase 1 works required the removal of the existing stud wall and glazing and the installation of temporary props beneath the corroded outer beam within the lightwell, as shown in figure 2.

Figure 2 – Section through lightwell showing propping

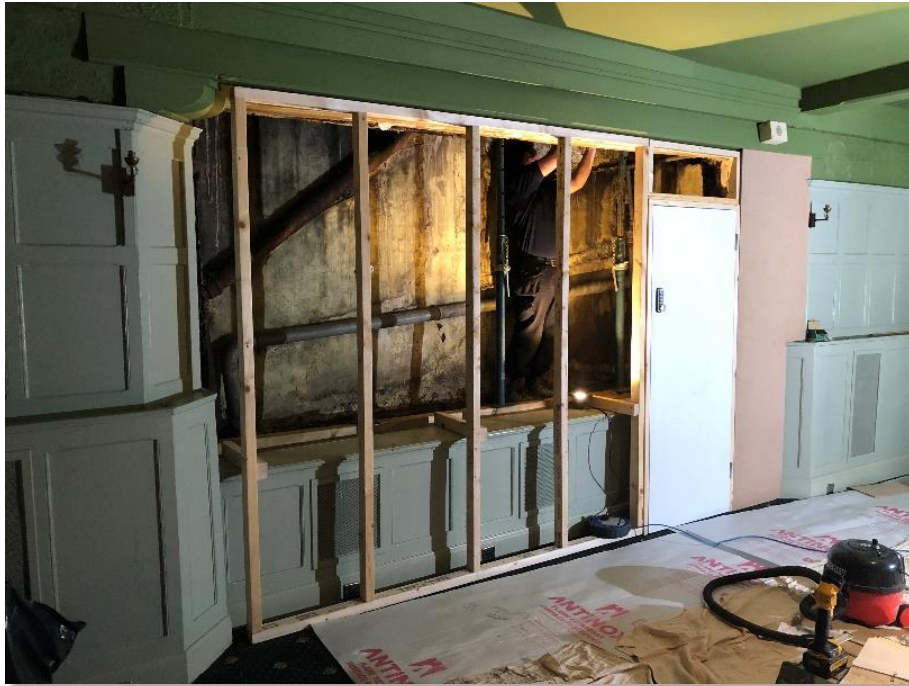
- 3.2. The installation of the props was completed in early September 2020 as shown in the photograph below in figure 3. The temporary work design of the props was completed on behalf of the contractor, and the calculations are included within appendix B. The design loadings for the props was specified by HBL Associates.

Figure 3 – Figure showing the installation of temporary props

- 5.3. In the short term, the temporary props should be inspected regularly (weekly) to ensure that they have not moved or shifted and that they are still tightened. The lightwell should be monitored for any new signs of spalled concrete or debris from the structure over. Should it be found that the props have moved or become looser, or debris is present then HBL Associates should be notified immediately.

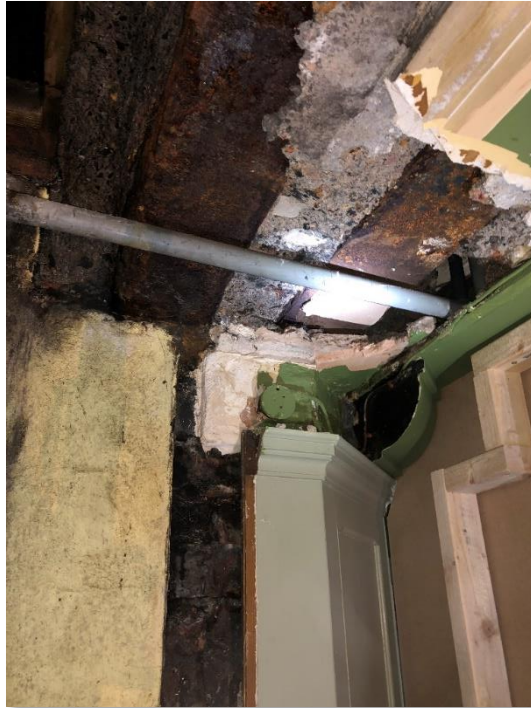
- 4.1. Further investigations were undertaken once the props were in place and the area more accessible. Removal of the spalled concrete revealed that the opening to the lightwell is formed using 2No steel beams with concrete fill between the webs and surrounding the beams. Figure 4 shows the pair of beams with concrete web infill at the bearing location.

Figure 4 – Image showing the 2No beams forming the light well opening. The outer beam (L) was heavily corroded.

- 5.1. In our opinion the corroded outer beam is no longer adequate and should be replaced. The inner beam and the concrete infill is likely forming a steel and concrete composite section, and removal of the outer beam will compromise this system. As such, we recommend allowance is made to replace the inner beam and infill structure also.

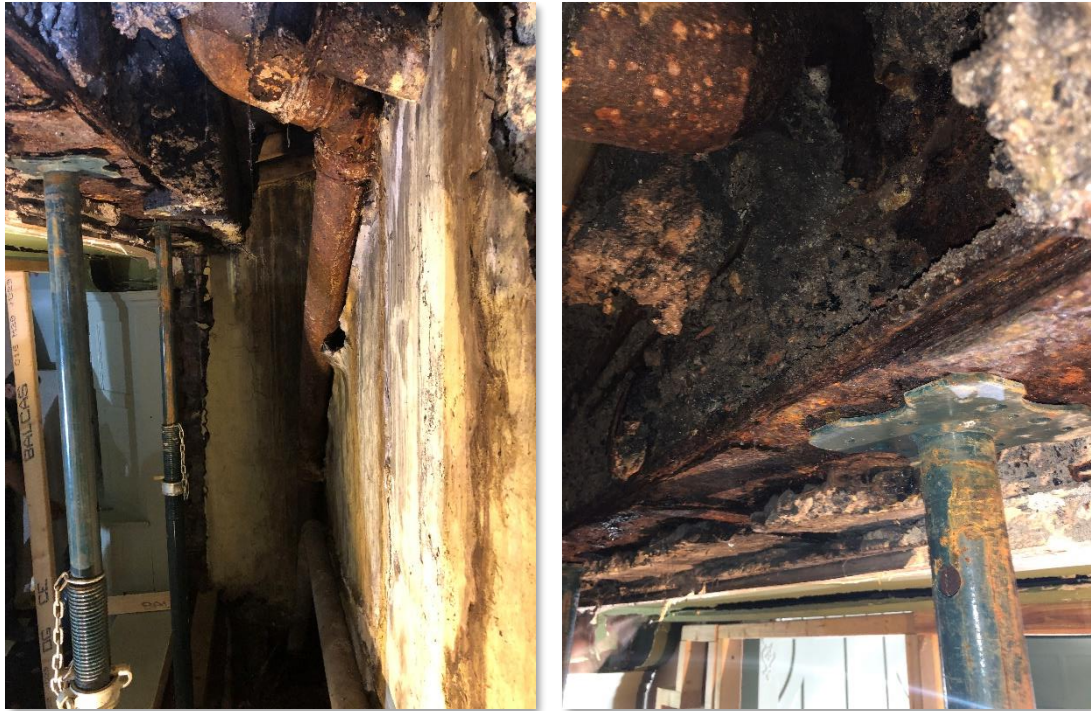
- 4.2. There was evidence of steel strapping or plate reinforcement within the spalled concrete that had heavily corroded and was no longer serving any structural purpose.

Figure 5 – Images showing corroded outer beam

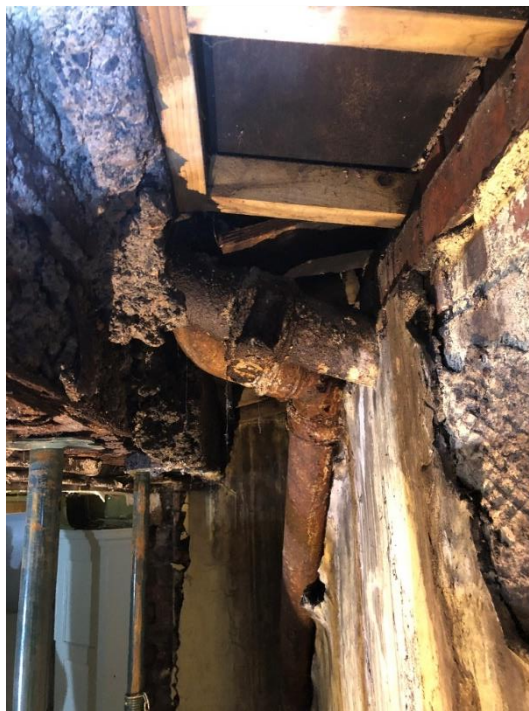
- 4.3. It was also noted that the pipework within the lightwell was open and there were uncovered drains and was likely one source of water causing the corrosion of the steelwork, see figure 6 below.

Figure 6 – Image showing open pipework

- 5.2. We also recommend further investigations are carried out to identify the source of any water entering the lightwell and attempt to reduce or eliminate the flow. Pipework should be reviewed to determine whether it is still functional or is now redundant and can be removed or capped off.
