Arboricultural Consultancy for Lloyds Bank

| Insured | Mr Terence Redhead and Mrs Rachel Redhead | Address | 89 West End March, Cambridgeshire, PE15 8DJ | | |
| Report Date | 12/02/2020 | | | | |

Scope of Report: To survey the property and determine significant vegetation contributing to subsidence damage, make recommendation for remedial action and assess initial mitigation and recovery prospects. The survey does not make an assessment for decay or hazard evaluation.

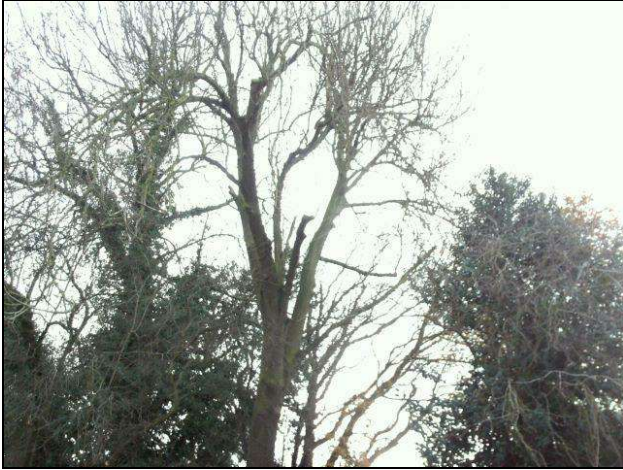
T1 - Ash

Based on our observations on site and with due regards to species profile, the Ash trees (T1 & T2) are considered the dominant features proximate to the area of movement, the source of the roots recovered and accordingly where vegetation is determined to be causal we have identified their collective / cohesive influence as the primary cause of any clay shrinkage subsidence damage.

| Tree No. | Species | Age Cat | Approx. Height (m) | Distance to Building (m) * | Ownership | Action | Requirement |
|---|---|---|---|---|---|---|---|
| T1 | Ash | 3 | 21 | 12.7 | D - Unknown | Remove | Remove close to ground level and treat stump to inhibit regrowth. Distance relates to man house, tree 16.0m to conservatory, age relates to conservatory. |

Consequently, complete removal of T1 & T2 will offer the most certain arboricultural solution likely to restore long-term stability.

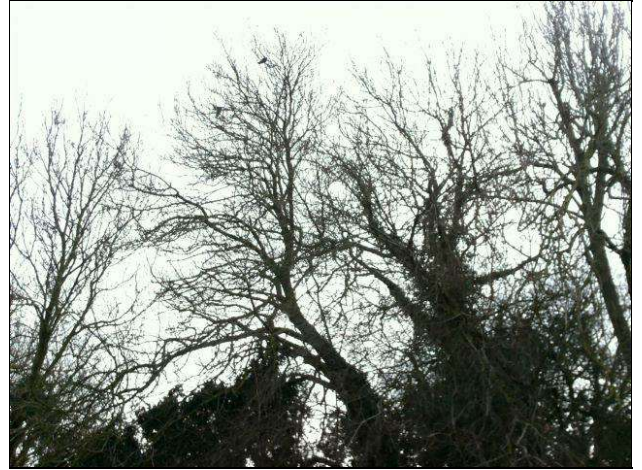
T2 - Ash

| Tree No. | Species | Age Cat | Approx. Height (m) | Distance to Building (m) * | Ownership | Action | Requirement |
|---|---|---|---|---|---|---|---|
| T2 | Ash | 3 | 21 | 14.7 | D - Unknown | Remove | Remove close to ground level and treat stump to inhibit regrowth. Distance relates to main house, tree 17.2m to conservatory, age relates to conservatory. |

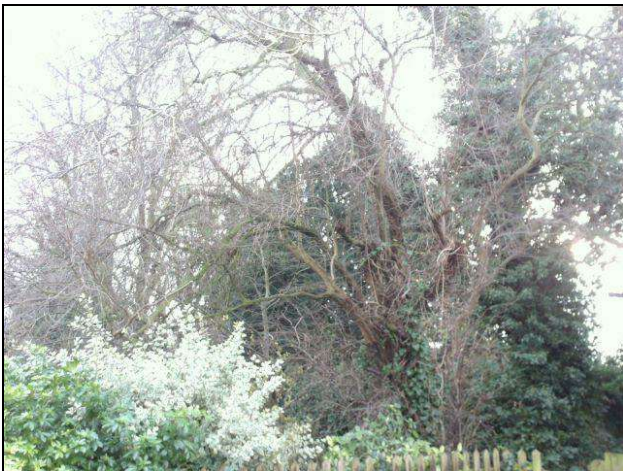
T3 - Plum

| Tree No. | Species | Age Cat | Approx. Height (m) | Distance to Building (m) * | Ownership | Action | Requirement |
|---|---|---|---|---|---|---|---|
| T3 | Plum | 3 | 8 | 10.0 | A - Third Party | Action to avoid future risk | Do not allow to exceed current dimensions by way of regular pruning. Distance relates to main house, tree 11.3m to conservatory, age relates to conservatory. |

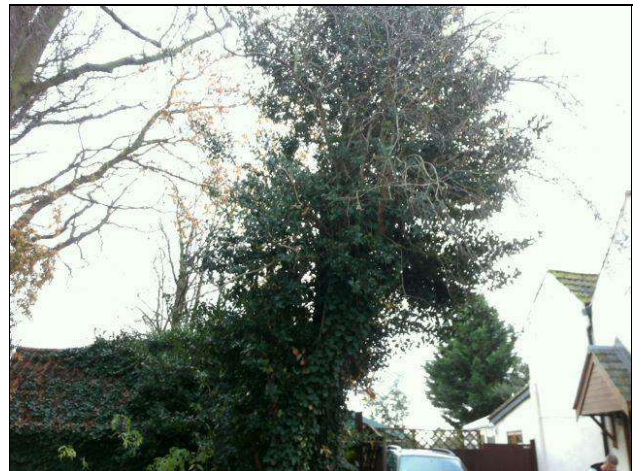
TG1 - Mixed species group

| Tree No. | Species | Age Cat | Approx. Height (m) | Distance to Building (m) * | Ownership | Action | Requirement |
|---|---|---|---|---|---|---|---|
| TG1 | Mixed Species Group: Oak, Holly & Hawthorn. | 3 | 8 | 9.2 | D - Unknown | Action to avoid future risk | Do not allow to exceed current dimensions by way of regular pruning. Distance relates to main house, trees 13.8m to the conservatory, age relates to conservatory. |

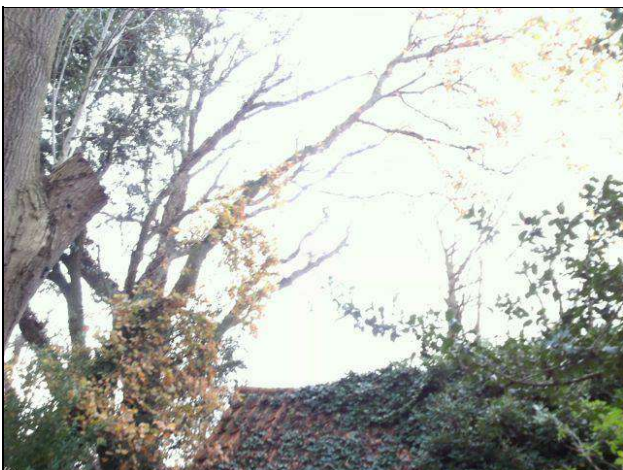
T4 - Oak

| Tree No. | Species | Age Cat | Approx. Height (m) | Distance to Building (m) * | Ownership | Action | Requirement |
|---|---|---|---|---|---|---|---|
| T4 | Oak | 3 | 12 | 16.7 | D - Unknown | Action to avoid future risk | Do not allow to exceed current dimensions by way of regular pruning. Distance relates to main house, Age relates to conservatory. |

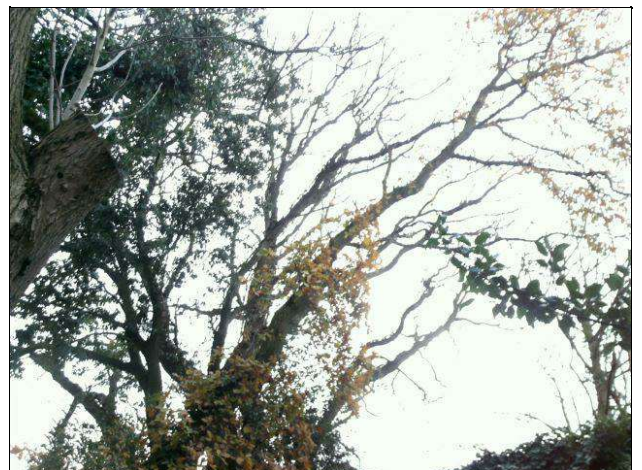
T5 - Oak

| Tree No. | Species | Age Cat | Approx. Height (m) | Distance to Building (m) * | Ownership | Action | Requirement |
|---|---|---|---|---|---|---|---|
| T5 | Oak | 3 | 18 | 21 | D - Unknown | Action to avoid future risk | Do not allow to exceed current dimensions by way of regular pruning. Age relates to conservatory |

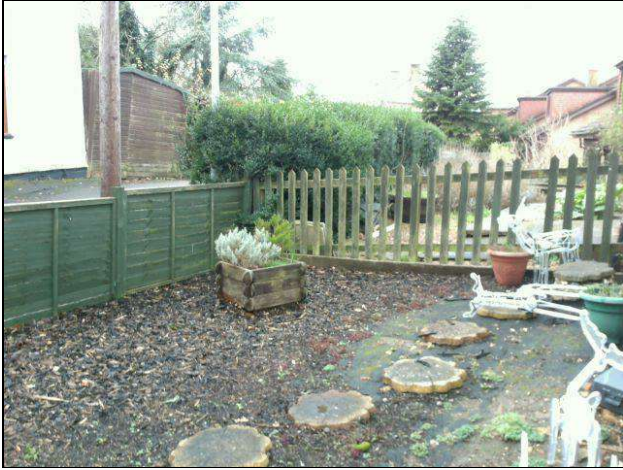
H1 - Box

| Tree No. | Species | Age Cat | Approx. Height (m) | Distance to Building (m) * | Ownership | Action | Requirement |
|---|---|---|---|---|---|---|---|
| H1 | Box | 1 | 1.5 | 3.9 | A - Third Party | Action to avoid future risk | Do not allow to exceed current dimensions by way of regular pruning. |

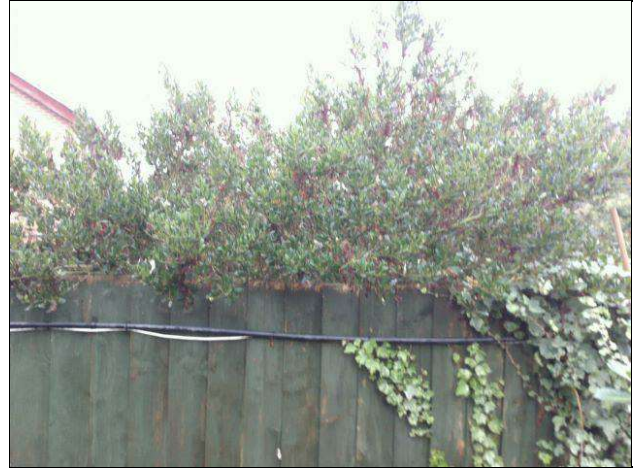
S1 - Ceanothus

| Tree No. | Species | Age Cat | Approx. Height (m) | Distance to Building (m) * | Ownership | Action | Requirement |
|---|---|---|---|---|---|---|---|
| S1 | Ceanothus | 1 | 2 | 2.9 | A - Third Party | Action to avoid future risk | Do not allow to exceed current dimensions by way of regular pruning. |

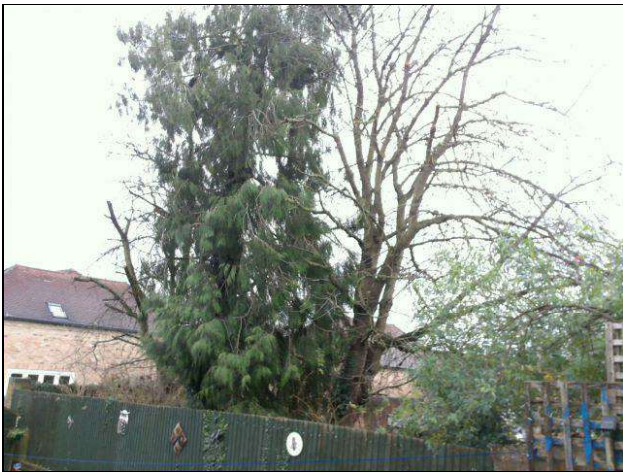
TG2 - Mixed species group

| Tree No. | Species | Age Cat | Approx. Height (m) | Distance to Building (m) * | Ownership | Action | Requirement |
|---|---|---|---|---|---|---|---|
| TG2 | Mixed Species Group: includes Cherry & Cypress. | 3 | 14 | 14.0 | A - Third Party | Action to avoid future risk | Do not allow to exceed current dimensions by way of regular pruning. Age relates to conservatory. |
