CRACK MONITORING

for Subsidence Management Services

89 West End, March, PE15 8DJ

| Our Ref: | M15019 |

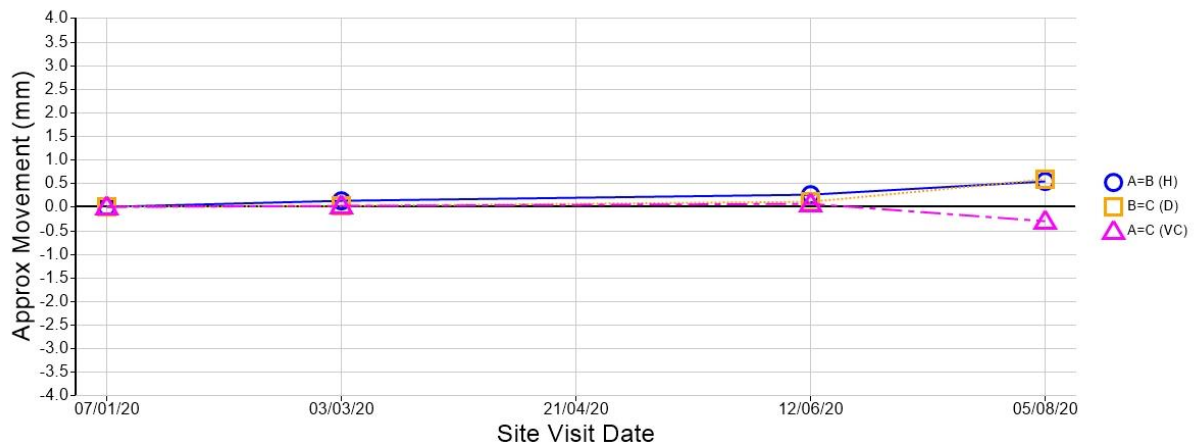
| Date | A=B (H) | B=C (D) | A=C (V)(C) | Crack Width |
|--|---|---|---|---|
| C1 - INT- Above Door Between Lounge and Rear Lounge | | | | |
| 5 August 2020 | 81.16 | 110.20 | 76.11 | 2.00 - 1.90 |

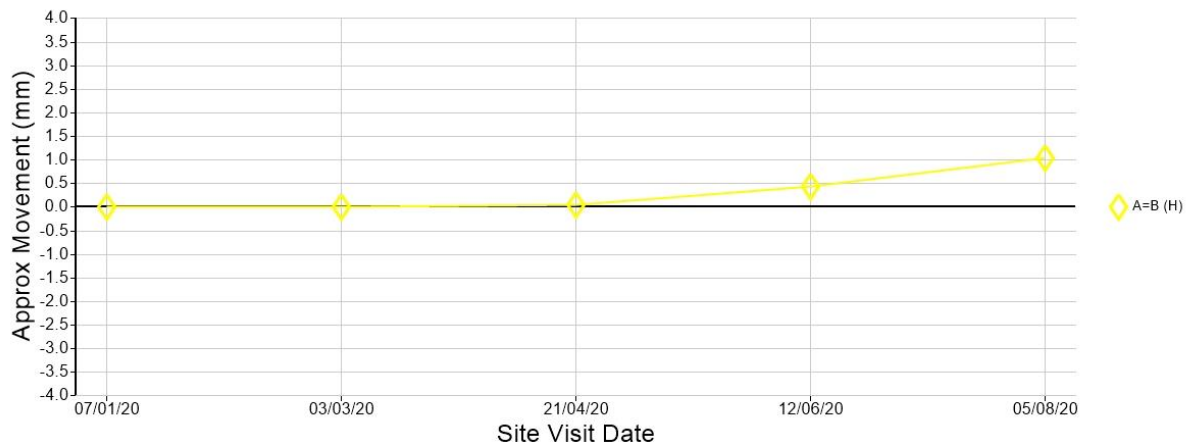
| Date | A=B (H) | B=C (D) | A=C (V)(C) | Crack Width |
|--|---|---|---|---|
| C2 - EXT- Below Front Door | | | | |
| 5 August 2020 | 95.60 | | | 4.70 |

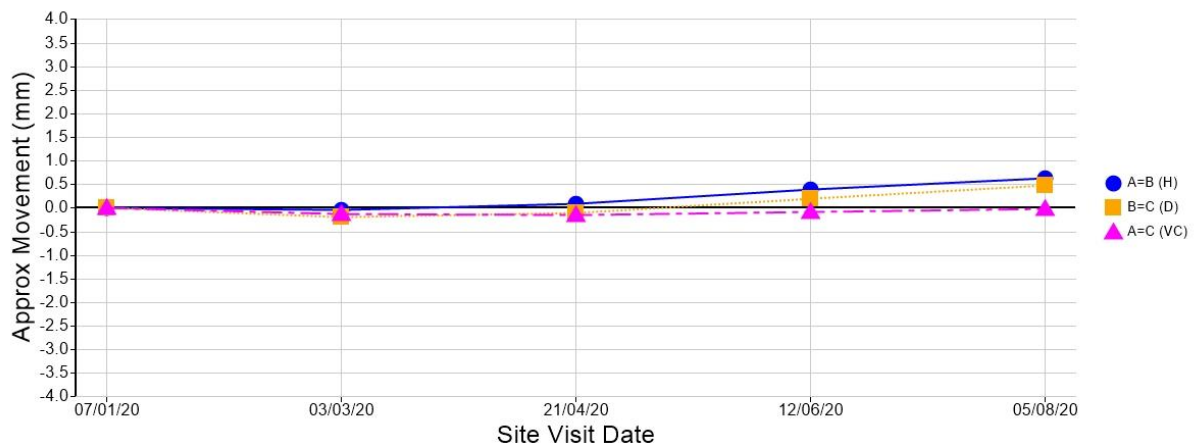
| Date | A=B (H) | B=C (D) | A=C (V)(C) | Crack Width |
|--|---|---|---|---|
| C3 - EXT- RHS above Front Window | | | | |
| 5 August 2020 | 88.87 | 111.39 | 66.13 | 3.50 - 3.60 |

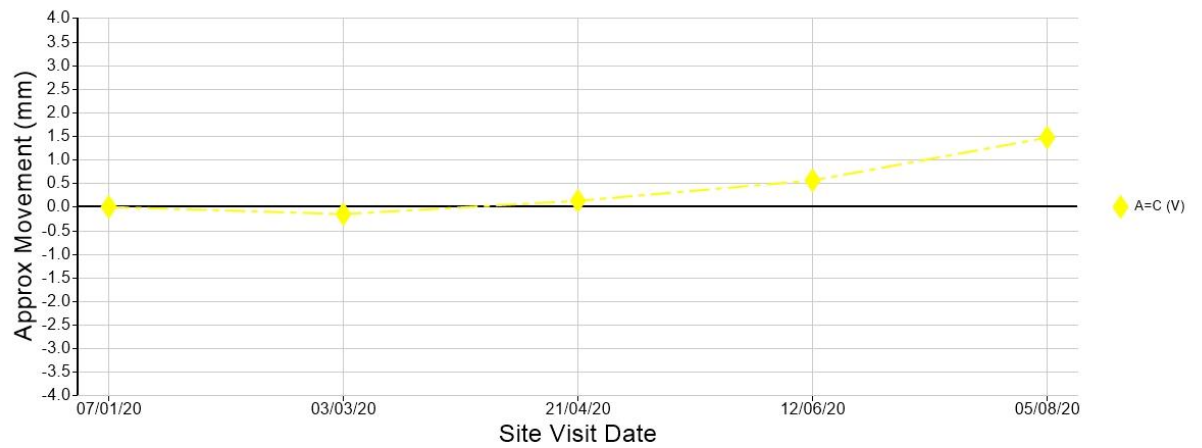
| Date | A=B (H) | B=C (D) | A=C (V)(C) | Crack Width |
|--|---|---|---|---|
| C4 - EXT- Above Front Door RHS | | | | |
| 5 August 2020 | | | 79.24 | 5.00 |
