**Tree Survey
and
Arboricultural Constraints**

**103/105 Henderson Street
Bridge of Allan**

Simply UK Ltd

December 2020

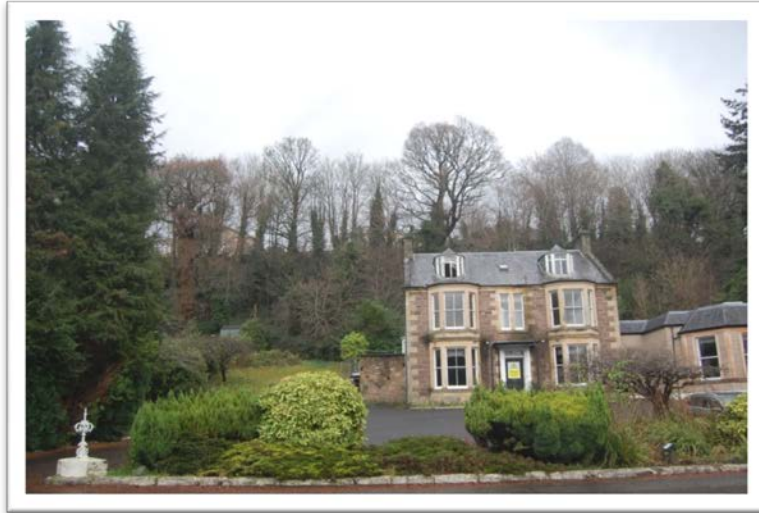
Photo 1. 103 Henderson Street.

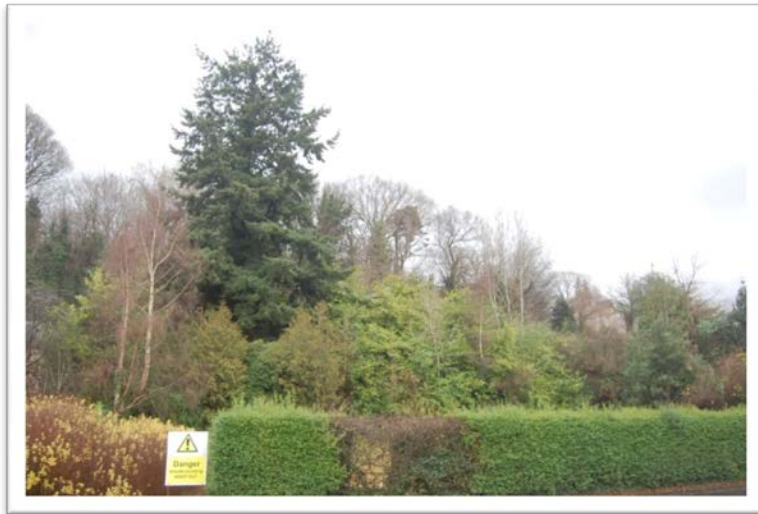
The most prominent and visually dominant tree is a single mature Douglas fir (248), which stands on an area of raised ground to the front of 105 (see photos 2 and 3). This is of large proportions and has been topped at some time in the past. This is probably contemporary with the properties.

Photo 2. 105 Henderson Street (house obscured).

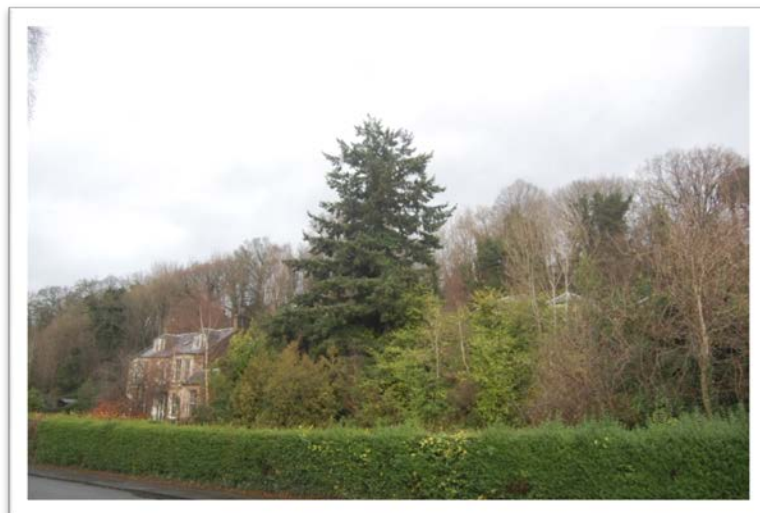
Photo 3. 103 and 105 Henderson Street.

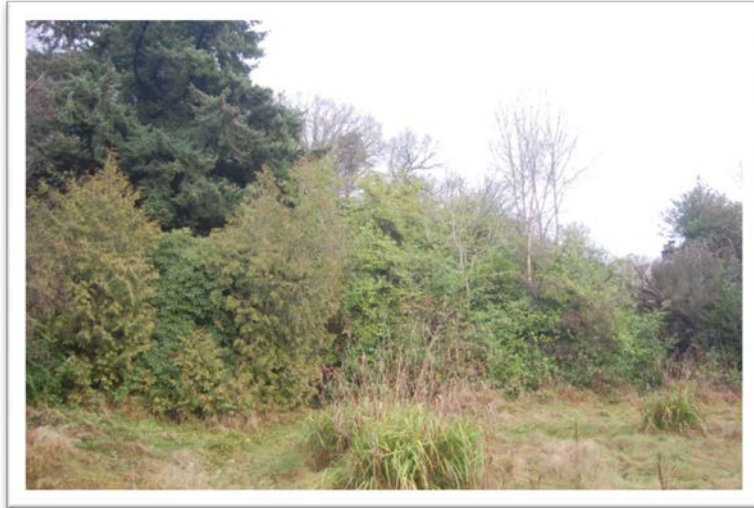
The area of survey comprises 103 and 105 Henderson Street, in Bridge of Allan (see photos 1 to 3). These are large, detached villas which stand on the northern side of the A9. Number 103 is heavily extended and was formerly used as a hotel. Both properties are vacant and in a poor and dilapidated state. The grounds of both properties are in a very overgrown and neglected condition. The grounds of number 105 are covered in a large, dense swathe of overgrown shrub material, making access extremely difficult (see photo 4).

The remaining trees within the site consist of relatively poor and small ornamental trees and self-seeded growth which has established in recent years as the properties fell into neglect. G1 within 105 consists of overgrown laurel, rhododendron and holly, with occasional young, self seeded tree. This has run rampant and forms a very dense and impenetrable clump which completely obscures the house. It is of poor quality and has limited future potential.

The area of overgrown shrub material (G1) and the small trees associated with it are also unsuitable for retention or of low retention value.

Photo 4. 105 Henderson Street (G1).

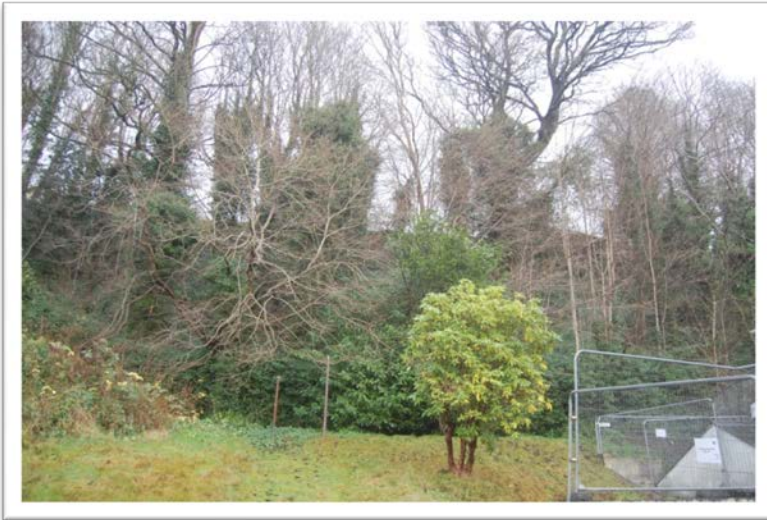
Photo 5. 103 Henderson Street (rear).

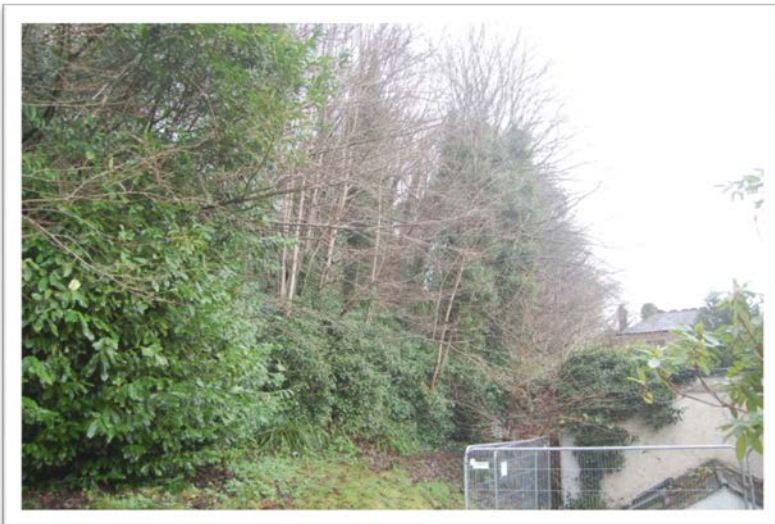
Photo 6. 103 Henderson Street (rear).
