**Re: Outbuilding at Moorpit Farm, Yarcombe**

## Structural Appraisal

Outbuildings at Moorpit Farm

Client	David & Liz Tyzak Moorpit Farm Yarcombe Devon EX14 9BG
Property	Small Outbuilding Moorpit Farm Yarcombe Devon EX14 9BG
Date of Survey	9 <sup>th</sup> November 2020
Weather	Overcast, damp
Brief	To undertake structural appraisal of the small outbuilding located on the farm stated with respect to its capacity to accommodate the proposed conversion to habitable dwelling.
Limitations	The survey is reliant by the owner of the property and no acceptance or liability to any third party is accepted as part of this instruction.
Services	The outbuilding was provided with a water supply although its source and functionality are unknown. There was an electric supply which could not be determined if connected and safe. The barn did not appear to be connected to any form of foul drainage although there was a septic tank located in the field next to the building.

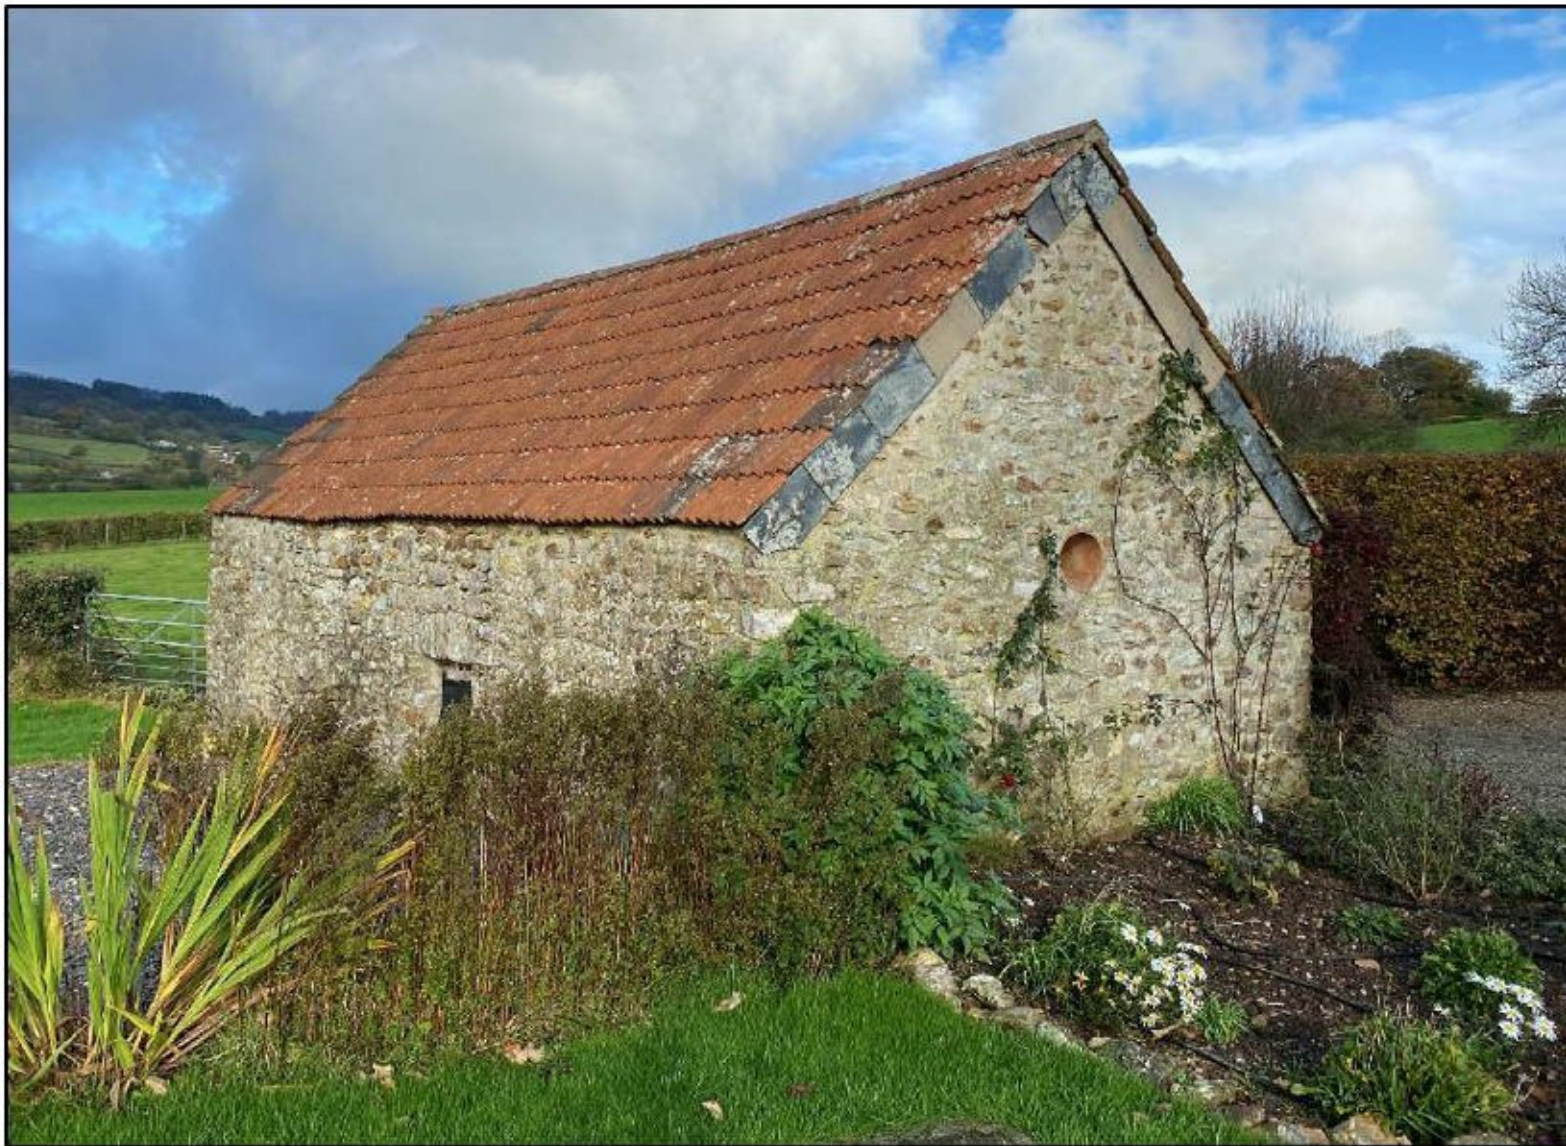
*Image 1 – Small outbuilding at Moorpit Farm.*

The barn consisted of a solid stone construction with principal trusses supporting a clay tiled roof. On the North Eastern side there was double access wooden doors with small single-pane timber frame windows either side of the doors.

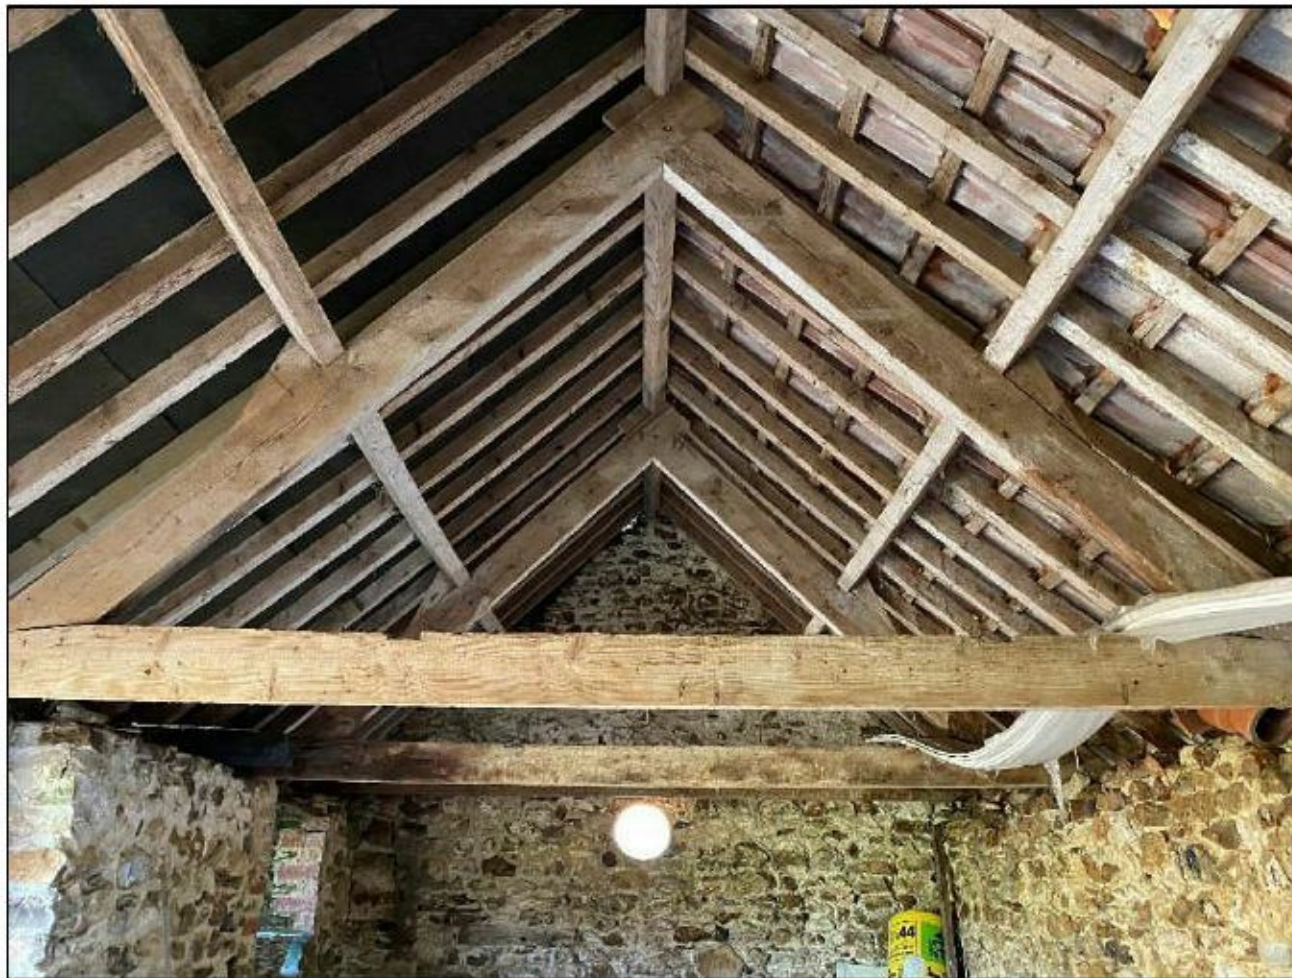
The original stone barn had a clay tiled roof. The roof was being supported by timber purlins which were, in turn supported by principal trusses, spaced at roughly 2.0m and bearing on wall plates fixed to the external walls.

The trusses were constructed from timber roughly 75x180 mm which appeared to be in good condition although slightly damp to the touch. It was noted that the bottom tension chord of one truss was bearing on the timber lintel over the double access doors.

*Image 2 – Timber principal roof trusses.*

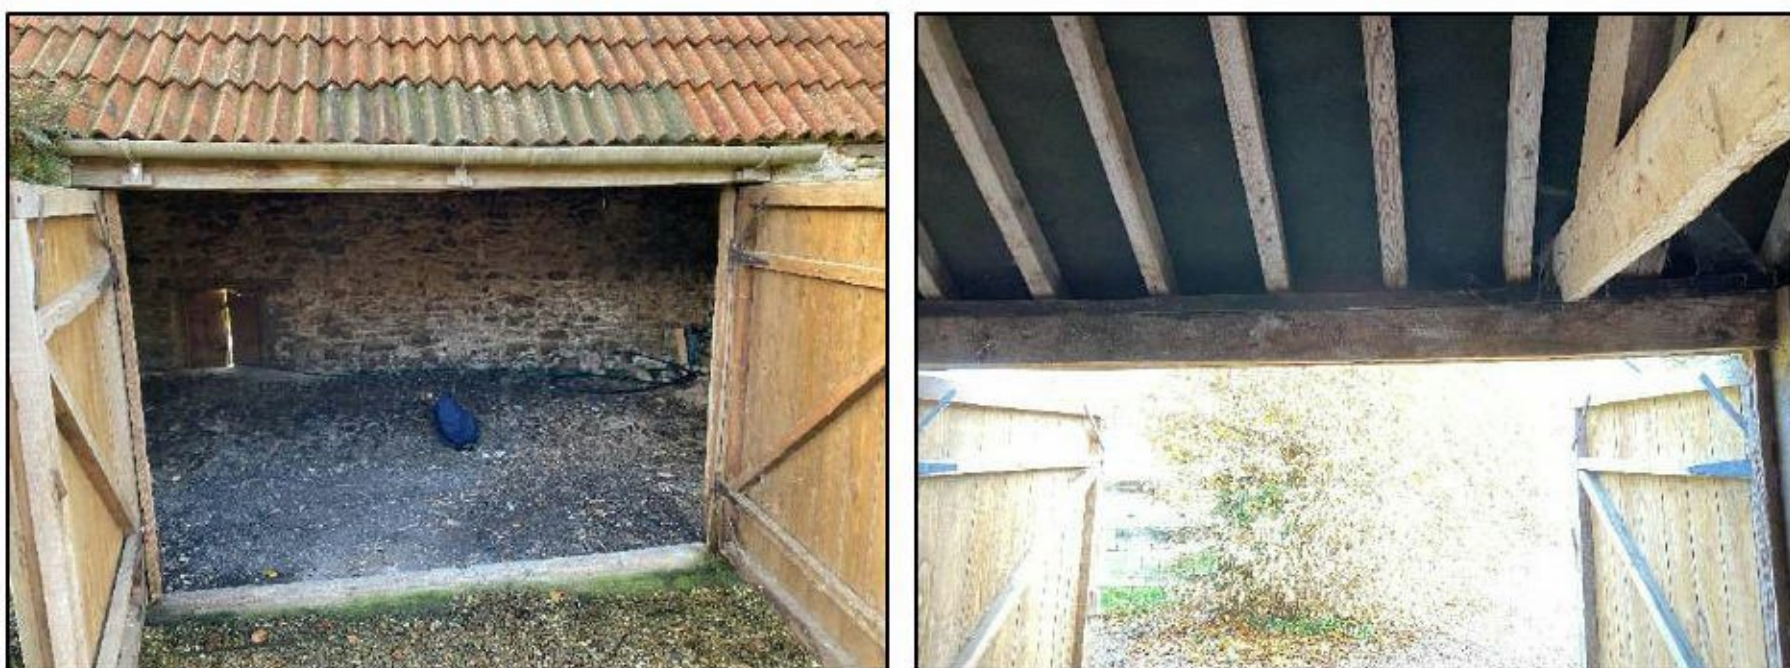
*Image 2 – Double door access (left) and roof truss bottom chord bearing on timber lintel over access doors (right).*

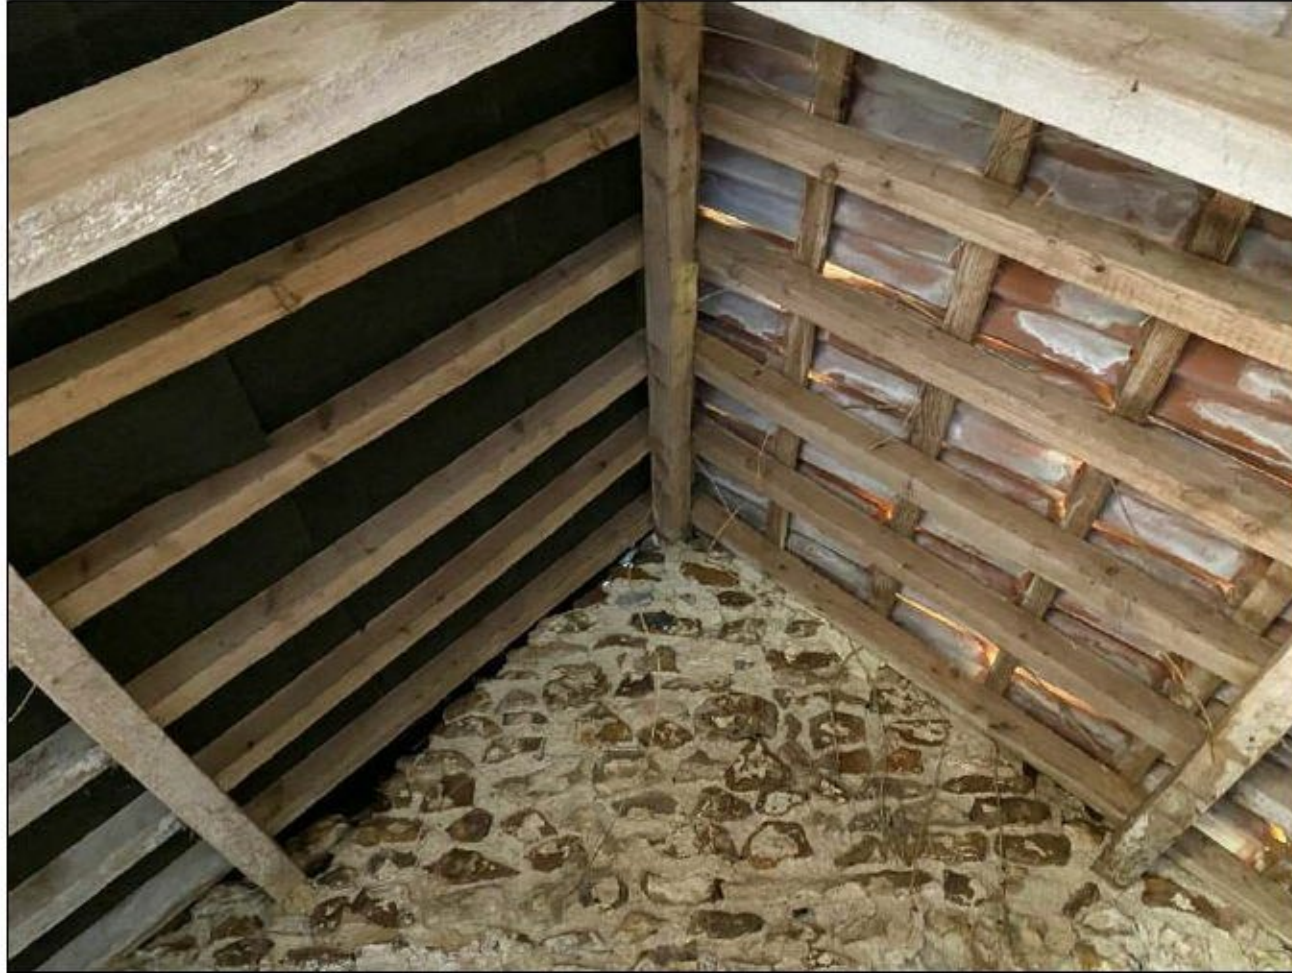
It appeared that roof felt had been installed, although only on the North Eastern side of the building. Some of the tiles, including ridge tiles, were partially damaged and so were allowing water to ingress inside the building.

*Image 3 – Evidence of roof felt installed on the North Eastern side of the roof only.*

The existing building appeared to be in relatively good order and structurally suitable for conversion with minimal alterations. The existing roof would need waterproofing and insulating but this would be relatively straightforward task. If proven suitable for modern roofing material and insulations loads, the existing roof structure could be reused.

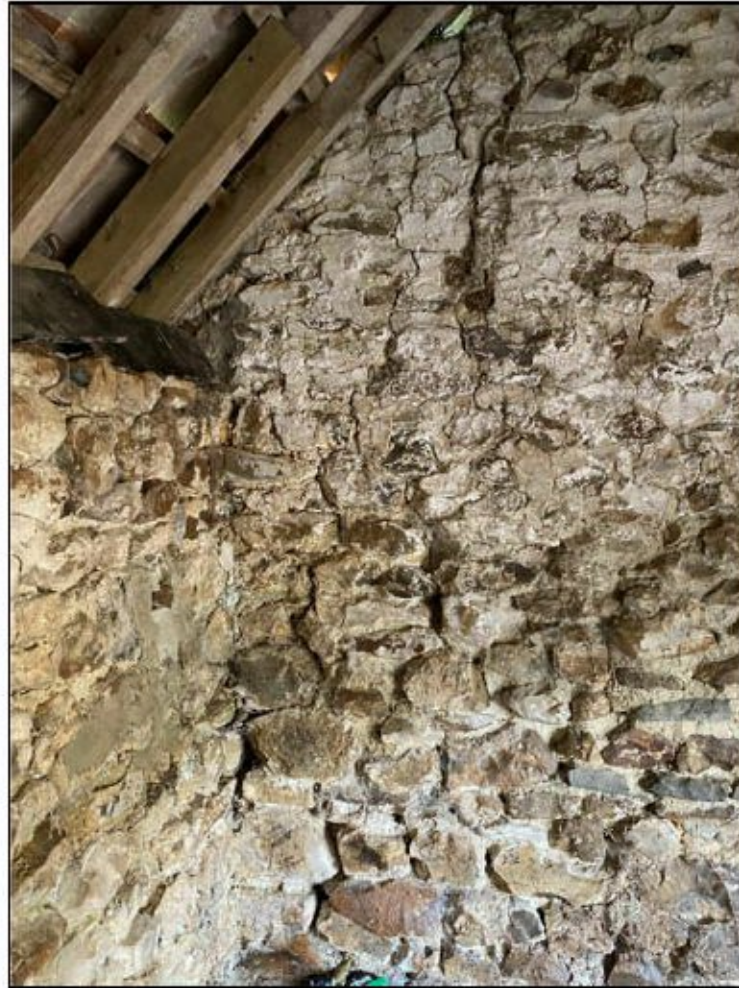
The original stone walls were approx. 300mm thick and appeared straight, true and relatively stable. There was some minor cracking where the roof purlin was bearing at the West corner although this could not be seen on the exterior face of the wall.

*Image 4 – Minor cracking in the West corner of the building under the purlin bearing.*

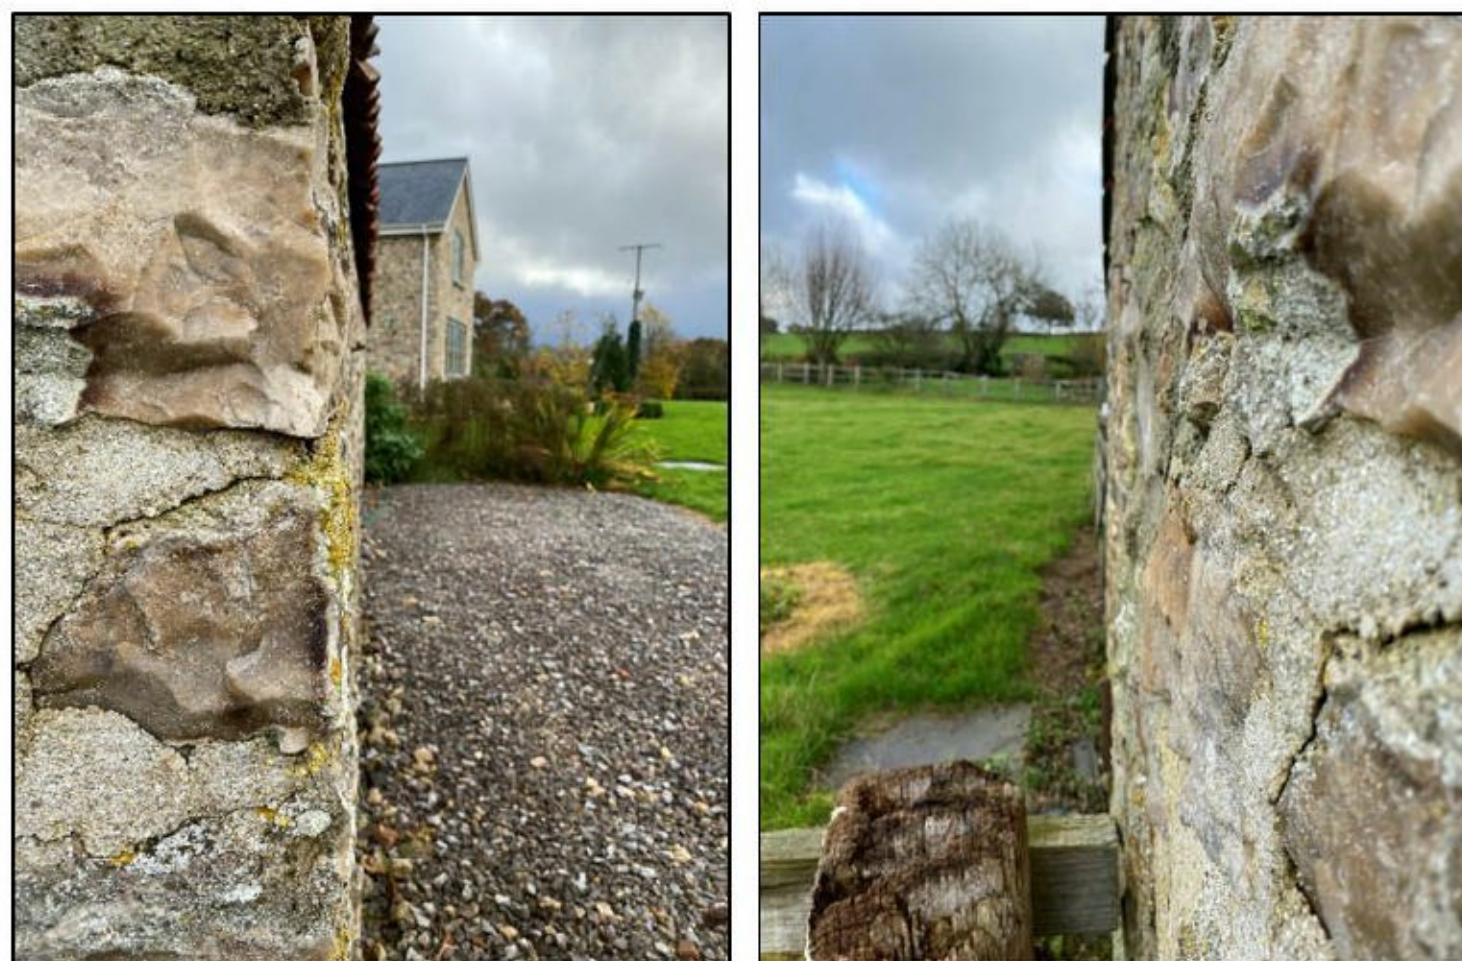
*Image 5 – Exterior walls appeared straight and true.*

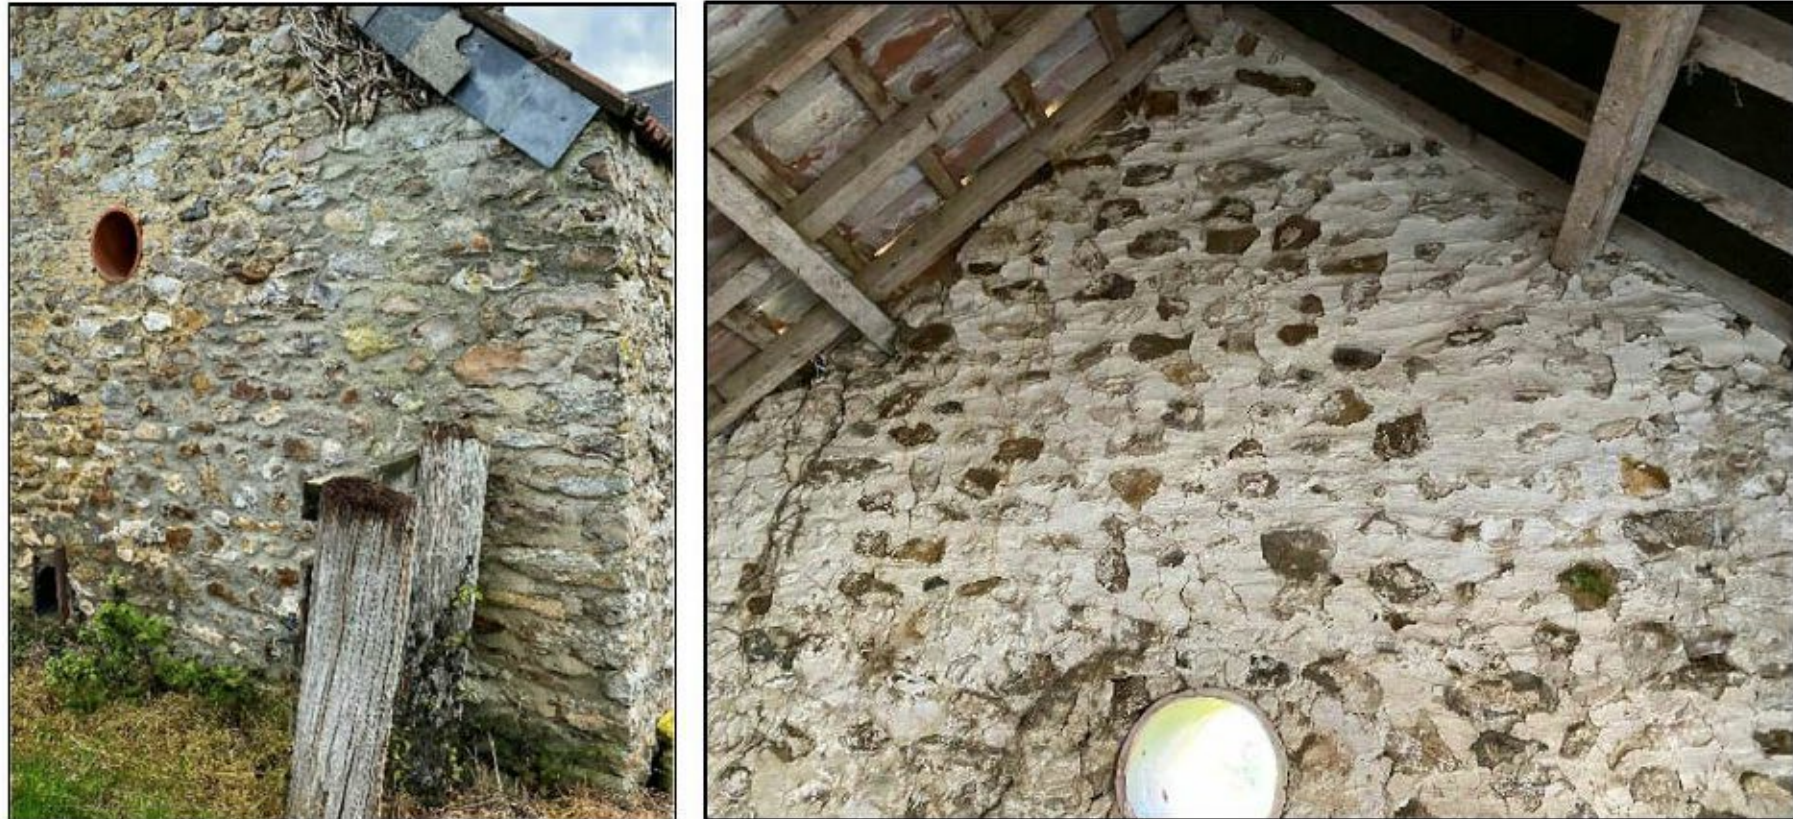
Some the original stone walls showed evidence of previously being repointed, there were other areas that would require repointing to prevent further deterioration.

*Image 6 – Evidence of previous repointing.*

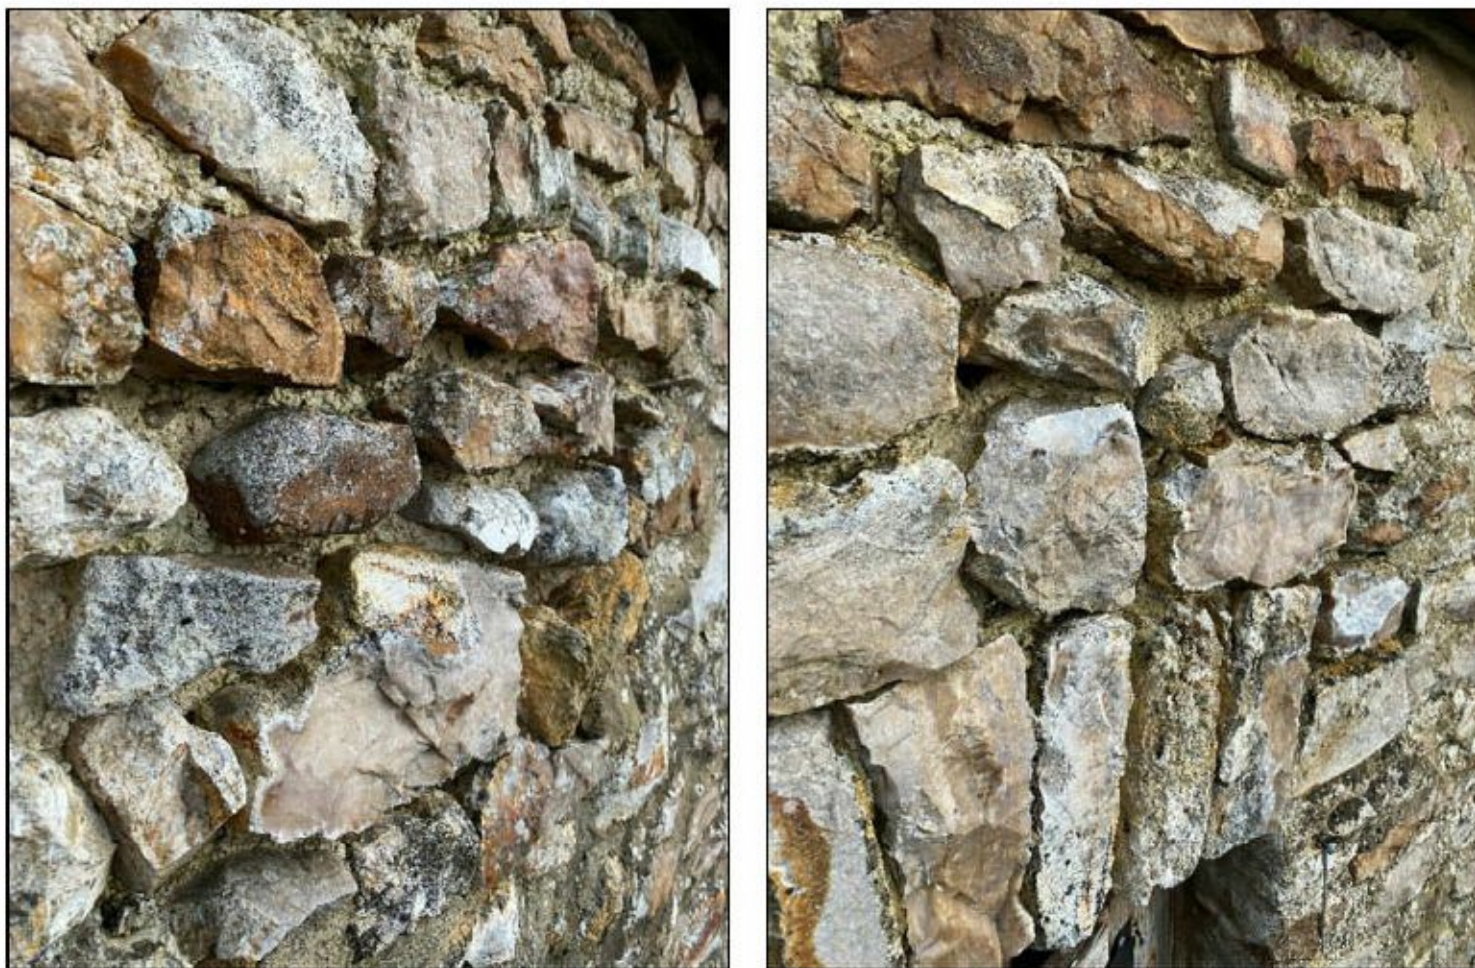
*Image 7 – Some areas of the exterior wall requiring repointing to prevent further deterioration.*

The walls may require some localised repointing, but this is to be expected with a building of this type / age and would provide a suitable structure for conversion.

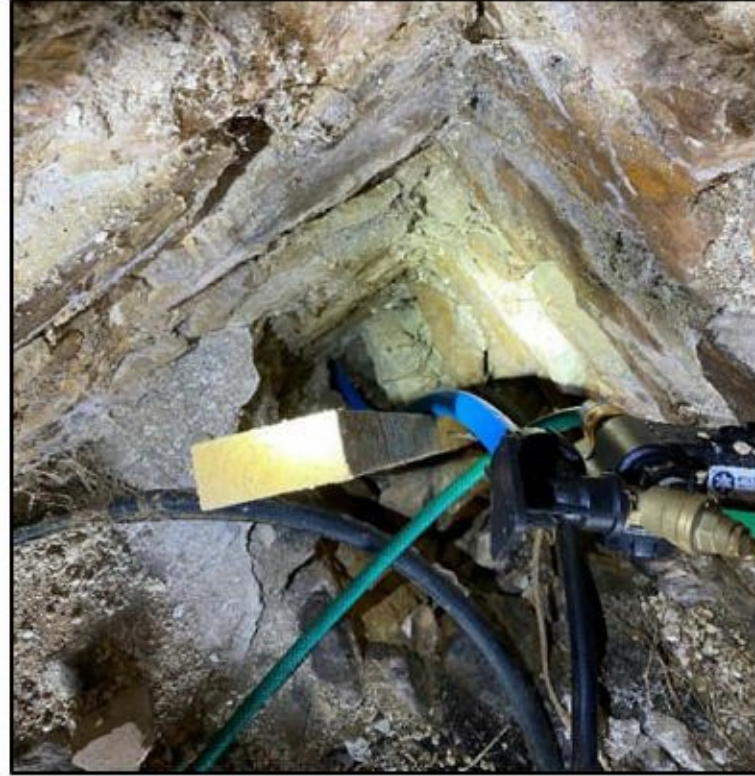
No trial holes were opened therefore the adequacy of any existing footings cannot be commented on at this stage. In the Western corner of the building, a water and electricity supply had been installed and, in this area, it was possible to see the stone walls extended roughly 400mm below ground level.

*Image 8 – Water and electricity supply in the Western corner, showing stone walls extending below ground level.*

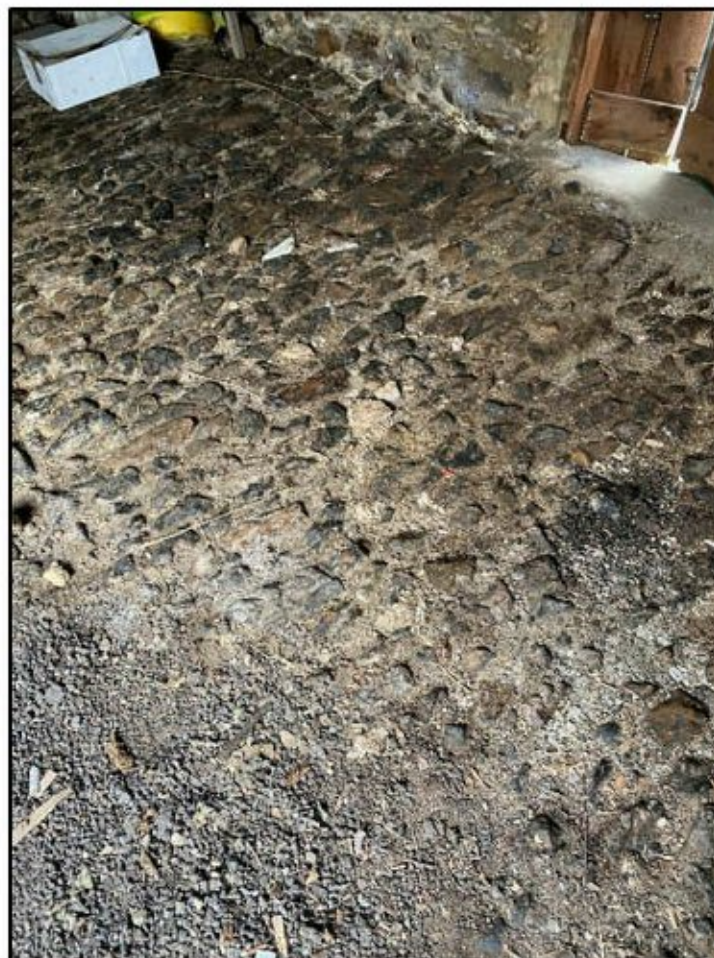
The outbuilding had an original cobbled stone floor that appeared stable and relatively level. This would provide a good base to support any new flooring that may be required.

*Image 10 – Original cobbled stone floor of the outbuilding.*
