Brief Report of Soil Investigation and Subsidence Findings at St Marys Church, Great Henny, Essex.

The PCC of St Mary's Church

Structural Report on structural damage to the North Transept Chapel & Vestry at St Mary's Church, Great Henny, Nr Sudbury.

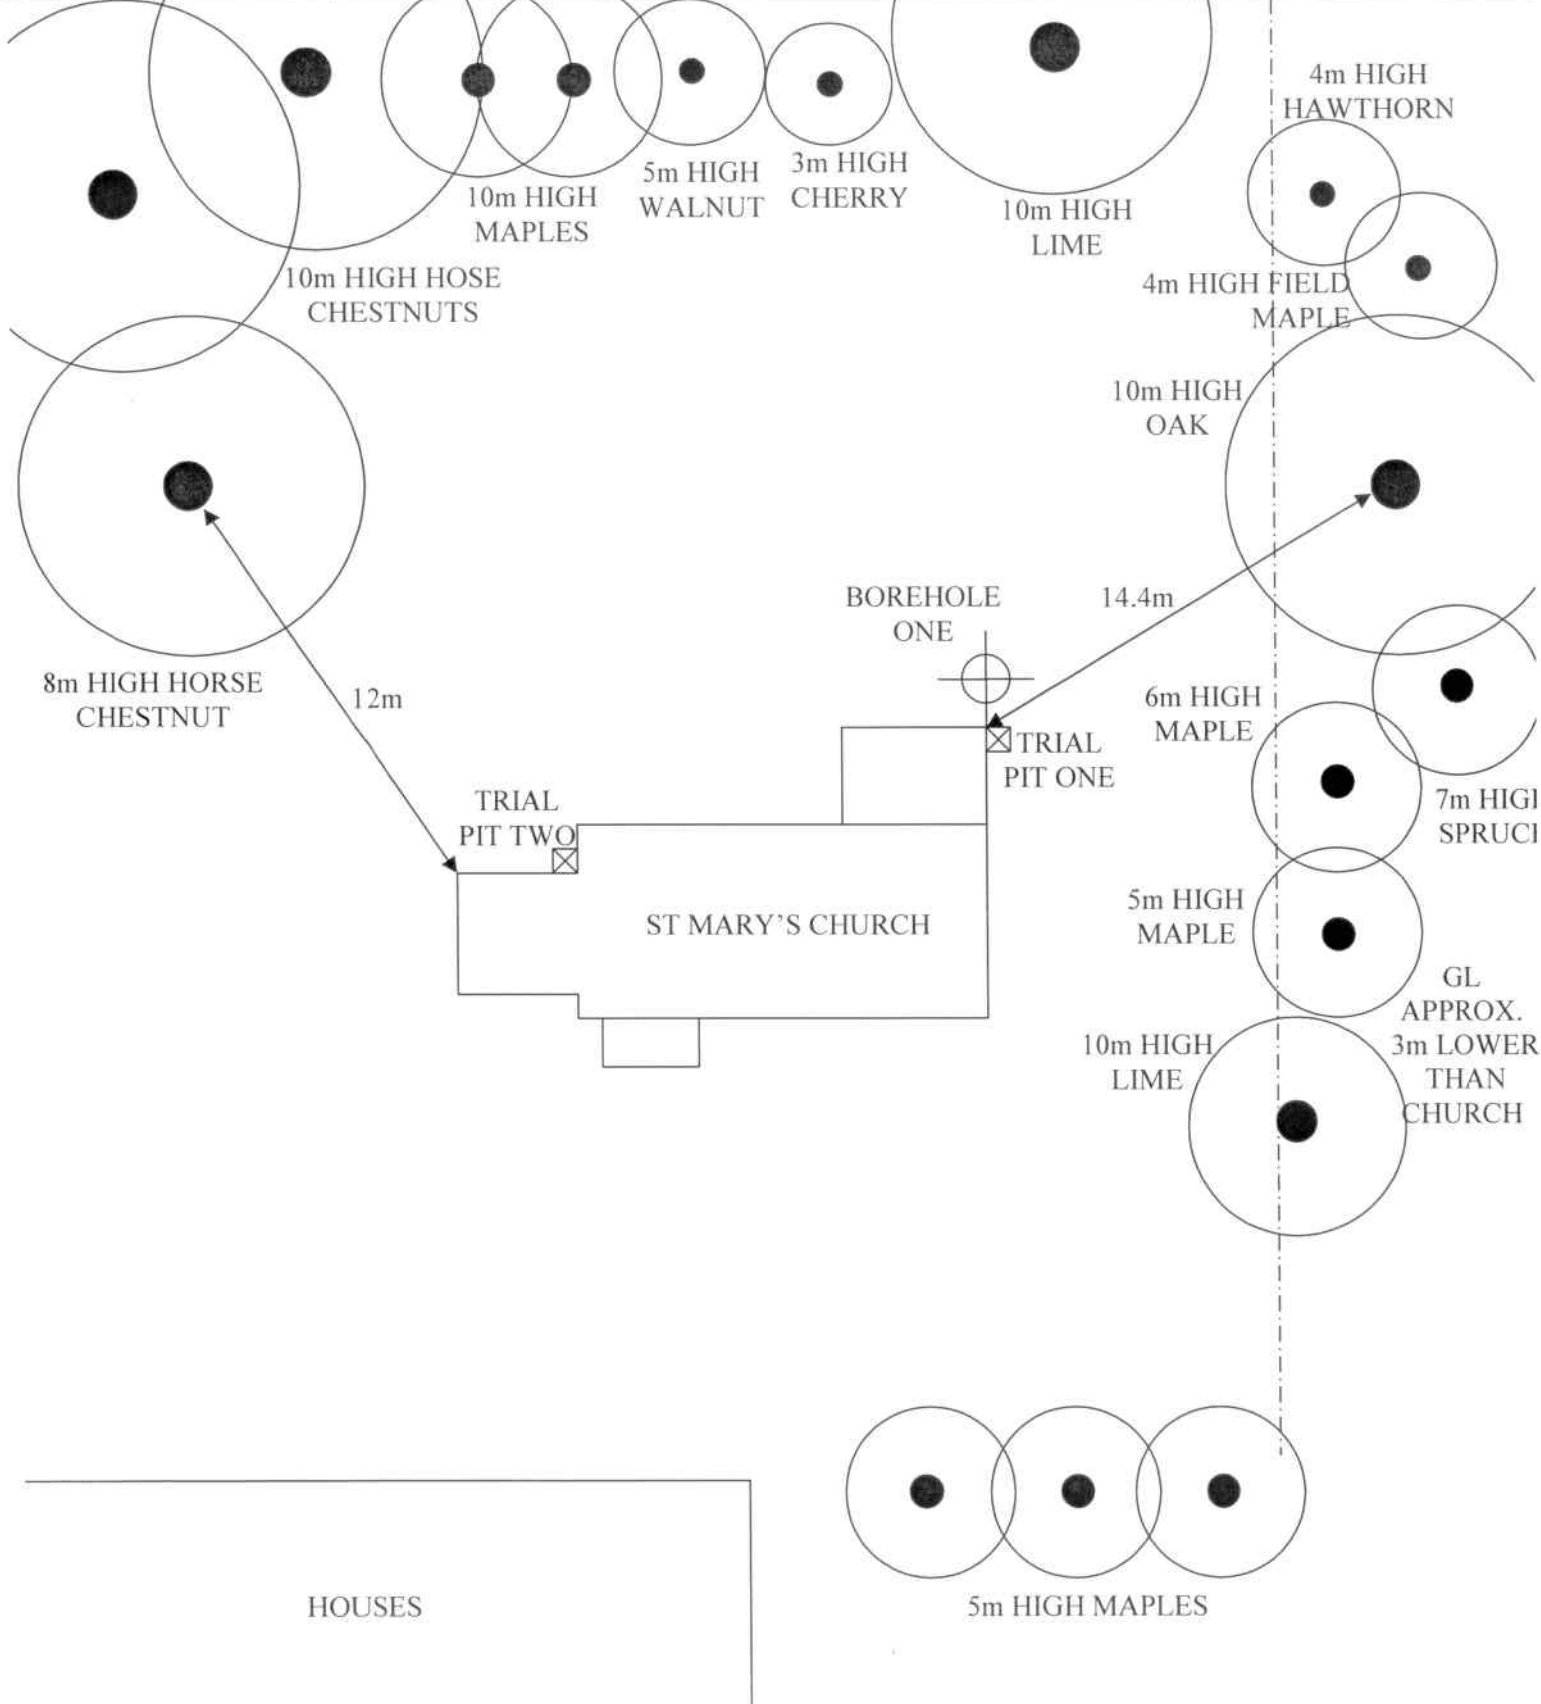
Site Plan NTS

The North Transept Chapel and Vestry extension sits on the North Eastern end of the Church and is surrounded by various large mature trees. Refer to attached plan and investigations by Barry Turner.

There are many other trees which must also be having an effect on the site and the building. Please refer to Barry Turners site plan for details.

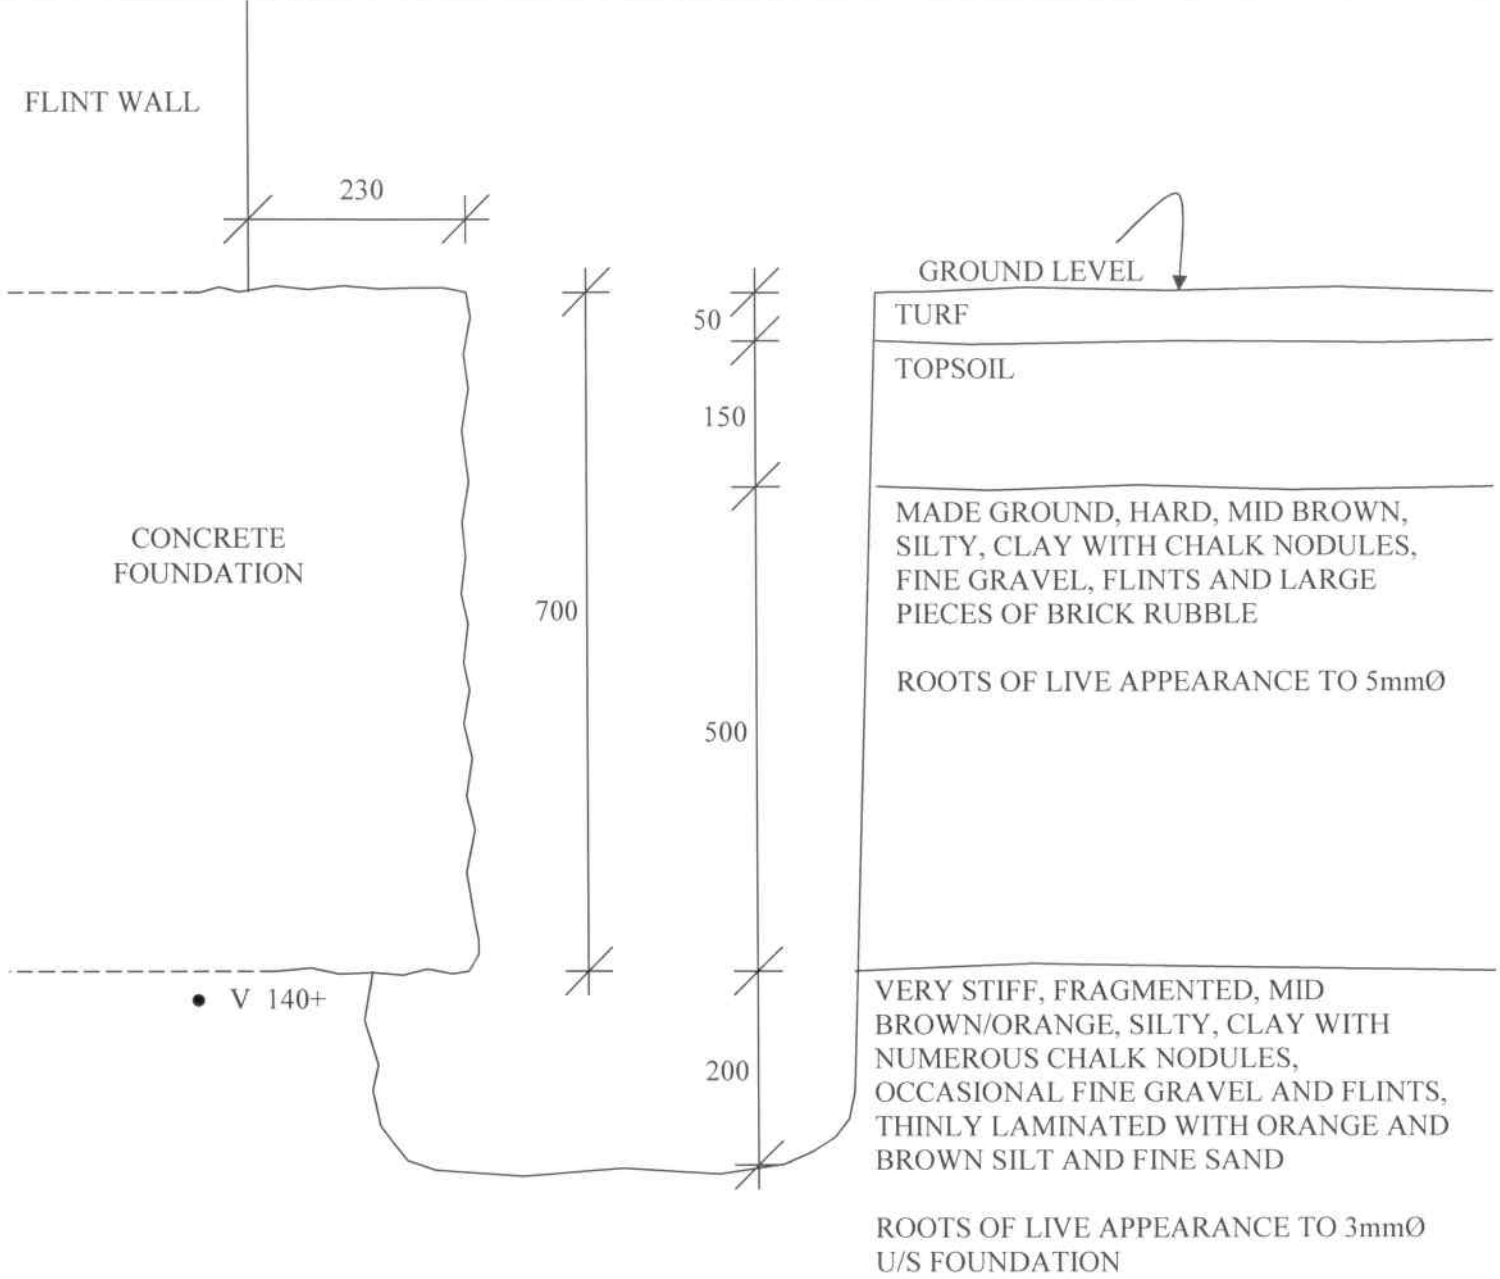
Ref. SI 0311 Trial Pit No. One Sheet No. One of One Date: 7th September 2020

Trial Pit 1 showed that the foundations to the North Transept Chapel and Vestry extension to have a 700mm deep concrete foundation which protruded from the wall face by 230mm. The foundation was taken through 700mm of turf/topsoil and brick fill made ground to bear onto a very stiff clay. There were roots of up to 5mm from GL to the u/s of foundation and then roots of up to 3mm from u/s of foundation to completion which was 200mm below u/s.

TRIAL PIT ONE ENDS AT 900mm

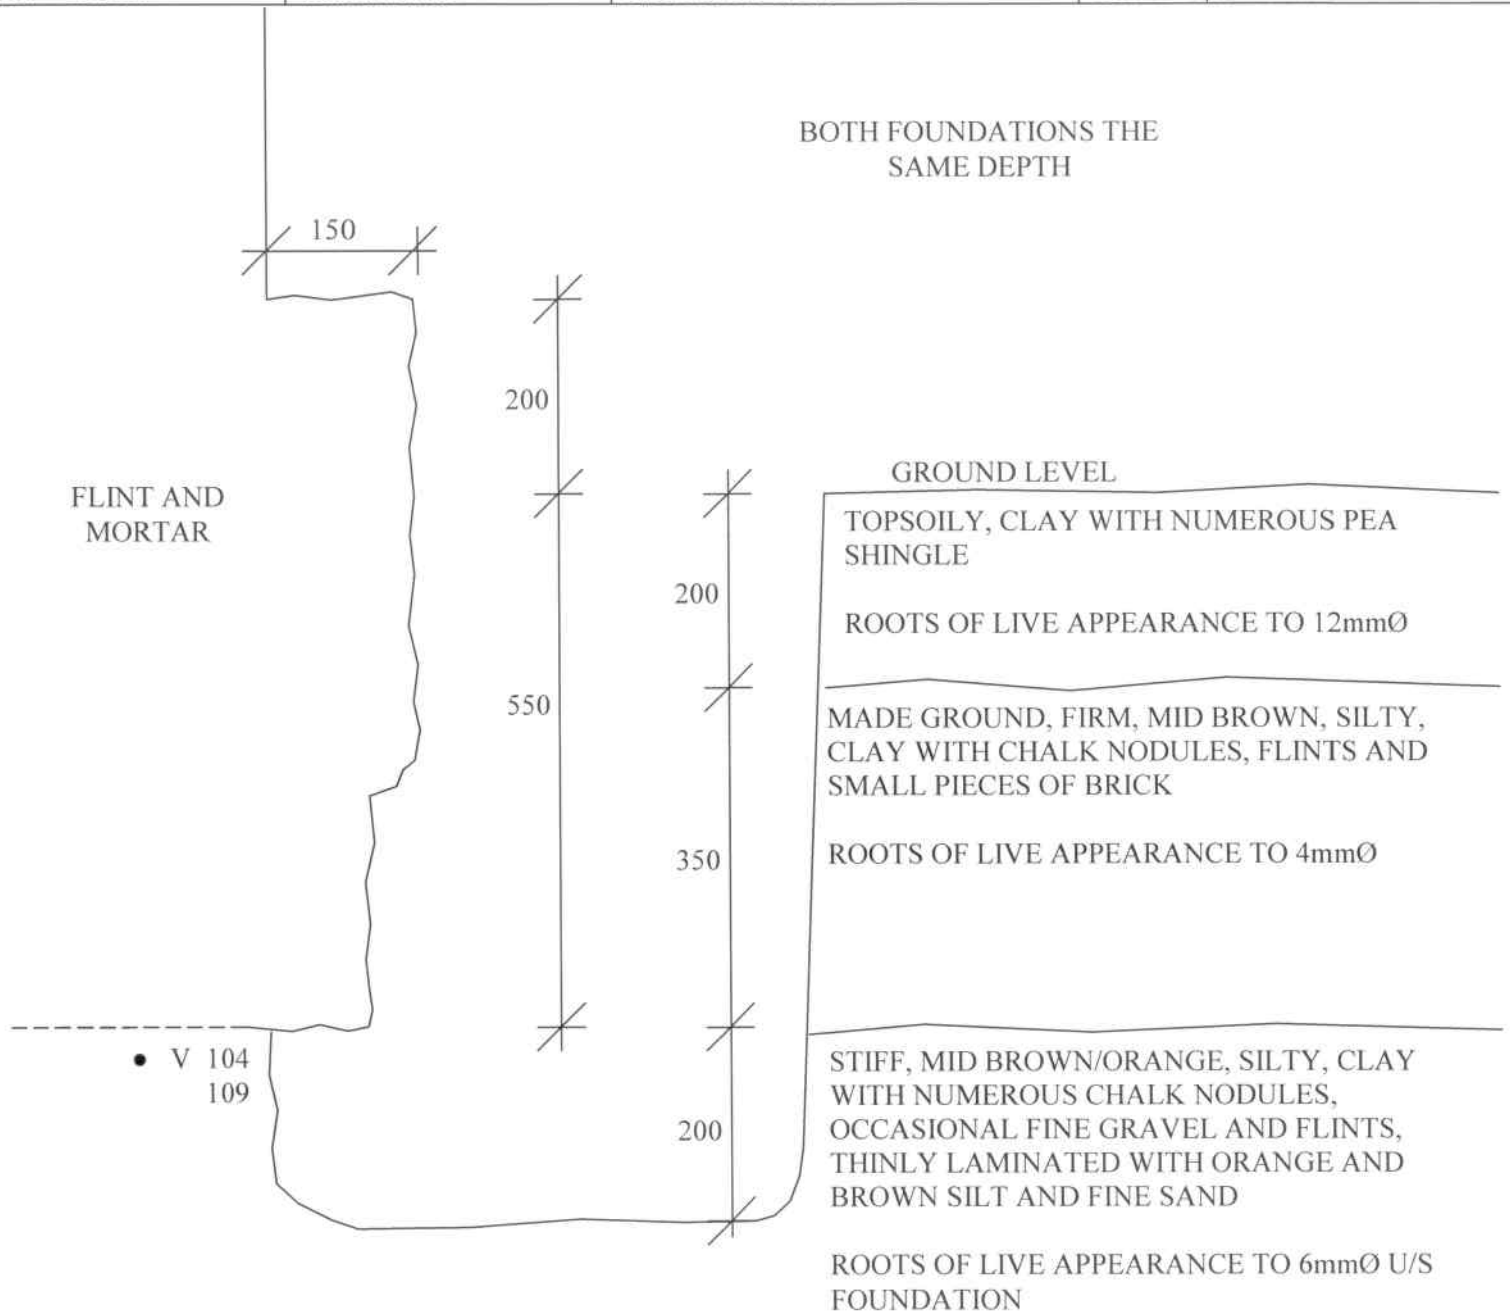
Ref. SI 0311	Trial Pit No. Two	Sheet No. One of One	Date: 7 th September 2020
--------------	-------------------	----------------------	--------------------------------------

Trial Pit 2 showed that the foundations to the main church Chancel and Nave to have a 550mm deep flint and mortar foundation which protruded from the wall face by 150mm. The foundation was taken through 550mm of turf/topsoil and brick fill made ground to bear onto a very stiff clay. There were roots of up to 12 & 4mm from GL to the u/s of foundation and then roots of up to 6mm from u/s of foundation to completion which was 200mm below u/s.

TRIAL PIT TWO ENDS AT 750mm
