## SITE INVESTIGATION FACTUAL REPORT

**CLIENT:** B & Maule Co Ltd  
**NAME:** Rowley  
**ADDRESS:** 18 Third Avenue, Frinton on Sea, CO13 9EG  
**CLIENT REF:** 36/20206386  
**OUR REF:** HH/20/65916

# SITE AND DRAINAGE LAYOUT

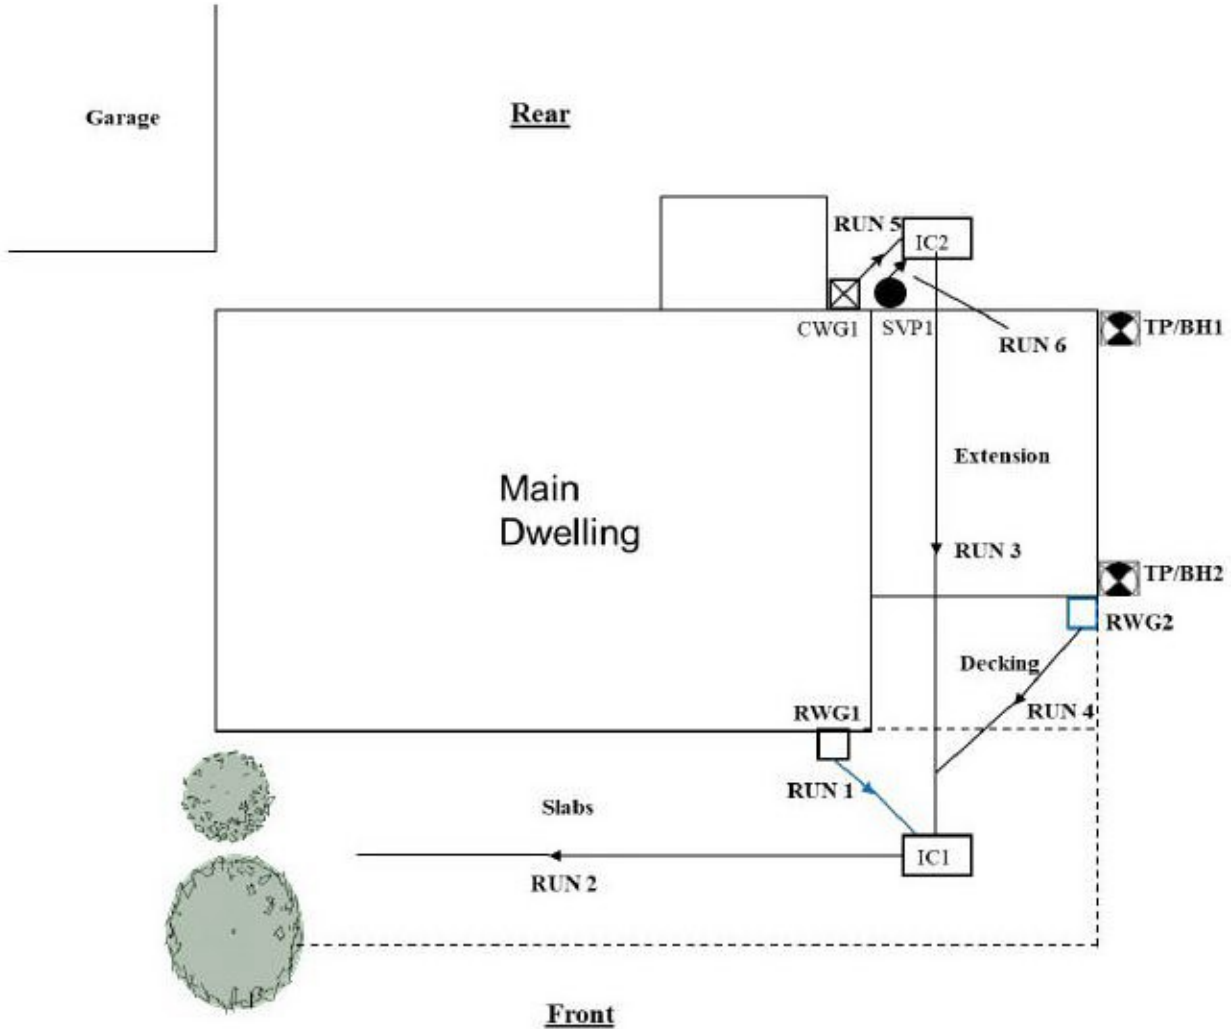
The property is served by a combined foul and surface water system.

Run 1: I/C 1 upstream to RWG: No defects identified.

Run 2: I/C 1 downstream to the limit of the survey requirement: Defects and root infiltration has been identified.

Run 3: I/C 1 upstream to I/C 2: Defects and root infiltration has been identified.

Run 4: Junction with run 3 upstream to RWG 2: Roots and debris identified.

Run 5: I/C 2 upstream to CWG 1: No defects identified.

Run 6: I/C 2 upstream to the SVP: No defects identified.

Item 1: Run 2: I/C 1 downstream for 6 metres: Root cut and reline.

Item 2: Run 3: I/C 2 downstream to I/C 1: Root cut, clean and reline. Lateral cut on junction to re-open junction for run 4 (RWG 2).

Item 3: Run 4: RWG 2: Excavate within the first metre downstream of the gully for lining access. Clean drain run and install a 3.5 metre lining.
