## **WALL INVESTIGATION AND ASSESSMENT**

**32D Manse Road, Linlithgow, EH49 6AR**

**Review of Garden Wall Condition and Repair**

**10 December 2020**

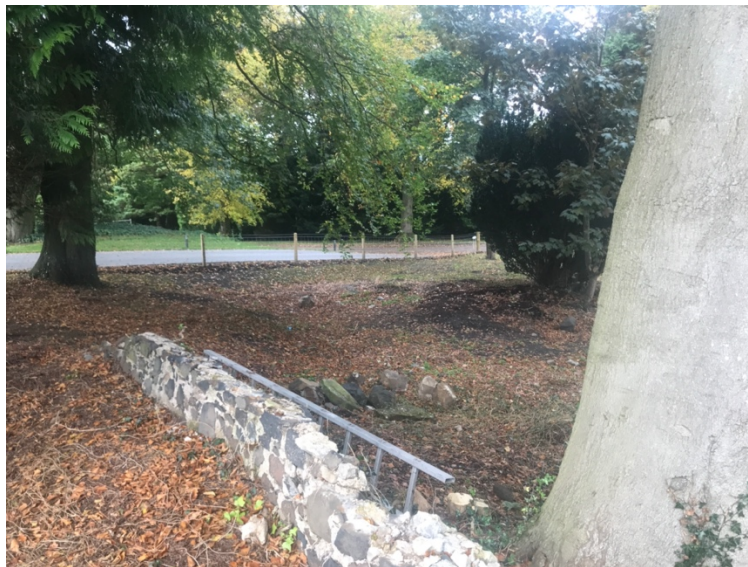
View of South elevation of the wall

The wall is a small section of an old wall which is understood to have acted as both a boundary and retaining wall, retaining around 900mm of ground to the south, or right side, in the photograph above.

The wall is in very poor condition and has collapsed in places due to forces from buried tree roots and long term weathering. It was a rubble masonry wall which has previously been repaired with mortar pointing but has since fallen into disrepair. The cope stones have all been dislodged and the northern half of the rubble wall has collapsed such that only a short length of the southern half of the wall remains in place.

The mortar is entirely eroded and the wall has insufficient strength to support to retained material. There is no evidence of any specific foundation, which would be common in this type of wall. However, the location of the wall adjacent to some very mature trees has meant the roots of the trees have affected the base of the wall causing it to rotate and become unstable.

I would suggest that the most practical way to deal with this would be to remove and retain the remaining small amount of stone. Regrade the garden ground either side of the wall, including importing some topsoil. This could be used to create a grassed area and the reclaimed stone could be used to form a new low feature stone edge detail in a suitable locations, perhaps at the edge of the drive way.

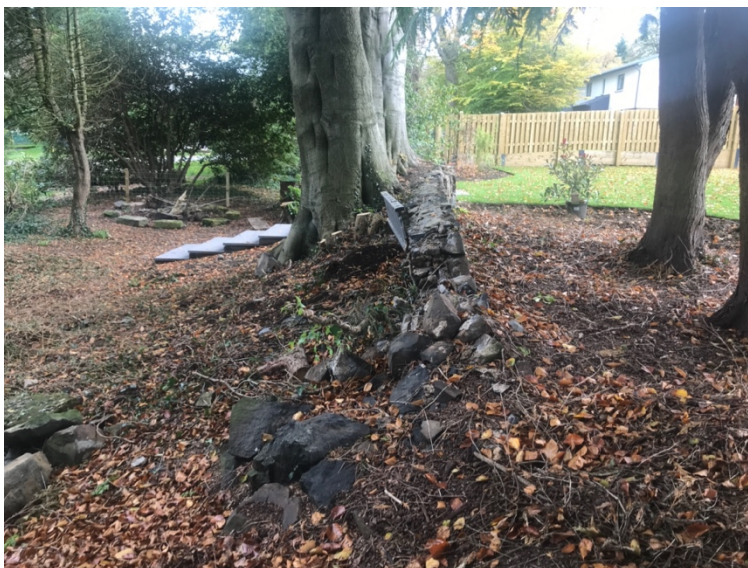
View from West looking along line of the wall
