Existing architectural fabric schedule

**26 Lower Belgrave Street
January 2021**

1.1 Overview

1.2 Purpose of the report

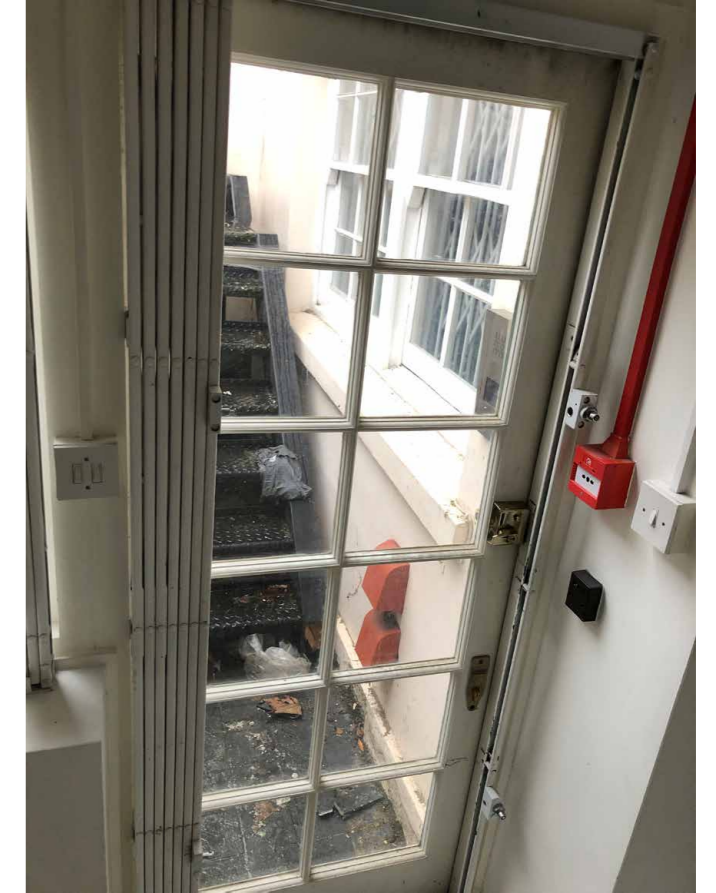
existing door (DB.02)

Specification description:
timber frame, single glazed

Condition:
damaged to base of the door, due to water ingress

Age:
unknown (not original- likely to be installed as part of enclosure below the entryway bridge, and subsequently replaced in modern times)

Proposed intervention:
remove door leaf and frame

Proposed specification:
hardwood, 4-panelled to match style of DG.01 to increase security;
new ironmongery and hardware

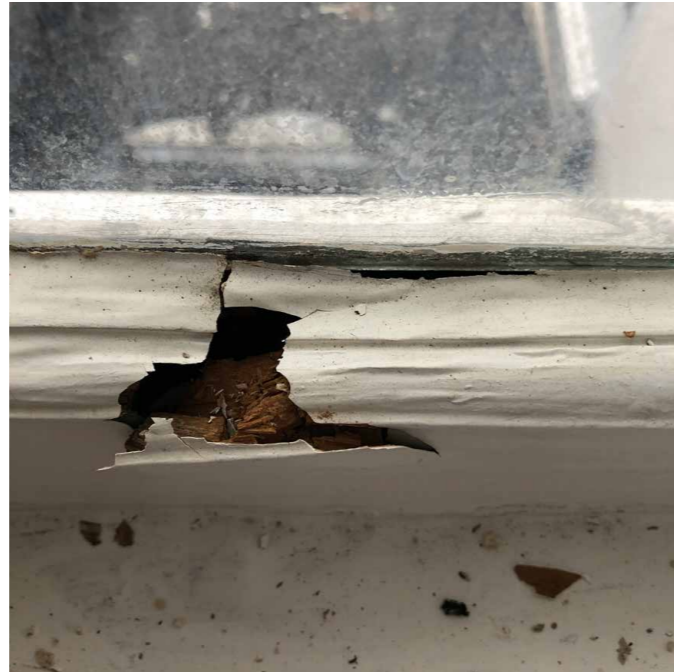
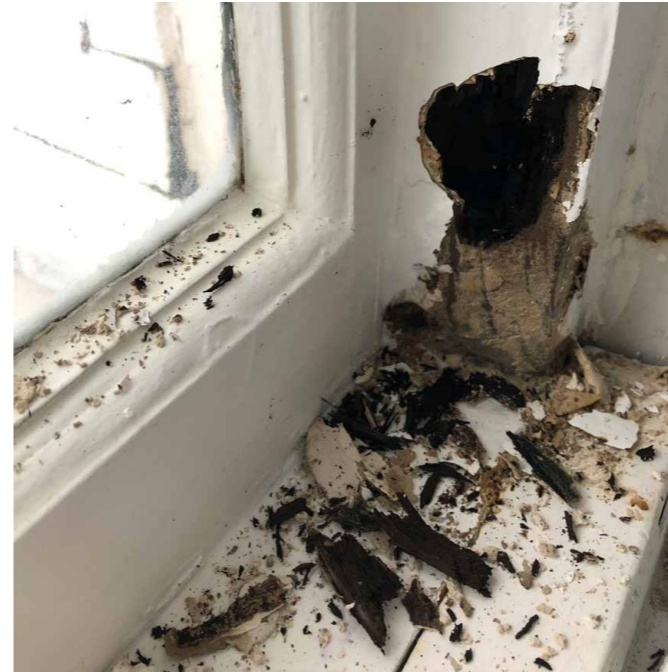
existing window (WB.01)

Specification description:
timber frame, single glazed, fixed

Condition:
frame rotten due to dampness in the masonry wall;
window vent in lieu of 1no pane

Age:
unknown (not original- likely to be installed as part of
enclosure below the entryway bridge, and subsequently
replaced in modern times)

Proposed intervention:
remove casement and frame

Proposed specification:
Red Grandis, 6.4mm laminated single glazed, mullion
detail to match existing, fixed lower casement with fan-
light above to provide ventilation;
wedi skirt & wedi bar;
new ironmongery and hardware

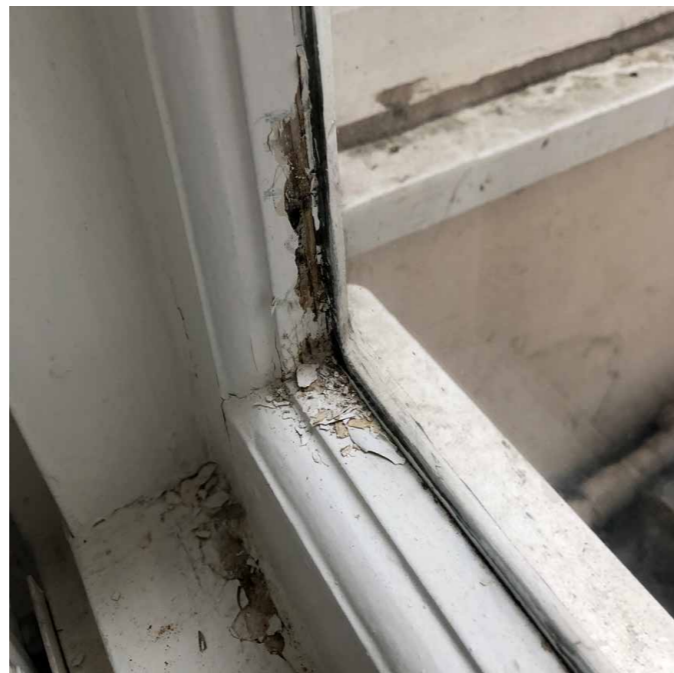
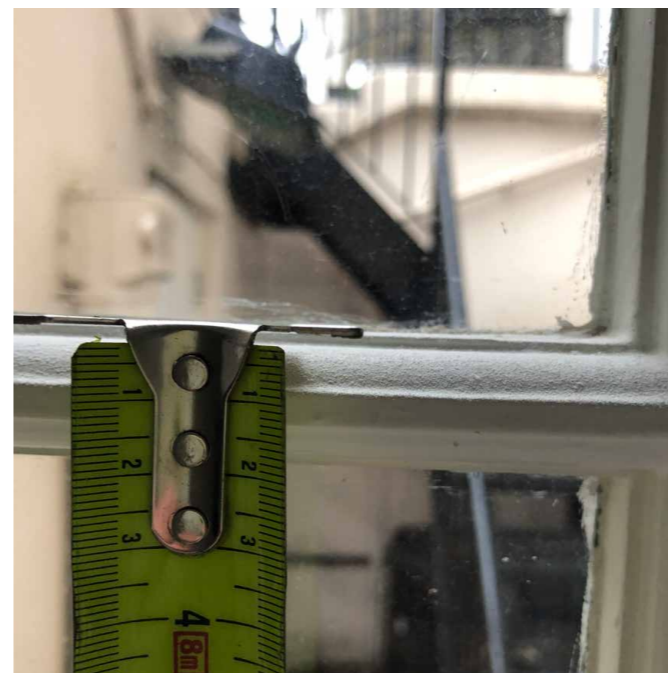
existing window (WB.02)

Specification description:
timber frame, single glazed, fixed

Condition:
frame damaged due to dampness in the masonry wall;
frame splitting and warping

Age:
unknown (not original- likely to be installed as part of
enclosure below the entryway bridge, and subsequently
replaced in modern times)

Proposed intervention:
remove casement and frame

Proposed specification:
Red Grandis, 6.4mm laminated single glazed, mullion
detail to match existing, fixed casement
wedi skirt & wedi bar

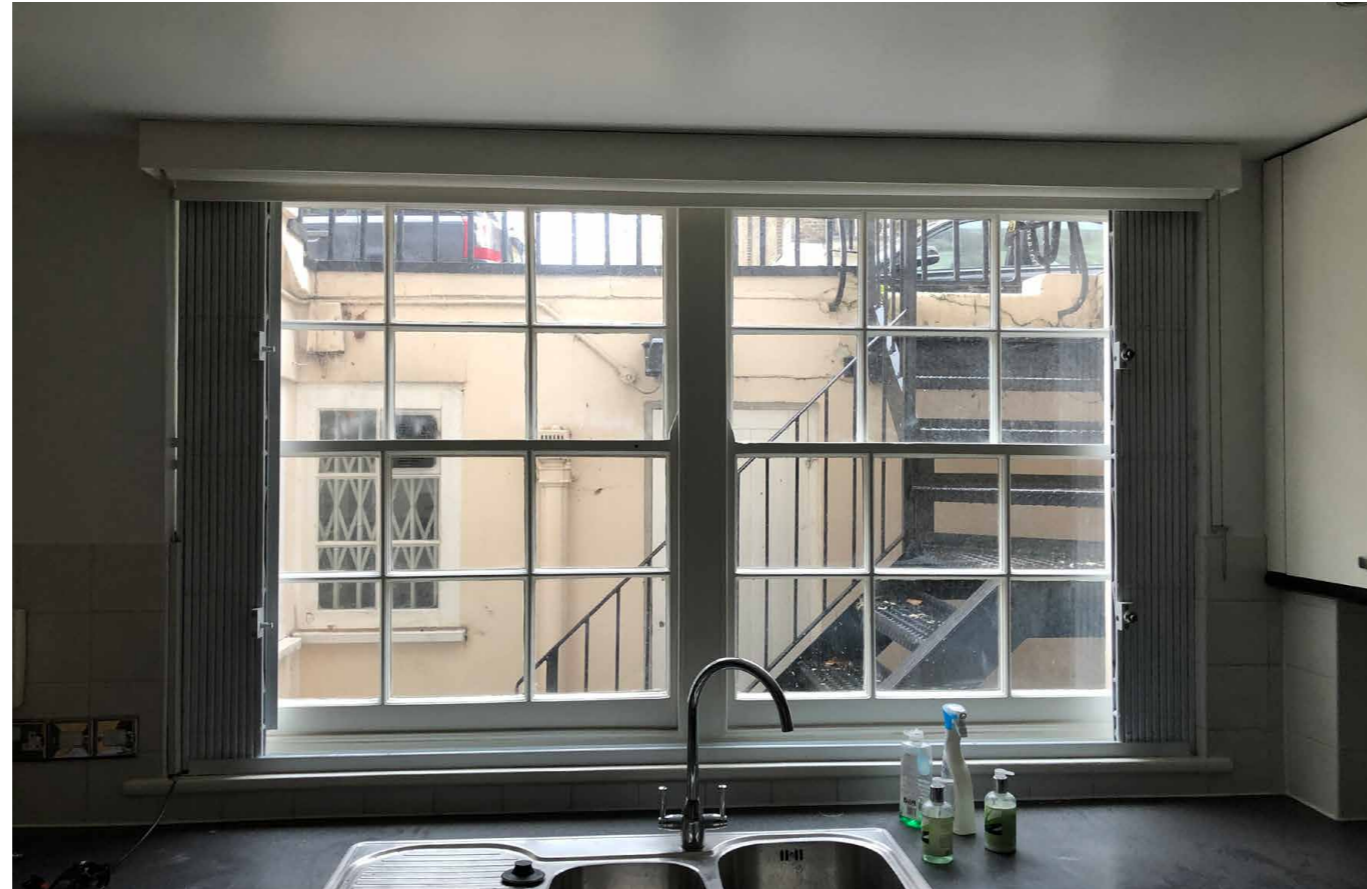
existing window (WB.03)

Specification description:
timber frame, single glazed, sashes

Condition:
acceptable;
some warping and paint peeling externally; both sashes are sealed and are currently unopenable

Age:
unknown

Proposed intervention:
release caulking/paint to reinstate sliding of the sashes;
new draft proofing- staff & parting beads; new pully & cord;
new ironmongery

Proposed specification:
redecorate to match

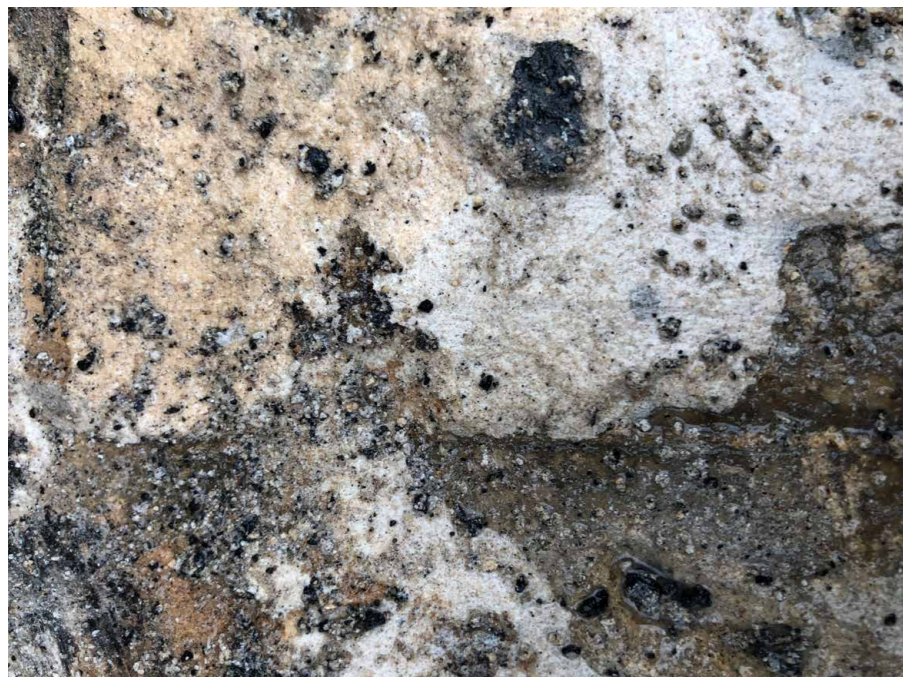
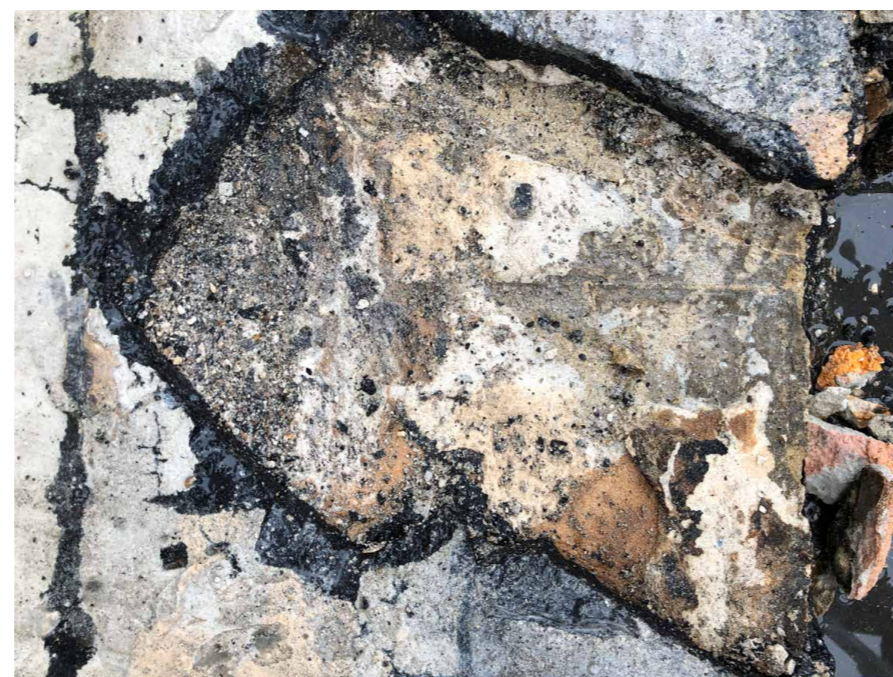
existing floor finish

Substrate:
based on limited investigative works, appears to be brick construction (to risers), although concrete is anticipated further down the build-up

Specification description:
c.150x150mm tiles on screed, over ashfelt, over stone (type TBC)

Condition:
fair

Proposed intervention:
strip out finish build-up down to waterproofing

Proposed specification:
repair waterproofing, lay new Portland stone with bullnose treads; contrast black inlay board to landing in granite
(ref. to drawing RAI055_PL_DT.02 for further details)

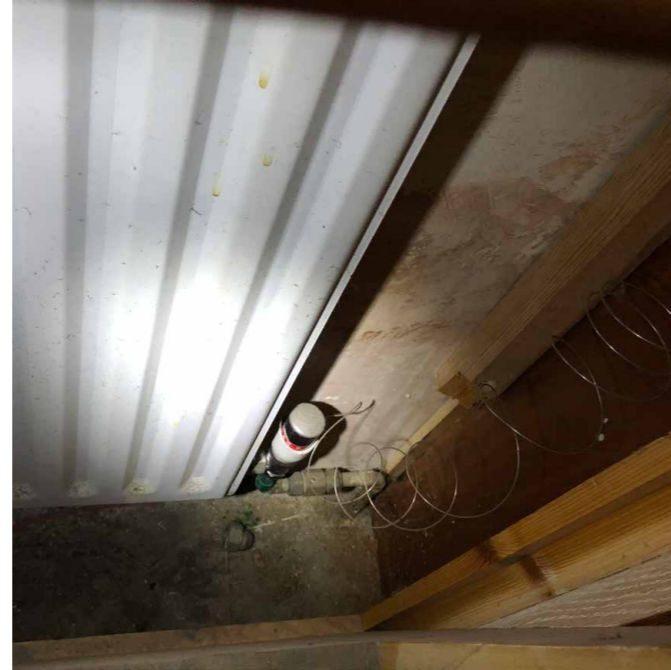
existing radiator and case

Specification description:
timber case with metal mesh to top and front panels

Condition:
good

Proposed intervention:
remove

Proposed specification:
new case to reduced size; style to match existing, metal mesh replaced with timber slats and top panel formed in marble;
paint over

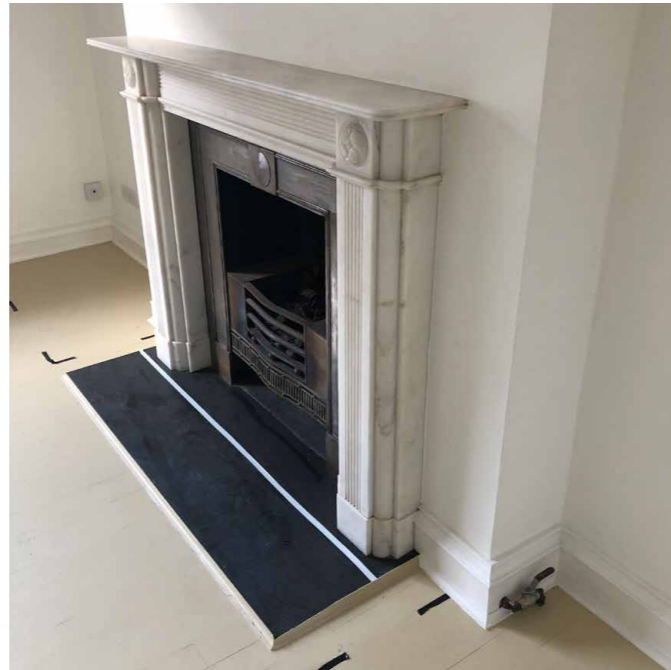
existing fireplace

Specification description:
marble and metal surround; stone hearth

Condition:
good

Proposed intervention:
remove surround, basket and gather; retain hearth

Proposed specification:
block up aperture with lightweight construction to facili-
tate functional family kitchen; vented

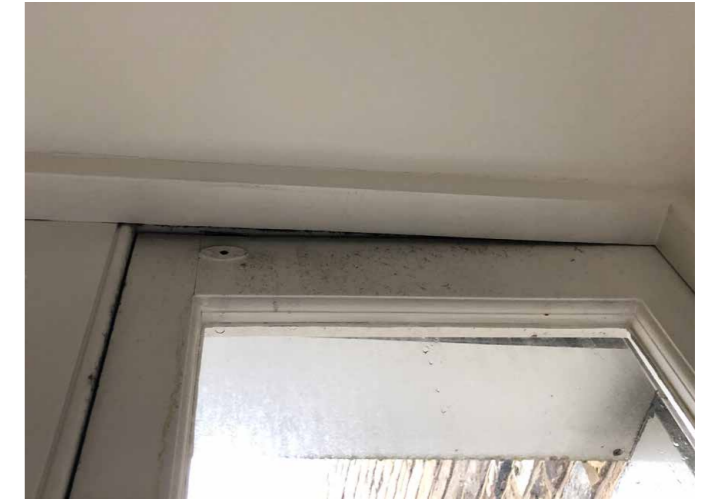
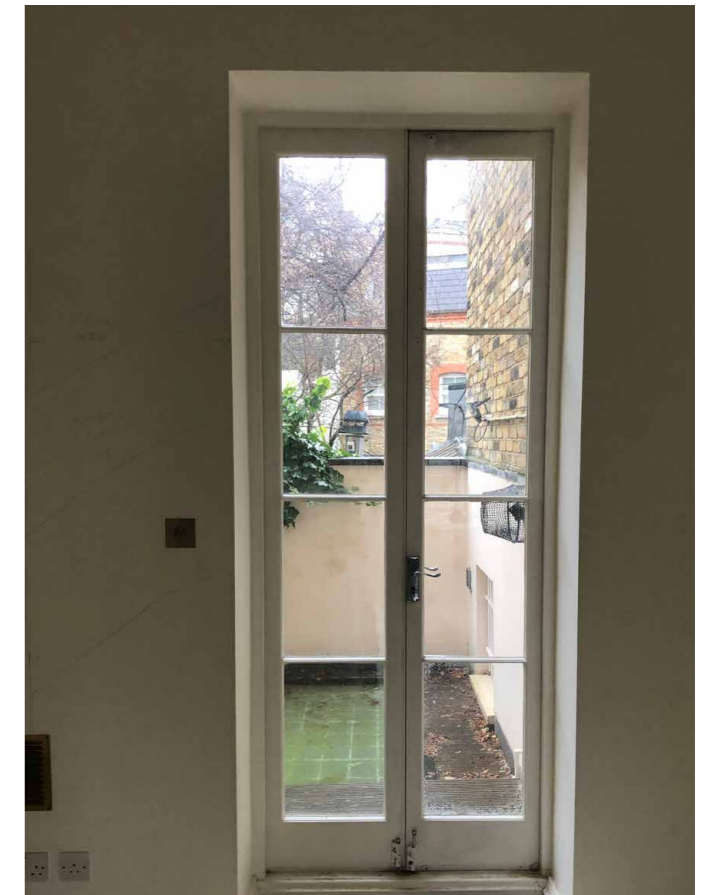
Condition:
fair; some warping and splitting due to water damage;
very difficult to open, shut and lock

Proposed intervention:
remove bottom rail to door leafs, sill and threshold

Proposed specification:
new hardwood replacement parts to match existing;
redecorate entire doorset; new draft proofing
new ironmongery and hardware

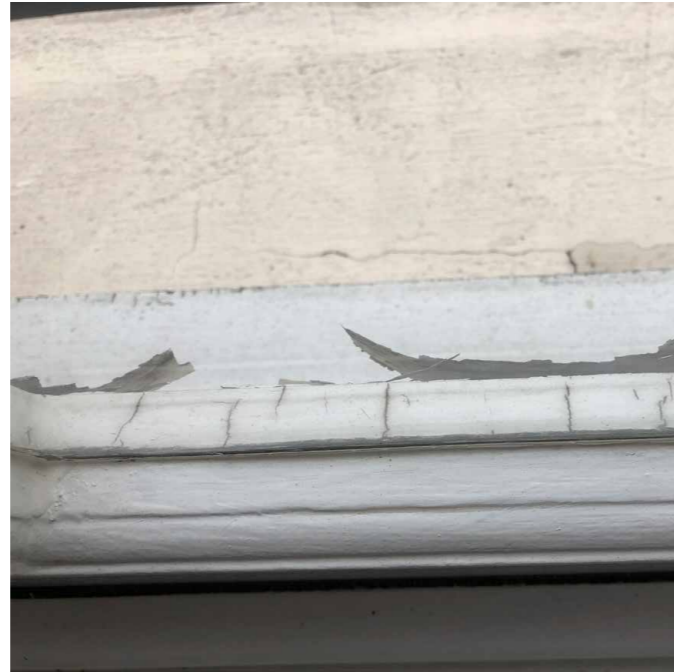
existing window (WS.01, WS.02)

Specification description:
timber frame, single glazed, sashes;

Condition:
very poor- glass delaminated at corners/top rail

Proposed intervention:
retain frame and sash box

Proposed specification:
new sashes, single glazed- laminated 8.8mm acoustic;
new staff & parting beads; new draft proofing, pully & cord;
new ironmongery; repair & re-decorate external sill where damaged;
redecorate to match;
new roller black-out blind (fabric) to internal reveal.

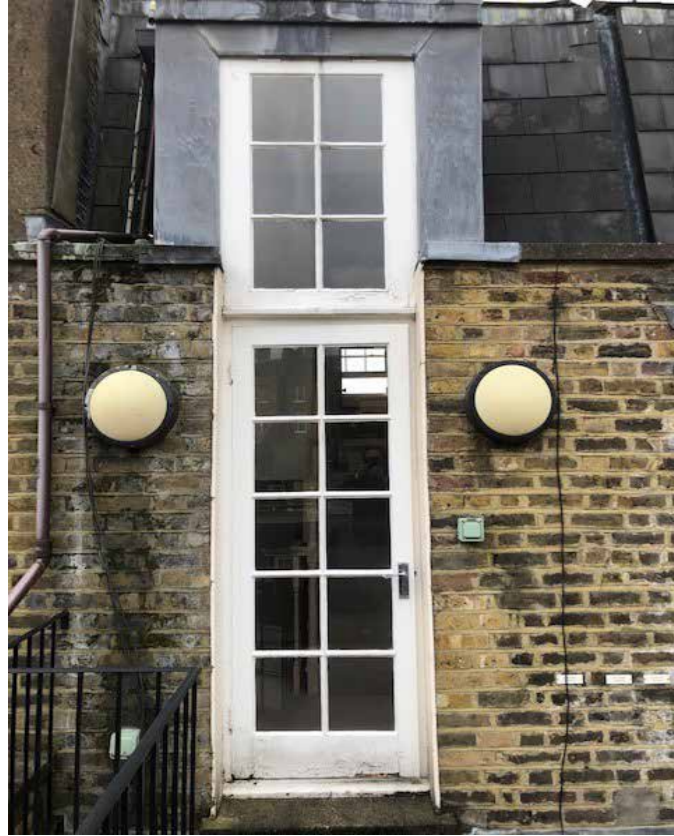
existing door (DT.01) and window

Specification description:
single glazed, timber frame

Condition:
rotten door panel and fixed window panel above; retain frames and sills

Proposed intervention:
remove door leaf and fixed window panel above

Proposed specification:
new hardwood replacement door and window to match existing- 4mm single glazing; redecorate entire doorset; new draft proofing, ironmongery and hardware

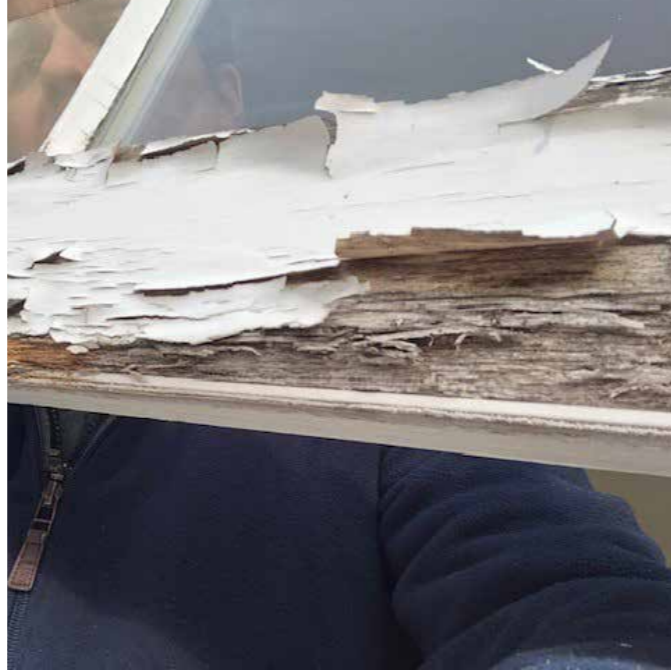
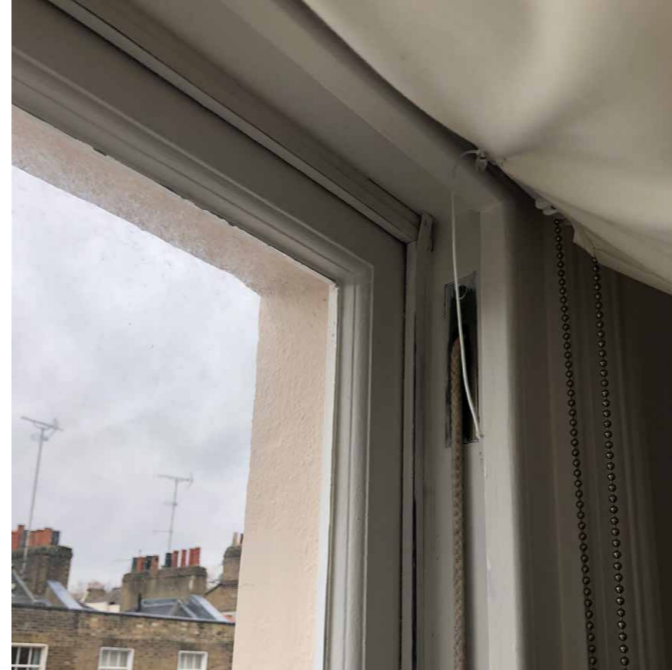
existing window (WT.01, WT.02)

Specification description:
timber frame, single glazed, sashes;

Condition:
very poor- glass delaminated to corners/upper rail

Proposed specification:
repair sill; new sashes, single glazed- laminated acoustic
8.8mm glass; new staff & parting beads
new draft proofing, pulley & cord;
new ironmongery; repair & re-decorate external sill
where damaged;
redecorate to match;
new roller black-out blind (fabric) to internal reveal.
