Planning Statement

Project **20612/01**

Title **Allanmore Farmhouse**
Pitkerrald Road, Drumnadrochit

Report Date **20 Jan 2021**

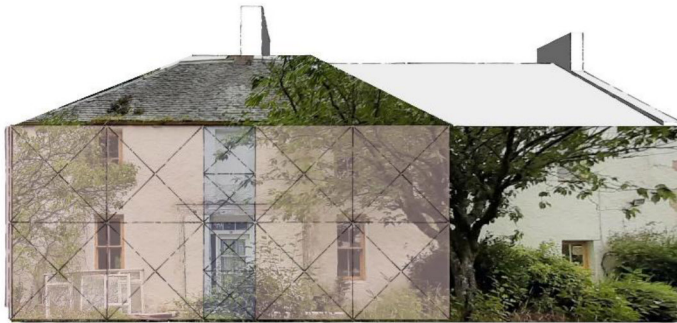
North Elevation Proportions (Front)

The geometry of the original house suggests that it is much older and possibly dating to around 1700. The piend roof and symmetrical composition is typical of this period in the Highlands. The central chimney is a unique feature of particular interest. The geometry is also interesting, strict proportions have been applied to each elevation, see attached images which again suggests the pre 1740s period.
