Summary Heritage Asset Assessment of Brundish Manor, Brundish, Suffolk.

May 2018

Nicolaas Joubert MSc.
Historic Buildings Consultant Ltd.
M: 07717533498
E: historicbuildings.haa@gmail.com

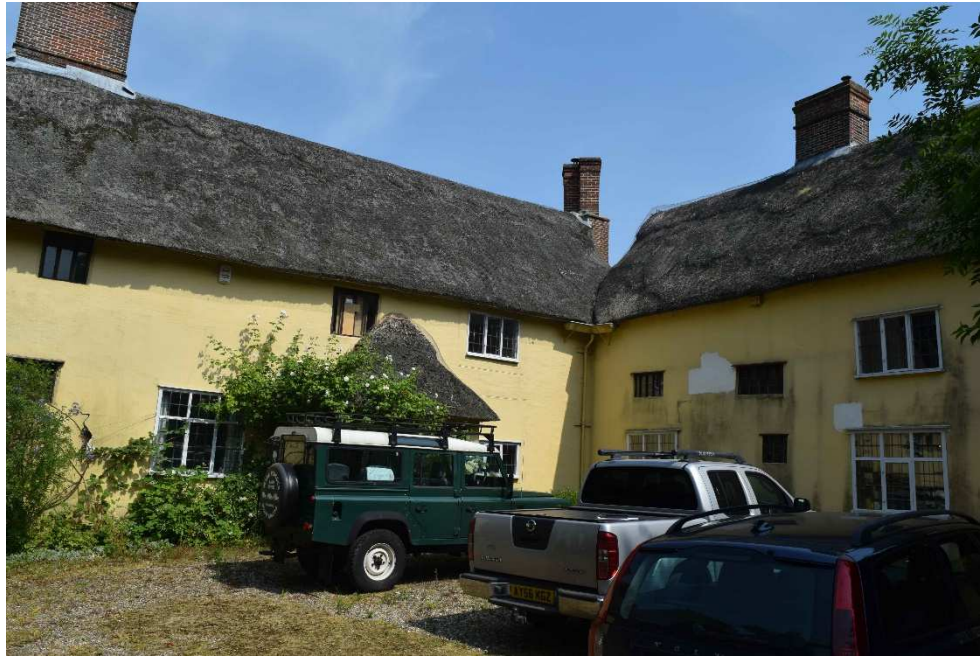
Figure 5: South end of the main range.

- 4.1.13 Both wings were re-rendered with cement render and expanded metal laths during the C20. The earlier lime render was removed but much of the lathing was retained. Both the laths and the expanded metal lathing have now come to the end of their lifespans due to the well documented detrimental effects of the cement render. As a consequence of this the render is now delaminating from the external walls and has severely cracked over several areas which are now allowing water ingress.

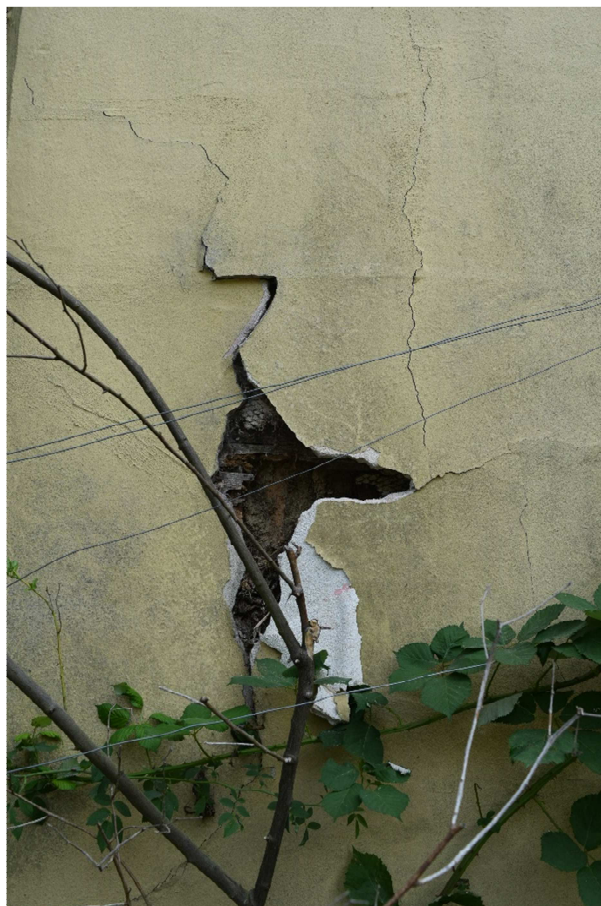
Figure 9: Condition of cement render.

5.3. The existing render consist of cement render on expanded metal lathing which was applied over the earlier wooden laths. As shown in Figure

9 below the render is in poor condition. There is evidence of severe cracking in several areas and the render is in the process of delamination. Investigatory works revealed that the soleplates around the building are in poor condition. This may also apply to the external face of the core timber framed structure. The condition of the timber frame could not be established as this would require the removal of the existing render. Permission is sought to remove the inappropriate C20 fabric to carry out the necessary repairs to the soleplates and timber frame of the building. Once the repairs have been carried out to the building the structure will be covered with sheep's wool insulation (wood fibreboard too rigid and will affect external appearance), a vapour permeable membrane, wooden laths and rendered with a scratch coat of WarmCote followed by a 7-10mm coat of Limecote with two 12mm coats of WarmCote. The products are lime based and supplied by 'Best of Lime' in Haverhill. These products have a proven track record as appropriate materials which is entirely compatible with timber framed structures as a vapour permeable alternative. The exterior will be painted with a Keim mineral paint. Specifications available on request.

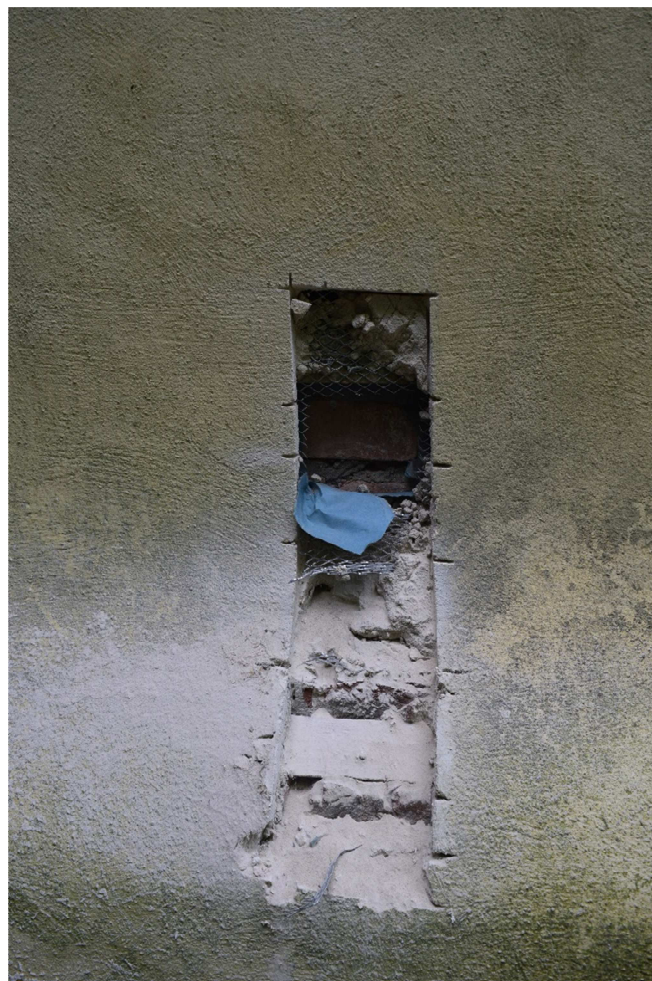
Figure 13: External view of the modern Fletton brickwork in the north-west gable end wall.

- 4.1.8 The north-west gable end of the main range is of much interest. Only the clerestory/flanking mullioned windows have survived but at the centre of these, on both the ground and first floor, were large oriel windows. These windows projected beyond wall line. The oriel windows were probably removed during the C18. The oriel window opening at first floor level was blocked in after its removal. At ground floor level the timber frame was removed and underbuilt in modern Fletton brickwork. It is fortunate that the clerestory windows were retained.

- 5.9. The replacement of the older boiler will not have any impact on the fabric of the main wing.
- 5.10. During the C20 the lower part of the north-west gable end wall was rebuilt in Fletton brickwork after the removal of the original timber framed wall (Figures 12 & 13). It is proposed to demolish the Fletton brickwork wall and reconstruct the wall with a timber framed structure as per the original construction. It is also proposed to re-insert a ground floor window into this elevation. The window is to match the existing early C19 leaded-light casement windows. The proposed works will enhance the character of the historical parlour and the inserted window will retain continuity with the existing fenestration.
