LAND ADJACENT TO SEAWYNDS ST CATHERINE'S ROAD **NITON ISLE OF WIGHT PO38 2NA**

DESK STUDY & SITE RECONNAISSANCE REPORT

STB/424918/jfd

November 2020

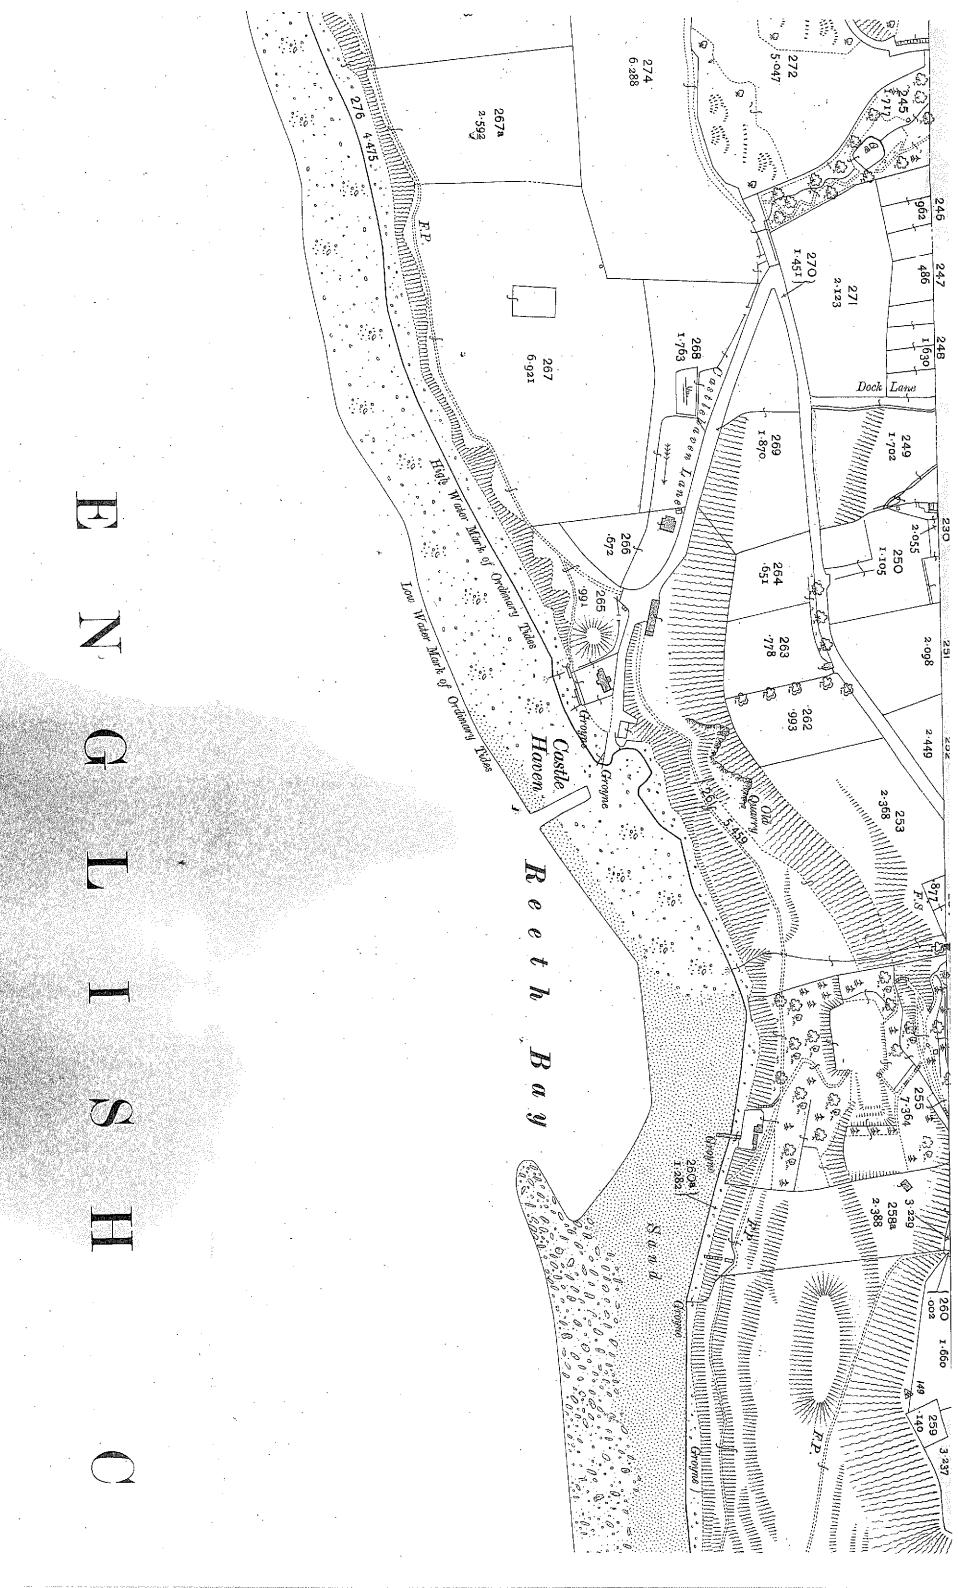
OS Map - 1908 Scale 1:2500 Sheet 2 of 2

The plot remains undeveloped and the building on the site of Seawynds is still present. St Catherine's House directly to the east and the Coastguard Station to the south remain. Lloyds Signal Station is shown to the south and the slope features are not shown.

To the southwest of the site, Niton Lodge is now named Reach Lodge, the quarry is noted "Old Quarry" and Victoria Hotel is no longer present.

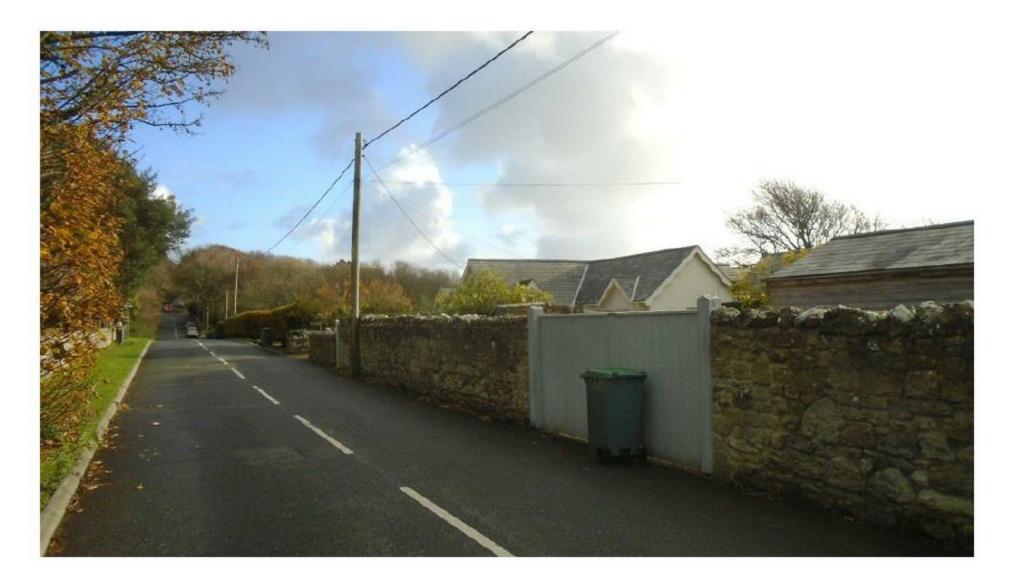
The site is accessed directly from St Catherine's Road via a gated access in a stone wall. Beyond the boundary wall is a level gravel driveway leading to a timber garage.

View of site access from St Catherine's Road

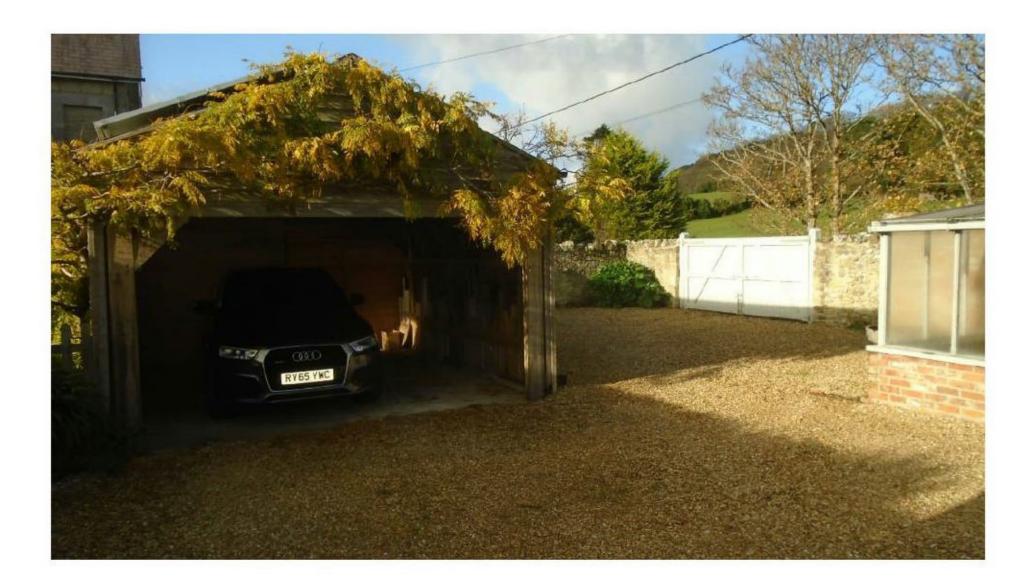
Gravel drive and garage

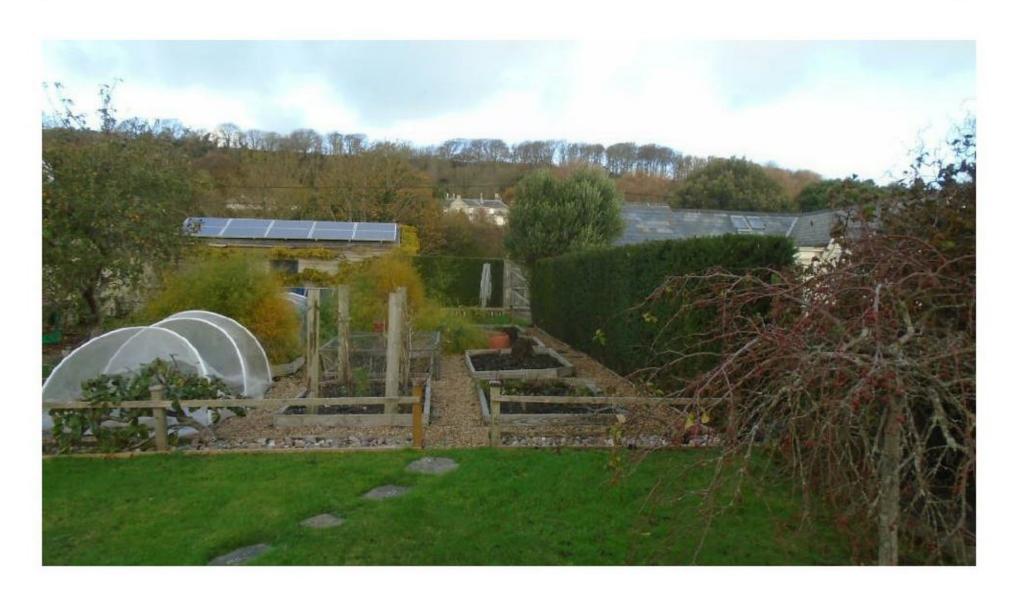
The site currently forms part of the grounds to Seawynds, however, the proposed eastern boundary is marked by an existing hedge line. The southern boundary will be formed approximately 15-20m north of the crest of the slope the leads down to Castlehaven Lane.

View of site facing north - Note: hedge marking proposed eastern boundary of site

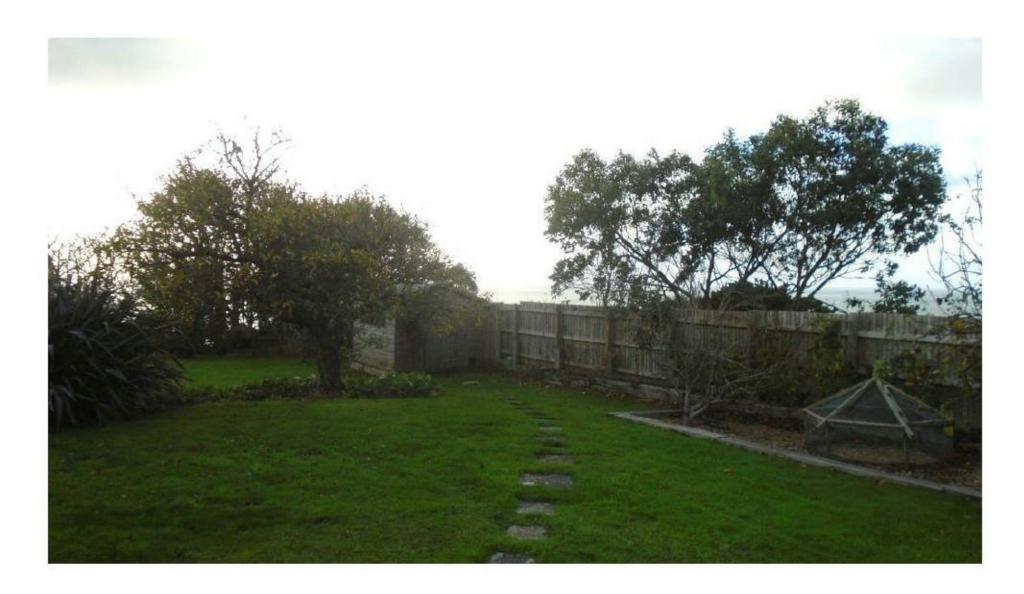
The remainder of the site is level comprising vegetable planters and lawn. There were no signs of ground movement noted on the site.

View of southern end of site

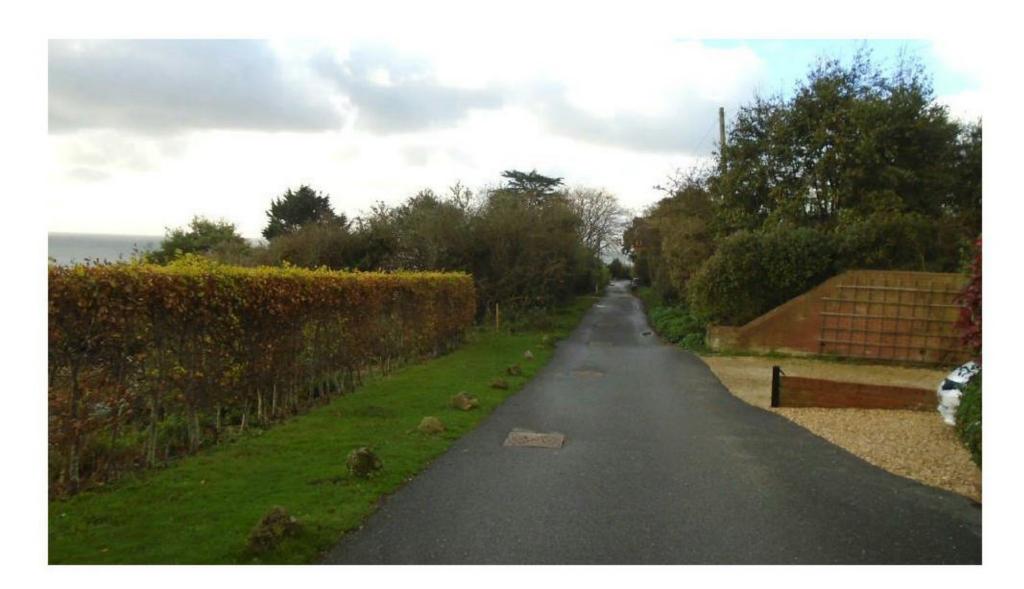
An inspection was also undertaken of Castle Haven Lane, to the south of the site. Similar to St Catherine's Road there are a series of manhole covers at close centres giving access to the dewatering system. The road surface was found to be in good condition. No sign of ground movements were noted to the roadway.

View of Castle Haven Lane to south of site

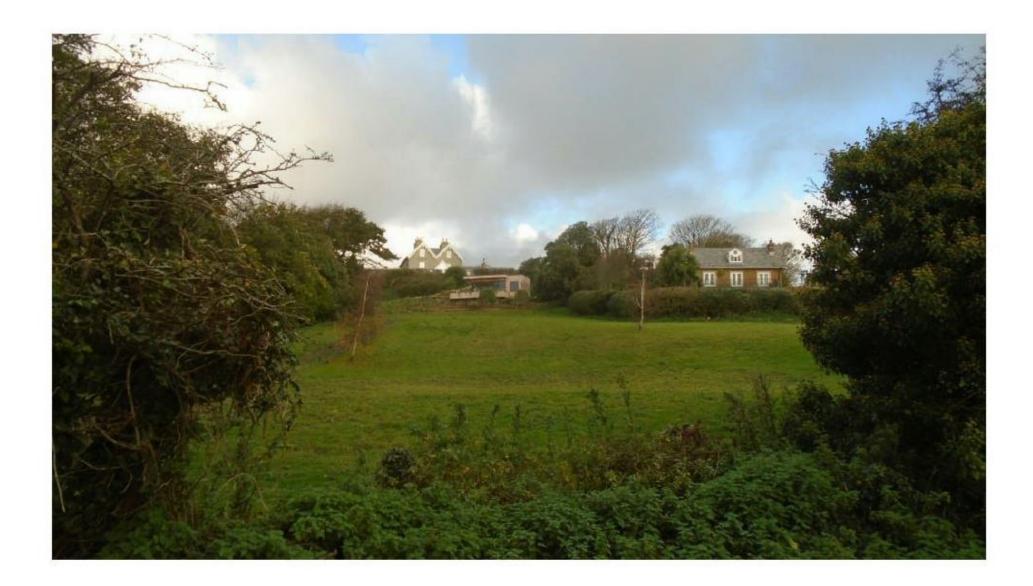
View from Castle Haven Lane looking north towards site
