SCHEDULE OF REPAIRS

(REFURBISHMENT)

The Malthouse
Beauworth Road
Beauworth
Hampshire
SO24 0PA

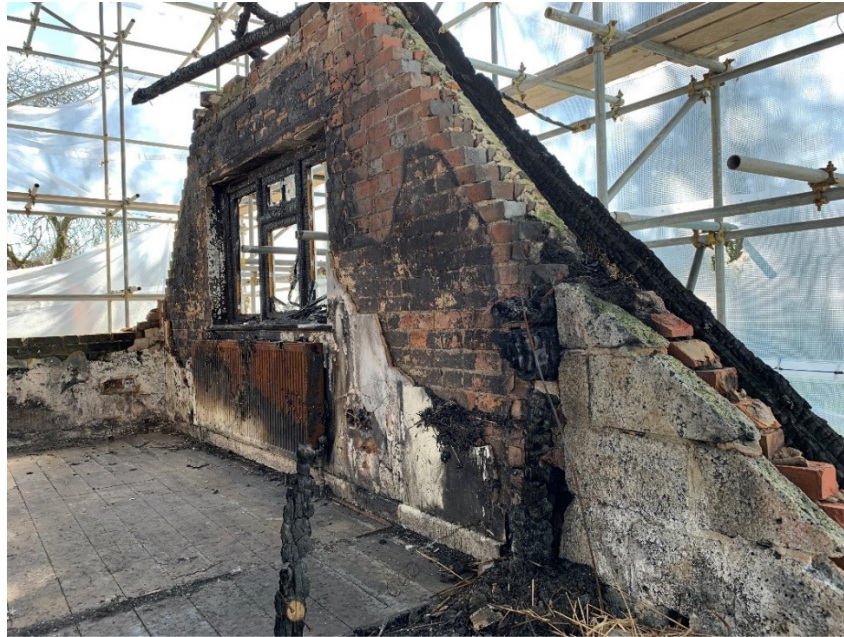
The southern gable to Bedroom 2 (see photo below) will need to be carefully taken down due to extensive fire damage to the wall to the existing floor. This will be rebuilt with a new brick outer leaf (painted finish), blockwork inner leaf and a plasterboard a skim finish internally.

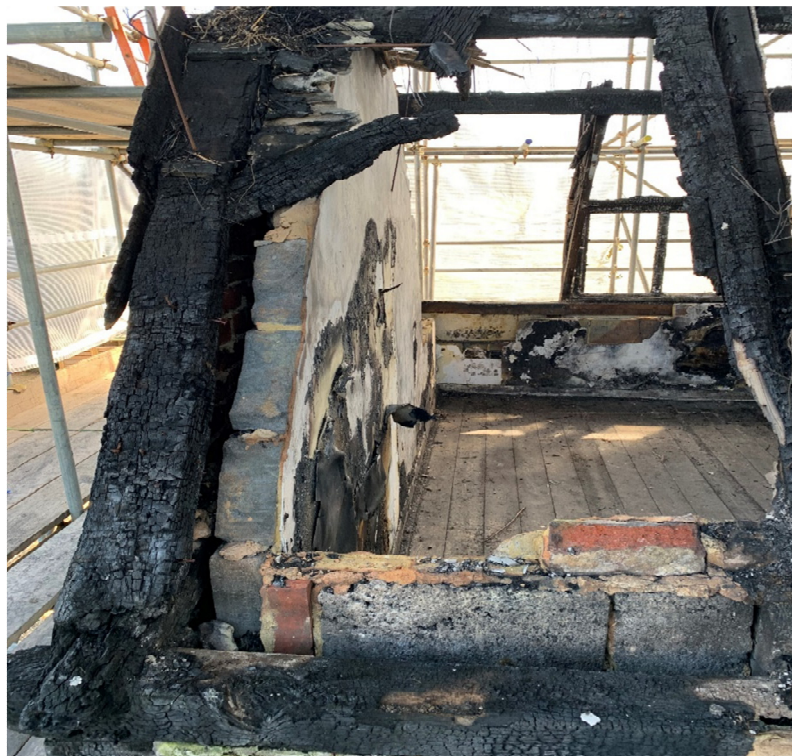
The northern gable to Bedroom 4 is in fair condition, but will require the horizontal timber to be completely replaced and the brickwork below to be repointed where cracking has taken place. It is noted that the inner skin of this wall is constructed from concrete blocks. (refer to picture below) which require removal to first floor level and rebuilt in timber stud with suitable ties to the original structure to provide stability. Any debris in the cavities should be removed. The SE's report has indicated connections are needed between the first-floor joists and the external frame and the internal side of the external frame.

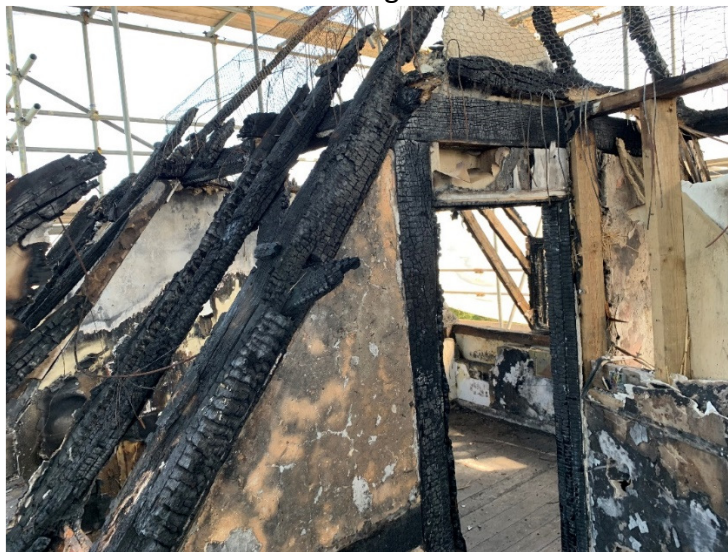
The wall between Bedroom 3 and 4 is an original framed partition with original wattle and daub infill. This frame will be retained and cleaned while the infill panels will be replaced as they are crumbling due to excessive moisture exposure. A lateral restraint at the head will give stability (refer to photo below and details in the SE's report). Although it was previously loading bearing this wall will be non-loadbearing in the re-built structure.

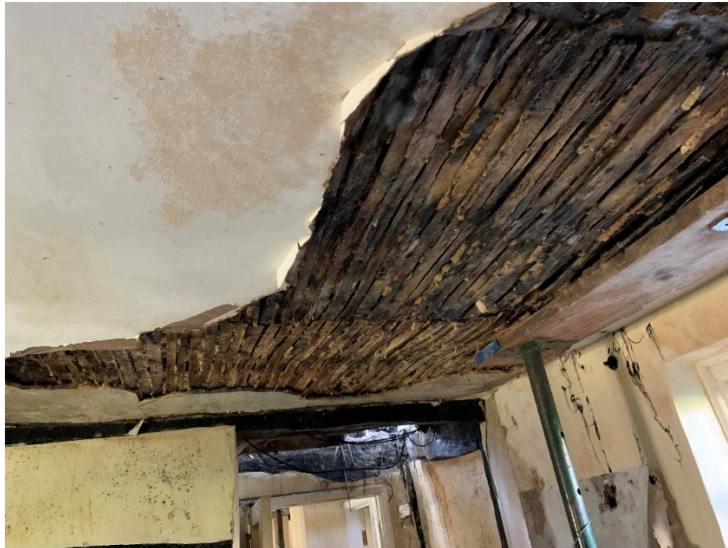
In bay 2 there is a lath and plaster ceiling which has had both major and localised failures (see photo on next page).

To the west of the spine beam the lime plaster has been skimmed with gypsum. Where exposed, the laths appear to be in a relatively fragile state due to age and, possibly, water damage.

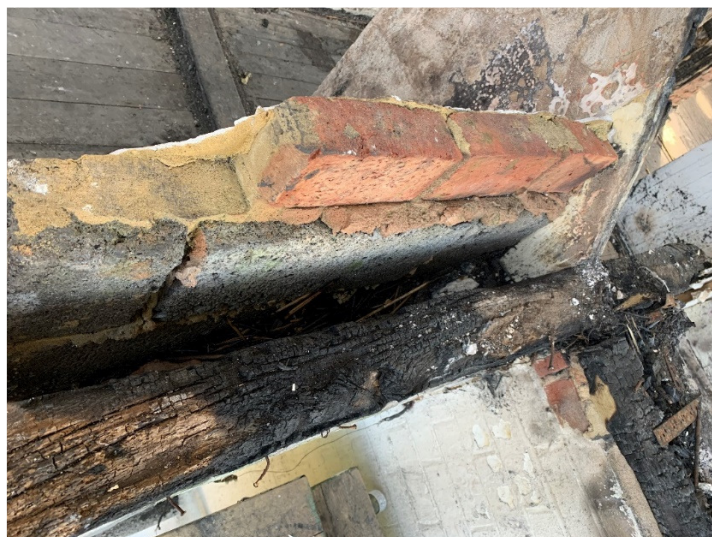
The external Oak frame up to and including the wall plate is generally in good condition with few elements to be replaced including the western wall plate adjacent to the corridor and Bedroom 3, refer to photo below:

The junction between the eaves and the gable to the western and eastern side may need to be cut back with new oak of a similar size to the existing being added. Refer to photo below:

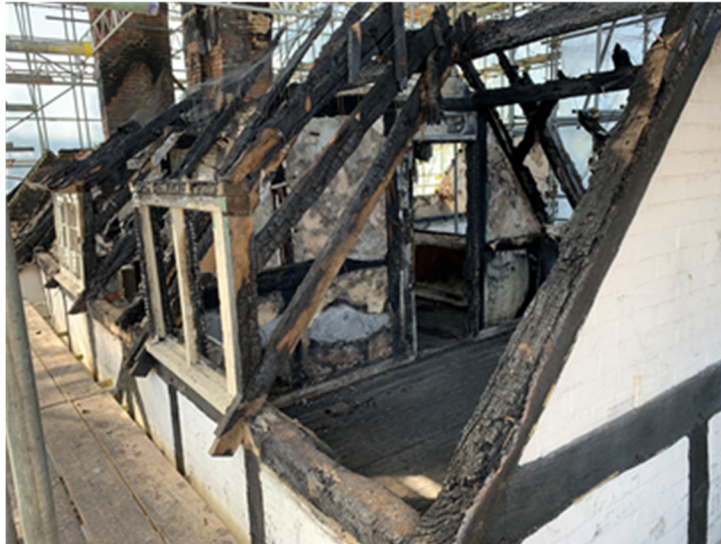
Internally the oak frame has been extensively damaged at first floor level, particularly around bedrooms 3 and 4. This frame is beyond repair and no longer capable of being load bearing. As such the purlin & wind braces on the east slope along with the principal rafters to the perimeter of the wattle & daub partition (mentioned above) will be removed and a new roof structure will be constructed (refer to photo below).

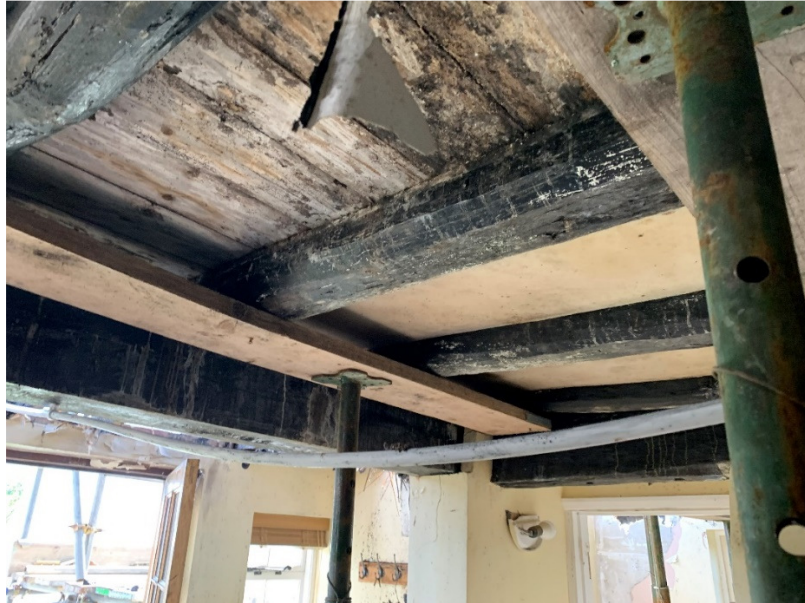
All existing floorboards have been warped or shrunk due to a combination of extreme heat and then water or received extensive fire damage. It is therefore proposed to remove all existing floorboards and replace with new sw floor boards throughout the first floor.
