**STRUCTURAL SURVEY**

Barn at Winswood House  
Burrington  
Devon  
EX37 9JN

168/19

11 November 2020

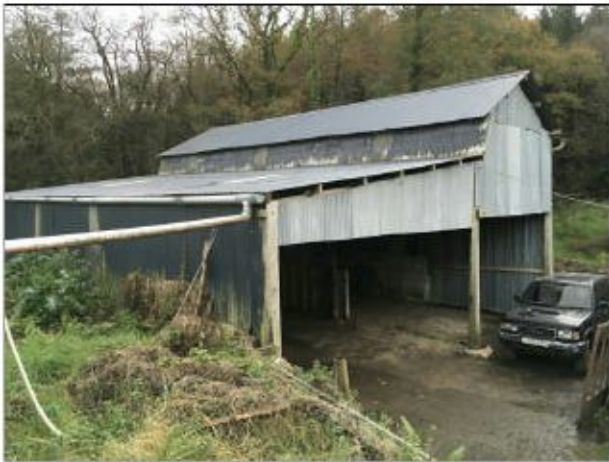
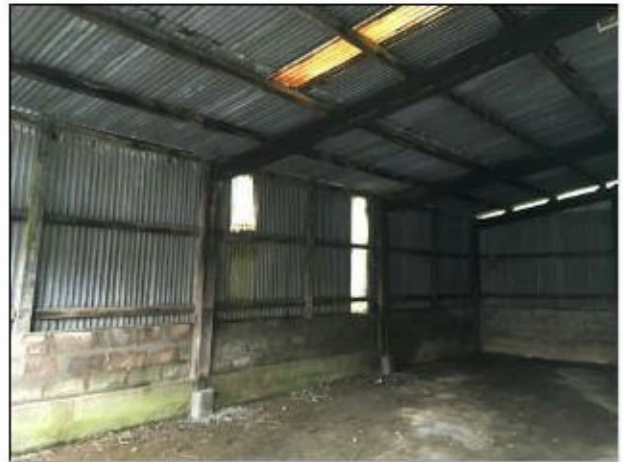
The barn is of concrete pad and strip foundations, timber framed and blockwork walls, with blockwork and steel cladding to the walls.

The roof is provided with corrugated metal sheet cladding to the roof

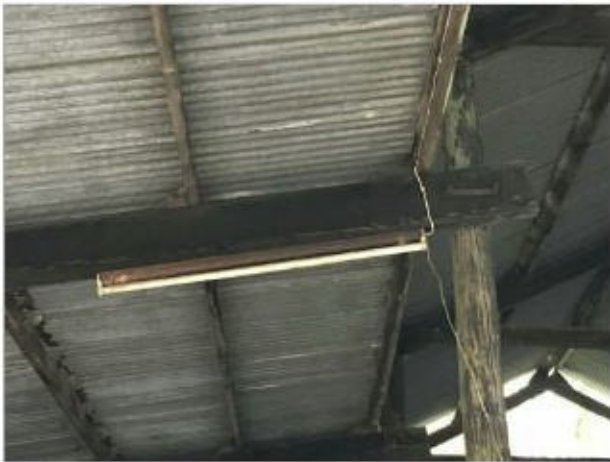
The barn is currently provided with a mains water supply and an electric supply that is situated within the curtilage of the land under the control of our client.

The building is not provided with any form of foul drainage and so would require a new septic tank or sewage treatment plant. The current owners however have sufficient land to allow for the provision of a new individual septic tank to serve this property.

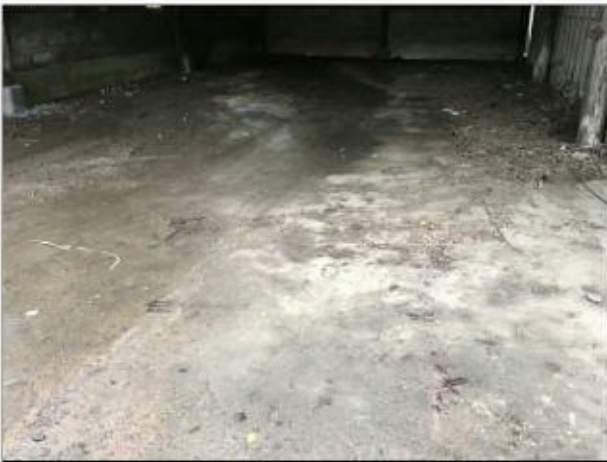
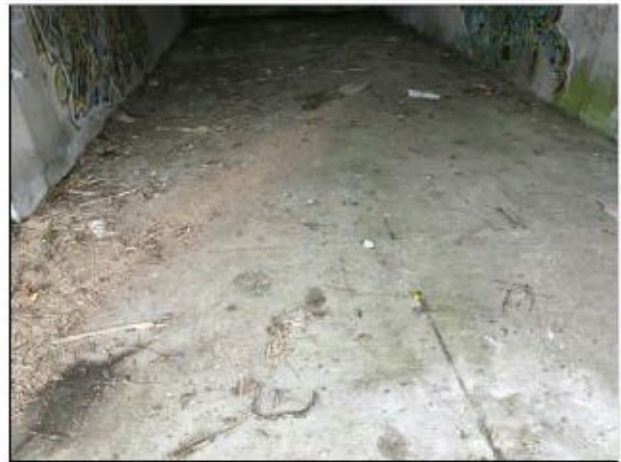
The ground floor is provided with a compacted earth floor finish, which appears to be in reasonable condition. The floor is relatively even and appears to have been well compacted by the previous agricultural use. There are no signs of movement or subsidence to the earth floor and generally it all appears to be in good order.

The ground floor is relatively level and is in good order with no signs of any movement or subsidence noted at the time of the survey. The compacted earth floors all appear to be in a stable condition and are suitable for retention.

The existing compacted earth floor will require a degree of levelling up with hardcore and then provided with a concrete base. I can see no reason why the existing compacted earth slab would require any significant remedial works in this situation. The floor will however require some degree of updating with the provision of insulation to comply with current building regulations but this will require the provision of a new concrete slab, which can be laid directly on top of the existing compacted earth floor finish.

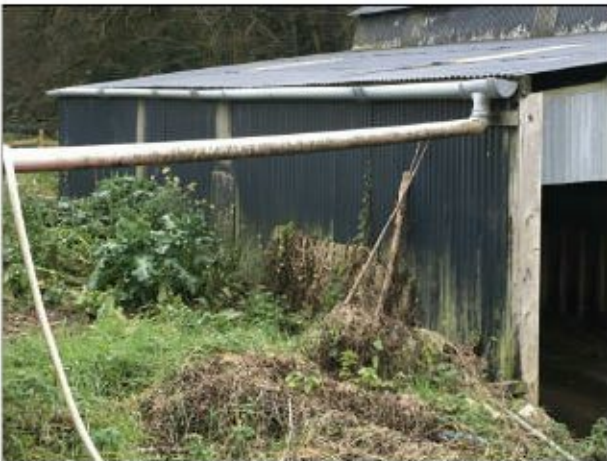
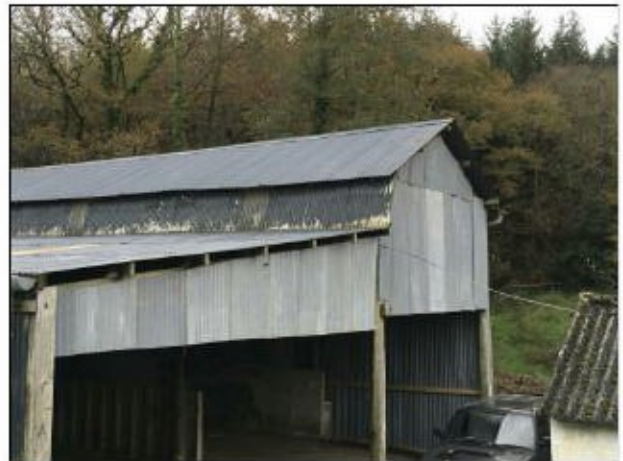
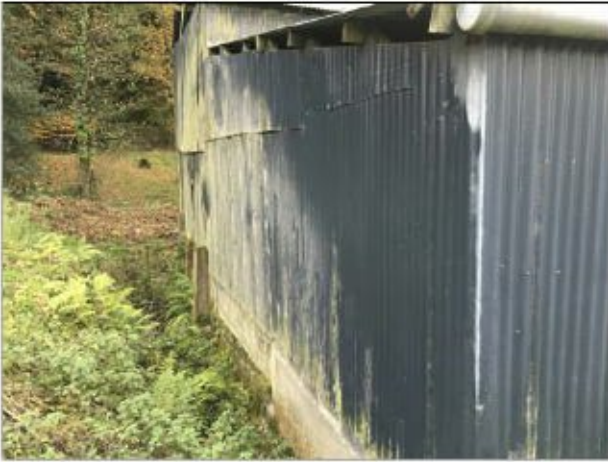
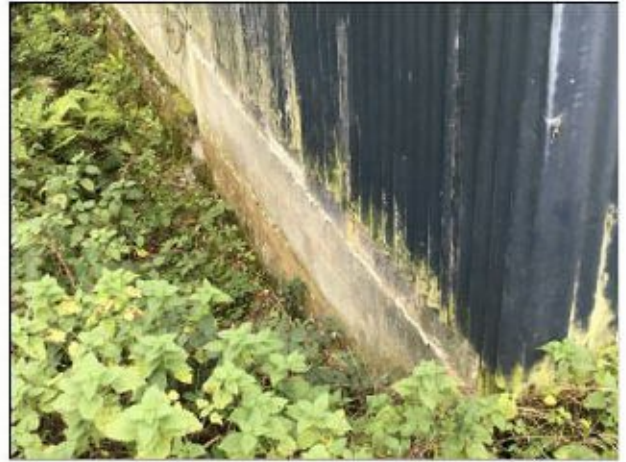
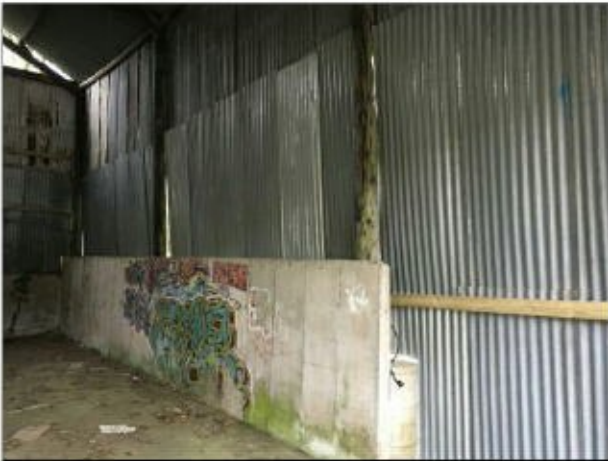
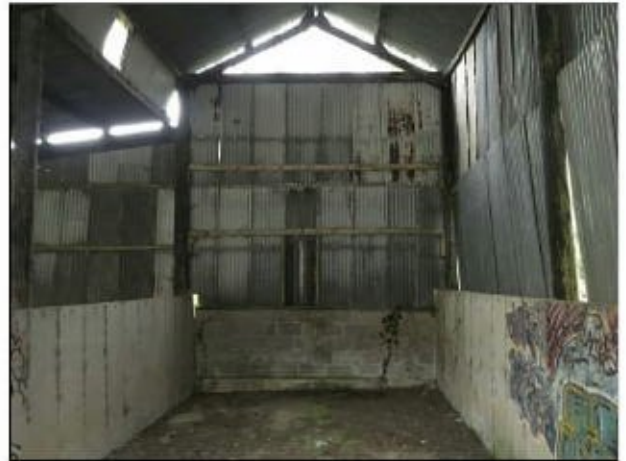
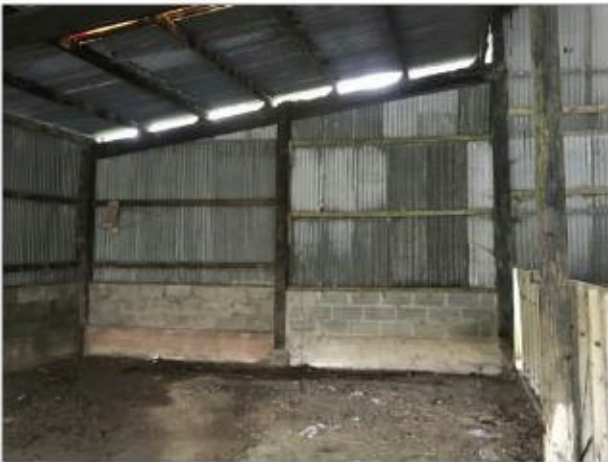
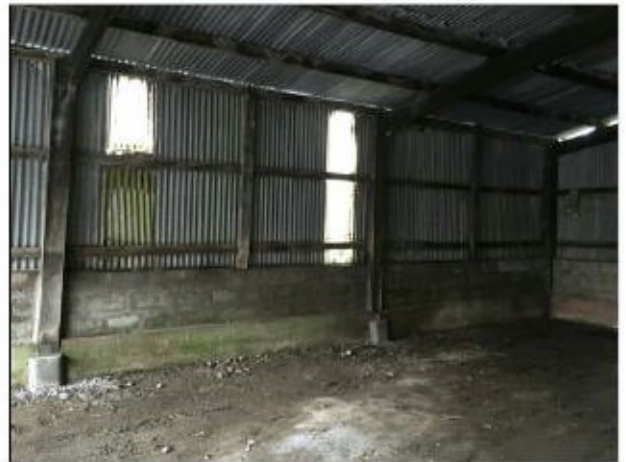
The low level concrete block walls are, on average, 100 to 150 mm thick. The walls are of a block work wall which is faced both sides with a pointed finish to both sides. There are no signs of any significant cracking or movement to the block work where visible. There are some small cracks being in the order of 2 to 4 mm in width, which is not unexpected in a property of this style and age. The cracks will just require filling with a mortar to keep them in good order. The block work generally appears to be in good order and is generally in a good structural stable condition.

The side ground floor walls are set below ground level and are retaining the earth bank. The walls appear to be in good order with no signs of movement or cracking. There is evidence of moisture ingress through the walls, but this is to be expected with the makeup and design of a traditional stone wall.

The walls are provided with a series of timber purlins, which have been used to support the corrugated metal boarding to the walls, all of which appears to be in reasonable order. The mid rails are in the order of 100 x 50 mm timbers with the eaves beam being in the order of 150 x 50 mm timber. The purlins are supported on the main structural posts with metal angles and bolted connections, all of which appear to be in good order. There is some evidence of minor deflection to the purlins and generally they appear to be in good order and are suitable for retention in this location. The walls are then provided with corrugated metal sheets to the high levels of the walls, which generally appears to be in reasonable order.

There is some evidence of rusting to the metal sheet cladding as expected with this method of construction. The metal sheets and concrete block could, if required, be retained and provided with insulated timber panels internally to comply with the requirements of the Building Regulations.

The timber frame and cladding to the barn all appear to be in good condition with no signs of structural movement or failure. The structural condition of the building is therefore in good order to the main roof and wall elements with no structural repairs required at the time of the survey.

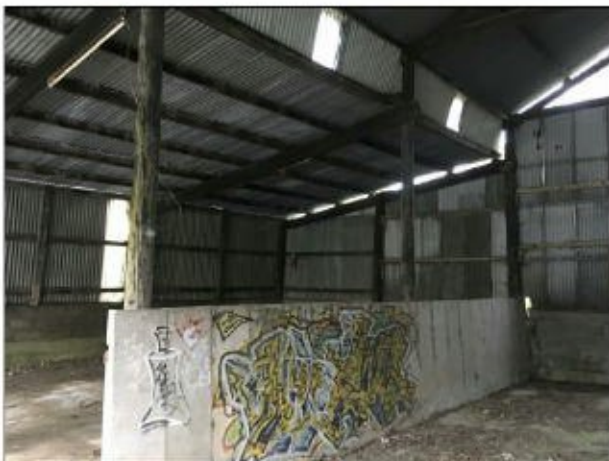
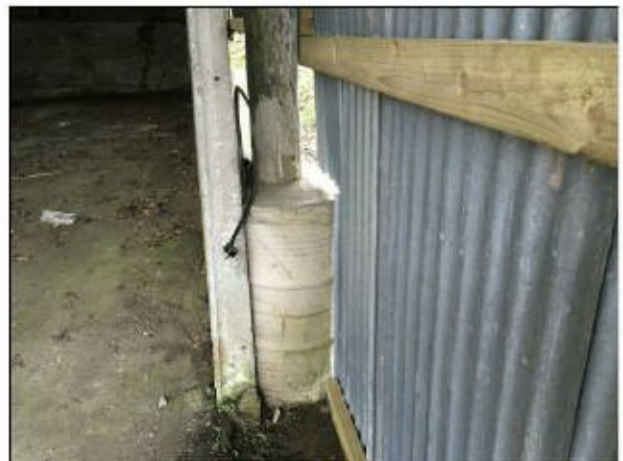
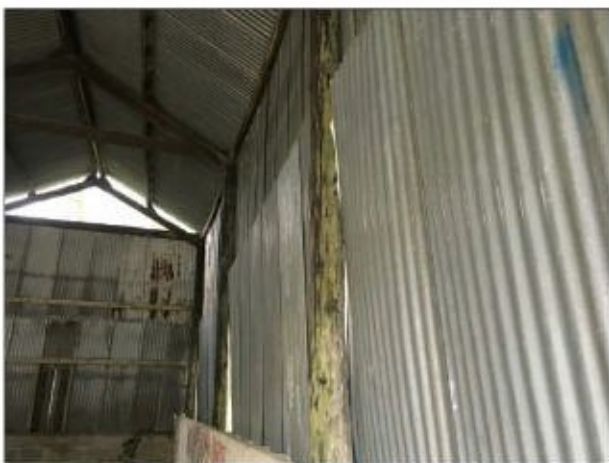
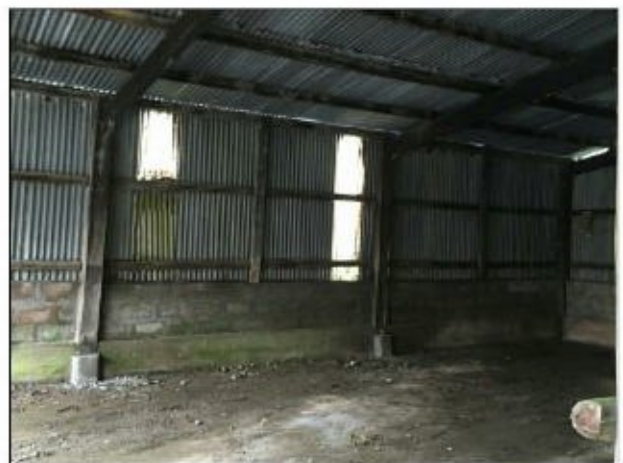
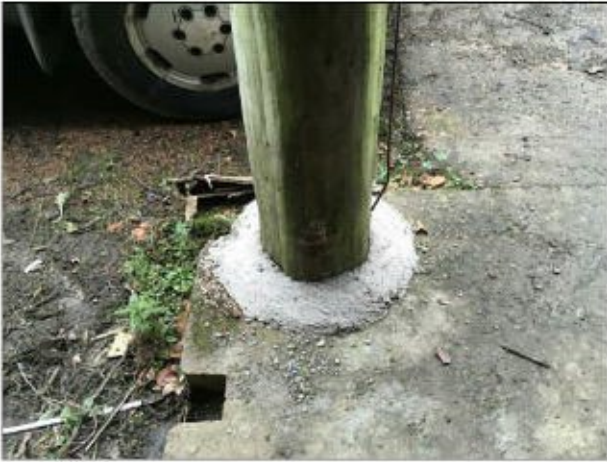
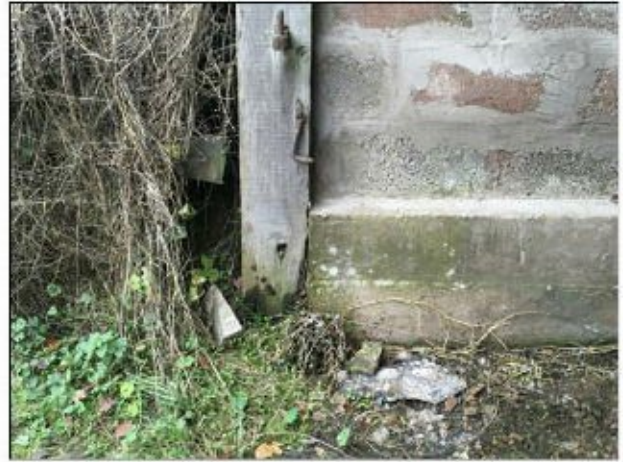
The building is primarily a three bay concrete block work and timber framed building, with an offset ridge running front to back on the building. The building is provided with four main frames, one to the front, one to the rear and two to the middle bays. The bays are provided with 200 x 200 mm timber square columns to the left hand side of the building with 225 mm circular timbers to the main structure all of which appears to be in reasonable order, with no evidence of deflection or decay noted at the time of the survey. The bays to the front and back of the barn are also provided with timber wind posts which are in good vertical order. The circular timber columns are provided with concrete posts to the base of the timber columns, with the concrete being in the order of 600 mm in diameter and 900 mm high. The concrete bases are in good order with no signs of any movement or rotation at the base of the columns.

There are no signs of decay or distortion to the frame and the frame appears to be in generally good structural condition

The timber frame and cladding all appears to be in reasonable condition with no signs of structural movement or failure. The structural condition of the building is therefore in good order to the main roof and wall elements with no structural repairs required at the time of the survey.

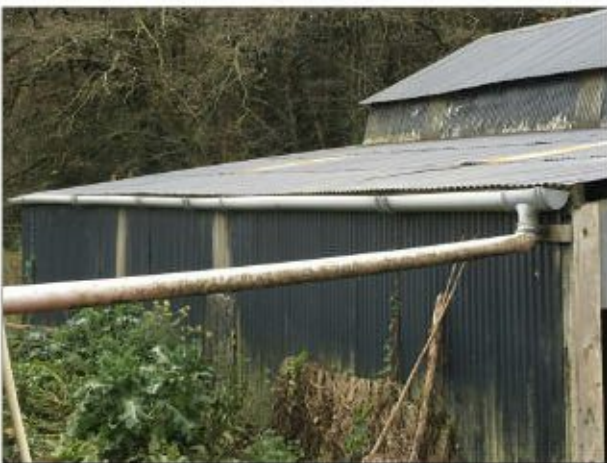
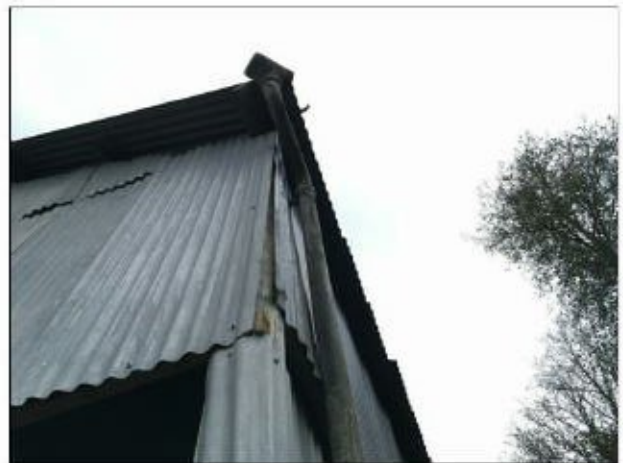
The existing roof on one side is provided with UPVC rainwater goods all of which were in working order at the time of the survey. The existing external joinery would be replaced as part of any conversion works but generally appears to be in working order at the present moment in time.

There are no formal doors or windows to the existing barn.

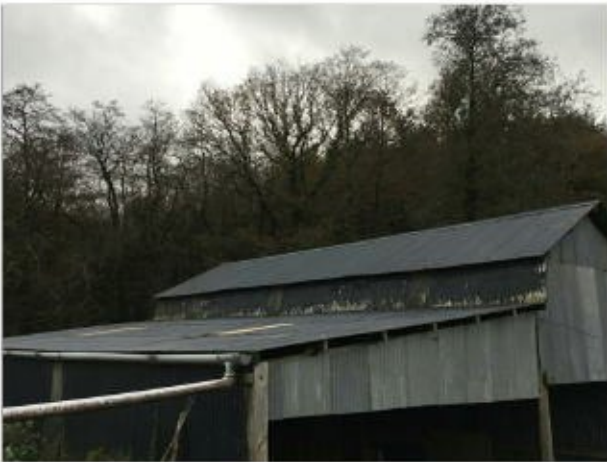
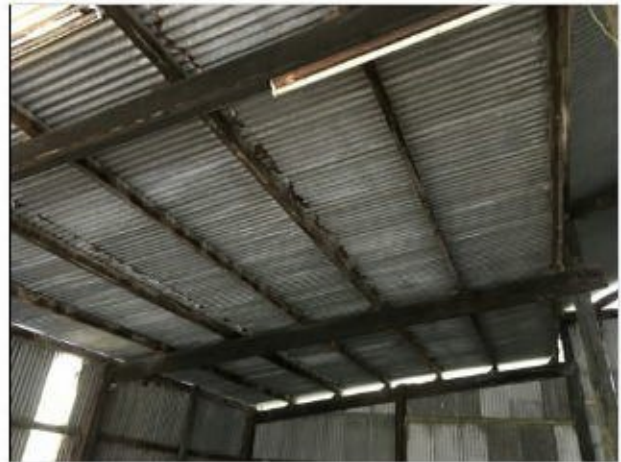
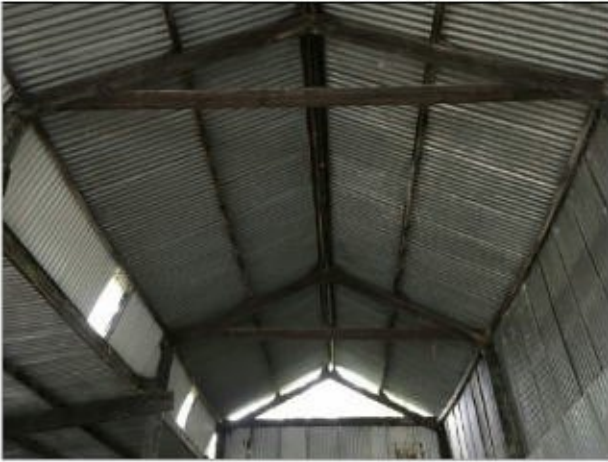
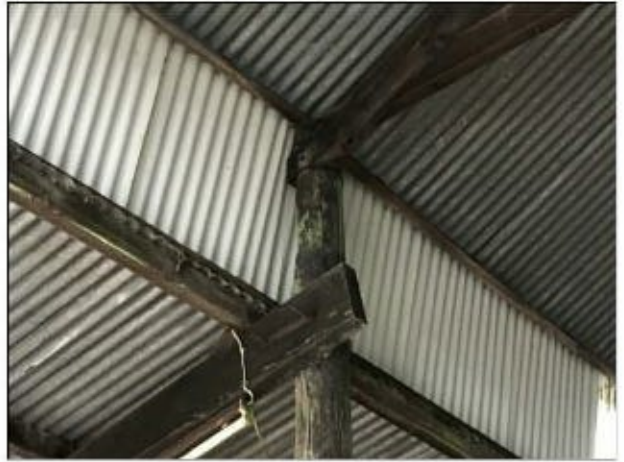
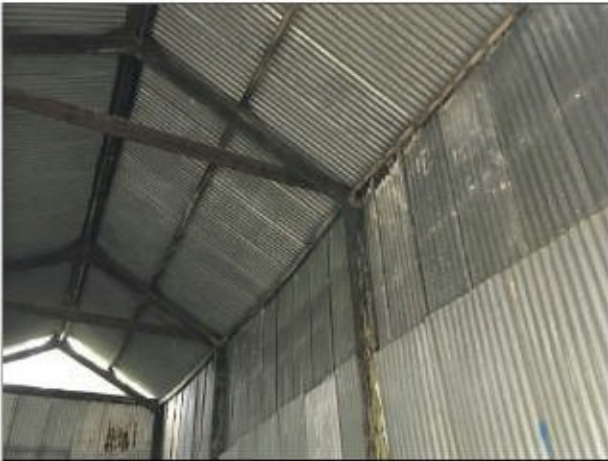
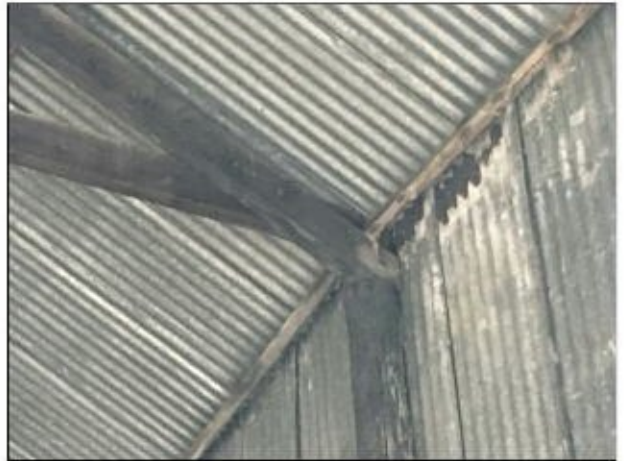
The roof is provided with a series of four trusses with extended diagonal members with the truss being of a traditional truss. The trusses appear to be provided with timbers in the order of 200 x 75 mm timbers which appear to be in reasonable condition. There is no evidence of any movement to the roof, which appears to be in good order. The main diagonal members are in the order of 280 x 75 mm timbers which are bolted to the main timber columns. The trusses and main diagonal members are then provided with a series of purlins which are supported between the trusses and also on the main diagonal members. The purlins are in the order of 150 x 50 mm timbers and appear to be in relatively good condition, with the timbers spaced at 1200 to 1500 mm centres and are in good structural order. There is some minor deflection and bowing to the timbers and this probably occurred shortly after the time of installation. The bowing could be due to the natural drying out of the timbers as there are no signs of any significant movement to the roof structure.

There is evidence of some wet rot attack to a couple of the timbers where they are situated adjacent to the outside walls. These timbers will need to be carefully removed and replaced with new timbers.

The roof is then provided with a metal profiled sheet covering. The metal profiled sheet covering is provided to about 95% with 5% being provided with light panels of the roof externally and appears to be in good condition. There is evidence of some minor damage to the cladding to the roof but again this is not to be unexpected, given the age and previous use of the building. The rooflight panels have suffered from solar degradation on the house side and will need replacing. The cladding however generally appears to be in reasonable condition with no signs of significant damage or repairs required.
