12th Jan 2021

Our Ref: 20-493 / R1

RE: Conversion and Extension of The Red House, Great Oakley, Essex C012 5AQ

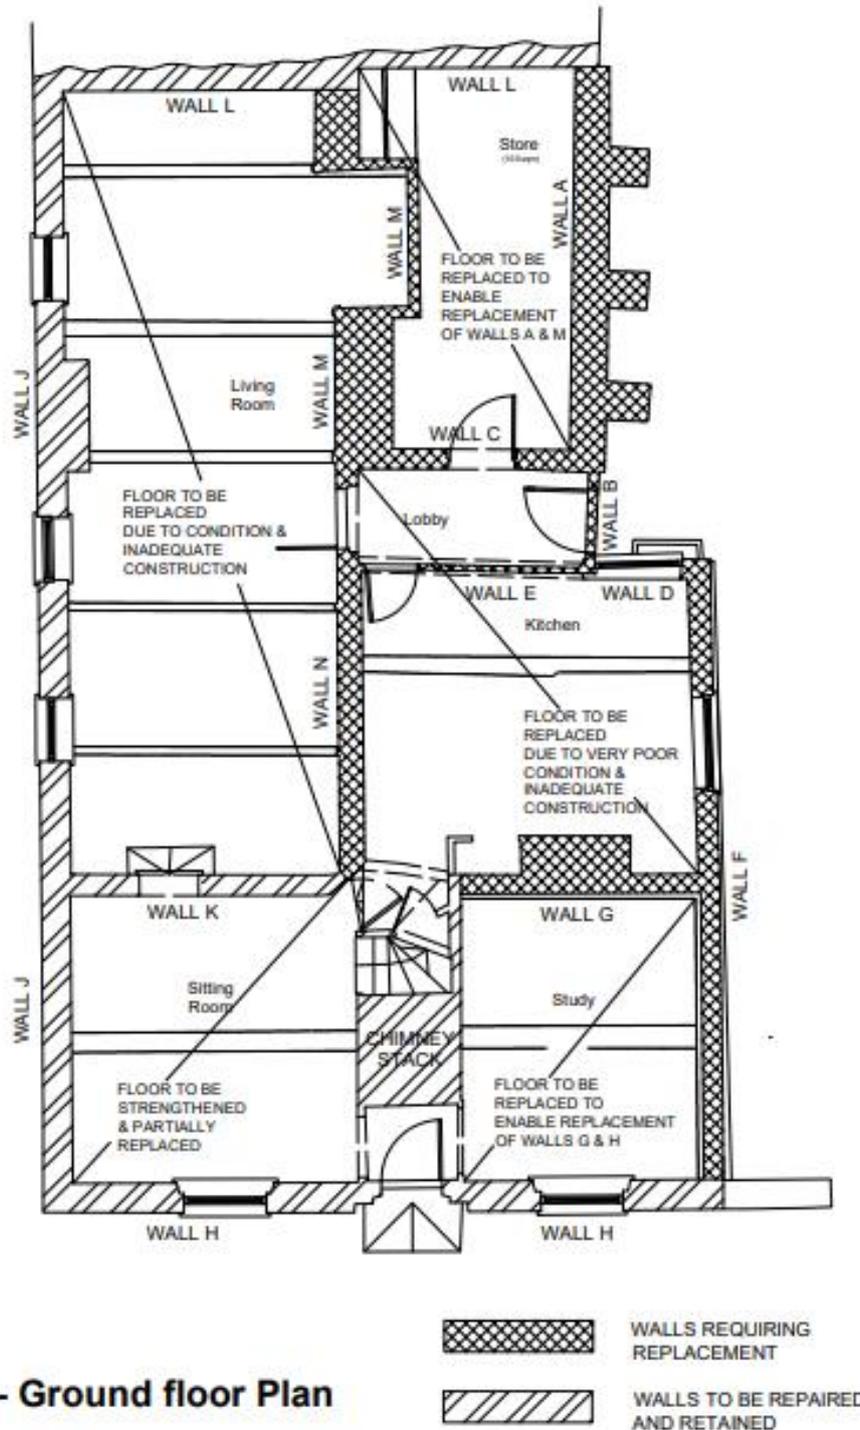
Figure 1 - Ground floor Plan

A significant portion of the existing structure has deteriorated beyond normal serviceable limits and requires replacement. Figures 1 & 2 below, show the existing ground and first floor layouts. We have indicated on these plans which of the existing walls we envisage could be retained and those which will most likely need replacement. Additional observations and notes are also provided below regarding the wall retention and replacement recommendations.

This wall has suffered significant lateral movement and damage. The external buttresses, tie bars and pattresses historically provided to prevent the movement of the wall appear to have been ineffective. The alignment and condition of the wall are such that it needs to be replaced.

This wall is located above the rear entrance door and has suffered significant damage due to the failure of the lintel over the ground floor entrance and lateral movement of the wall. The condition of this wall is such that replacement would be the most practical and safe option.

This wall is located above the rear kitchen window and has suffered significant damage due to the failure of the lintel and lateral movement of the gable wall (Wall F). The condition of this wall is such that it needs to be replaced.

Wall F (Gable wall facing the Maybush Inn) has suffered lateral movement and appears to be leaning outward from the building significantly. The wall has been constructed with full length timbers imbedded in the internal side of the wall. These timbers have perished due to rot and decay leaving deep unsupported horizontal chases in the wall that have created points of weakness.

Wall F is not restrained at first floor or roof level and Wall G is not bonded into the gable. At the rear end of the wall, it is un-buttressed.

This wall is in poor condition and consists of badly bonded masonry combined with embedded timbers. A Chimney Stack is located mid-way along this wall. The required replacement of Wall F and the adjacent first floor construction and roof will make it difficult to retain this wall. For practicality and safety, we would recommend that this wall is also rebuilt.

The condition of both these walls is such that they could be retained, albeit with the requirement for significant strengthening and repairs. The walls would need to be tied into the new and existing internal walls and first floor construction using "Helifix" type remedial "bow"

Significant damage is evident to the top section of Walls H & J, due to moisture penetration from above. Loose masonry with little or no bond is evident. We envisage the top portion of these walls will need to be carefully dismantled and rebuilt.

The condition of this wall is such that it could be retained. The top of the wall would need to be re-built, due to damage. Additional provisions would be needed to tie the wall to the new roof and floor structures each side. This could be achieved using steel straps / fixings. All works to Wall L would be subject to Party wall agreement, as appropriate.

These internal walls appear to be formed in timber studwork construction which does not appear sufficient to support the loads of new construction. We recommend that these walls are replaced with more robust construction adequate to be used as a load bearing.

The required replacement of walls A, B & M will make it difficult to retain this wall. For practicality and safety, we would recommend that this wall is also rebuilt.

The required replacement of walls A, B & D will make it difficult to retain this wall. For practicality and safety, we would recommend that this wall is also rebuilt.

In consideration to the condition and construction of this wall and that of the adjacent structure, the replacement of the Wall F appears to be the only practical option.

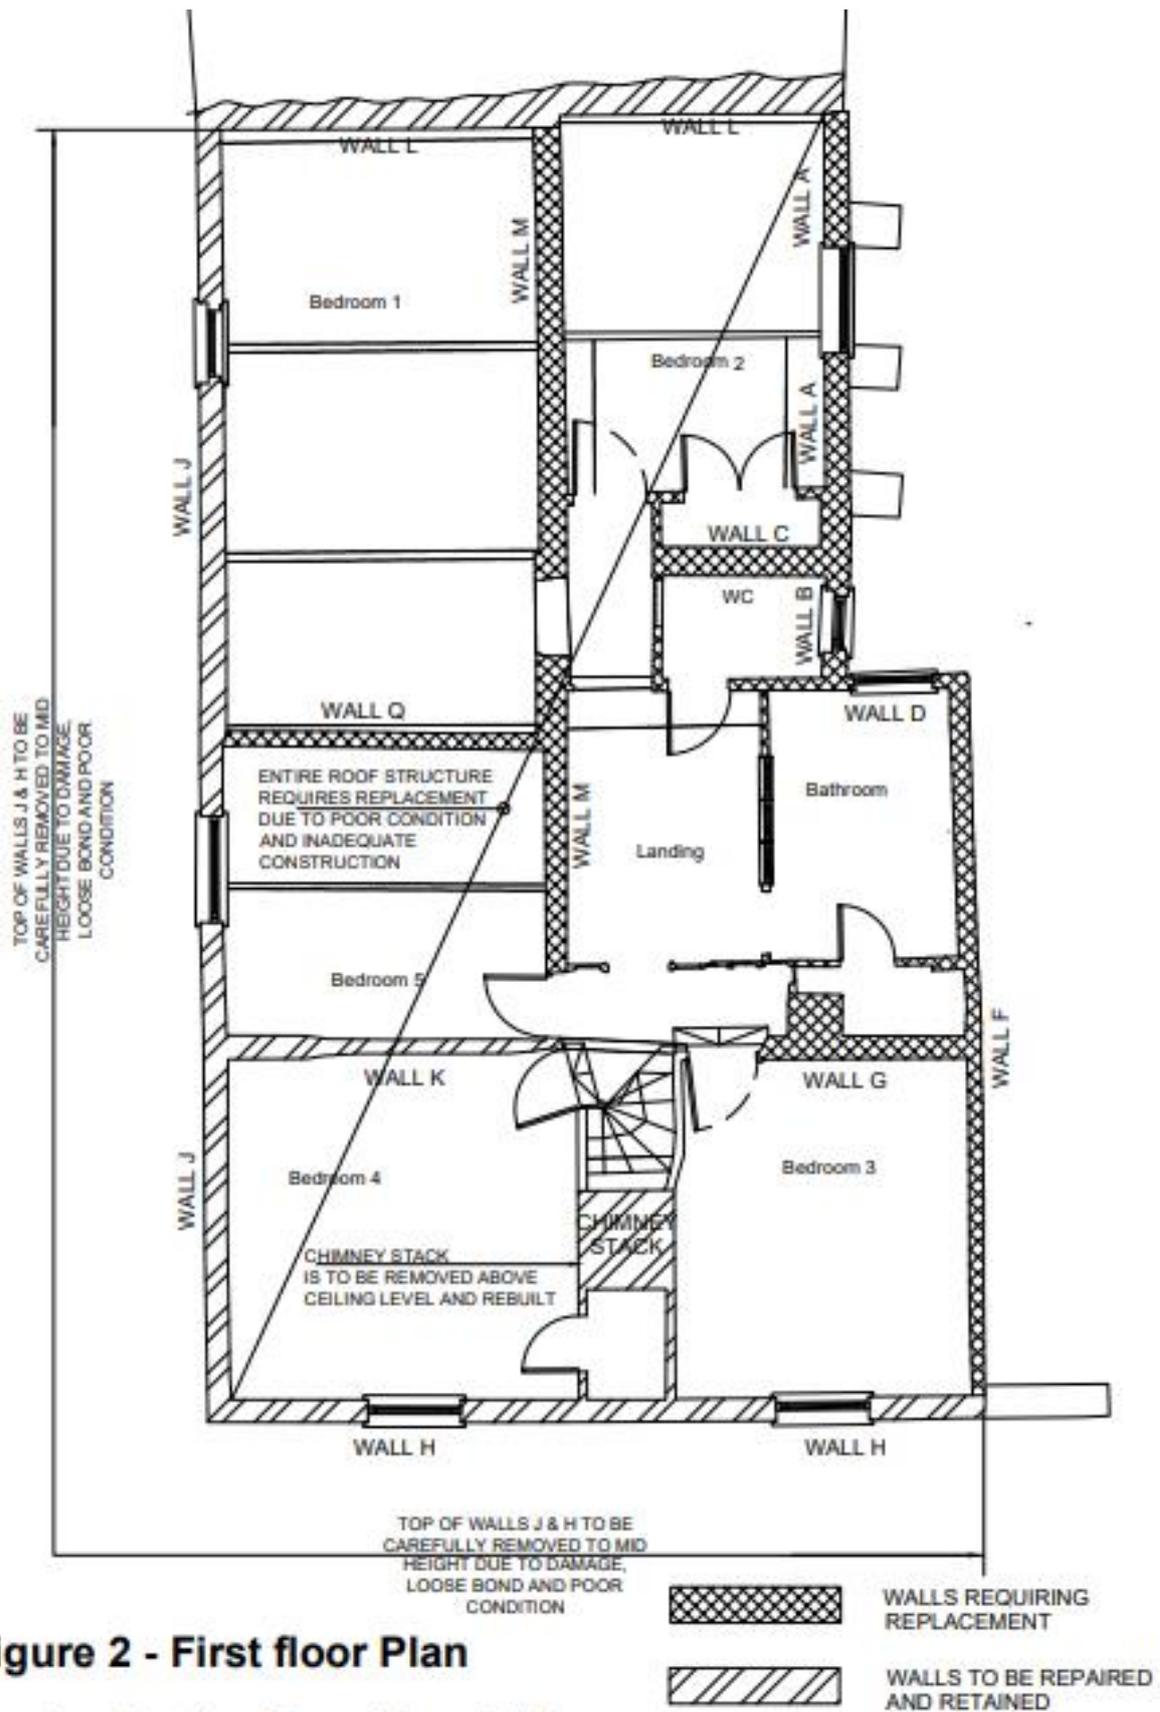
Figure 2 - First floor Plan

The roof structure is inadequate and in very poor condition and needs full replacement.

The majority of the first floor construction needs to be replaced due to its poor condition and/or inadequate construction. Areas are evident where the existing floor timbers have suffered extensively from rot and timber infestation. There are various locations where the floor members are undersized for their span and loadings.

The first-floor construction above the kitchen adjacent to Wall F is in very poor condition and will need to be replaced.
