June 2020

**Tree Report for Beech Tree at Staunton House, Staunton
For Annie Dyson**

AUTHOR: MARK CHESTER

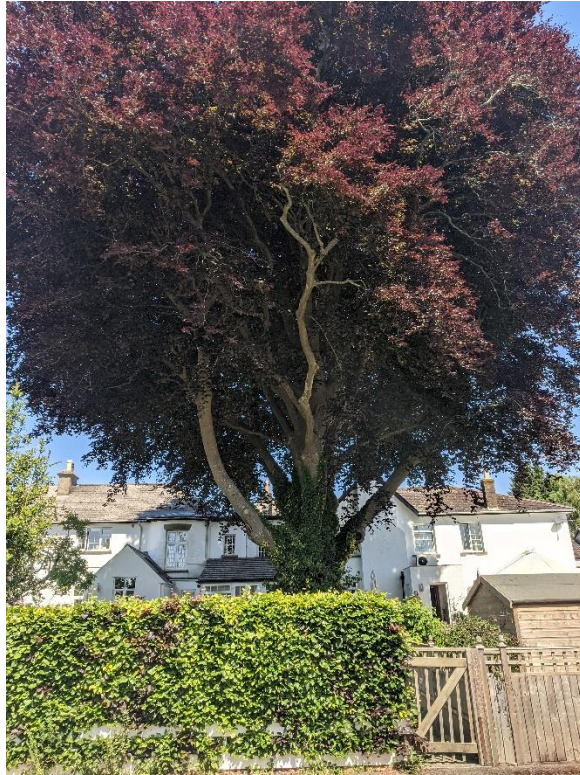
IMAGE 1: The tree viewed from beyond the rear garden of 3 Staunton House.

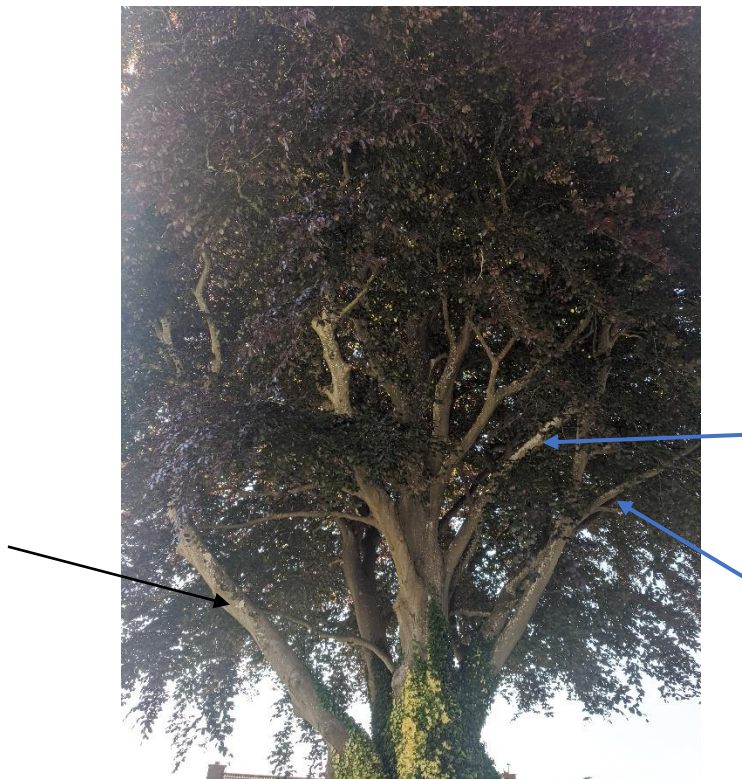
extensively pruned including removal of lower lateral branches (see photograph 2). This has resulted in a significant gap between the foliage and the union of the branch and the main trunk. There is limited scope for further pruning without cutting back to the trunk, which would leave a large wound of about one metre diameter. This is highly undesirable, and contrary to best practice.

IMAGE 2: The tree viewed from within 3 Staunton House, looking upwards. The blue arrows point to large dead branches present, the black arrow to a long branch over no. 2, which has limited potential for prune due to the lack of lateral growth. If there is too great a distance between foliage on a branch and the union of the branch to the trunk, there is a risk that future growth will not be sustained and the branch will die.

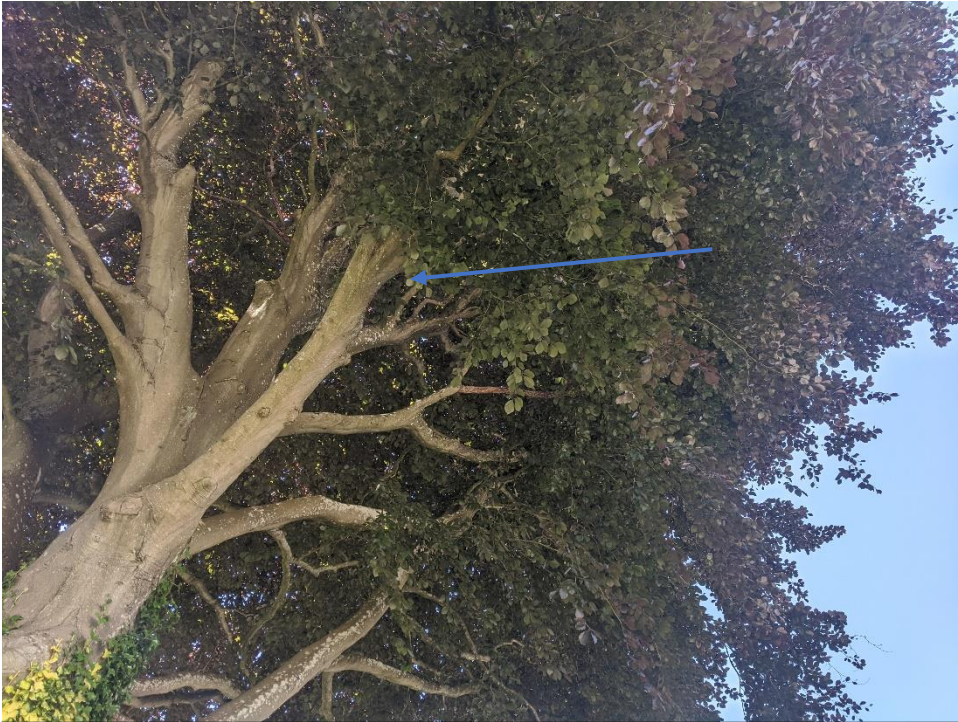
IMAGE 3: Looking in to the crown where it is near to 3 Staunton House. The aim is to prune the branch where the arrow is pointing.

Proposal: Thin crown by up to 25% and reduce crown spread towards Staunton House by about five metres through targeted pruning.

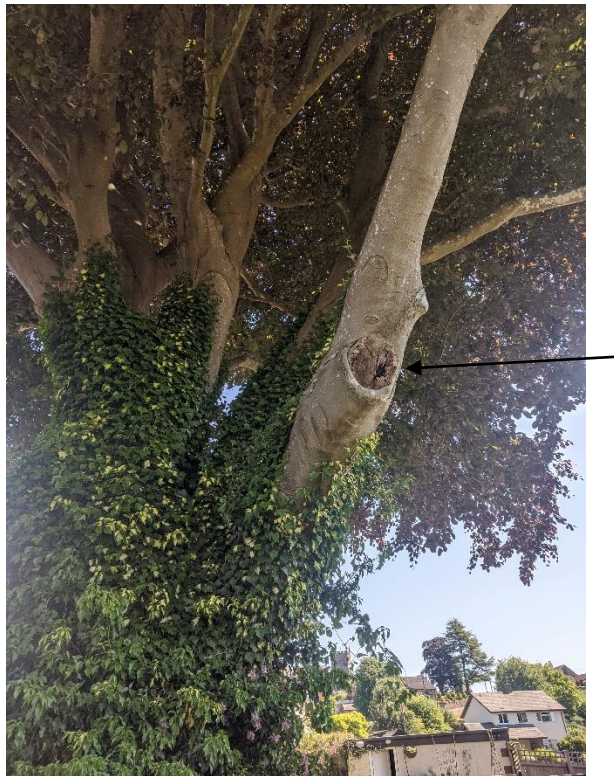
Ivy has become established to about 8m, so that it is not possible to assess the condition of the trunk. However, within the crown, there are a number of dead branches with diameters exceeding 200mm. The tree regularly sheds branches in windy conditions. This includes both dead branches and branches still sustaining foliage. The applicant has been hit by falling debris. There is on-going concern of the implications if one of the larger branches was to fail.

IMAGE 4: The tree viewed from within the garden of 3 Staunton House. Note that the ivy is covering the trunk and lower crown. Note also the wound and decay on the branch on the right.

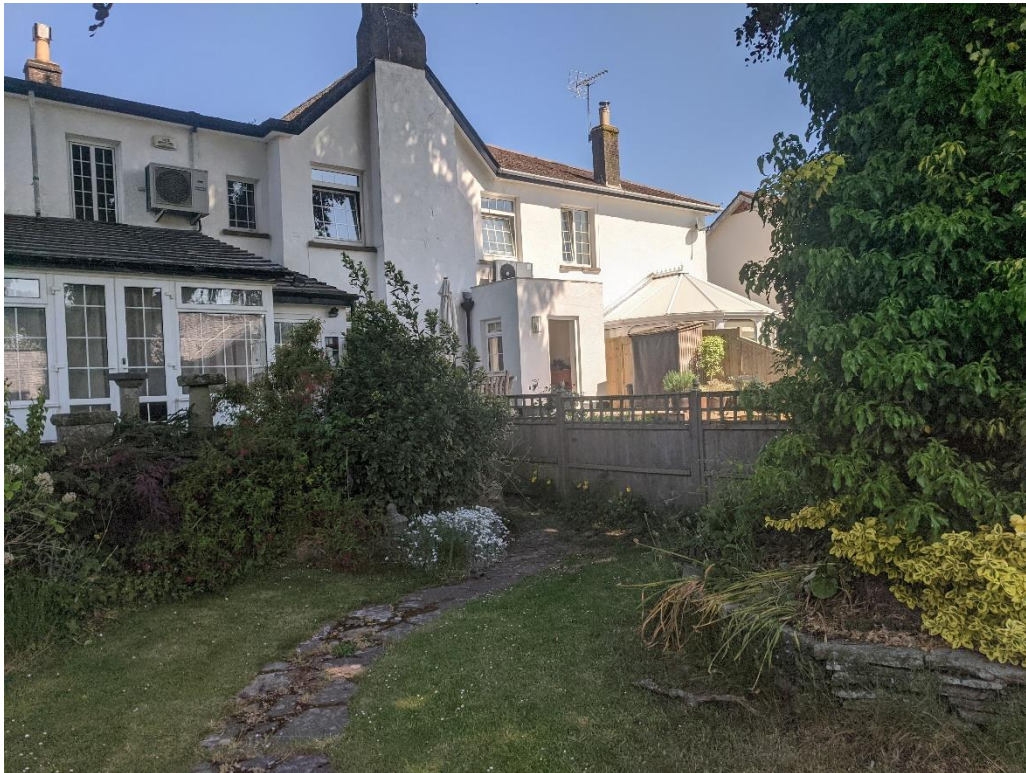
IMAGE 5: The tree in relation to 3 Staunton House. Note how thick the ivy is at the base of the trunk.

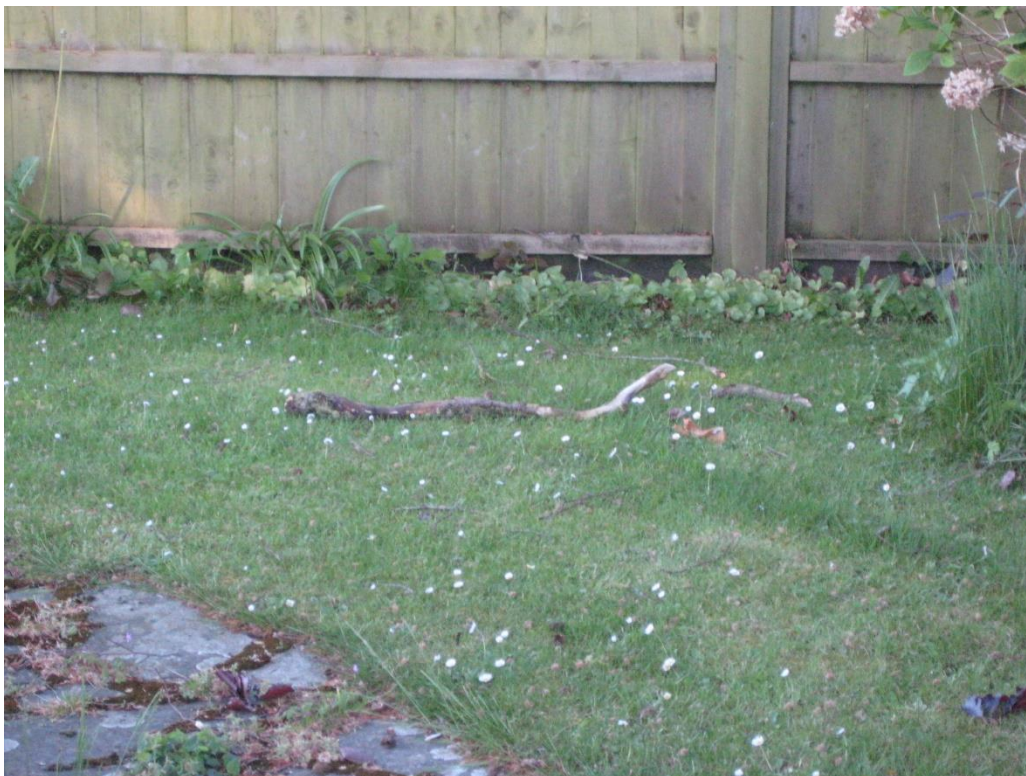
IMAGE 6: A branch which landed in 3 Staunton House in spring 2020

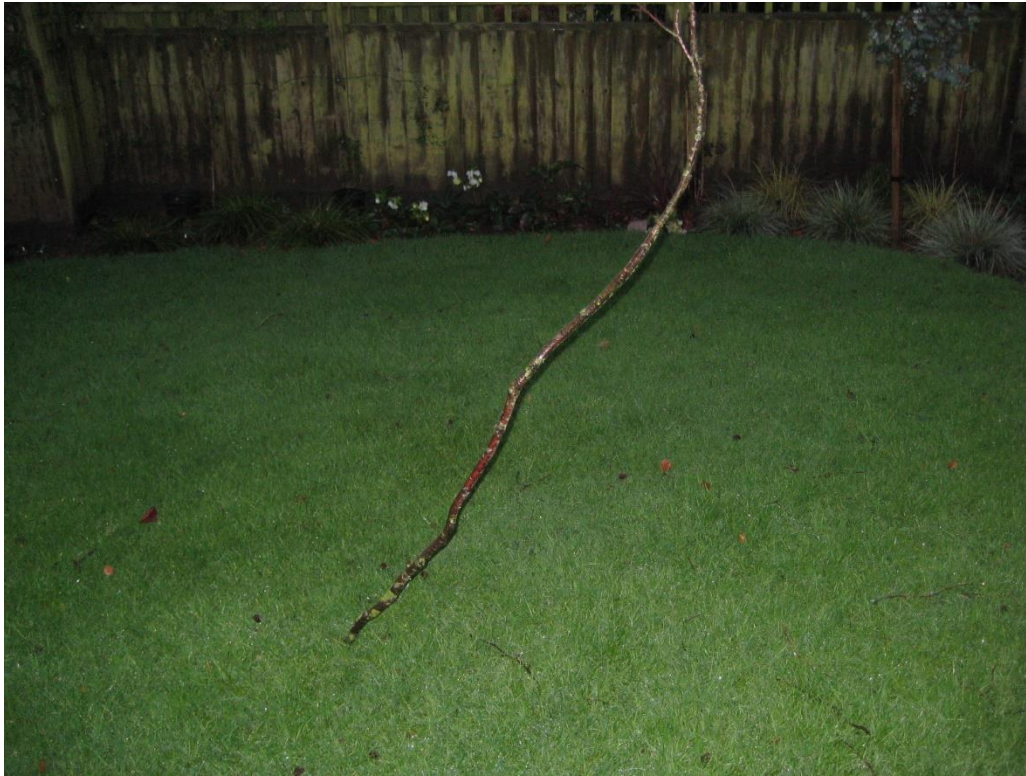
IMAGE 7: A branch in 4 Staunton House, spring 2020

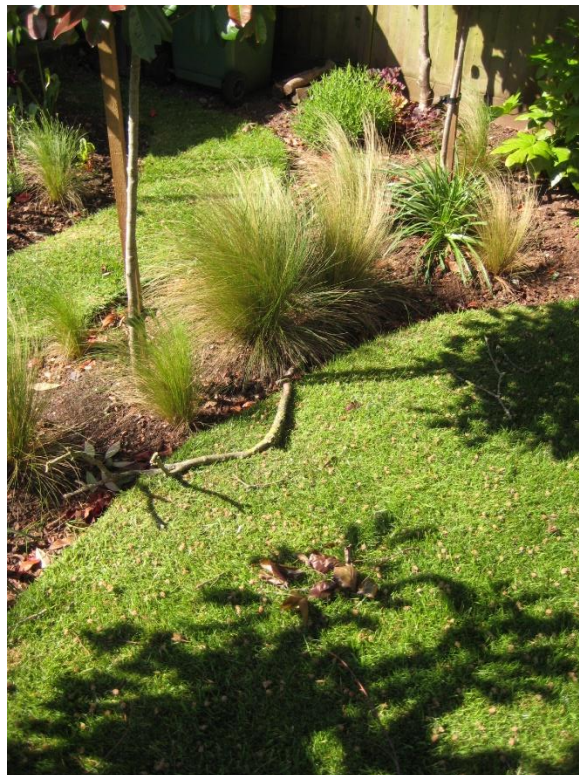
IMAGE 8: 2 Staunton House April 2020 following breeze.
