1-3 Sudborough Road Slipton

Further to my report of 18th October 2018 on the initial clearance and support work for the property following the fire I would confirm that I have re-inspected specifically to comment on the amount of masonry to be rebuilt on the rear elevation. An extract showing this area is copied below.

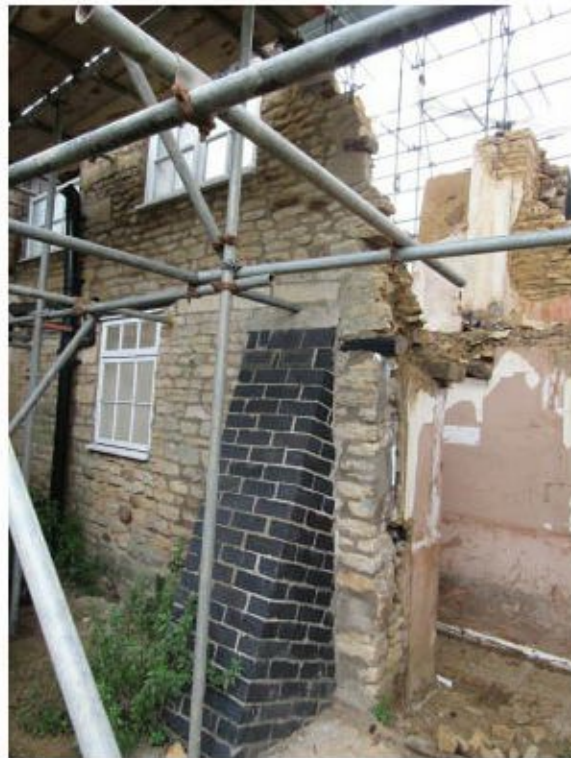
Photograph No.1

Now the debris has been removed the wall could be inspected in detail and it is evident that from the current line where it has been taken down that this should include an additional 1m which takes it past the external buttress as can be seen on photograph No.1. The masonry on this section, apart from being significantly out of true is in a poor condition as noted when viewing the end exposed section as can be identified on photograph No.2.

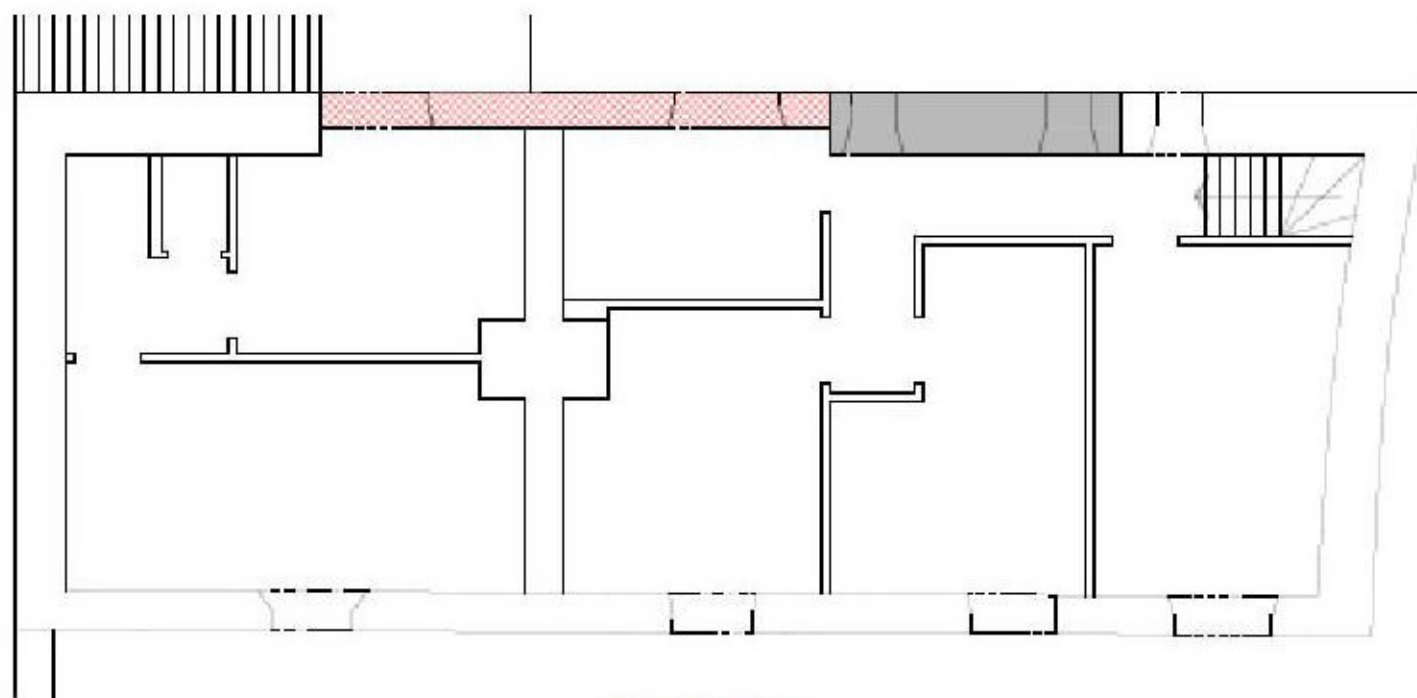
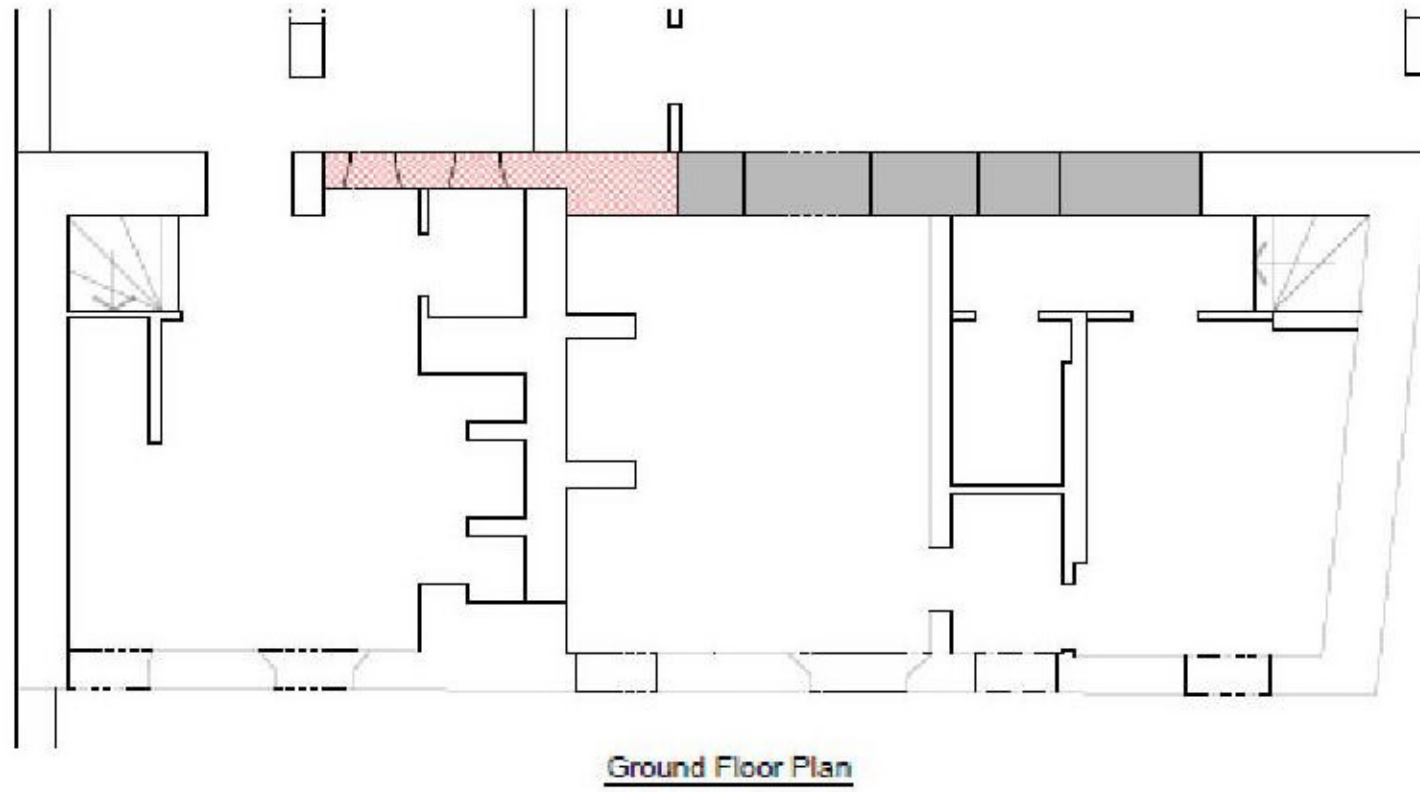
First Floor Plan

Based on your proposed scheme shown on drawing 1341-02-11 and also on the demolition drawing 1341-02-10 then the amount of the existing masonry that can be retained can be increased as shown on the diagram below. The red hatch shows the areas to be rebuilt which includes that already removed and then the grey shaded section is the area previously shown as being taken down but we recommend can remain. It is appreciated that for the scheme to be viable that the first floor when rebuilt, should be 450mm wide so as to provide room for the bathroom and this is acceptable from a structural point of view. As the inner skin of the wall will now partly off the hearting then this also means that it is important for this to be grouted.

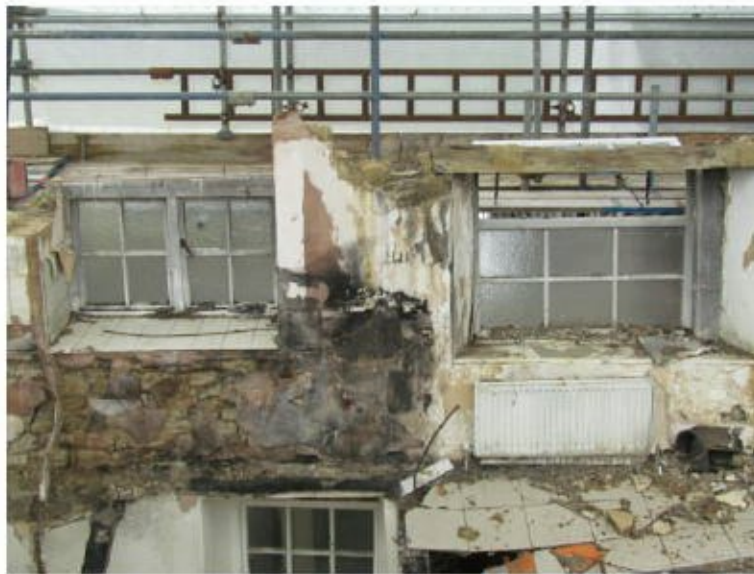
Photograph No.3

On the existing walls then the windows are a slightly different configuration than currently shown as can be made out below. It is also evident that the first floor window is a later insertion based on the brickwork forming the reveal.
