## **STRUCTURAL REPORT**

1, 2 and 3 Sudborough Road  
Slipton

## **DRAYTON ESTATE**

13 Allesley Old Road  
Coventry

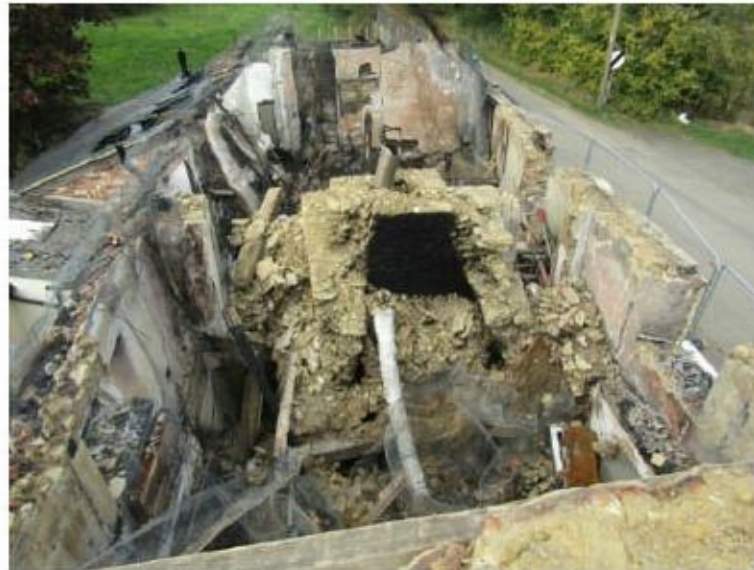
Photograph No. 1

The fire has caused significant damage insofar as the roof and quite a large percentage of the first-floor has been lost and a general view is shown on photograph No. 1 where all of the above can be appreciated.

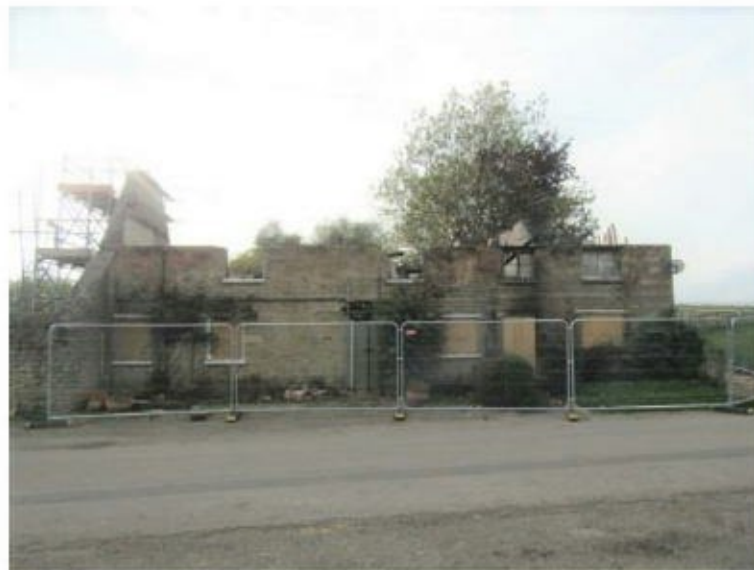
Photograph No. 2

On the front elevation, as shown on photograph No. 2, the wall head has been cleared and the remaining masonry, although smoke damaged, looks to be relatively stable. The entrance door to Number 1 has, in fact, been propped and this is recorded on photograph No. 3 and in detail on photograph No. 4.

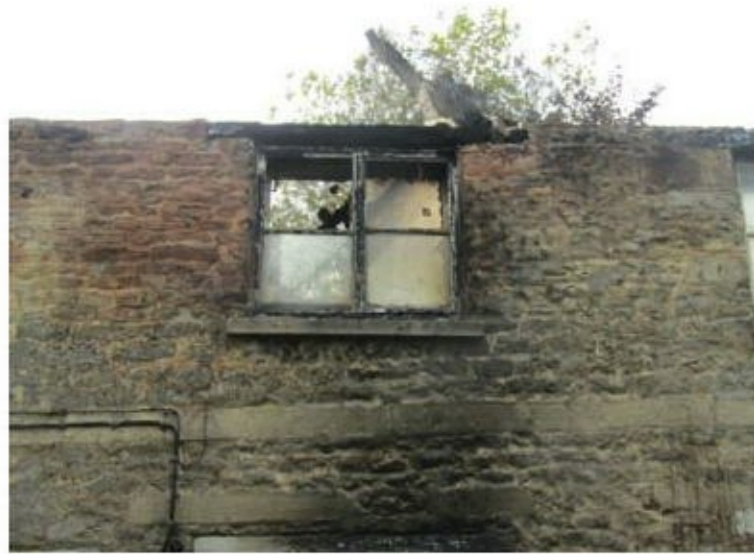
Photograph No. 5

The damage to the windows and the lintols is clearly evident from photograph No. 5 and the pile of stone to the side of the front door also indicates the fire damage to the stonework, this being indicated by the pink tinge.

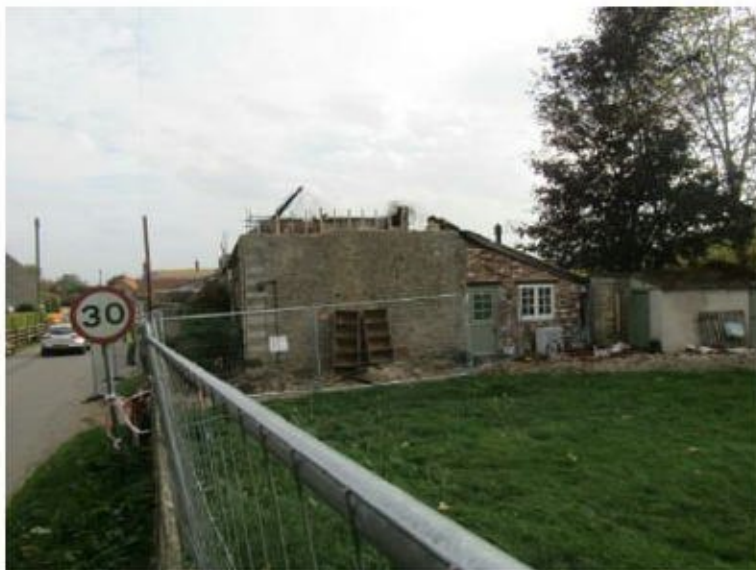
Photograph No. 6

The right-hand gable, as can be seen on photograph No. 6, has already been removed prior to the inspection and to the lower area that remains, there is a very distinct inward bow as can be appreciated on photograph No. 7.

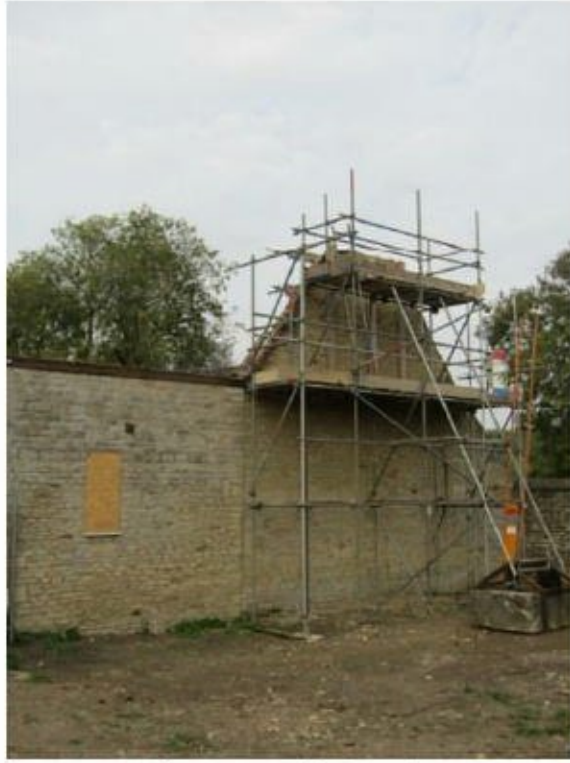
Photograph No. 8

On the left-hand gable, this has had a scaffold erected and is currently restrained in place to the upper section as can be seen on photographs No. 8 and 9.

With the left-hand gable, it is felt that this is capable of being retained, however, in the short-term, it would be recommended that a third brace is introduced above eaves height to provide additional restraint.

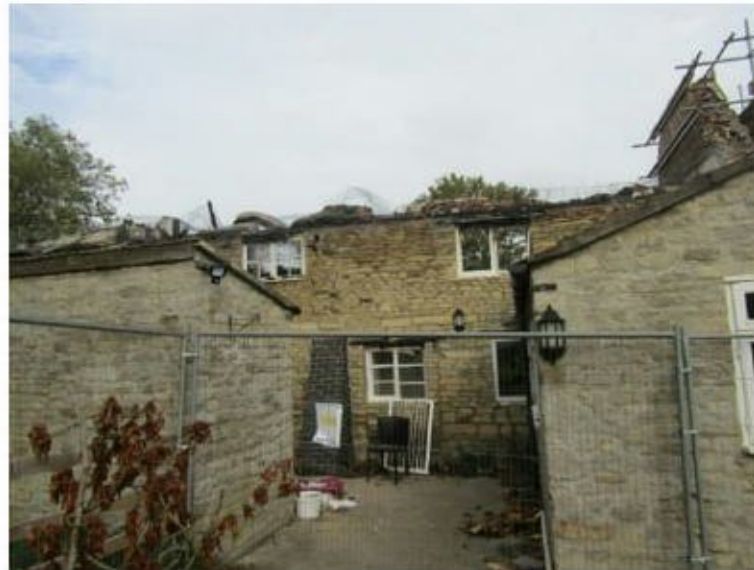
Photograph No. 10

The rear elevation was more difficult to view due to concern over its condition, but a general view is shown on photograph No. 10.

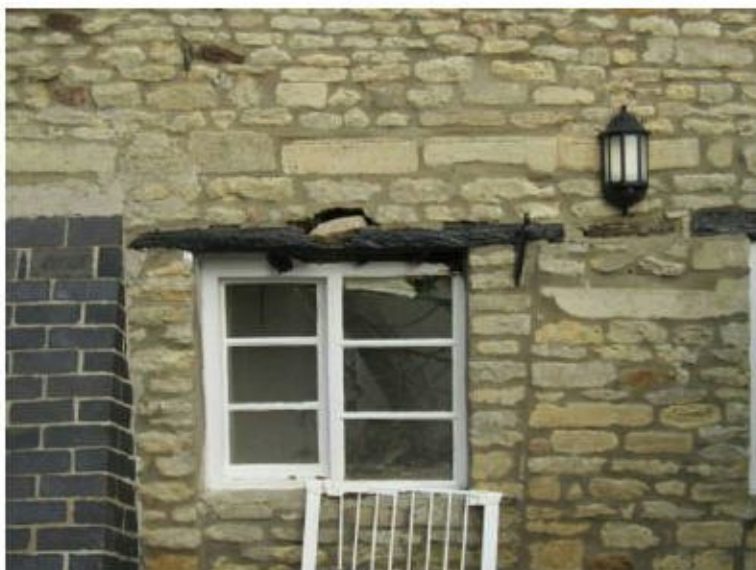
Photograph No. 11

What is apparent is that to the central section, there is a previous doorway which has been infilled and is now a window as shown on photograph No. 11 and that the lintol at this position has burnt through and is beginning to fail as shown on photograph No. 12.

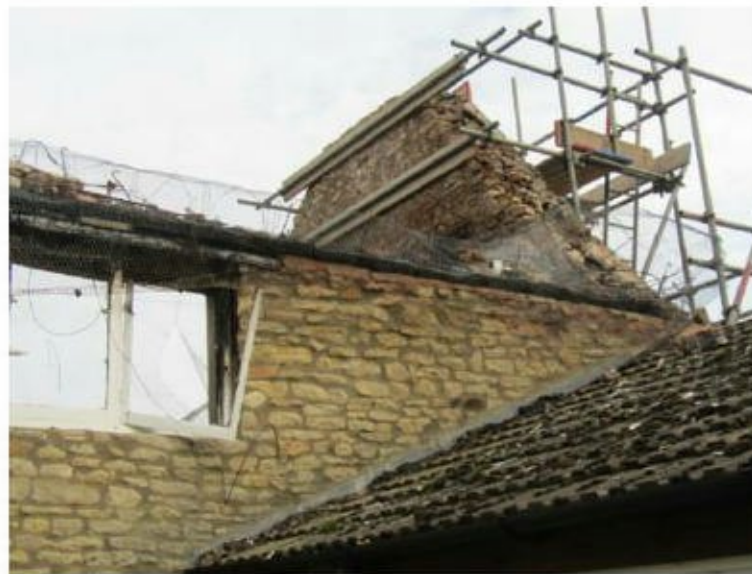
Photograph No. 13

On the elevation, there is clearly fire damage to the first course under the wall plate and occasionally those below indicated by a reddening of the stone. However, the lower sections externally would appear to be in a more reasonable condition and a typical view of the rear left-hand corner where the above points can be noted is shown on photograph No. 13.

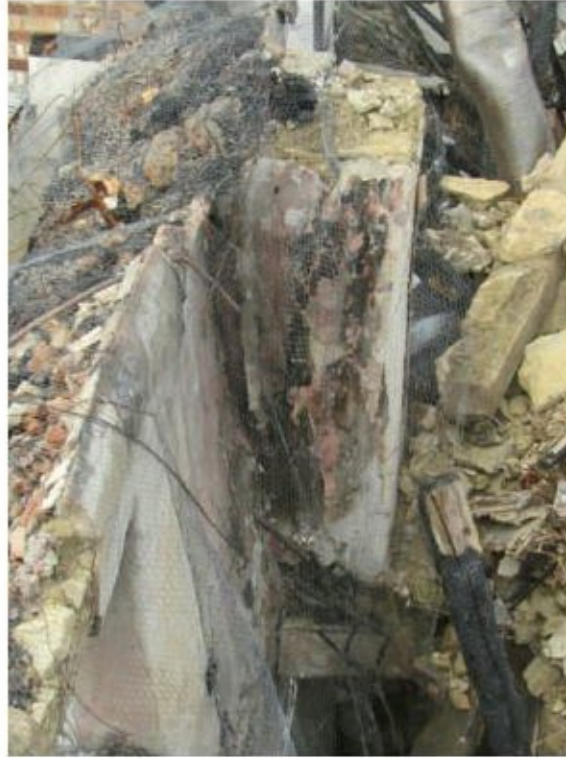
Photograph No. 14

The area of concern on this building is being able to safely access the rear elevation and most especially the centre. Historically, this wall has bulged which is clearly identifiable when viewed from the scaffold and also by reference to the pier at first-floor level. On inspection of the width of the pier, the distance to the door reveal at the eaves is considerably larger than at first-floor level. This is identifiable on a general view as shown on photograph No. 14 and in more detail showing the upper and lower sections respectively, on photographs No. 15 and 16.

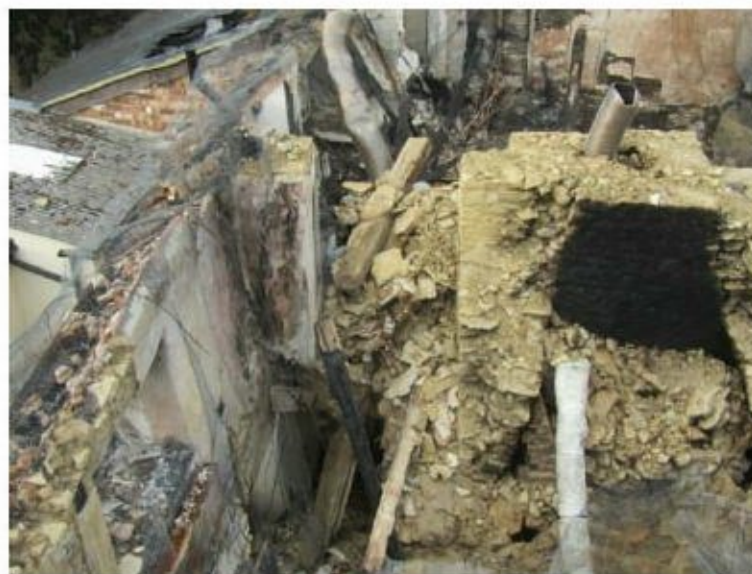
Photograph No. 17

The main concern with this area is the condition of the stonework immediately adjacent to this pier at ground-floor level which is over the doorway. The first-floor masonry pier does not extend down to ground-floor level where the line of the wall runs through as can be seen on photograph No. 17.

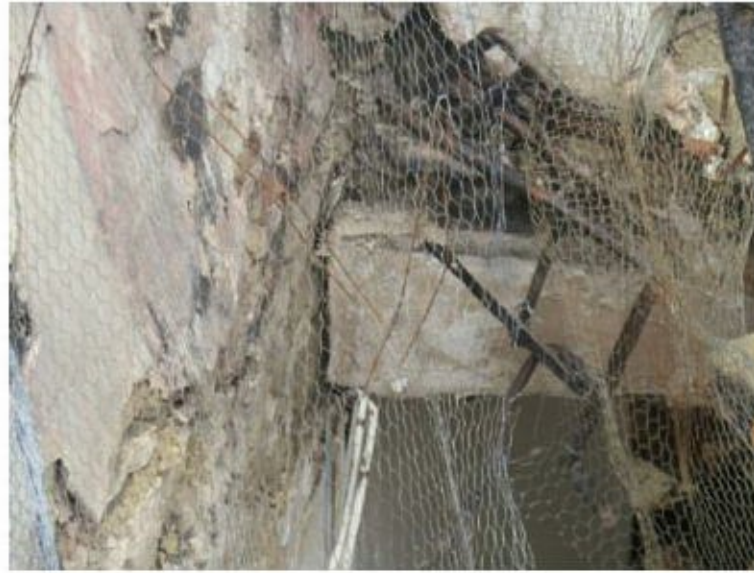
Photograph No. 18

The supporting beam which runs front to back to support this pier is in a precarious condition with a very noticeable fracture against the rear wall and there is also a void in the left-hand corner where pipework has been put through, all as can be seen on photograph No. 18.

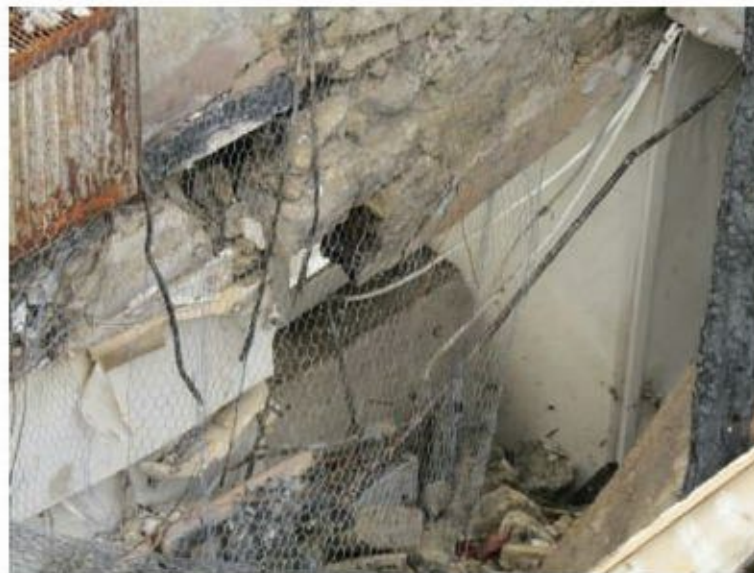
Photograph No. 19

Adjacent to the bearing of this beam is the ground floor window opening (blocked-in doorway), the relationship of which can be determined on photograph No. 19.

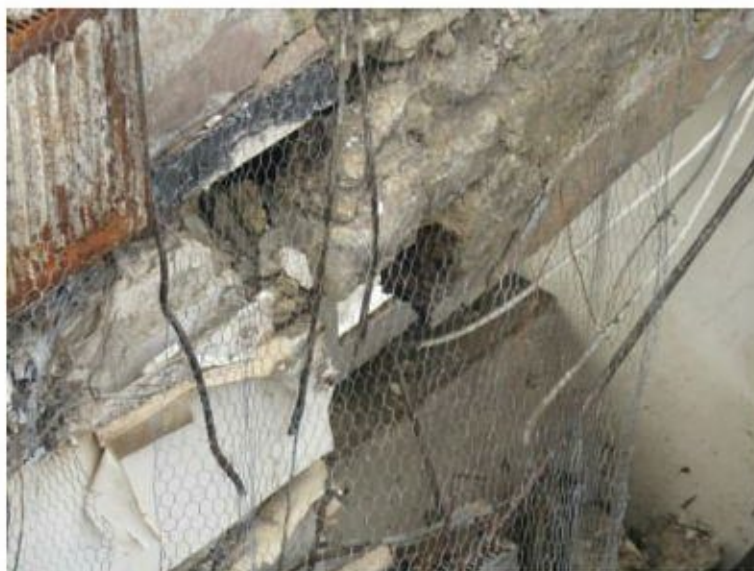
Photograph No. 20

The lintol over this window opening has clearly failed as shown on photograph No. 20. The resultant cracking extends halfway up the first-floor level where the masonry is starting to naturally arch, as shown on photograph No. 21.

It has already been noted externally the extent that the lintol over the window has failed. It is therefore of concern for any persons working immediately adjacent to this area due to the existing bow and the current condition of the adjacent masonry. If these factors were not present, along with the potential split between the pier and the external wall then a raking shore would be erected prior to any works being carried out. However, with the degree of movement present, this is not considered practical under Health and Safety grounds at this time. It is therefore recommended that the area around the window opening adjacent to the buttress is carefully taken down.

There is damage to the top courses of stonework above this area and the fractured stonework will be lost whilst replacing the lintols, it is therefore felt that overall, there is not a significant loss of historic fabric over and above that which would be required to be rebuilt as part of the reinstatement process.

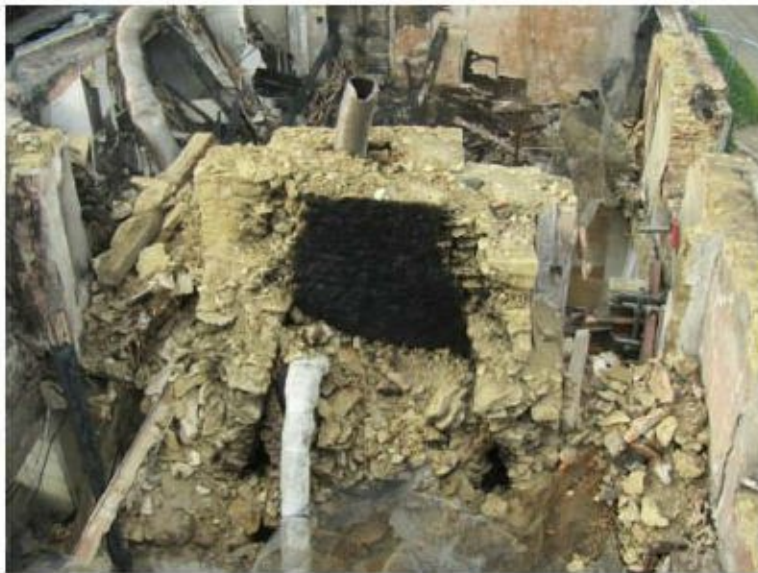
Photograph No. 24

The one area where the amount of historic fabric that can be retained cannot be fully established is the large chimney. At present, the right-hand wall would still appear to be intact, however, it is the left-hand front face where the concern is raised due to the amount of collapsed masonry on this area and a general view is shown on photograph No. 24 and the area of concern above the main bressummer on photograph No. 25. The intention would be that the loose rubble is removed so the full extent of the remaining sound masonry can be established.

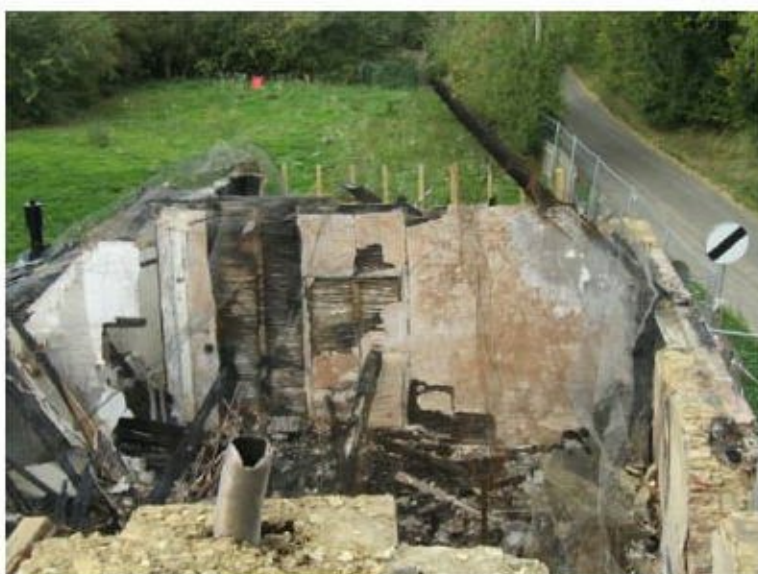
Photograph No. 26

On the remainder of the building, it is unfortunate that the reed and plaster partition at the right-hand end has suffered from damage as shown in general on photograph No. 26 and in more detail on photograph No. 27. What can be seen, however, is that previously there was collared ceilings and the remaining rafter above this partition should be utilised to be able to record the pitch and collar position and if possible, this partition should be left and retained in place and this is shown on photograph No. 28.
