Project Number	445
Survey Number	I
Drawing Reference	445 II

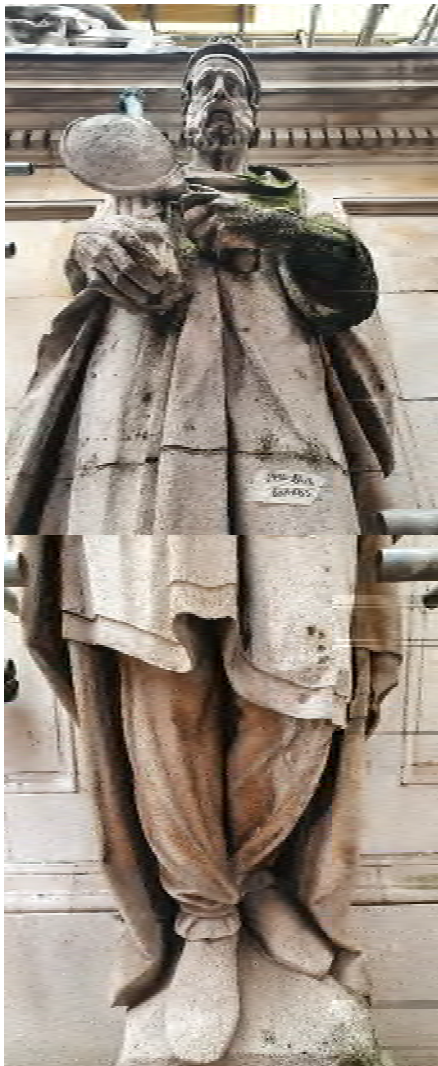
Item Reference	I4
Item	Statue 3
Observations	A. Minor staining and dirt collection, especially within more intricate areas of stone carving. B. Some loose pointing at stone junctions.
Recommended Action	A. Light clean. Carry out prior to any repairs. Refer to method statement 445 MSI. B. Rake out joints where loose/failing and repoint with lime mortar.

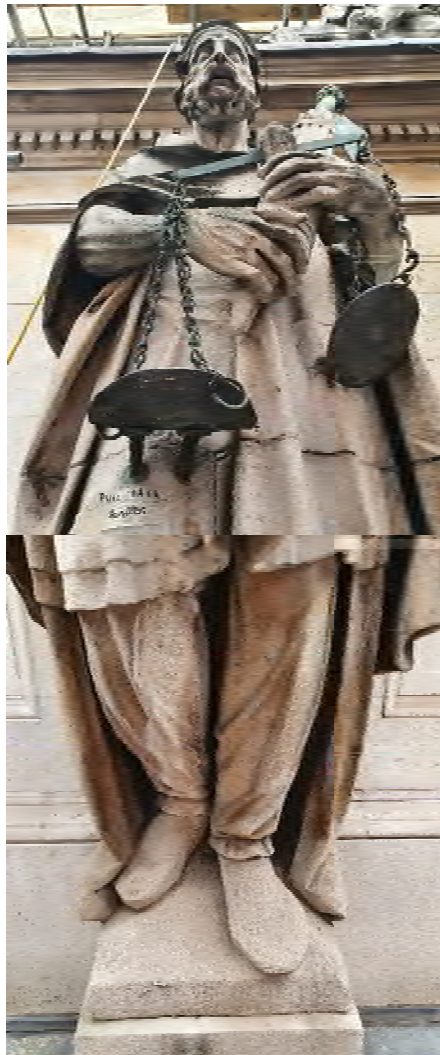
Item Reference	I5
Item	Statue 4
Observations	B. Light pressure water clean. Carry out prior to any repairs. C. Rake out joints where loose/failing and repoint with lime mortar.
Recommended Action	B. Light clean. Carry out prior to any repairs. Refer to method statement 445 MS1. C. Rake out joints where loose/failing and repoint with lime mortar.

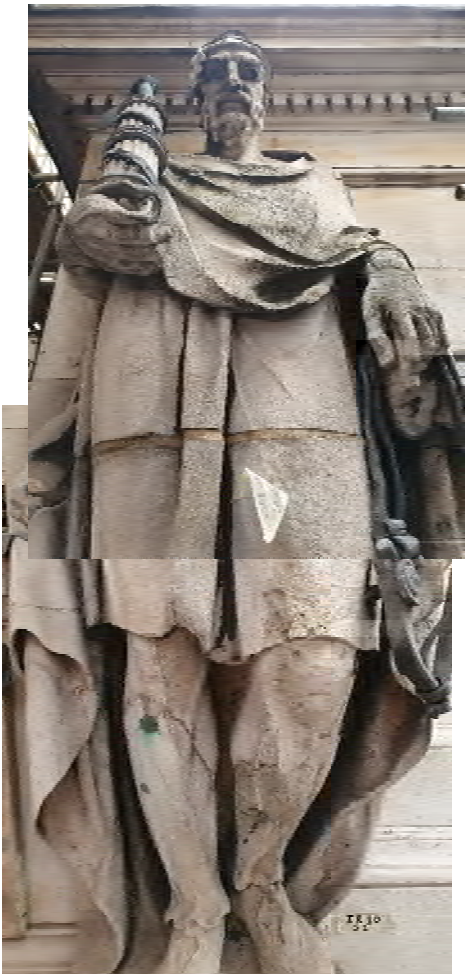
Item Reference	I6
Item	Statue 5
Observations	A. Cement haunching at connection with balustrade coping removed. B. Metal pins holding sections of shin and calf together. Some localised staining. C. Minor staining and dirt collection, especially within more intricate areas of stone carving. D. Some loose pointing at stone junctions.
Recommended Action	A. Form lead upstand at junction with lime mortar haunching over. B. Lime mortar patch repair over ends of pins. C. Light clean. Carry out prior to any repairs. Refer to method statement 445 MSI. D. Rake out joints where loose/failing and repoint with lime mortar.

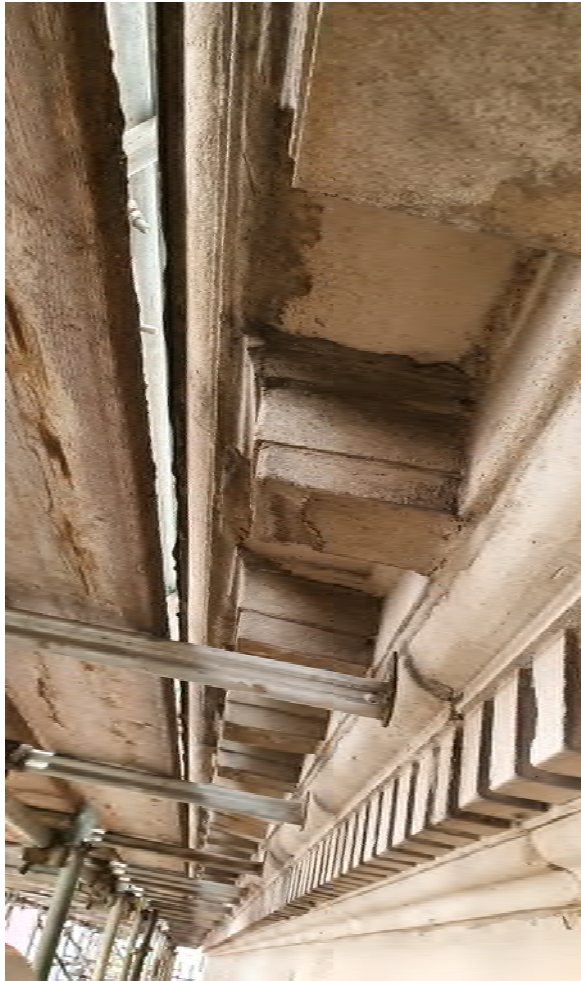
Item Reference	I7
Item	Main Cornice
Observations	A. Large quantity of modillions have cement mortar repairs.
Recommended Action	A. Damage appears to be caused by water run off from leadwork above, which does not have an adequate drip detail. Ease out leadwork drip along edge of cornice to throw water away from building face.

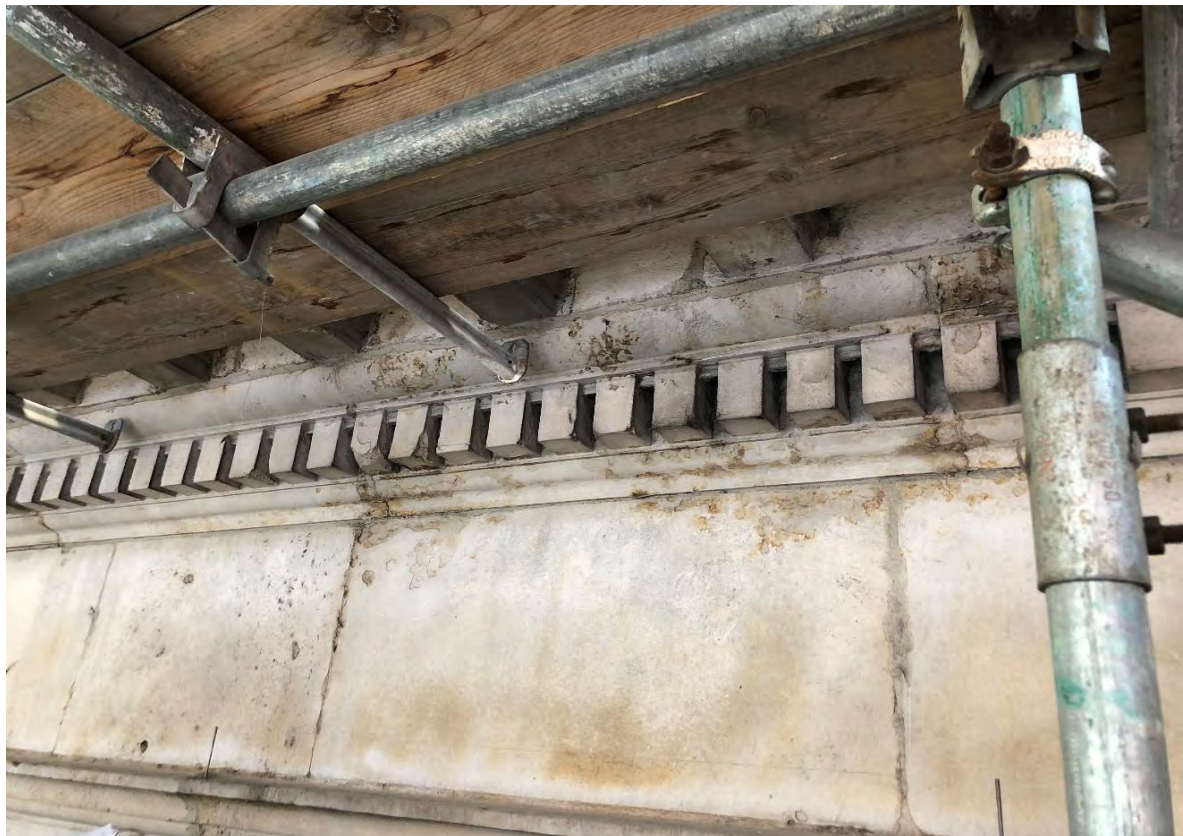
Item Reference	I8
Item	Dental course
Observations	A. Flecked orange staining. Pitting and light spalling to dentals and ashlar face.
Recommended Action	A. Light clean. Carry out prior to any repairs. Refer to method statement 445 MSI. Patch repairs in lime mortar to dentals and face of ashlar below where spalling has occurred.

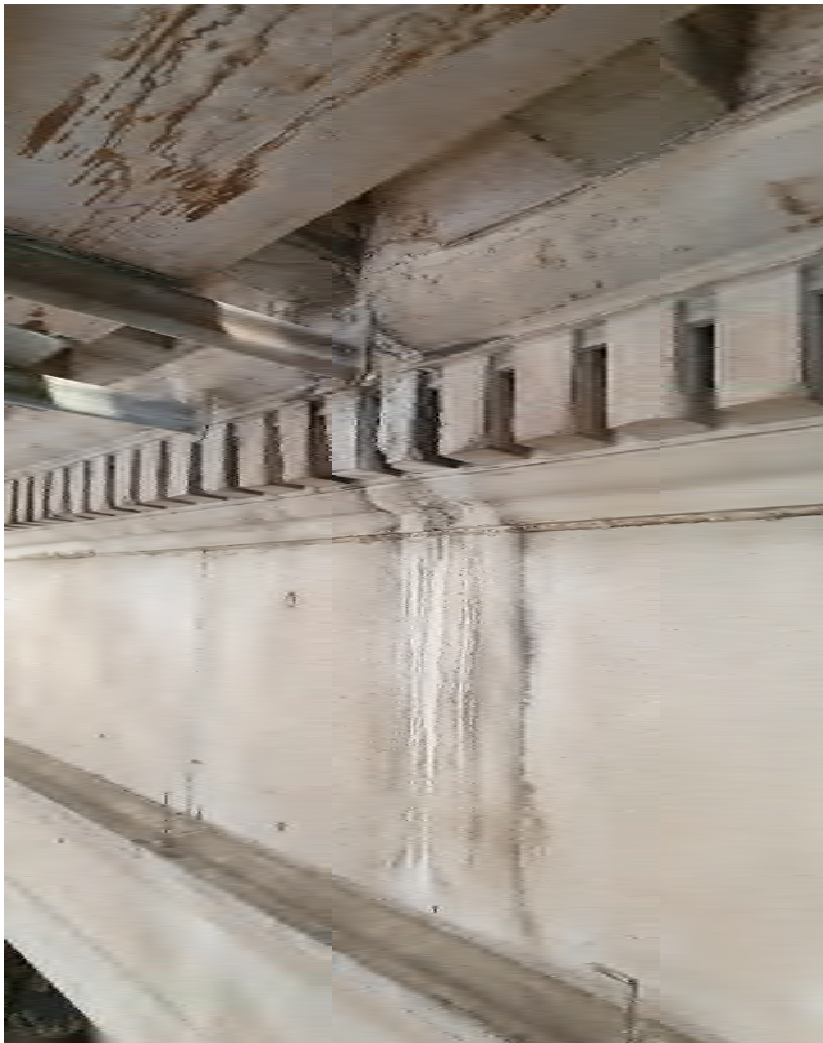
Item Reference	19
Item	Dental course
Observations	A. White encrustation. Possible emanating from cement repair to modillion, or from water run off through scaffold tube.
Recommended Action	A. Light clean. Carry out prior to any repairs. Refer to method statement 445 MSI. Ensure that lead drip is eased to throw water away from building face as item 17.

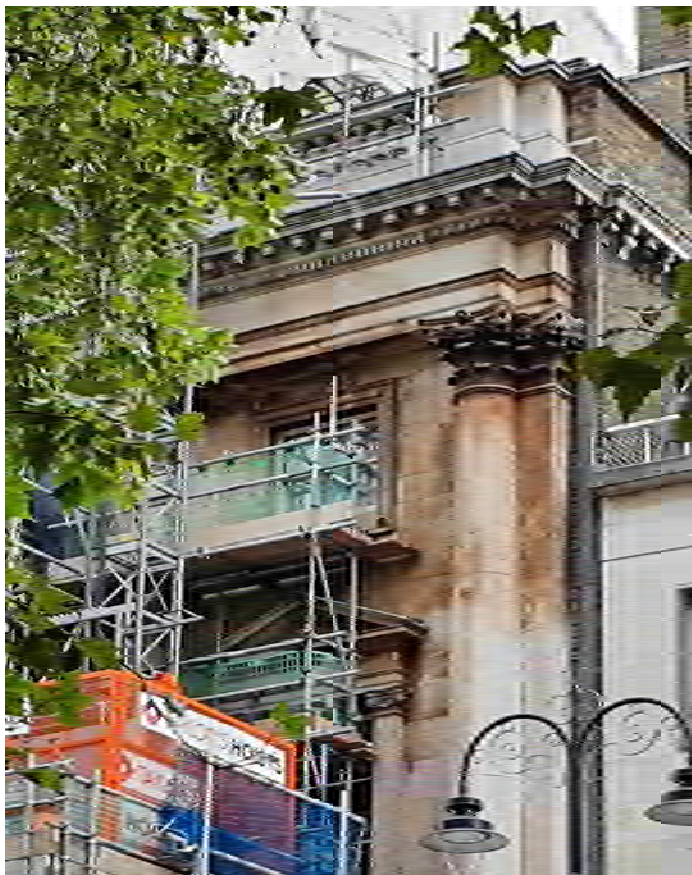
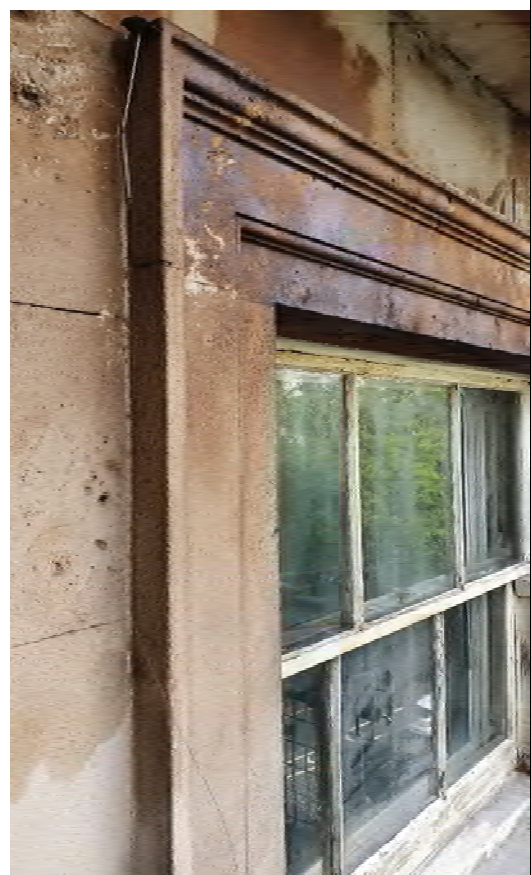
Item Reference	20
Item	Large orange/brown stain below cornice, West end of elevation.
Observations	A. Large orange/brown stain, emanating from stone and stone joints. Oily appearance to surface. Possibly as a result of defective parapet gutter detailing and heavy rain, allowing water into construction zone behind stone. Refer to sketch no. 445 SK01.
Recommended Action	A. Investigate initial cause of water ingress. Suggest clearing gutter of debris and lifting existing leadwork at eastern end to confirm above hypothesis. Trial cleaning methods, including probable use of poultice treatments in discreet areas tbc with architect. Monitor results of poultice treatments to determine whether stain returns to cleaned areas. Once confirmed that cause of staining has been identified and dealt with, agree cleaning schedule with architect based on success of trials.

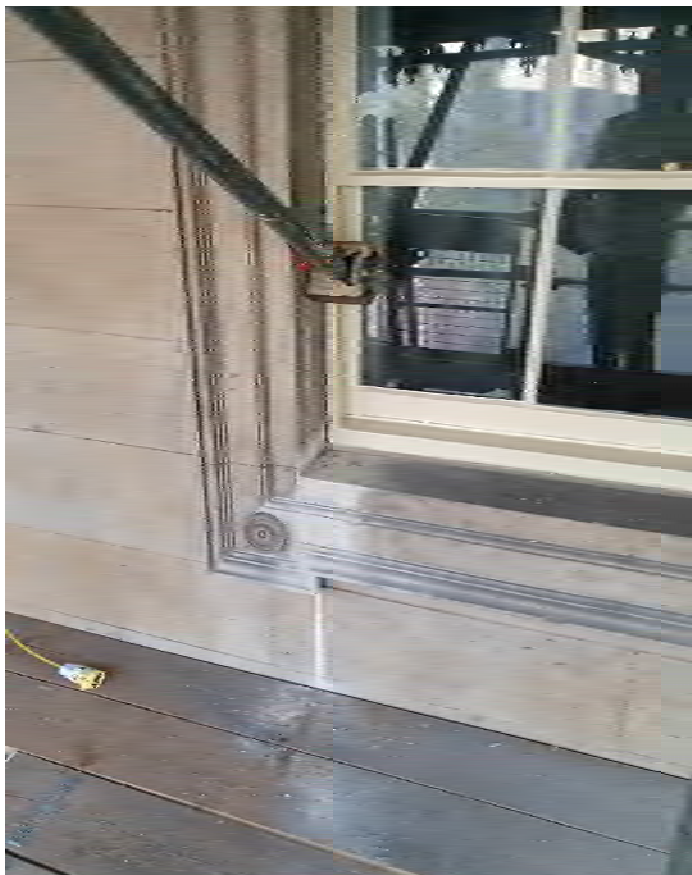
Item Reference	21
Item	Staining around window reveals and cills
Observations	A. White staining corresponding with fixing points for scaffold. Probably occurring as a result of stone dust from bolt locations mixing with rainwater and running down face of building.
Recommended Action	A. Clean. Carry out prior to any repairs. Refer to method statement 445 MSI.

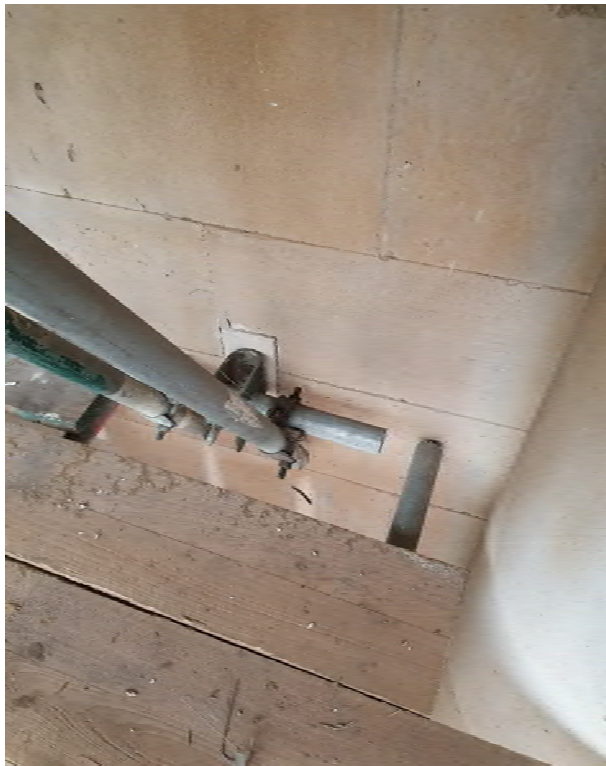
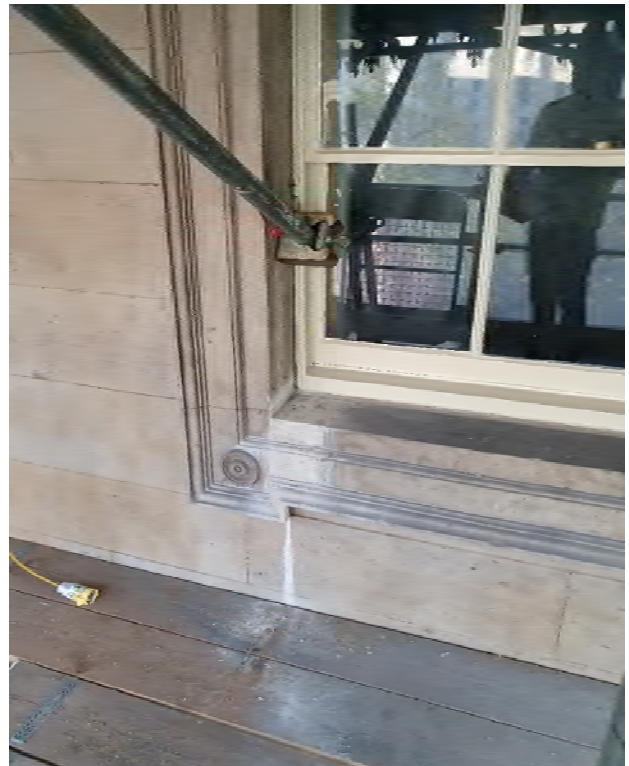
Item Reference	22
Item	Scaffold fixing points
Observations	A. Scaffold has been fixed directly into building façade, as agreed with Statutory Authorities under application 19-00795-LBC. At second floor level, fixing points are located within window reveals and occasionally directly into face of elevation. As detailed in the relevant LBC application, these latter fixings coincide with previously repaired fixing points for a historic scaffold.
Recommended Action	A. Where scaffold anchor holes are clean and have not resulted in surrounding damage to stone, fill with lime mortar, coloured to match. Where damage has occurred to surrounding face, further assessment to be undertaken on removal of scaffold.

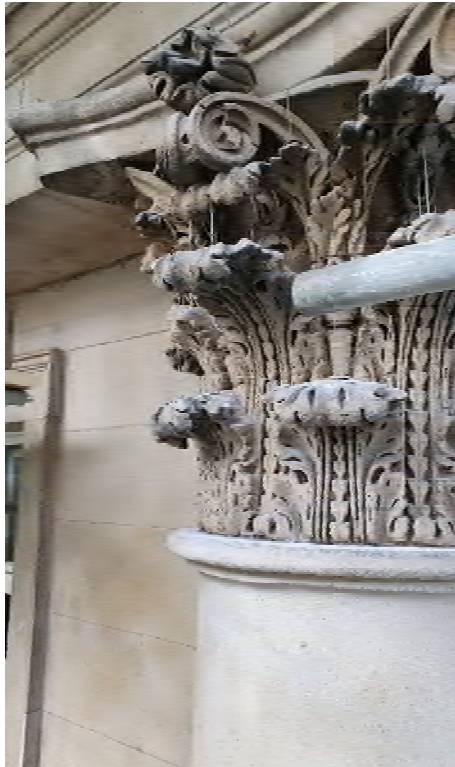
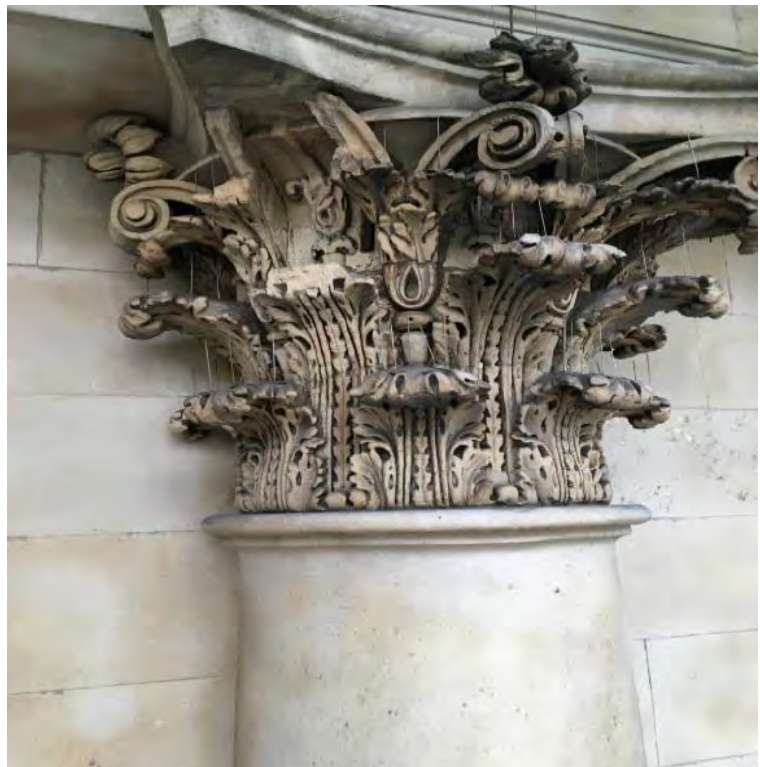
Item Reference	23
Item	Corinthian Capital
Observations	A. 1 volute and 3 sections of acanthus to top of capital missing B. Historic patch mortar repair to corner of abacus. C. Central Fleuron damaged.
Recommended Action	A. Take detail from existing, carve and fit acanthus and volute from carefully selected stone. B. If existing mortar repair prevents adequate structural connection of item A then remove existing repair and replace with stone profile to match. C. Lime mortar patch repair. D. Light clean. Carry out prior to any repairs. Refer to method statement 445 MSI. Clean remainder of corinthian column heads to match.

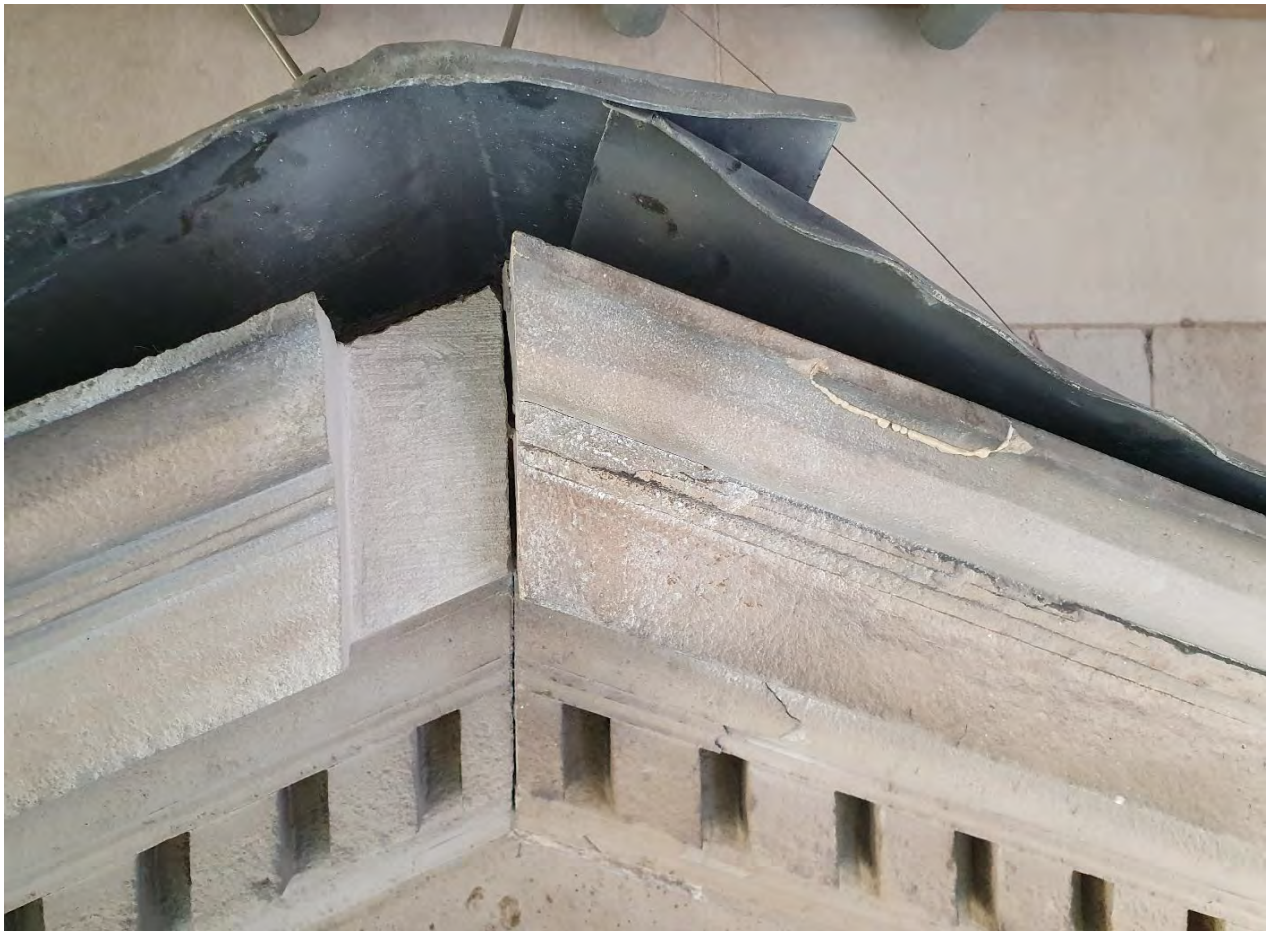
Item Reference	24
Item	Window pediment
Observations	A. Stone indent repair begun to left side of point. B. Cracking to right side of point.
Recommended Action	A. Fit stone indent to existing cut in carefully selected stone to match. B. Lime mortar patch repair, coloured to match. Ensure leadwork creates sufficient drip to cast water away from building when replaced.

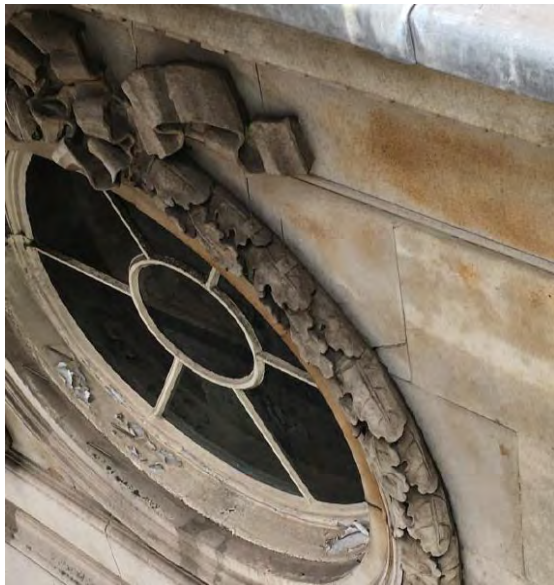
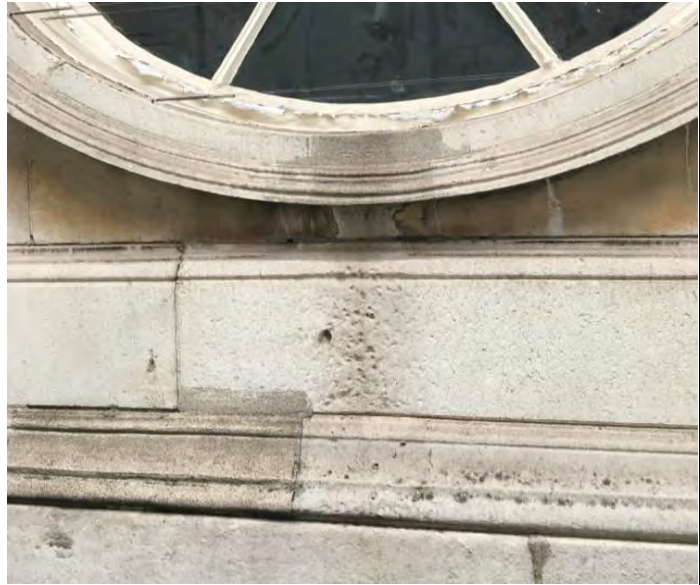
Item Reference	26
Item	Pointing around elliptical window
Observations	A. open joints and failed pointing around window.
Recommended Action	A. Repoint in lime mortar.
