Project No.	445
Project Name	The Courtauld. Stone Repairs
Address	Somerset House, Strand, London WC2R 0RN
Survey Location	Strand Façade
Survey Number	1
Revision	A
Date	24.08.20; 26.08.20; 16.09.2020
Survey carried out by	Peter Baynes, Brendan Higgins
Access	Scaffold. Limited access to East and West ends of elevation and chimney stacks.
Weather	Sunny and warm
General notes	Visual and non intrusive survey. Carried out with reference to Chichester Stoneworks Condition Survey Report, undated. Repair works based on above survey begun and halted. Some repairs complete, others underway. Scaffold does not currently extend to ends of elevations, preventing full inspection and future undertaking of works. Likewise, scaffolding does not currently encompass all chimney stacks.

SUMMARY

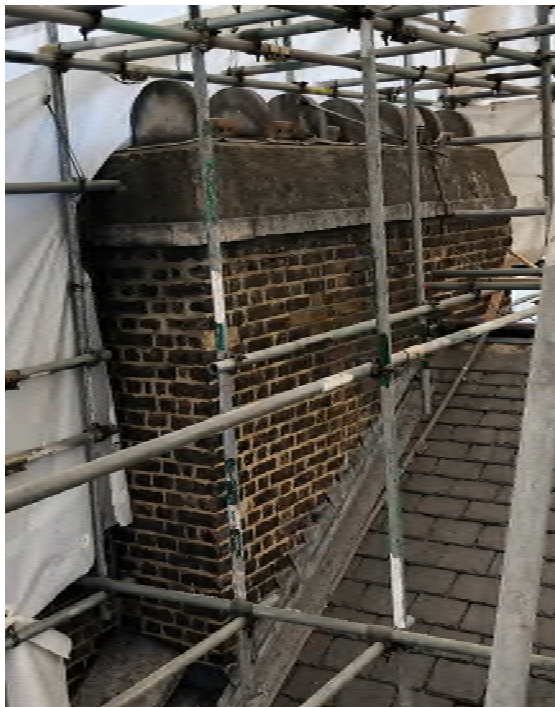
Item Reference	I
Item	Brick chimney, North East
Observations	A: Eroded and failed bricks and pointing. Existing pointing visually and materially inconsistent. B: Use of inappropriate cement mortars, potentially including recent leadworks as part of re-roofing.
Recommended Action	A/B: Cut out existing mortar and failed bricks. Repoint chimney with lime mortar and replace bricks with matching. Check pots and flaunching for defects and loose material.

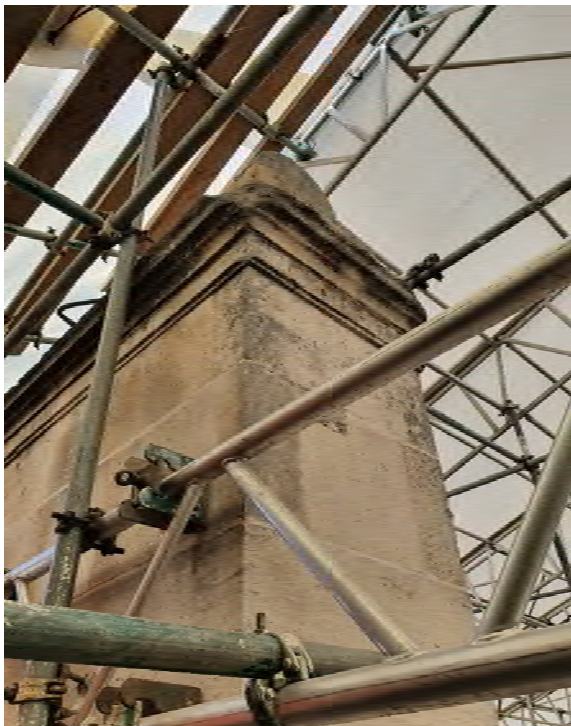
A/B/C

Item Reference	2
Item	Stone chimney East of centre, North
Observations	A: Numerous holes in stonework & redundant metal fixings. B: Scaffold fixed to stonework. C: Cornice eroded on South West corner. D: Face of stone at abutment of chimney and parapet to South West damaged, possibly by scaffold construction.
Recommended Action	A: Remove redundant fixings and repair all holes with lime mortar. B: Repair with lime mortar as scaffold removed. C: Inspect closer for resulting damage from water run off. Leave if none observed. D: Cut away damaged area and install new stone indent. General: Check pots and flaunching for defects and loose material.

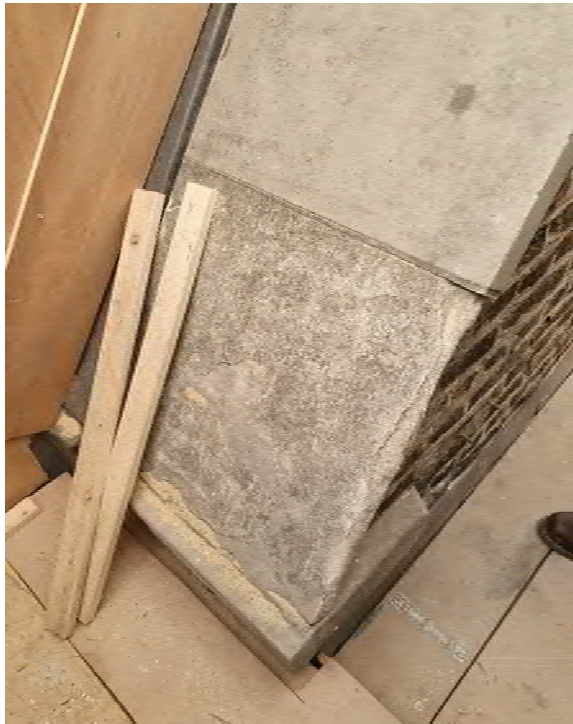
A

Item Reference	3
Item	Brick chimney East of centre, middle of roof
Observations	A: Damaged coping stone, West side at base B: Eroded pointing C: Damaged coping stone with existing cement repair.
Recommended Action	A: No proposed repair. B: Cut out existing mortar and repoint C: Remove existing cement repair and replace with lime patch repair. General: Check pots and flaunching for defects and loose material.

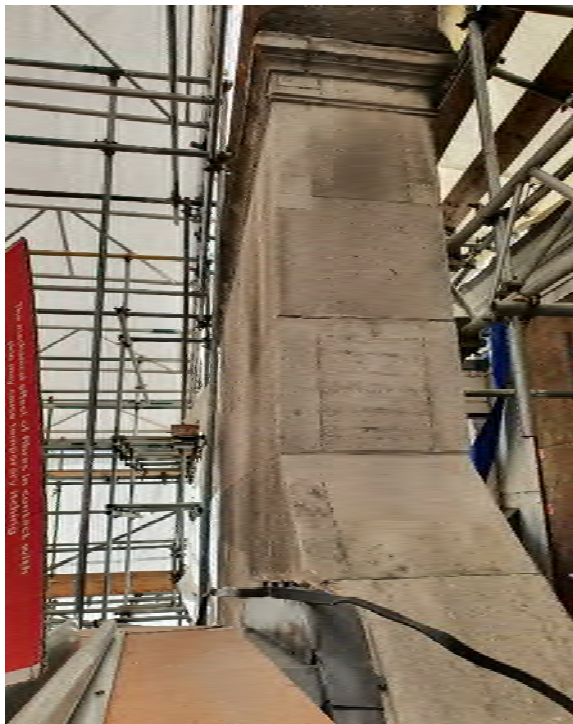
Item Reference	4
Item	Stone chimney East of centre, South
Observations	A: Numerous holes in stonework & redundant metal fixings. B: Scaffold fixed to stonework.
Recommended Action	A: Remove historic fixings and repair all holes with lime mortar (approx 20 no.) B: Repair with lime mortar as scaffold removed. General: Check pots and flaunching for defects and loose material.

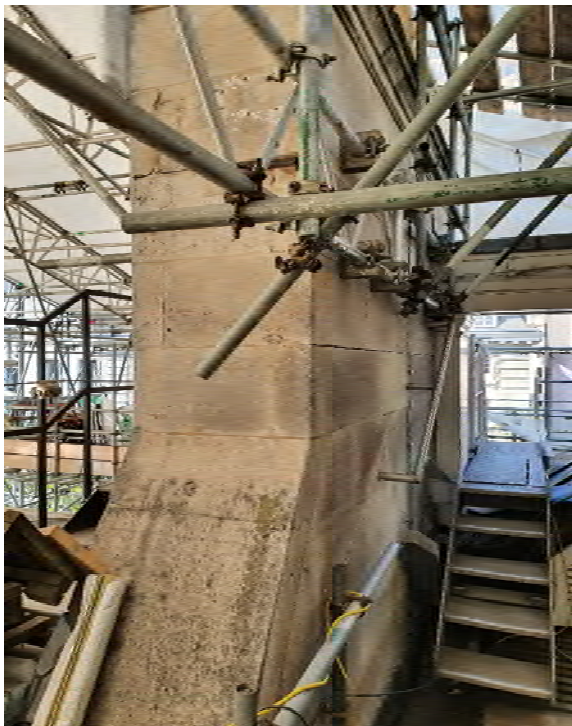
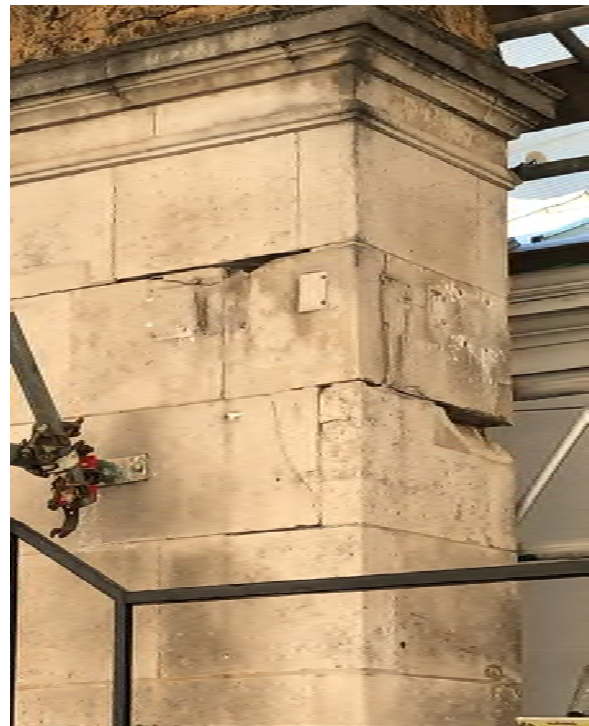
Item Reference	6
Item	Stone chimney West of centre, North
Observations	A: Joints opening up due to suspected movement caused by scaffold. B: Numerous holes in stonework & redundant metal fixings. C: Splitting and spalling on South East and South West corners. Rusting cramp evident.
Recommended Action	A: Amend scaffold attachments and monitor movement. Once scaffold removed and stonework settled, repoint joints with lime mortar. B: Remove redundant fixings and repair all holes with lime mortar. C: Cut away damaged area to agreed line and remove rusting cramps. Fit 2 no. new stone indents on SE corner and SW face C using SS pins as required. Repoint in lime mortar as req. General: Check pots and flaunching for defects and loose material.

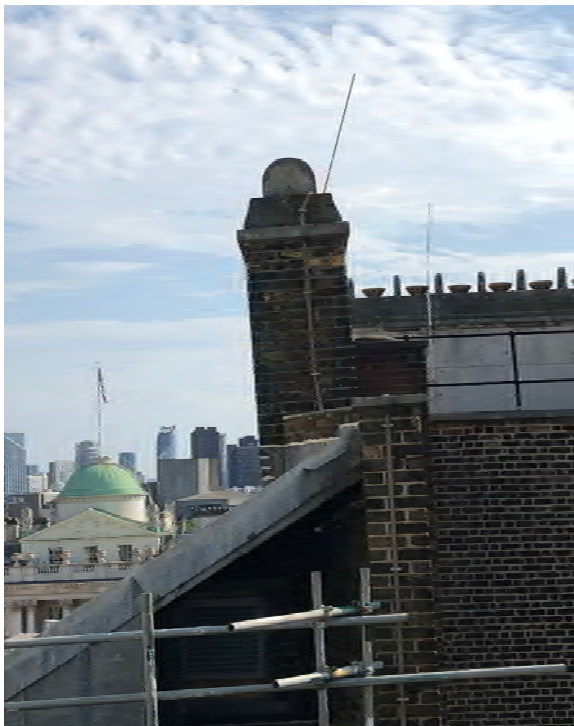
Item Reference	8
Item	Brick chimney South West
Observations	A: Slight lean on chimney stack eastwards
Recommended Action	A: Structural Engineer to inspect. General: Check pots and flaunching for defects and loose material.

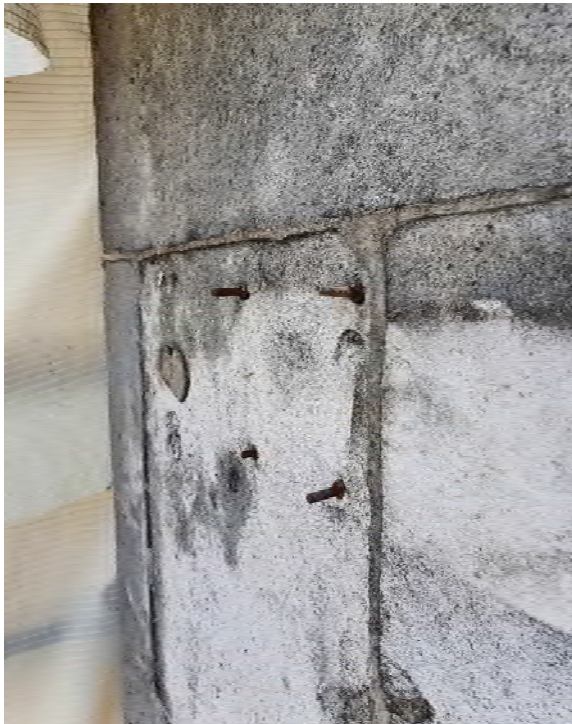
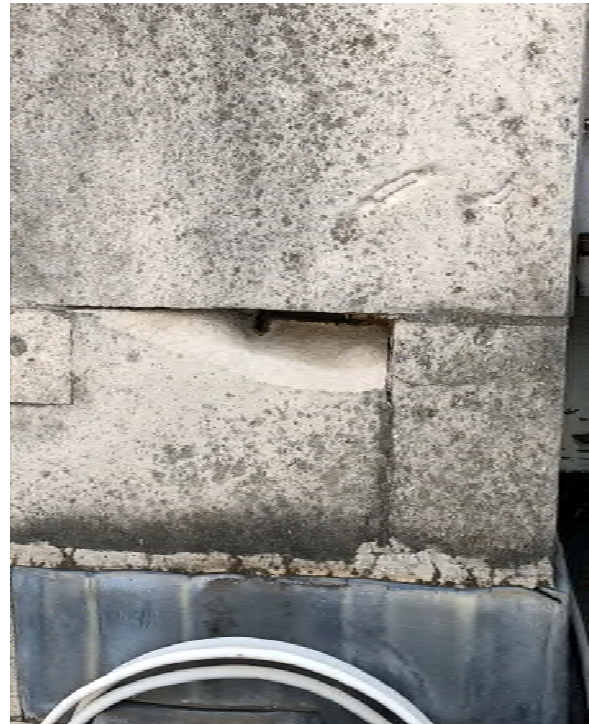
Item Reference	9
Item	Stone chimney West of centre, South
Observations	A: Numerous holes in stonework & redundant metal fixings. B: Splitting and spalling of stone at base. Rusting cramp evident. Loose pointing.
Recommended Action	A: Remove redundant fixings and repair all holes with lime mortar B: Remove rusting cramp. Cut away damaged material to agreed line and insert new stone indent using SS pins as required. Rake out loose mortar to base and repoint in lime. General: Check pots and flaunching for defects and loose material.

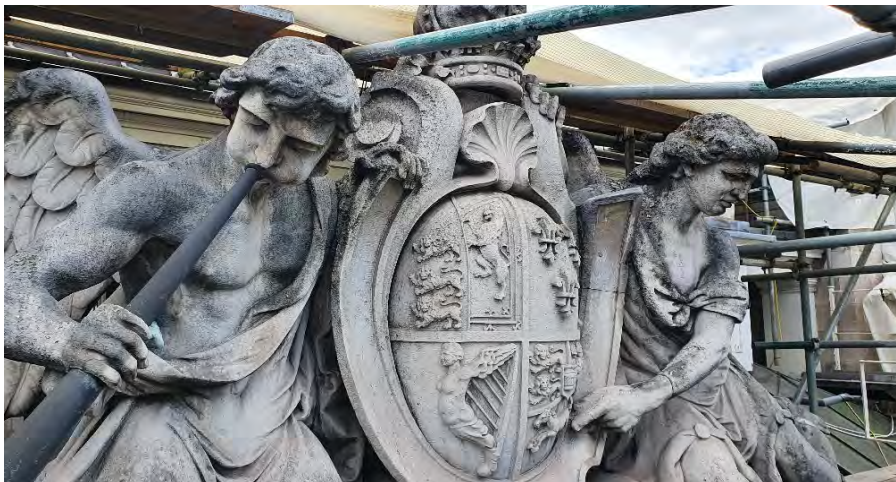
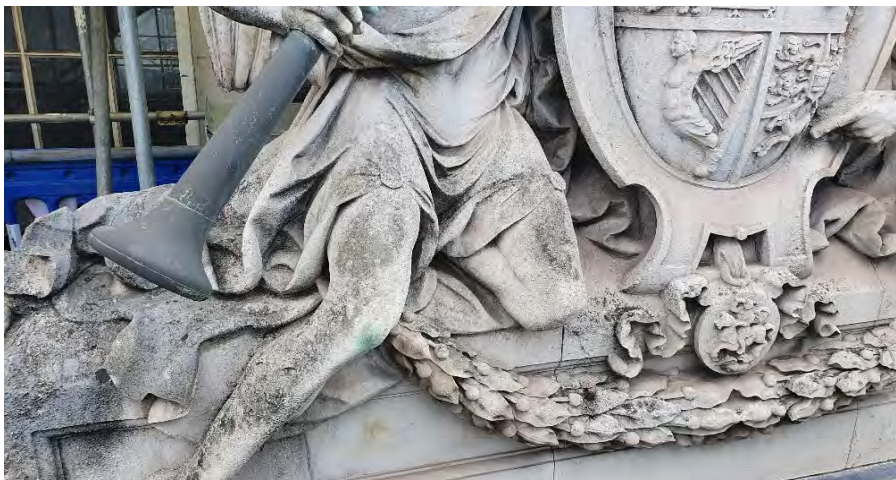
Item Reference	I0
Item	Statue I, central, top.
Observations	A: Minor staining due to water run off from copper elements. General discolouration on most exposed areas, (heads and shoulders) including some stone deterioration. B: Minor cracks where stonework particularly intricate - pinkie finger on angel holding horn, and index finger on angel pointing to horse. C. Stone joints absent of mortar.
Recommended Action	A: Light cleaning. Test on small areas and agree total scope. Refer to method statement 445 MSI. B: Patch repair with lime mortar. C. Repoint in lime mortar.

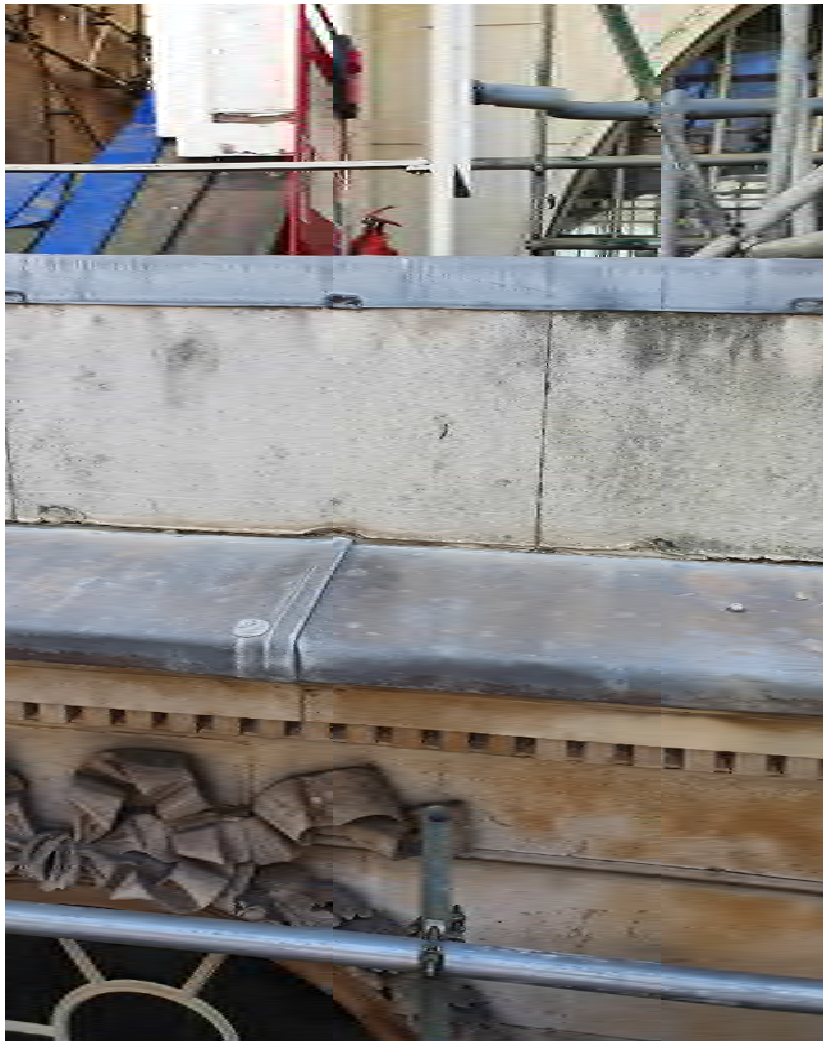
Item Reference	II
Item	Lead parapet below central statue
Observations	A: Failed sealant to lead flashing has been removed. Open joint now visible.
Recommended Action	A: Point open joint with lime mortar.

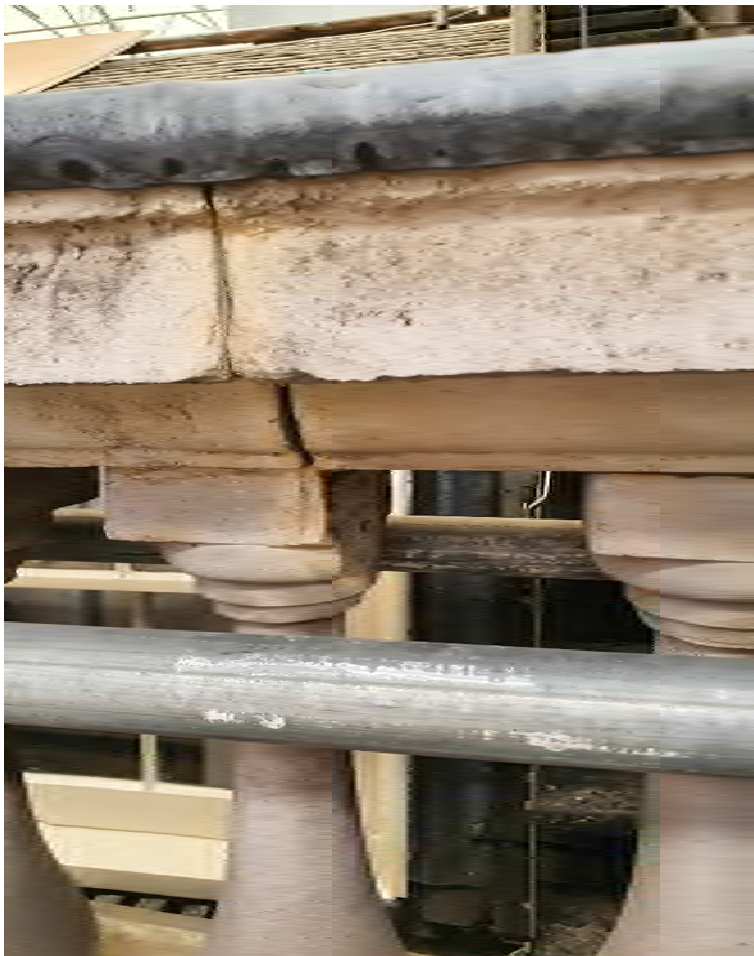
Item Reference	I2
Item	Bottle and Parapet Capping
Observations	A: Movement at parapet capping joint B: Spalling to top of bottle, probably as a result of item A. Evidence of historic repair, since failed.
Recommended Action	A: Peel back leadwork and fix adjacent parapet cappings together with 2 no. SS brackets and resin anchors to prevent movement. Point joint in lime mortar. Replace leadwork. B: Cut damaged stone to agreed line, minimising amount of stone removal. Piece in new stone section to match existing profile with SS dowels as req.

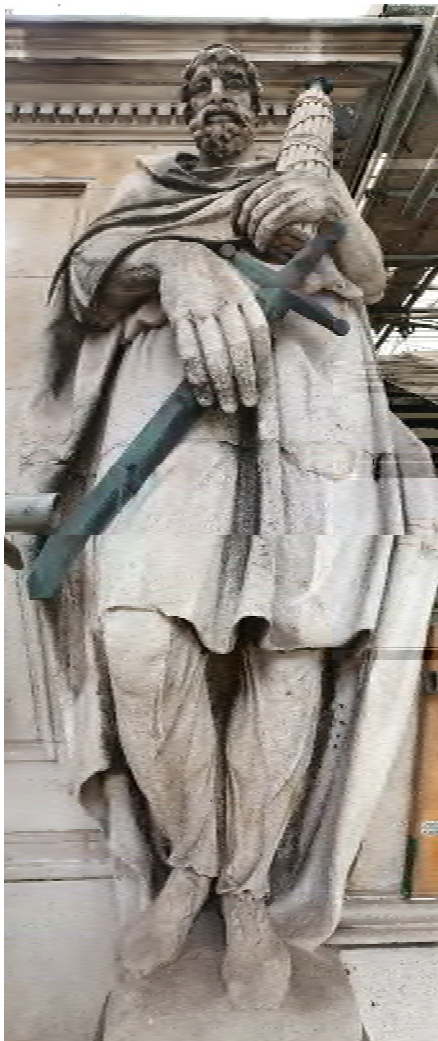
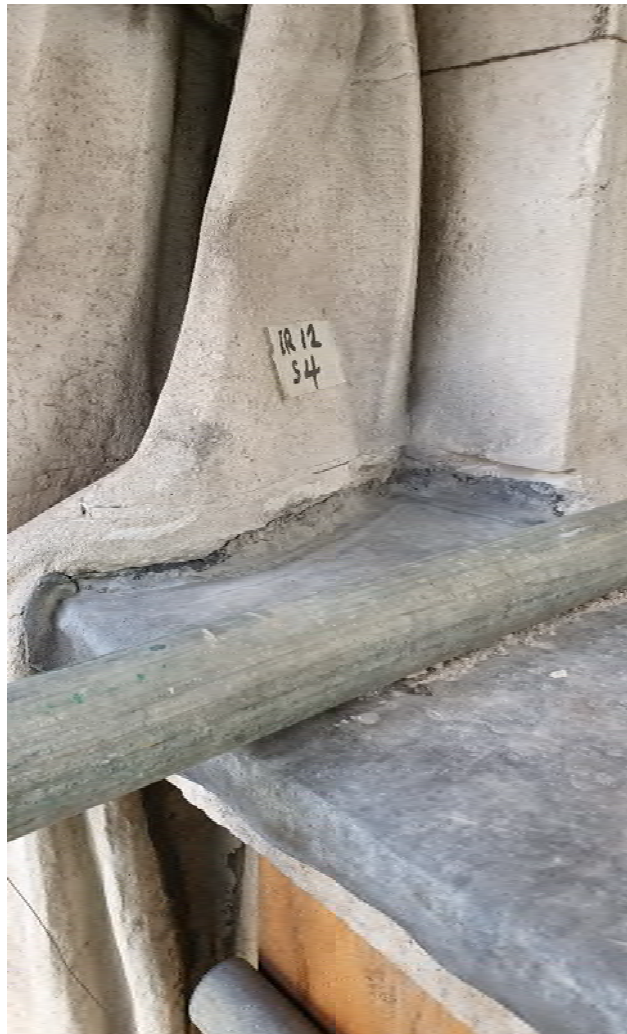
Item Reference	I3
Item	Statue 2
Observations	A. Leadwork at connection to balustrade coping has been tapped up and into joint in attempt to prevent previously recorded water ingress. B. Minor staining and dirt collection, especially within more intricate areas of stone carving. C. Some loose pointing at stone junctions.
Recommended Action	A. Form lead upstand at junction and apply lime mortar haunching over. B. Light clean. Carry out prior to any repairs. Refer to method statement 445 MS1. C. Rake out joints where loose/failing and repoint with lime mortar.
