## **Elford Farm, Dalwood**

### **Design and Access Statement.**

## Elford Farm, Dalwood

### Statement of Significance

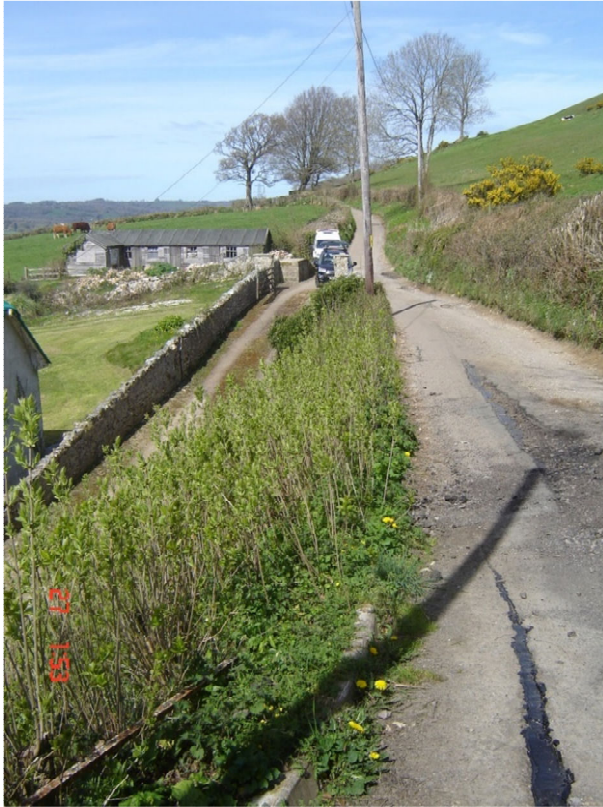
View along Nower Road at top of retaining wall.

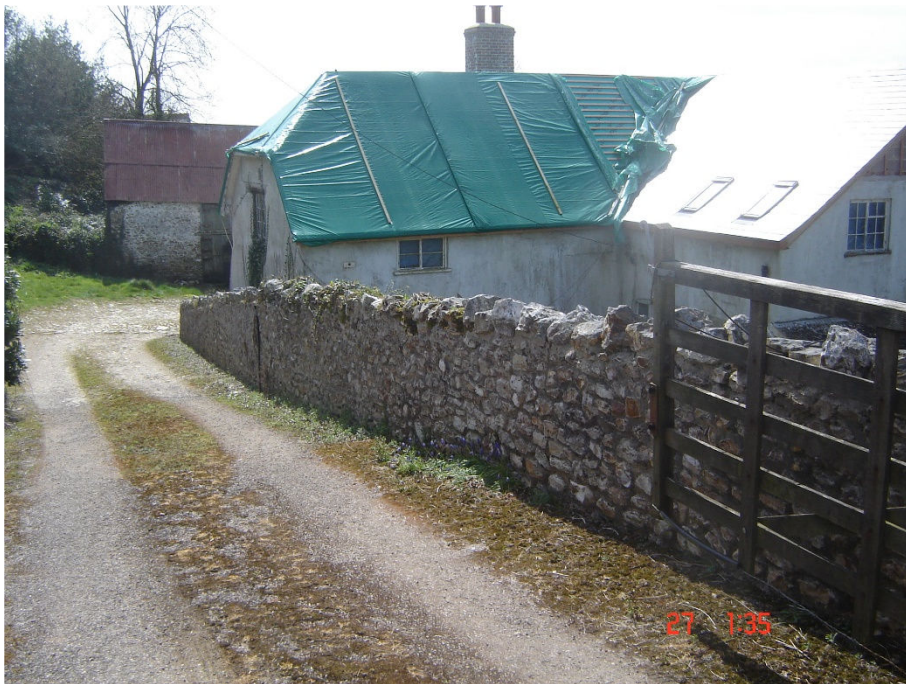
View along access track to Elford Farm from Nower Road.

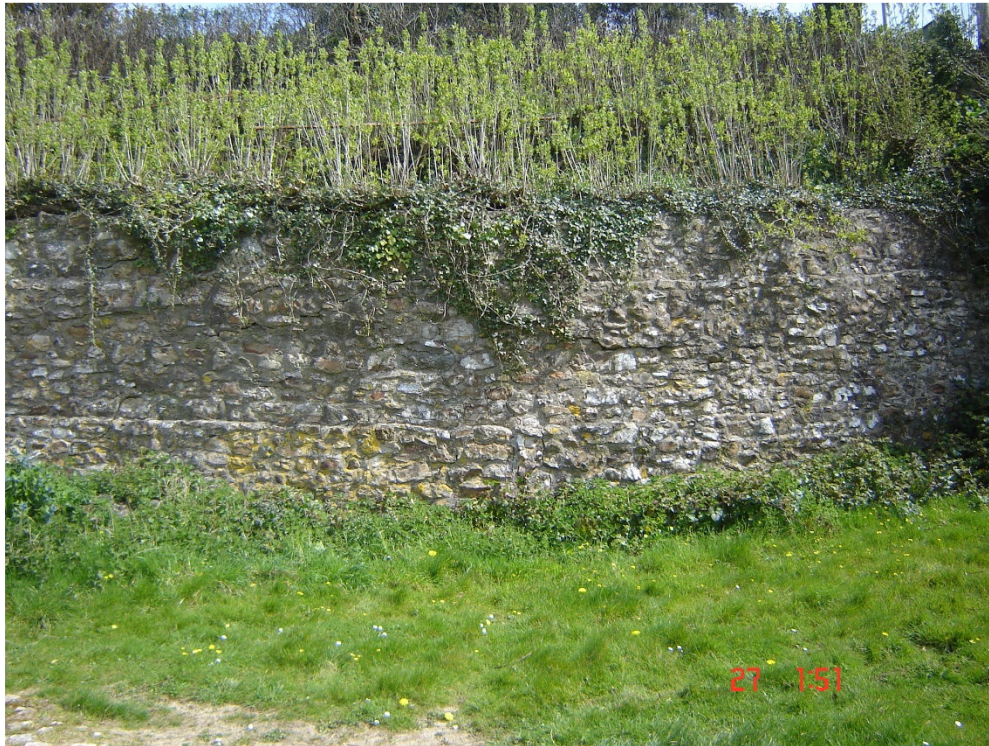
The retaining wall is of Flint/Chert and Sandstone construction with cement mortar bedding/pointing to the face stonework. The wall is approximately 300mm thick the rear layers of masonry have been laid with lime mortar. The form of construction and type of masonry used is not similar to either the farmhouse or the associated barn/outbuildings. Although the natural stone construction is sympathetic to the listed farmhouse it has no historic significance.

The cement mortar indicates that the wall has been repaired/reconstructed. There are two near horizontal bed joints at approximately 1.0m and 2.0m height which suggest the wall has have been raised or partially rebuilt in the past.

Existing masonry wall from farmyard prior to collapse.

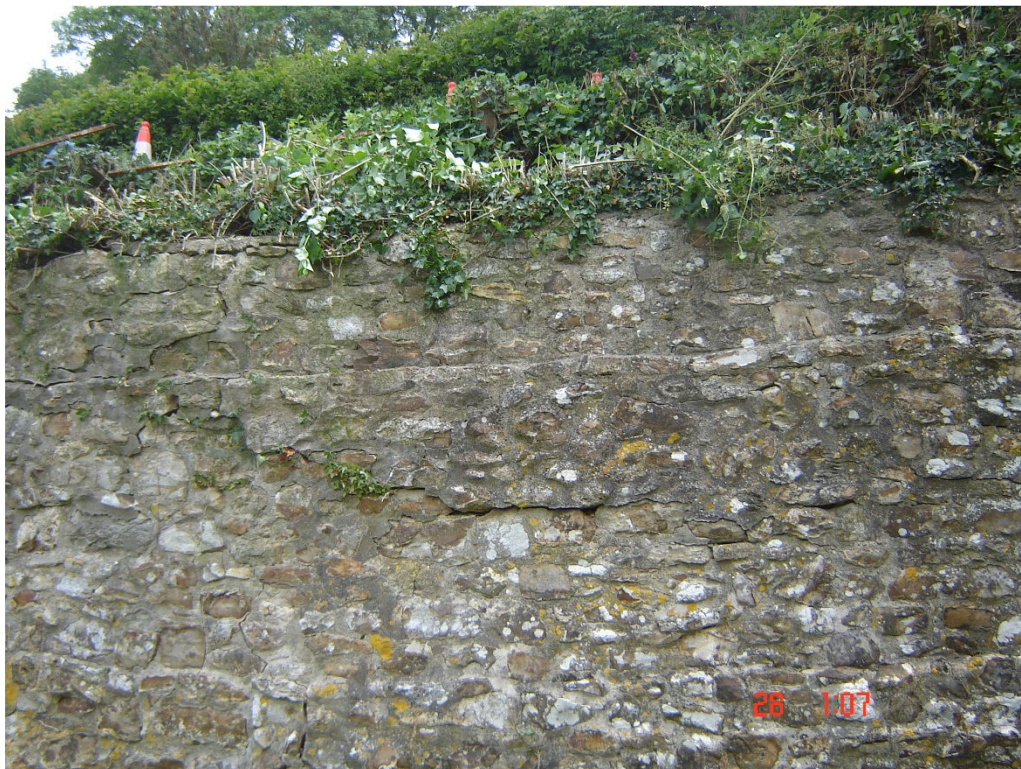
There has been settlement and movement of the road surface first noted in March 2020. The settlement of the road was reflected in bulging and cracking to the masonry wall. As a precaution the road was closed from April 2020 while geotechnical investigation and design of a structural solution was carried out. In January 2021 the road suffered further settlement resulting in complete collapse of the masonry wall.

Cracks in wall prior to collapse

The preferred repair option is for a mass gravity retaining wall. The ground behind the wall to be excavated and the new structural wall constructed below the road surface. This structural wall comprising interlocking concrete blocks or gabion baskets will then be faced with masonry to match the existing using stone recovered from the collapsed wall. Other areas with minor cracking will be repointed as necessary. The proposed works will reinstate the masonry wall on its original line and will have no significant detrimental impact on the setting of the listed building.

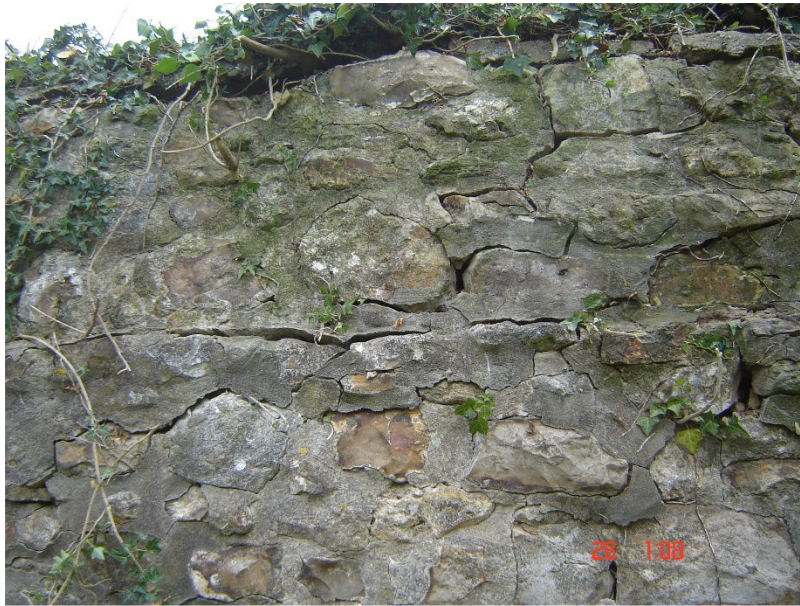
Cracks in wall prior to collapse.

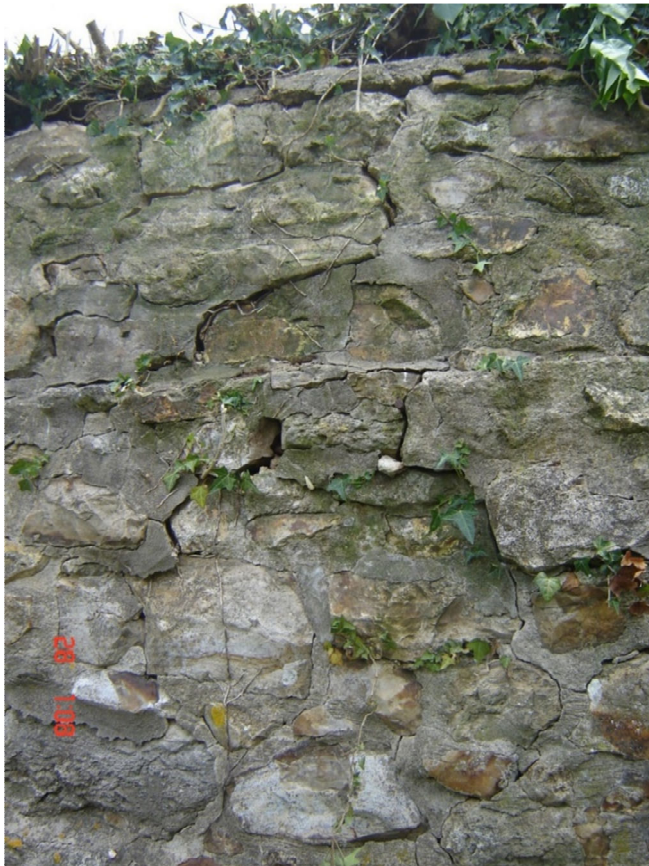
Cracks in wall prior to collapse.

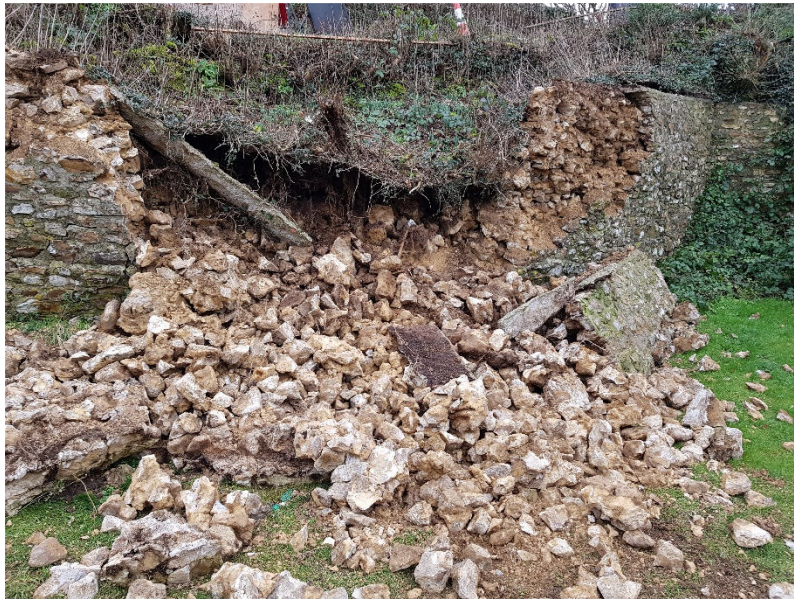
Collapsed wall – January 2021

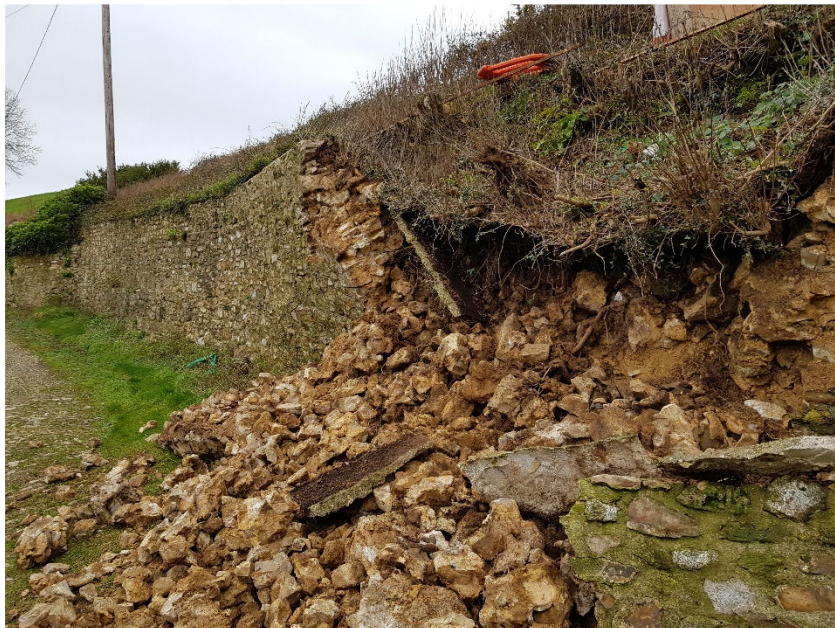
Collapsed wall – January 2021
