## Heritage Impact Assessment – Barn at Trevarth House, Gwennap TR16 6BW

**Appendix A – Subsidence Damage**

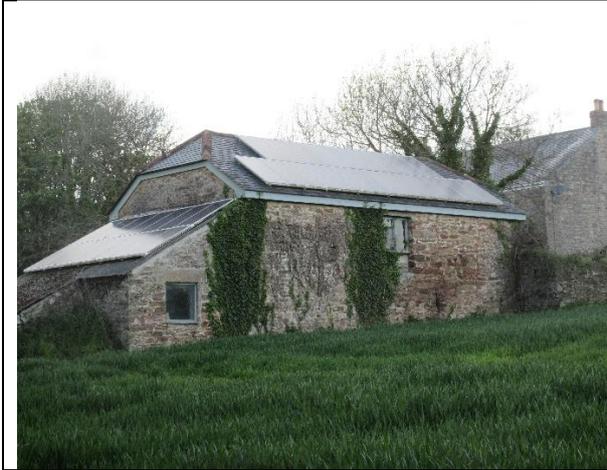
Barn and Extension from field to east

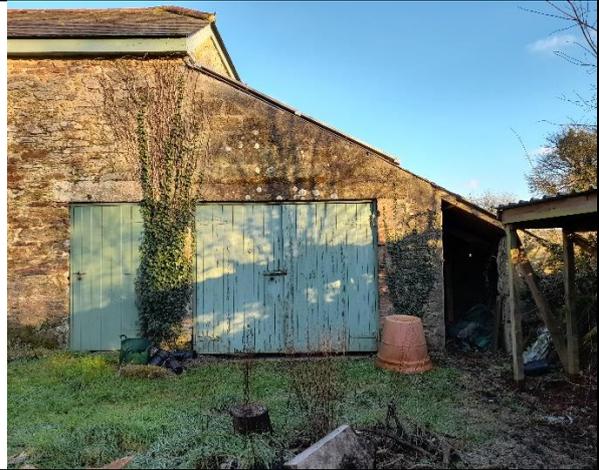
Extension from west

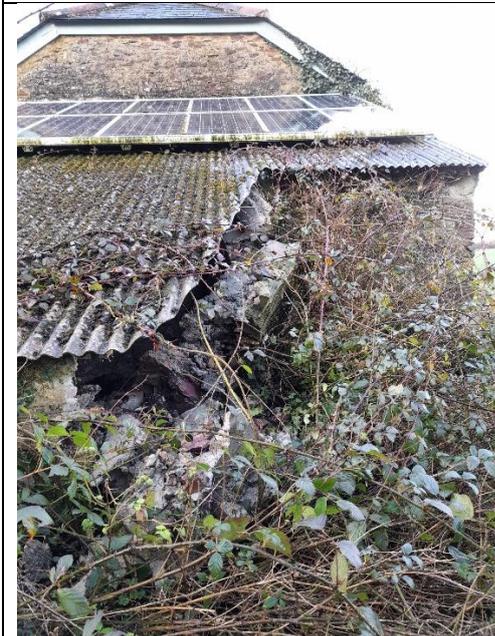
2. The Building: See Appendix A for photos. The Barn is formed of two parts, the first a two-story stone-built agricultural building of indeterminate but considerable age with a tiled roof and external stone steps giving access to the upper floor. It is used for storage and has a small workshop area. The second part is a more recent lean-to Extension, primarily constructed of stone, but with one long wall of cement blocks and a roof of corrugated cementitious sheeting. It has been used as a garage. This extension has suffered from serious foundation subsidence, caused by a tree which was removed in 2018, and it requires extensive repair or rebuilding.

Subsidence damage to southern end

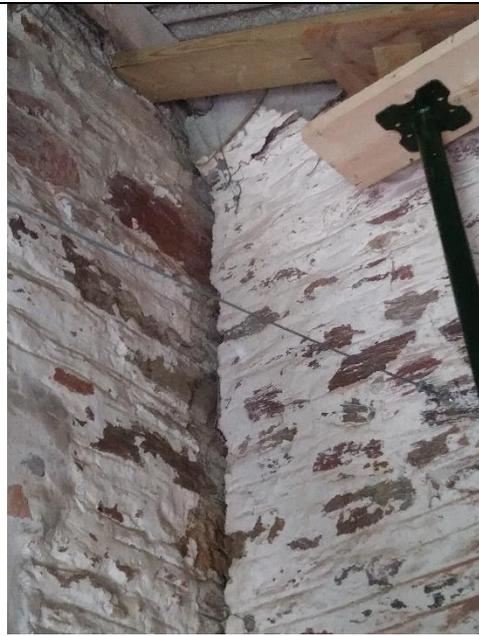
Eastern wall of Extension rotating outwards – wall of Barn is to left. Temporary tie and supports installed by insurer.

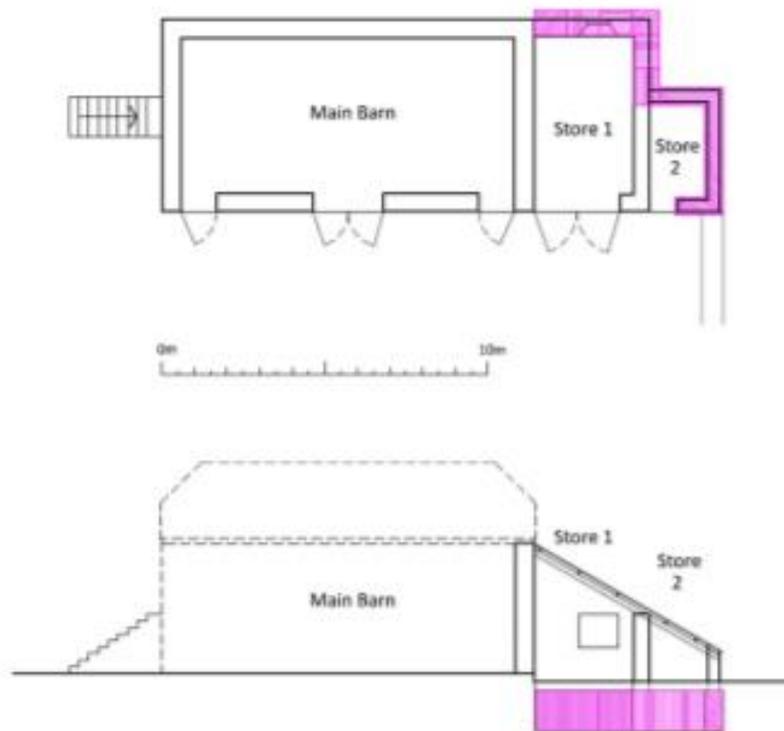
Figure 3 – Plan of barn and stores, showing the extent of the proposed underpinning

Noting that the western wall is of modern concrete block construction, it can be seen that the underpinning and wall reconstruction areas are almost equal to the original stone walling that can be retained, and that the small size and low ceiling height (1.5m) of the lowest part of Store 2 make it almost unusable.

**Option A - Conservation:** Appendix B shows the Insurers' proposal for the work required to repair the Extension, referred to as Stores 1 and 2. Fig. 3 shows the extent of the underpinning foundations required and Fig. 4 shows the walls which have to be rebuilt, as they have effectively collapsed. The eastern wall (at the top of the page) has rotated about 10cm outwards, to the east, but the proposal is to introduce steel ties to secure it to the Barn wall. The existing corrugated cement sheeting must be replaced by corrugated metal or cement sheeting, as the roof slope is too shallow to use tiles.

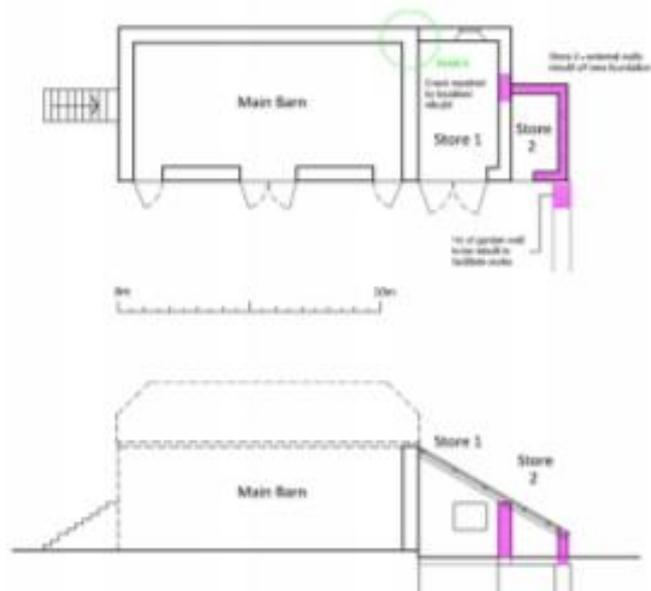
Figure 4 – Plan of barn and stores, showing the extent of the proposed superstructure repairs

Figures 4 and 5 illustrate the nature and extent of superstructure repairs proposed.
