# Report on a Structural Inspection

**Project: Existing Stable, Structural Condition Survey  
Sawmill Barn, Main Street, Hawksworth, Notts**

Project No: 20-118

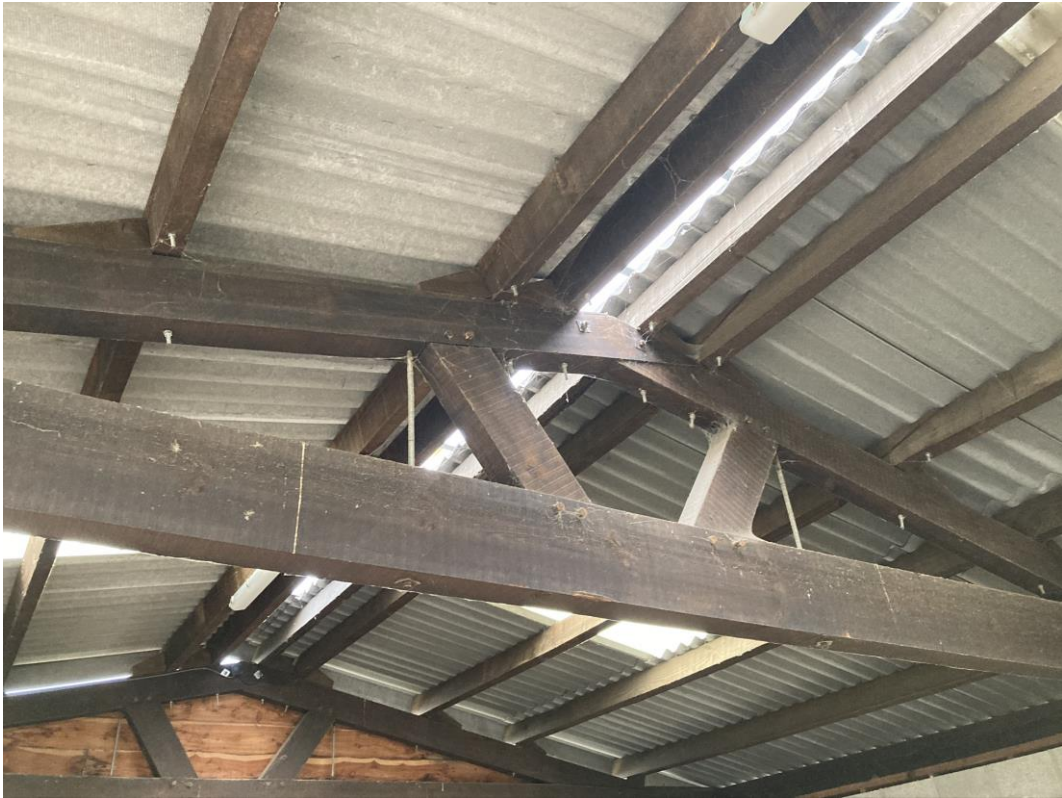
6.7 Internal View on Roof Truss and Purlins

- 3.01 The structure is formed with 5No. duo-pitch timber trusses spanning between timber posts at each side of the building.
- 3.02 Timber purlins supporting the roof sheeting span between the trusses.

- 4.07 Timber preservative spray treatment of the structural timbers should be undertaken prior to covering over with internal finishes.
- 4.08 Therefore, the building is of a robust and permanent structural condition which is considered fit for retention and conversion into a dwelling.
