STRUCTURAL SURVEY
FOR FIRE DAMAGED PROPERTY –
CROUCHERS, BIRDHAM ROAD, CHICHESTER PO20 7EQ7

1. The inspections were carried out on Tuesday 15th September 2020, on Monday 12th October and on Wednesday 6th January.
2. Description
 - 2.1 The property was a two-storey five-bedroom detached house with several outhouses.

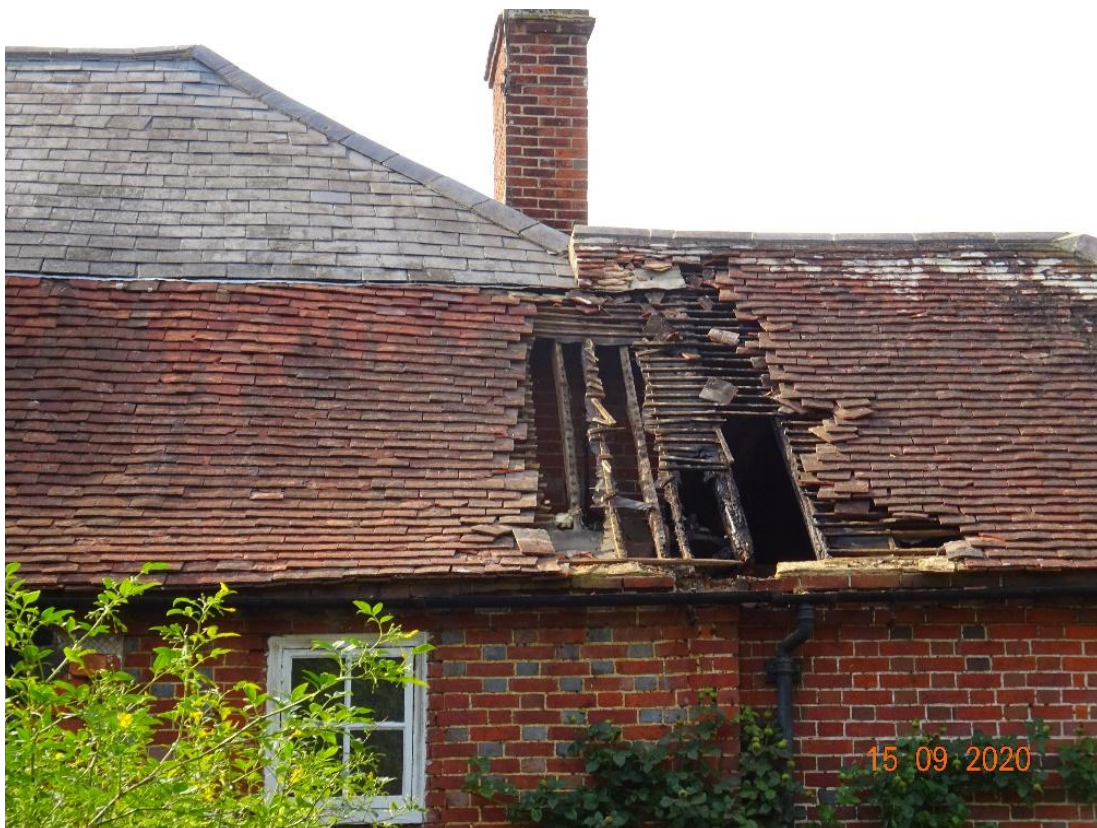
- 3.3 The fire may have caused damage to the rafters and externally it was noted that the tiles were missing in an area of approximately 2m wide x 3m high. (This may have been an access made by the fire brigade.)

View of damaged part of the roof externally

- 4.1 In order to ensure that the roof is protected where open, I requested the contractor install tarpaulin sheets over it on a temporary basis, with a scaffold roof being provided over this small section of the building.

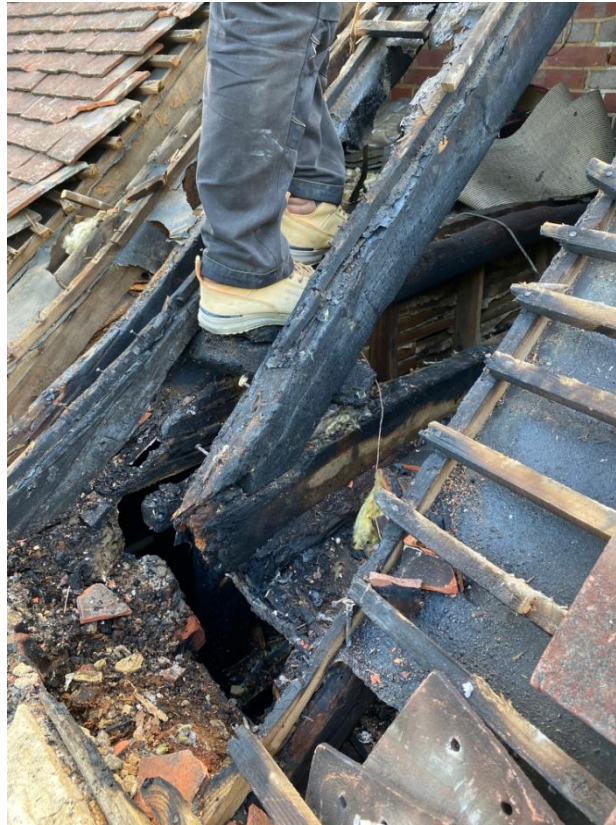
Detail of damaged roof

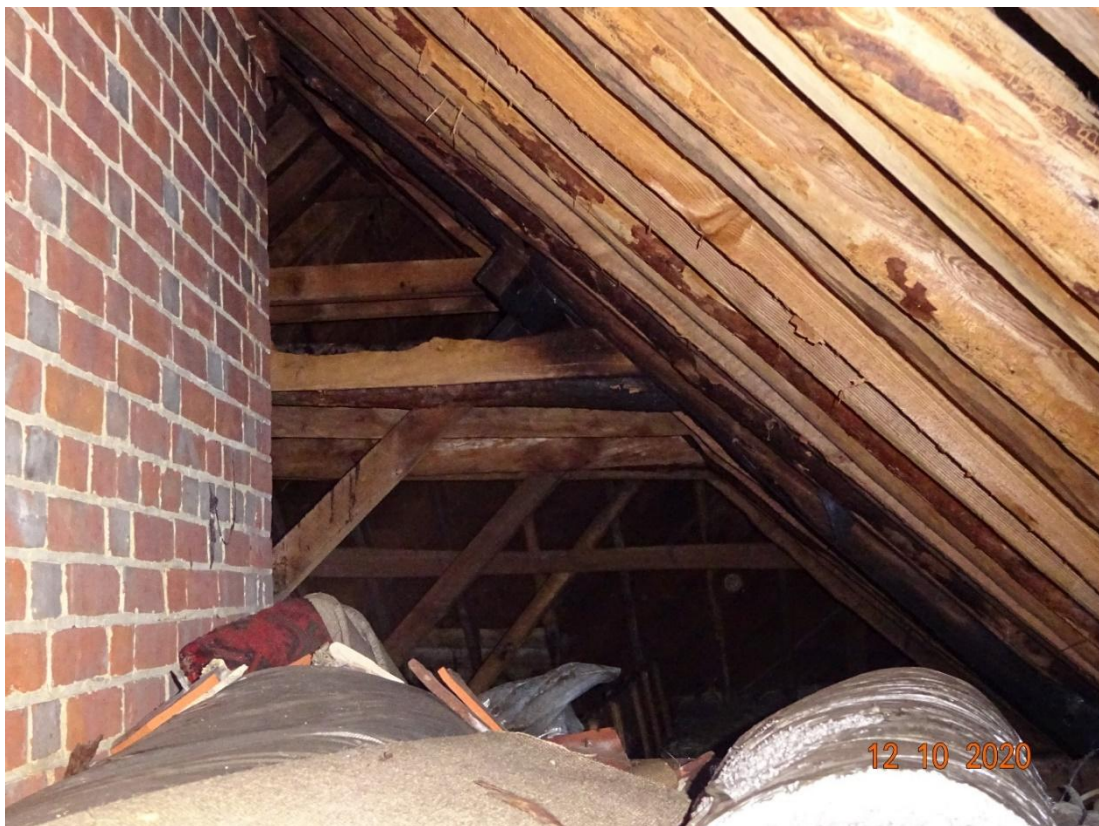
roof was constructed in a combination of softwood and hardwood timber. I assume that the fire damaged rafters and ceiling joists are made of oak.

View of damaged part of the roof internally

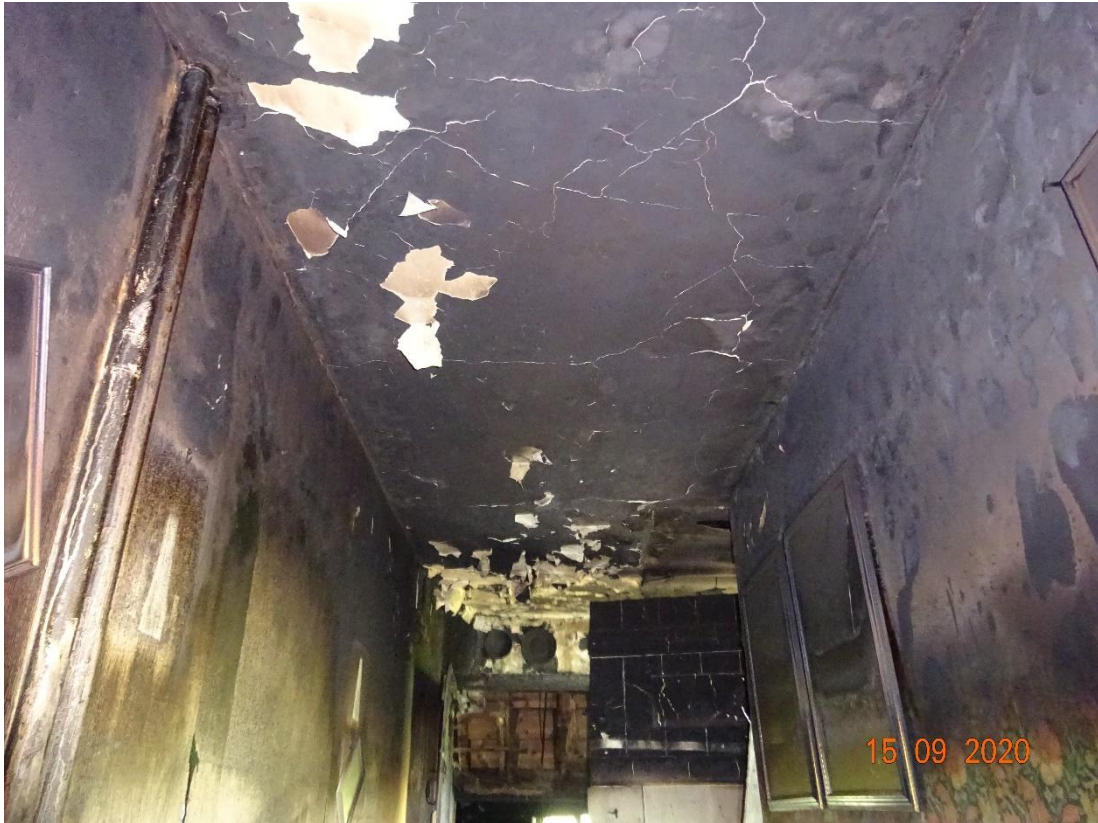
View of fire damaged ceiling in the corridor on the ground floor

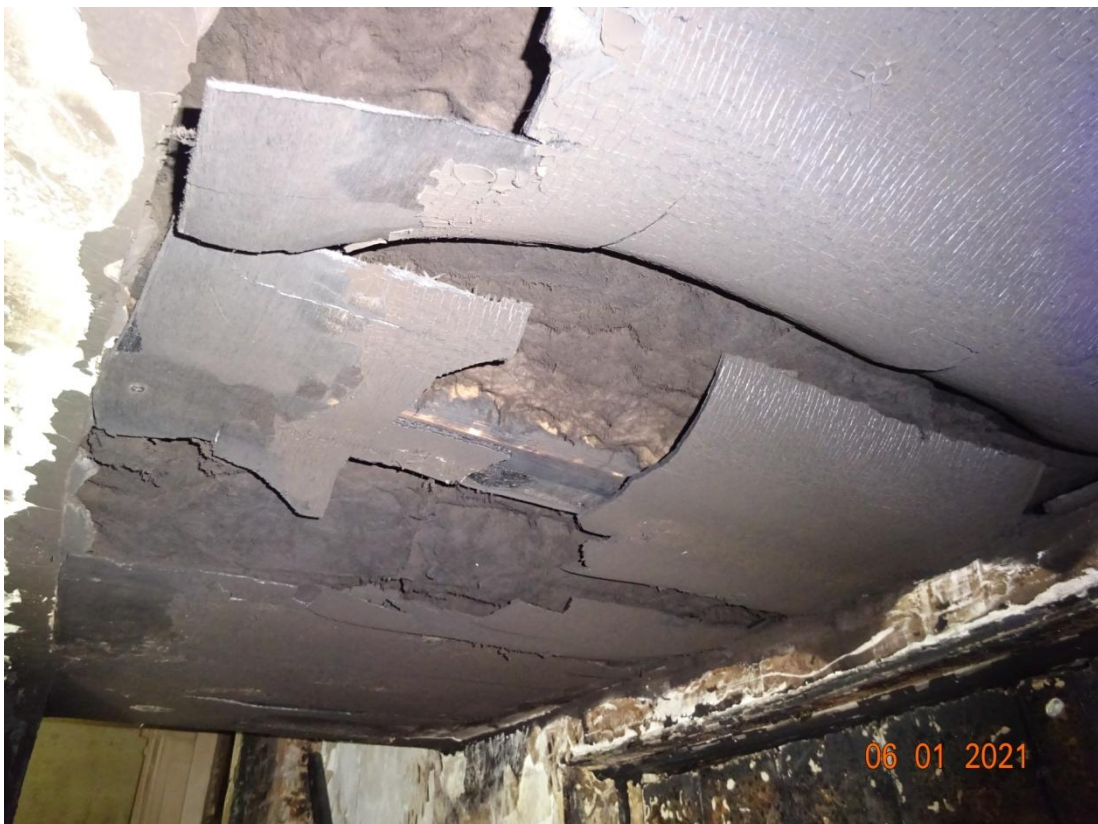
Detail of fire damaged ceiling in the corridor on the ground floor

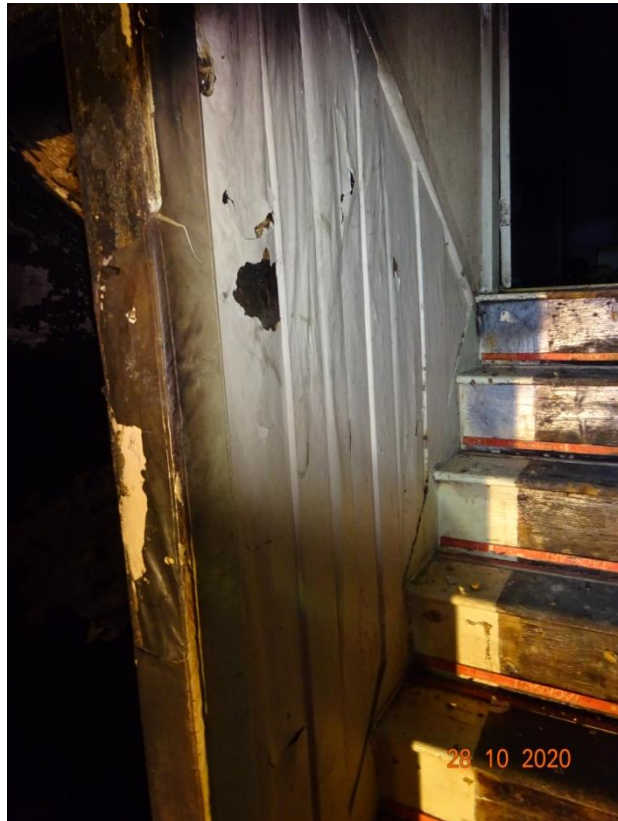
Cladding of the wall between the stairs to bedroom 5

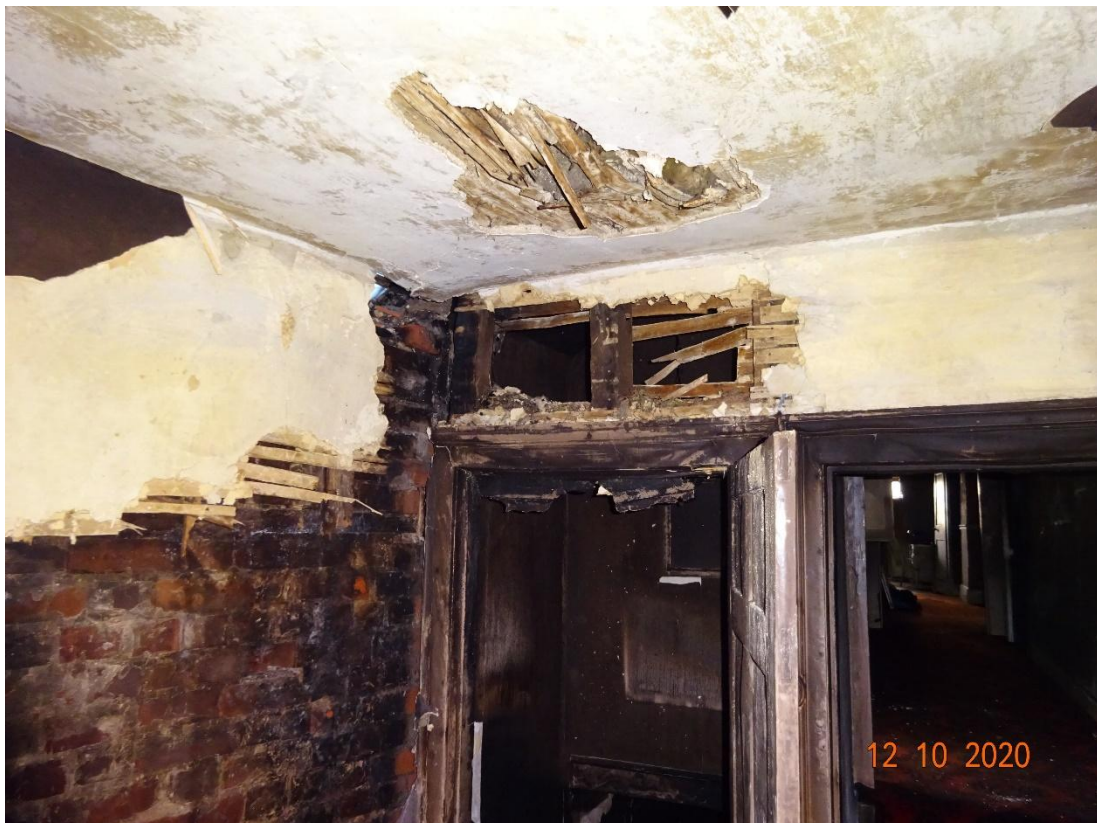
View of fire damaged structure in bedroom 5

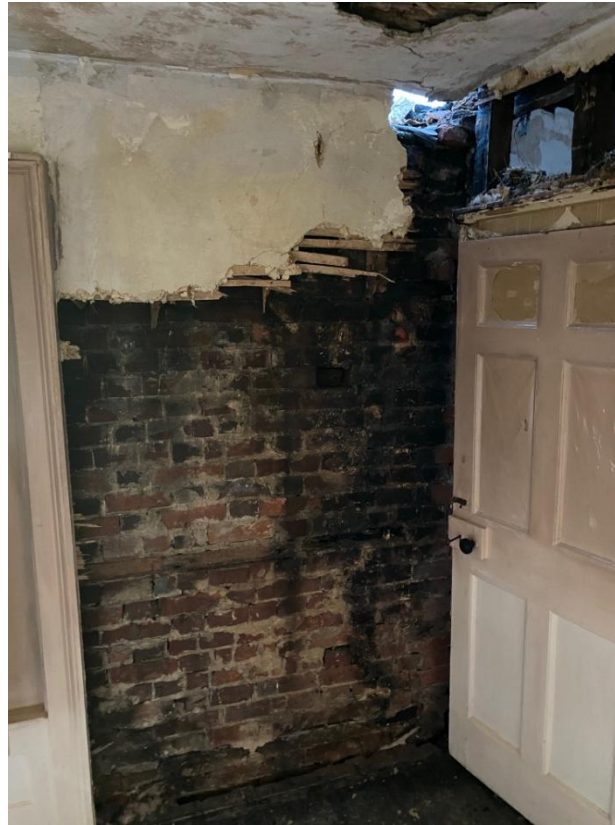
View of fire damaged structure in bedroom 5

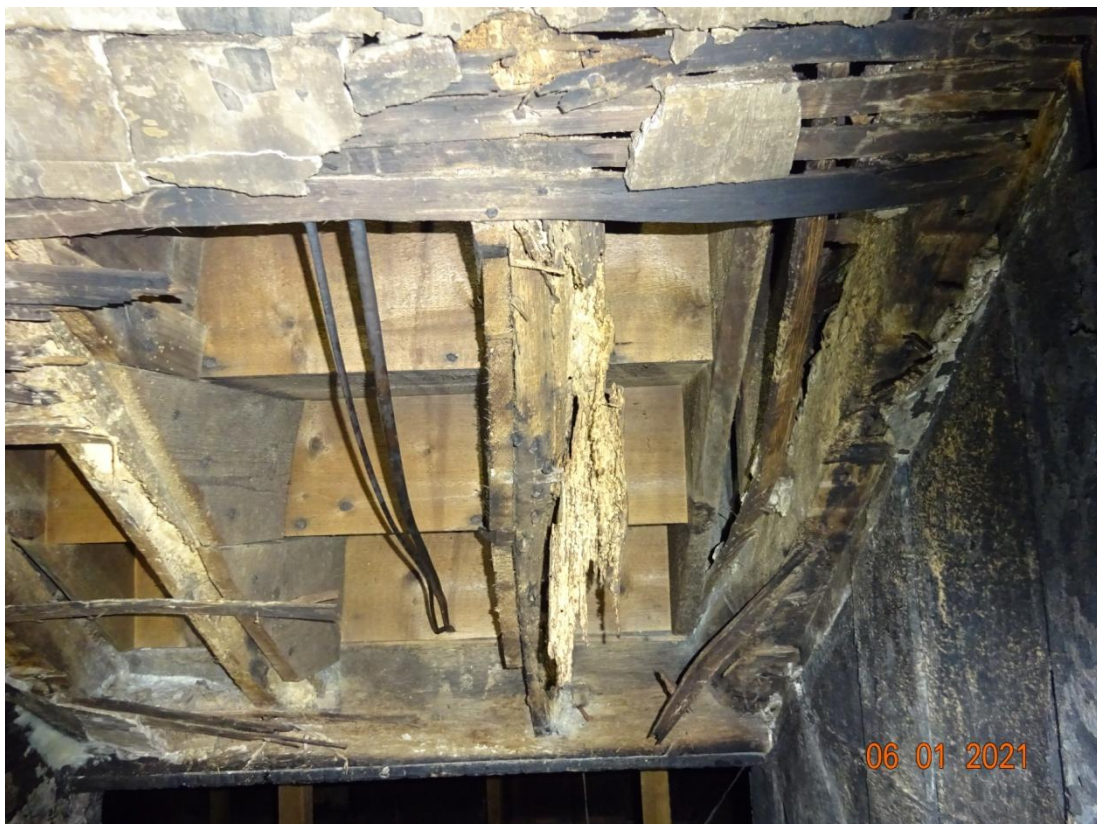
Detail of deteriorated and infected timber stairs from bedroom 5 to the hall on the first floor

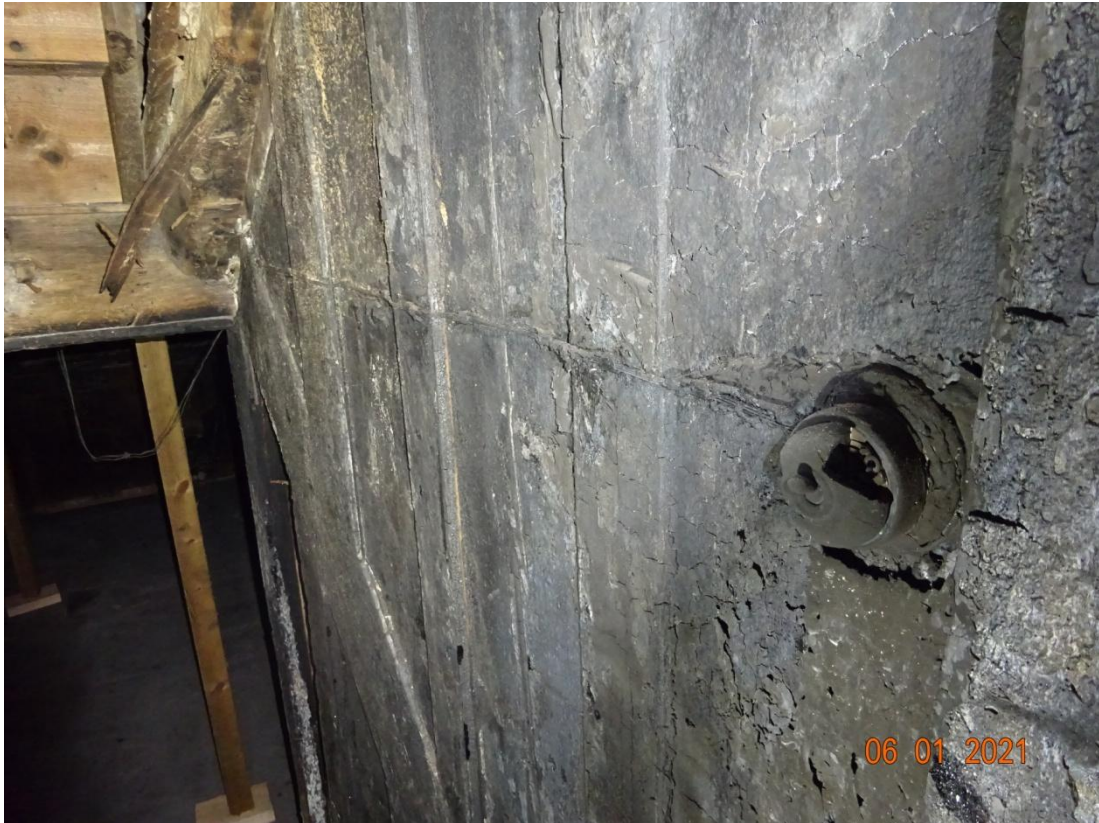
Detail of cladding of the wall between the stairs to the basement

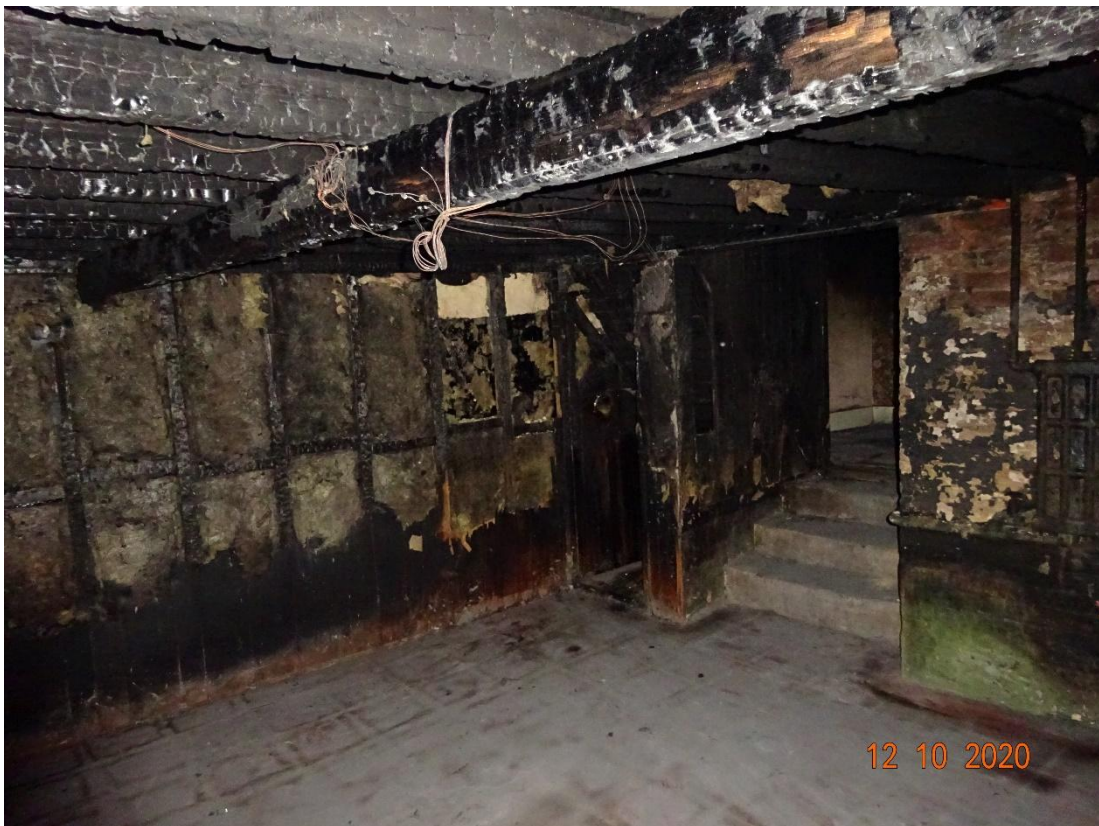
- 3.2 The fire was believed to have commenced in the lower ground floor area, due to a refrigerator. The fire has seriously damaged the floor joists above and appears to have probably gone into the first-floor bedroom, possibly via the void created by the stairs and lath and plaster covering the east wall of the building.

View of fire damaged floor joists in the basement

- 4.3 The cleaning of the property (smoke contaminated finishes) is being undertaken using appropriate method such as dry ice blasting to exposed timbers.
- 4.4 The property will require a complete rewire.
- 4.5 The beam and the floor joists in the basement were heavily damaged by fire and repair is not possible. The size of replacement structure should meet current design standards.

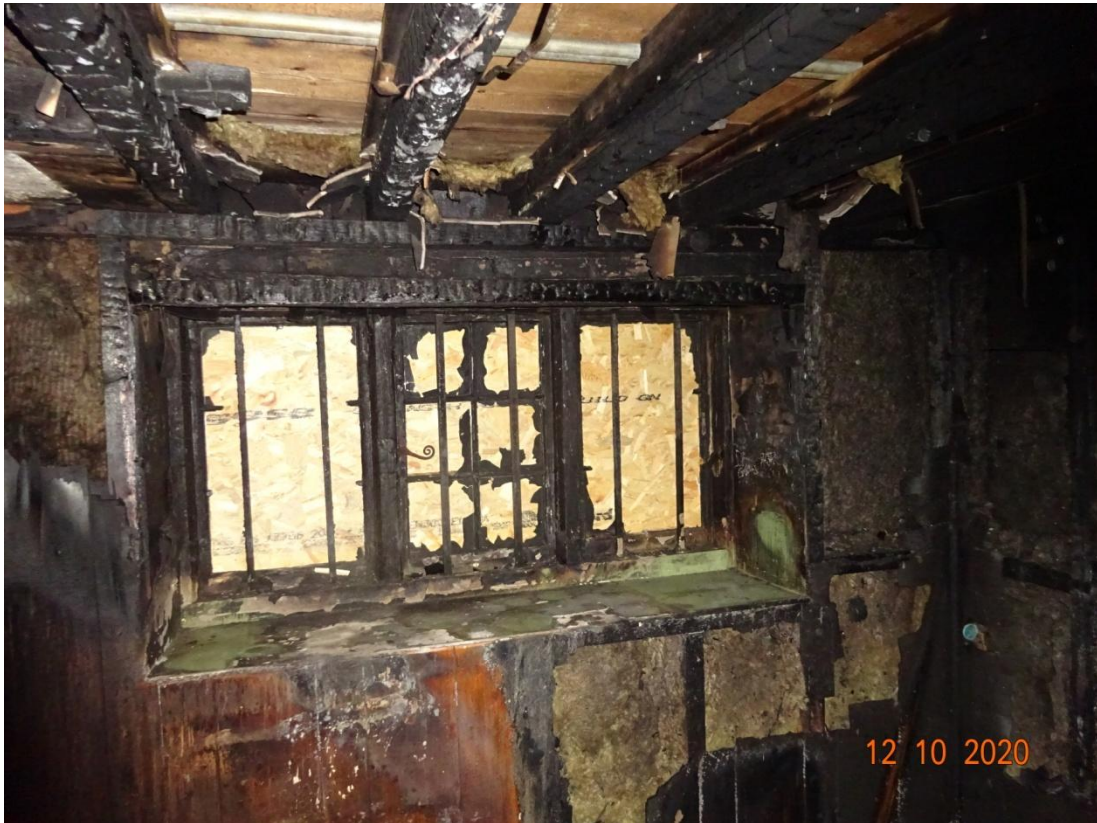
View of fire damaged window in the basement

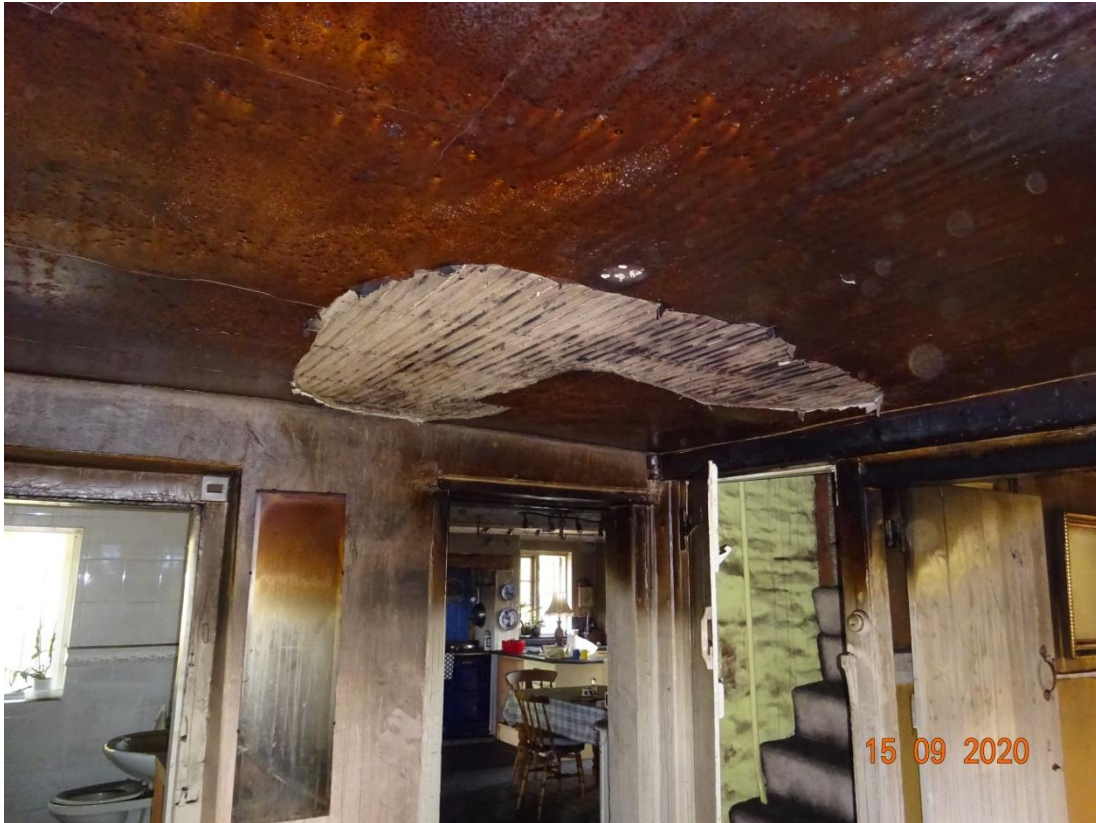
- 3.4 The structural damage appeared to be generally isolated to this area, although in the hall area accessing the kitchen and study a section of the lath and plaster ceiling was noted to have collapsed.

Damaged lath & plaster ceiling in the hall on the ground floor

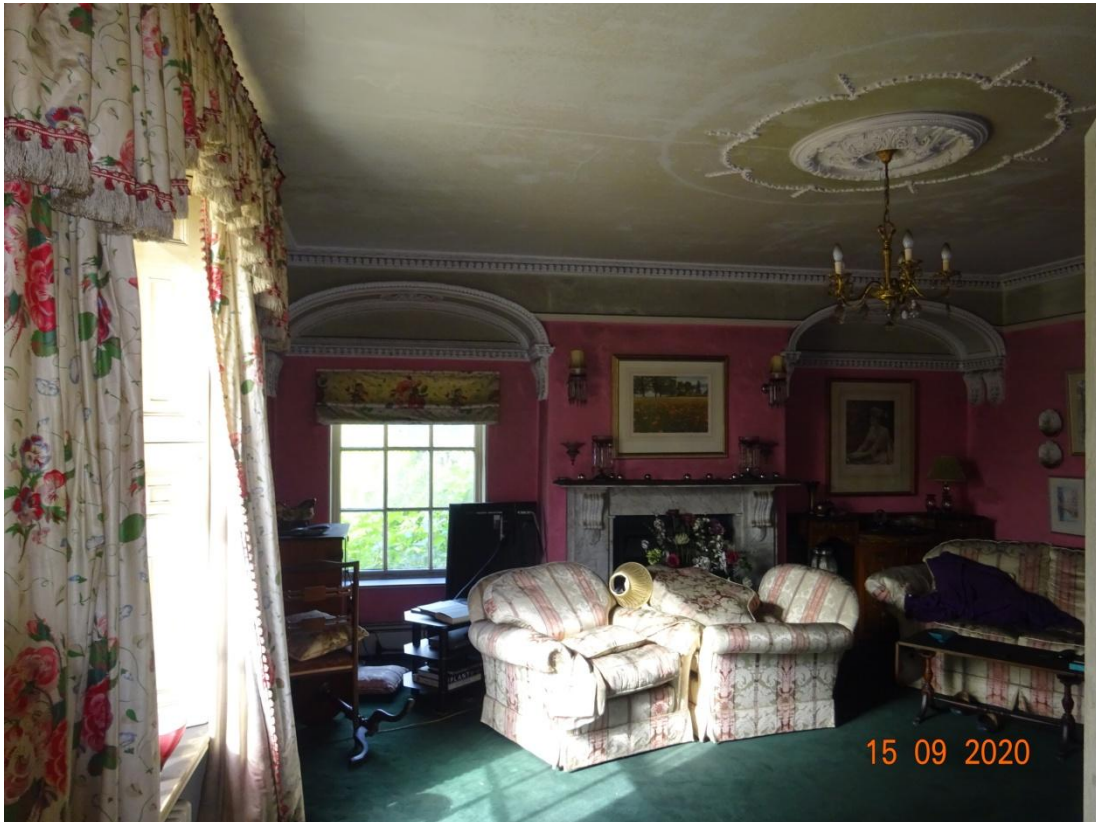
Living room after fire

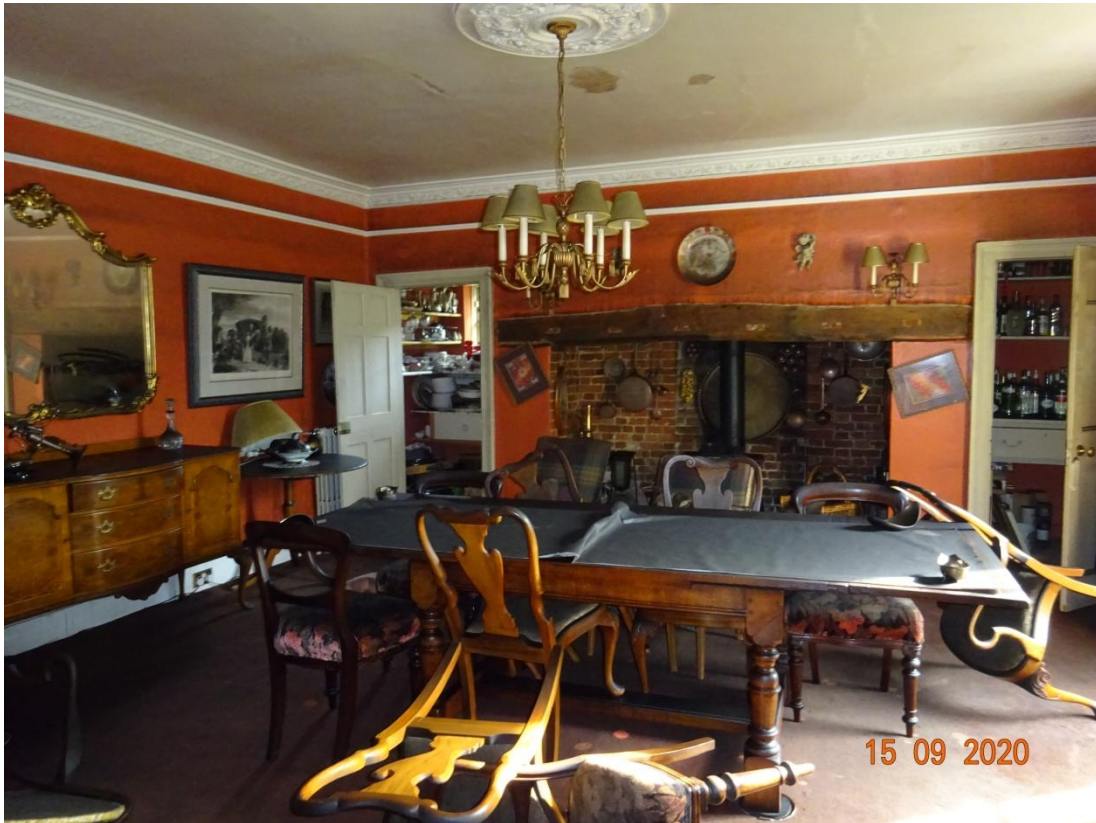
Dining room after fire

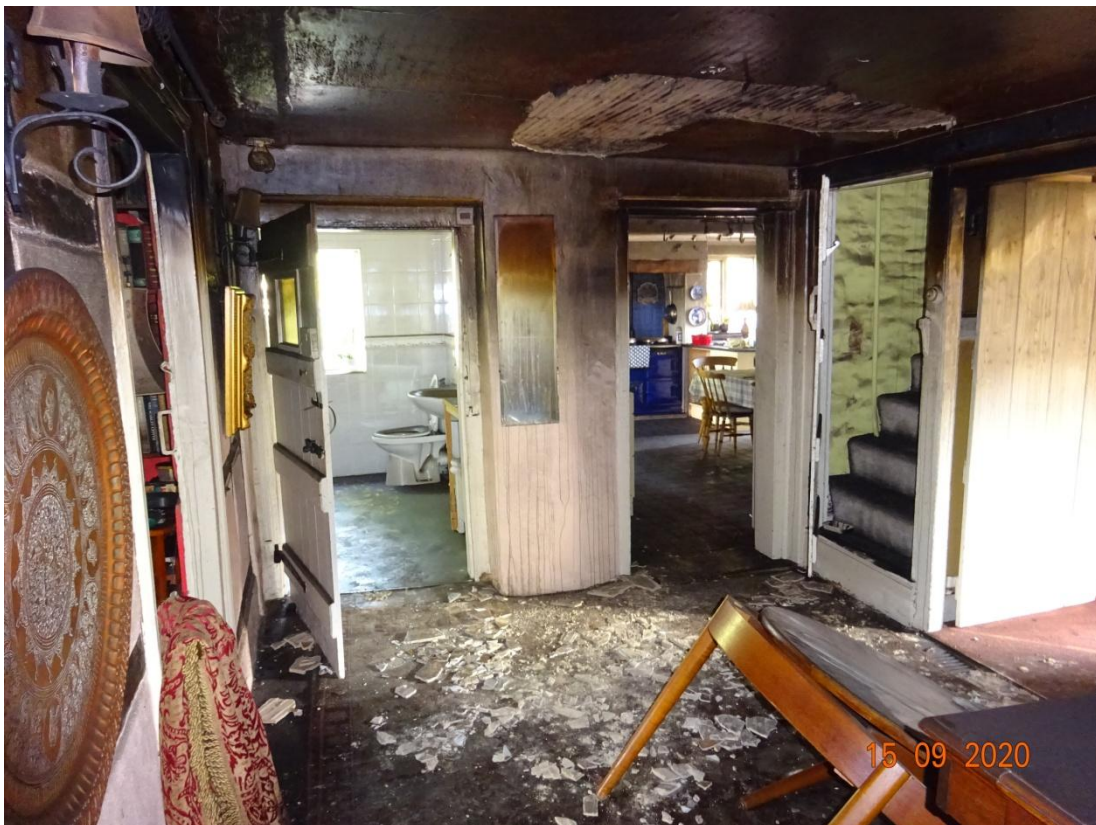
Hall on the ground floor after fire

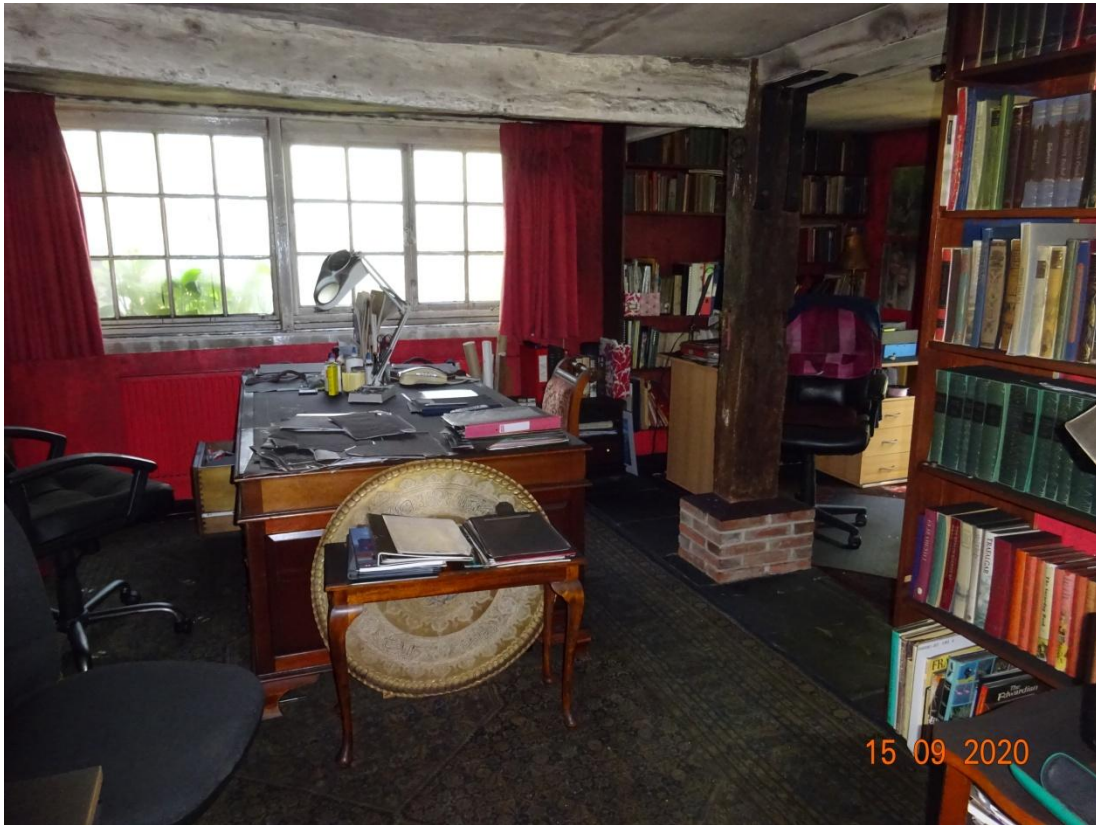
Study after fire

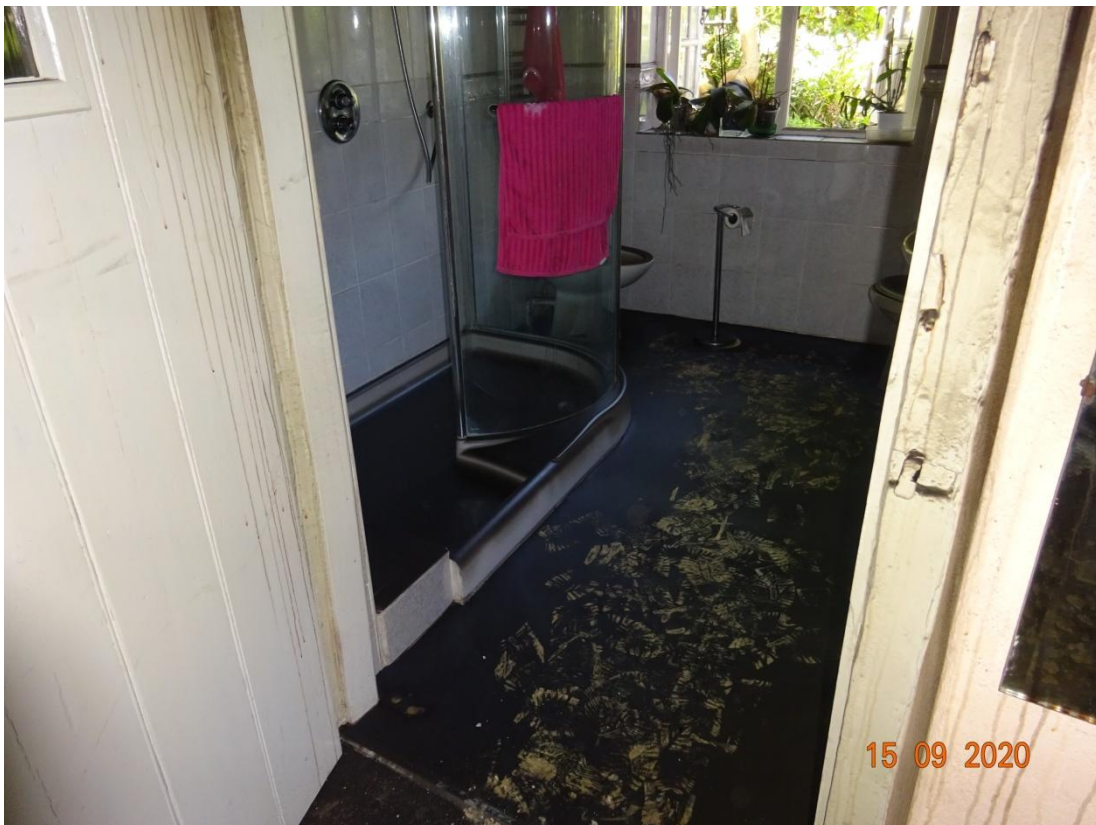
Bathroom on the ground floor after fire

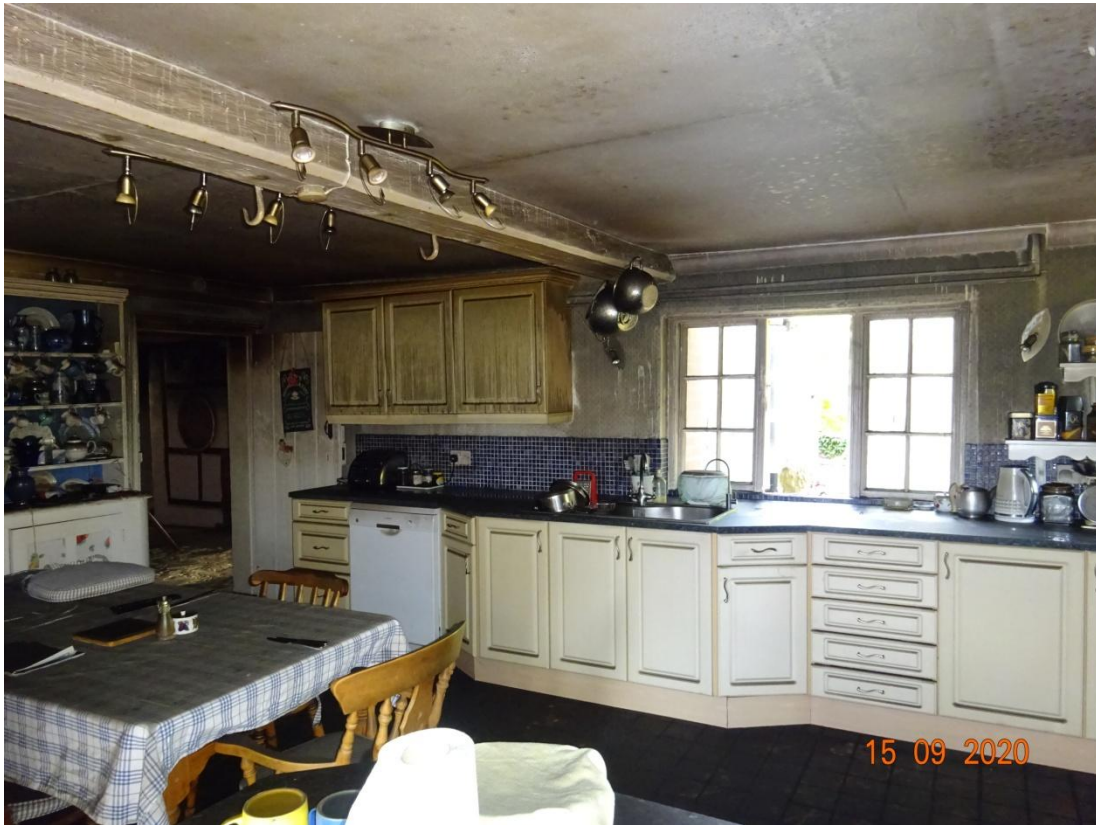
Kitchen after fire

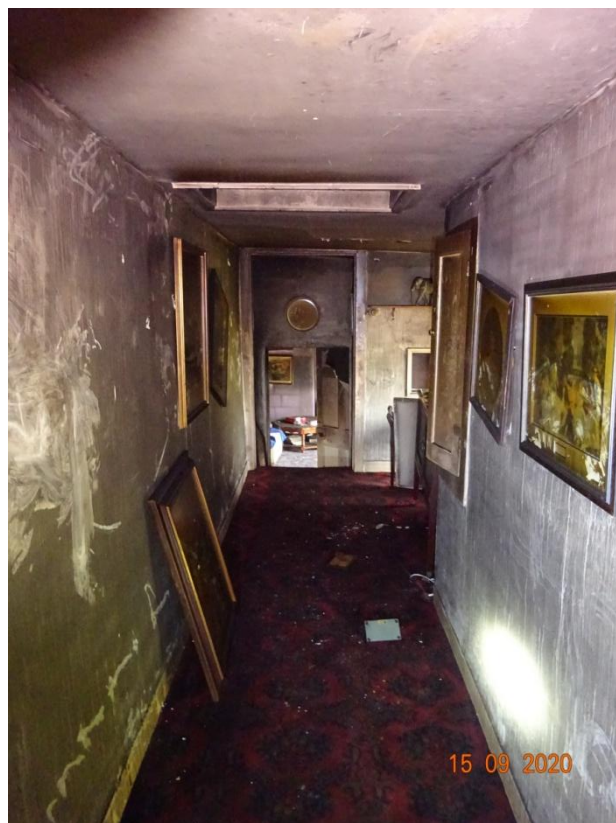
Corridor on the first floor after fire

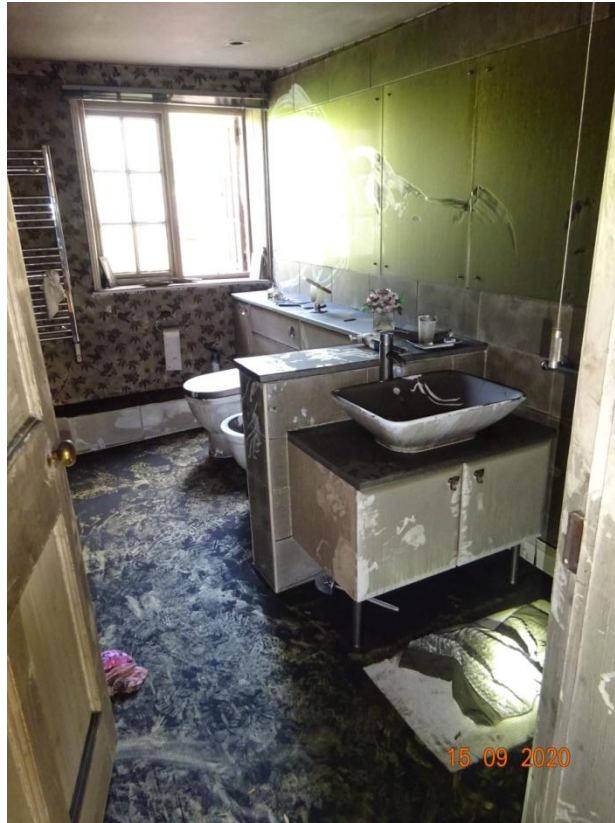
Family bathroom on the first floor after fire

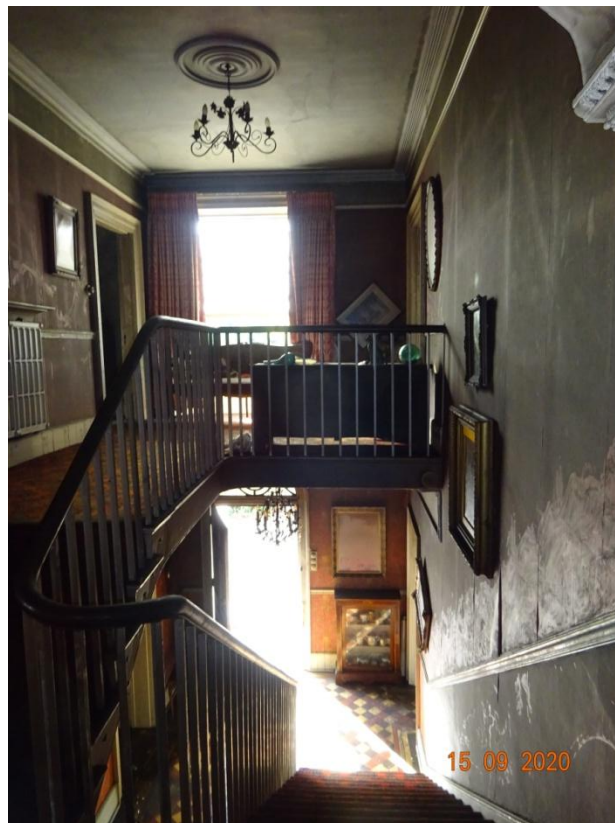
Entrance hall after fire

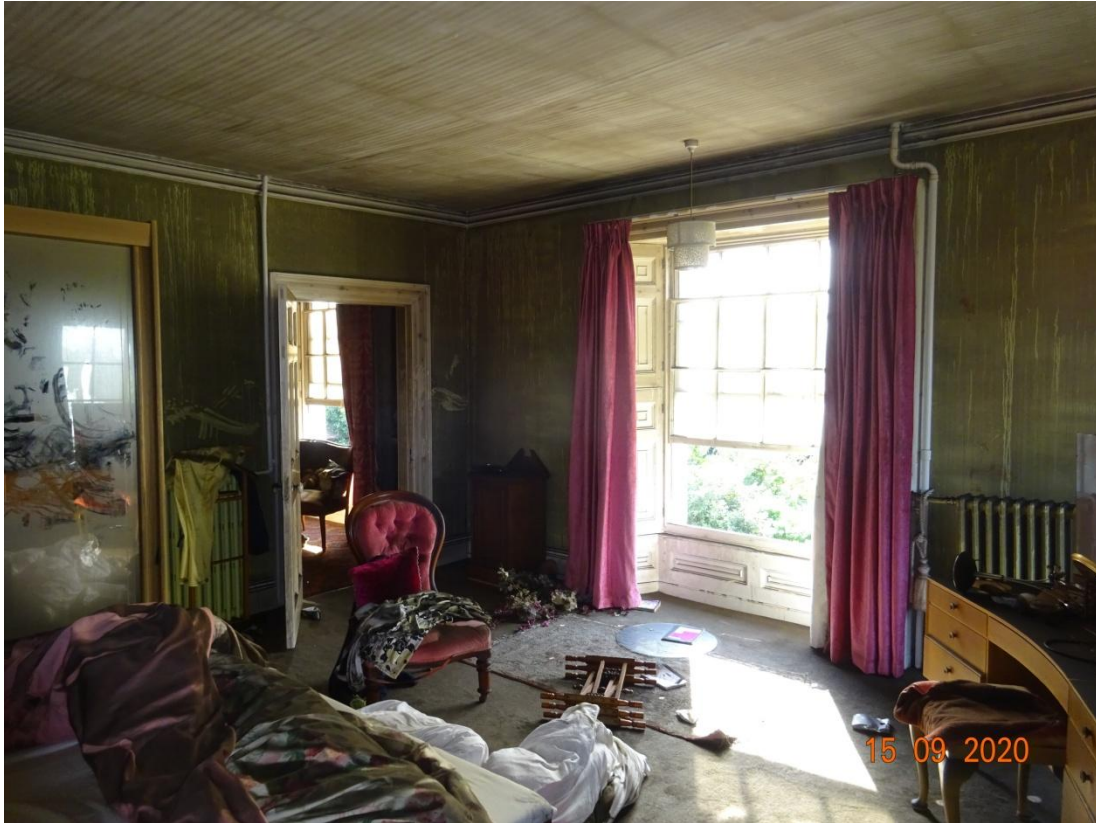
Bedroom 2 after fire

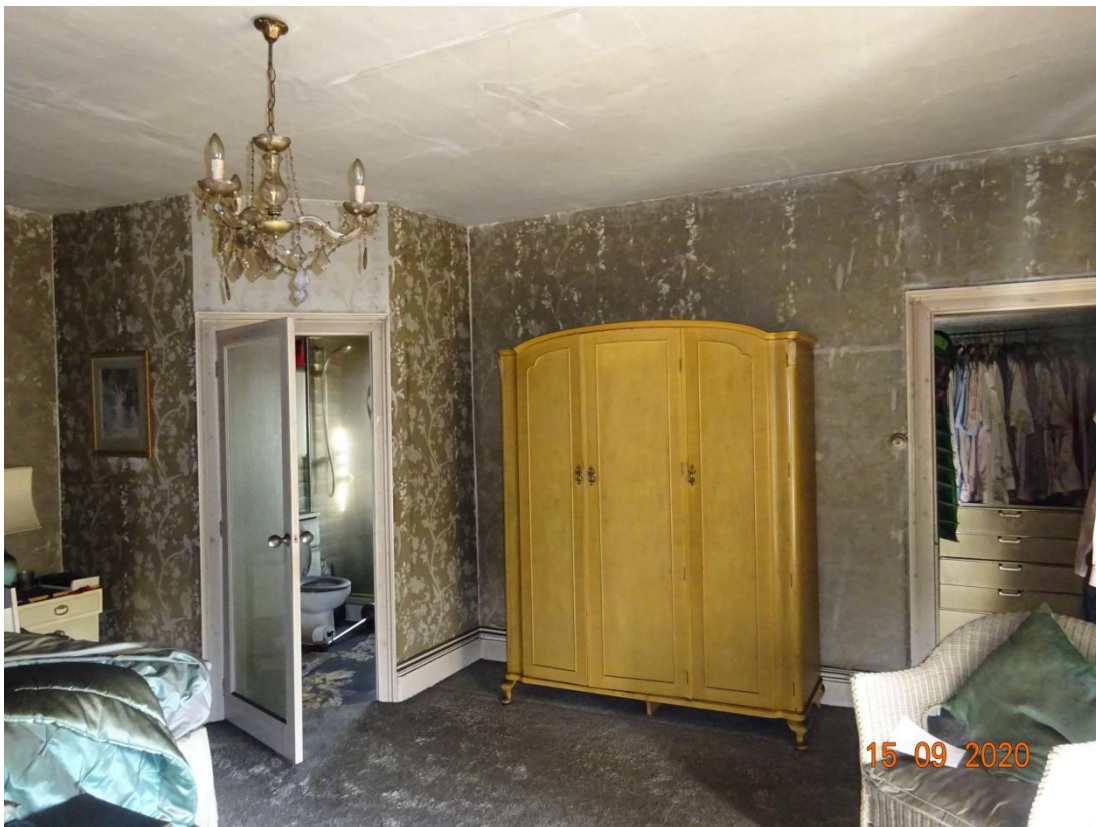
Bedroom 1 & en-suite after fire
