Structural Inspection
Redundant Water Tank
At Kerley Downs
Chacewater

For

Mr F Brannan

Job no 17:7178

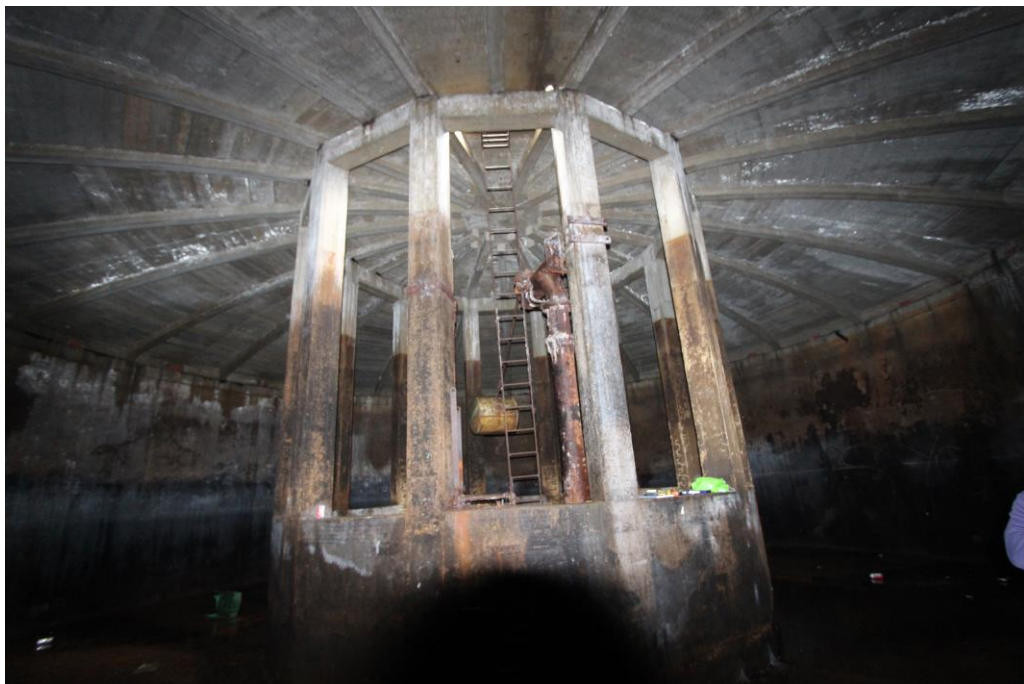
Central ring of columns supporting ribs in roof.

It is proposed to further strengthen the roof by the introduction of a system of further radial beams enable the roof to support additional loading from the proposed new finishes as well as to aid in the support of new internal flooring.

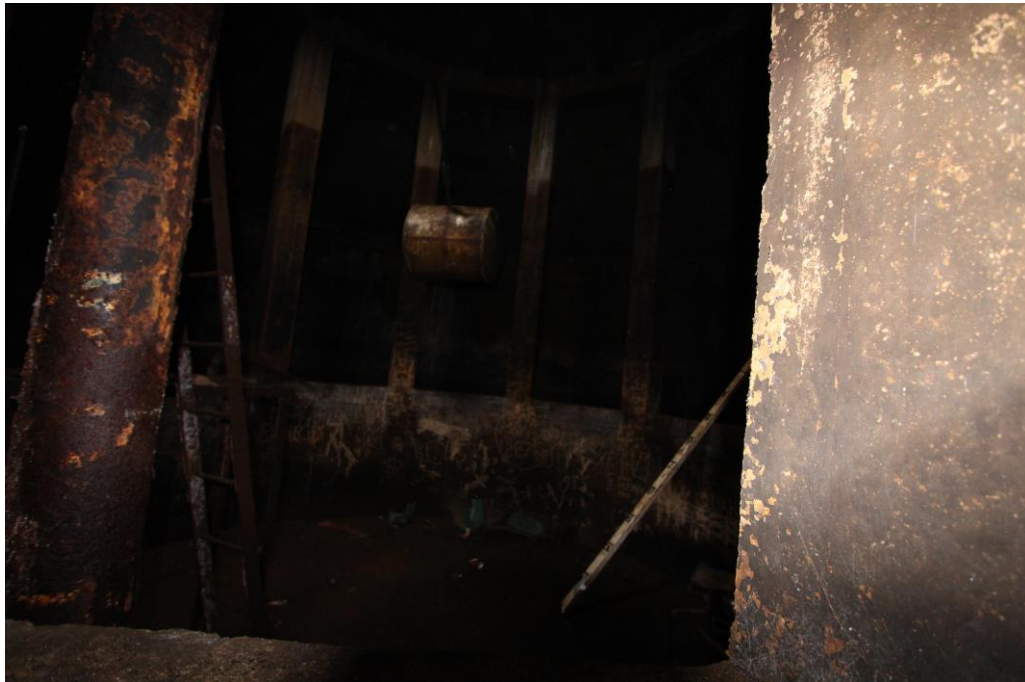
Inspection of the concrete used shows that there is no deterioration of the fabric, the cover being intact in every position inspected. (It should be noted that at the time of the inspections there were no openings in the walls and roof other than a new access doorway and that inside was very dark. Light provided was lost in such a large space).

Condition of the cover to the column.

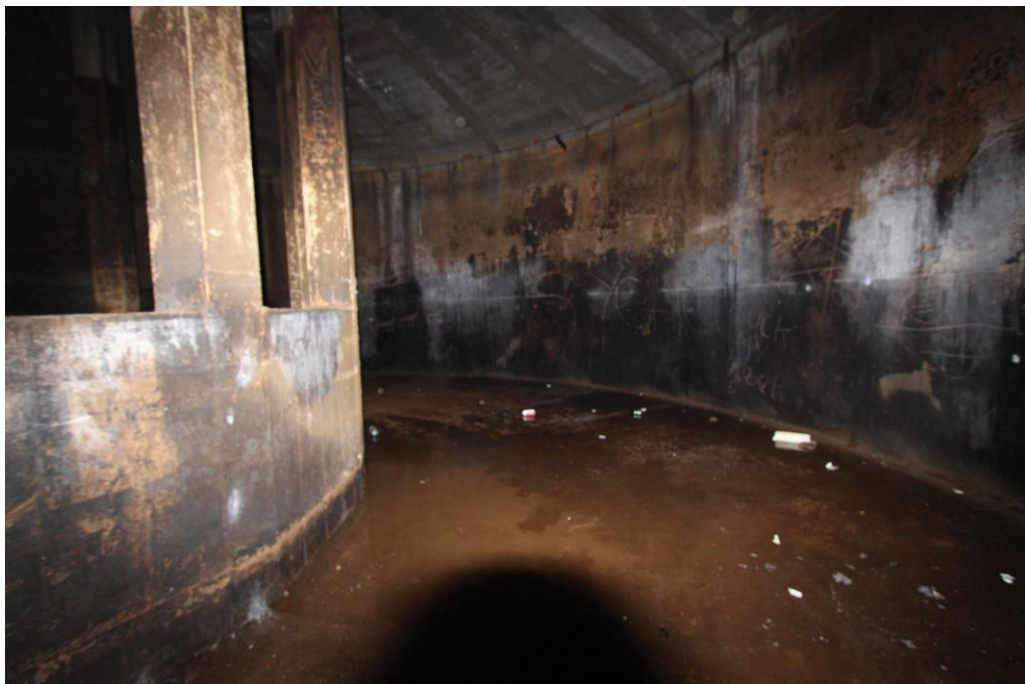
View of central columns and external wall. Wall staining is not rust from the reinforcement.

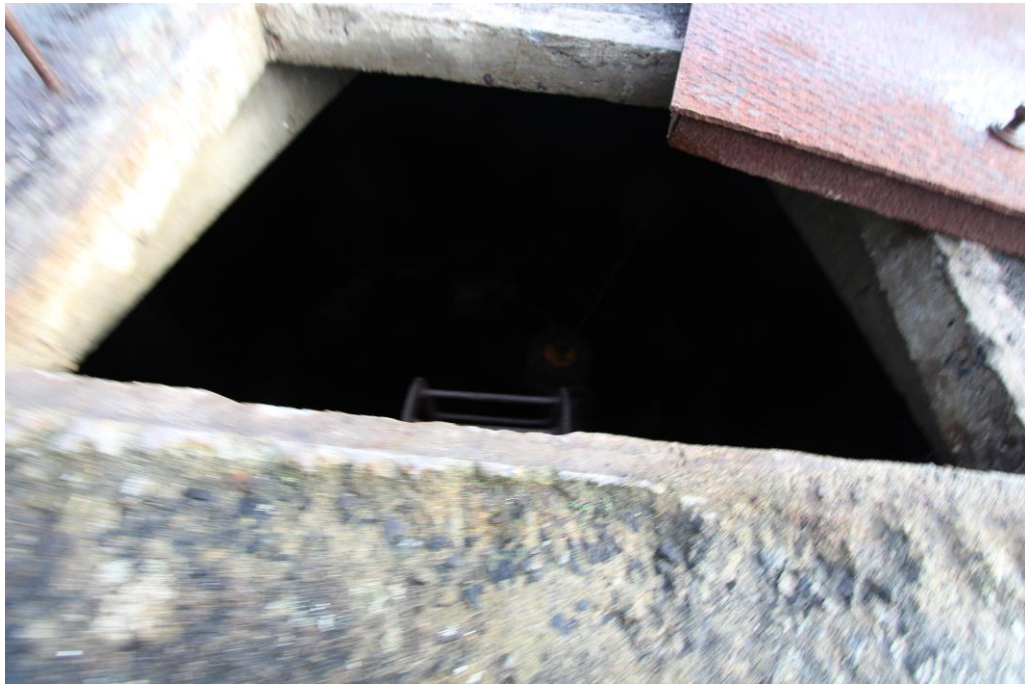
Access hatch in roof.

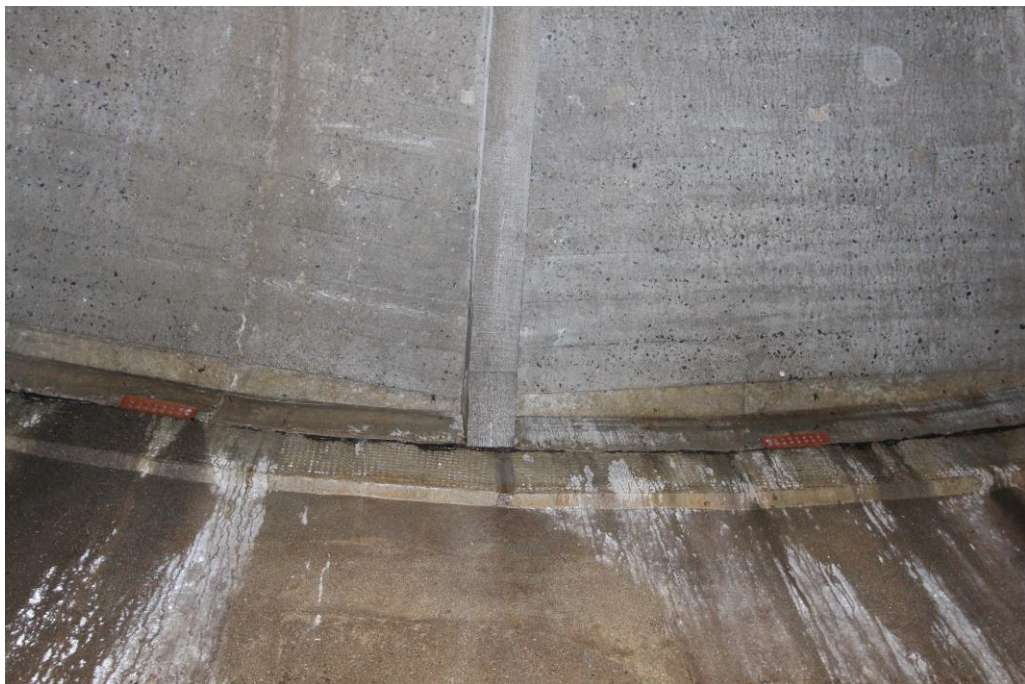
View up wall to junction with roof and ring beam
