# Tree Report

**Haughton Road Retail Park**

Date – 20th October 2020

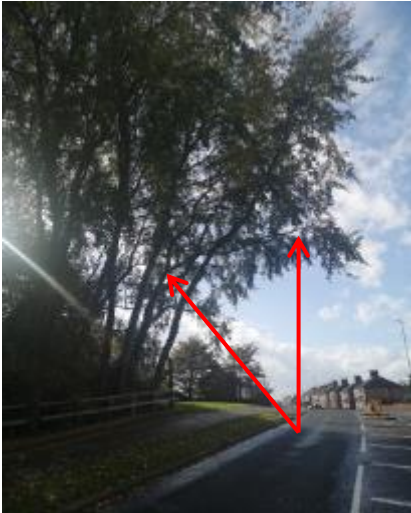
**G1** - A number of the trees are growing at extreme angles out of the embankment over the car park as well as out toward and over Houghton Road (figure 1 & 3). Some trees also have a build-up of waste around the bases (figure 2) which can lead to decay of the base of the stems. The trees do have an aesthetic value to the area and provide some amount of screening from the retail units for the residential properties. It is advised that the leaning tree over the road is removed along with the overextended limb (figure 1) which would subsequently be left exposed. It is recommended that some end weight is removed over the car park area and toward the building (figure 3 & 4) from the more severely leaning trees, to reduce the leverage effect, the remaining group should be monitored on an annual basis due to the high usage of the site.

Figure 1: Leaning tree over main road G1 and over extended limb (arrowed).

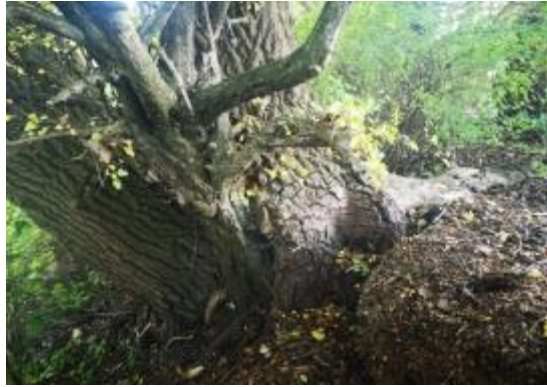
Figure 2: Built up ground around base, G1.

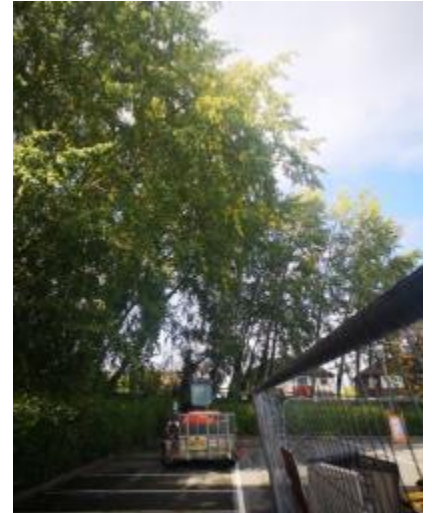
Figure 3: G1 overhanging car park.

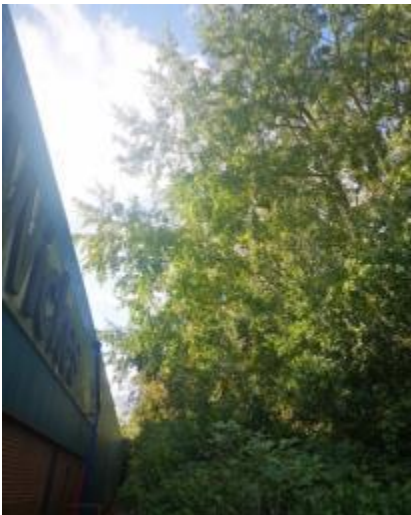
Figure 4: G1 overhanging building.

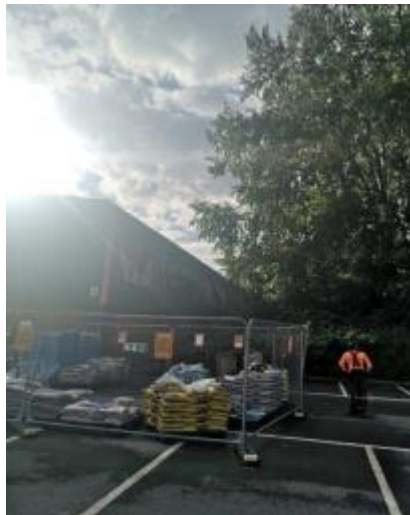
Figure 5: Use of car park spaces under G1.

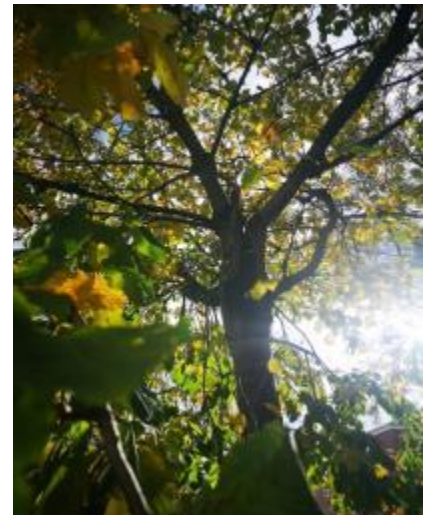
Figure 6: Failed union in T2 recommended for removal.
